## *Structural Inspection*

| <i>Project:</i> | <i>Bridge Farm<br/>Twycross Road<br/>Sibson<br/>Leicestershire</i> |
| <i>Project No:</i> | <i>23-20197</i> |

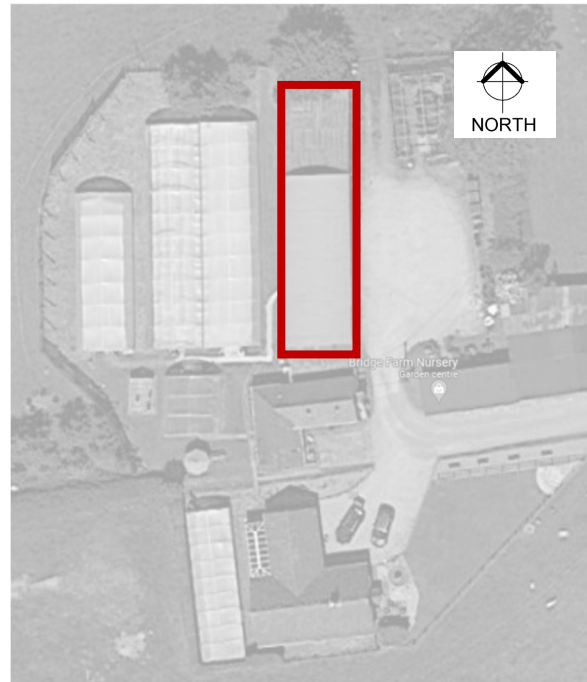
Figure 1

- 2.1. The agricultural building inspected is an independent structure forming part of an existing farm complex. [Figure 1]
