# GeoShield Verification Report 01

GEO105396

R4 Civils,  
Barlestone,  
Barton Road,  
Osbaston  
Nuneaton,  
CV13 0EU

JUTA GP1 Gas Barrier  
JUTA GP1 SAM

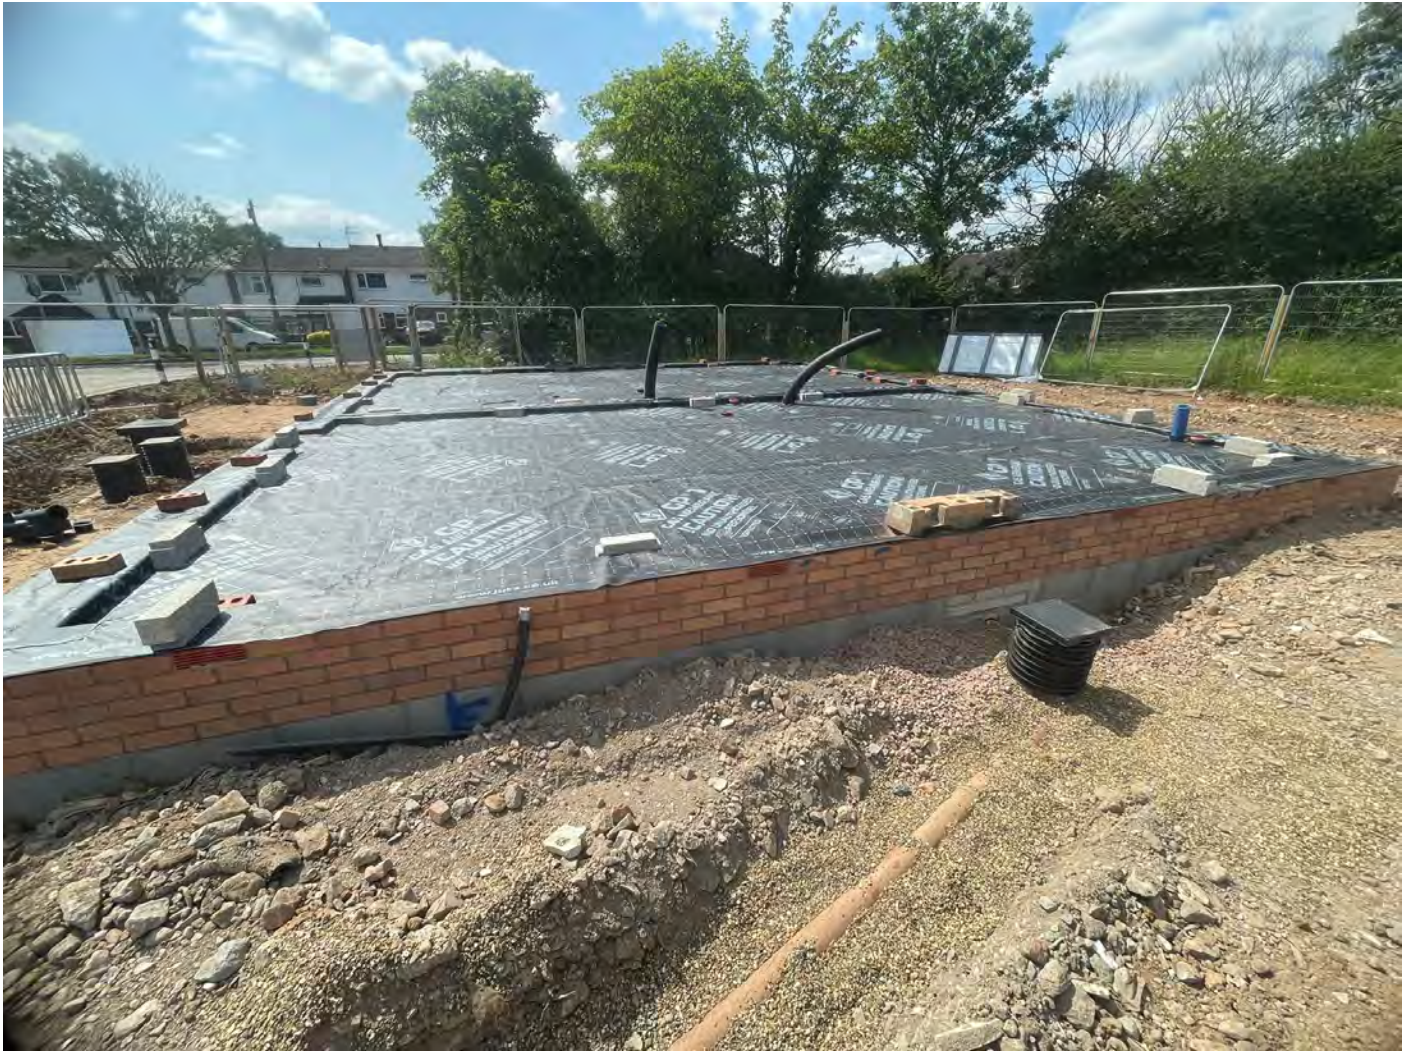
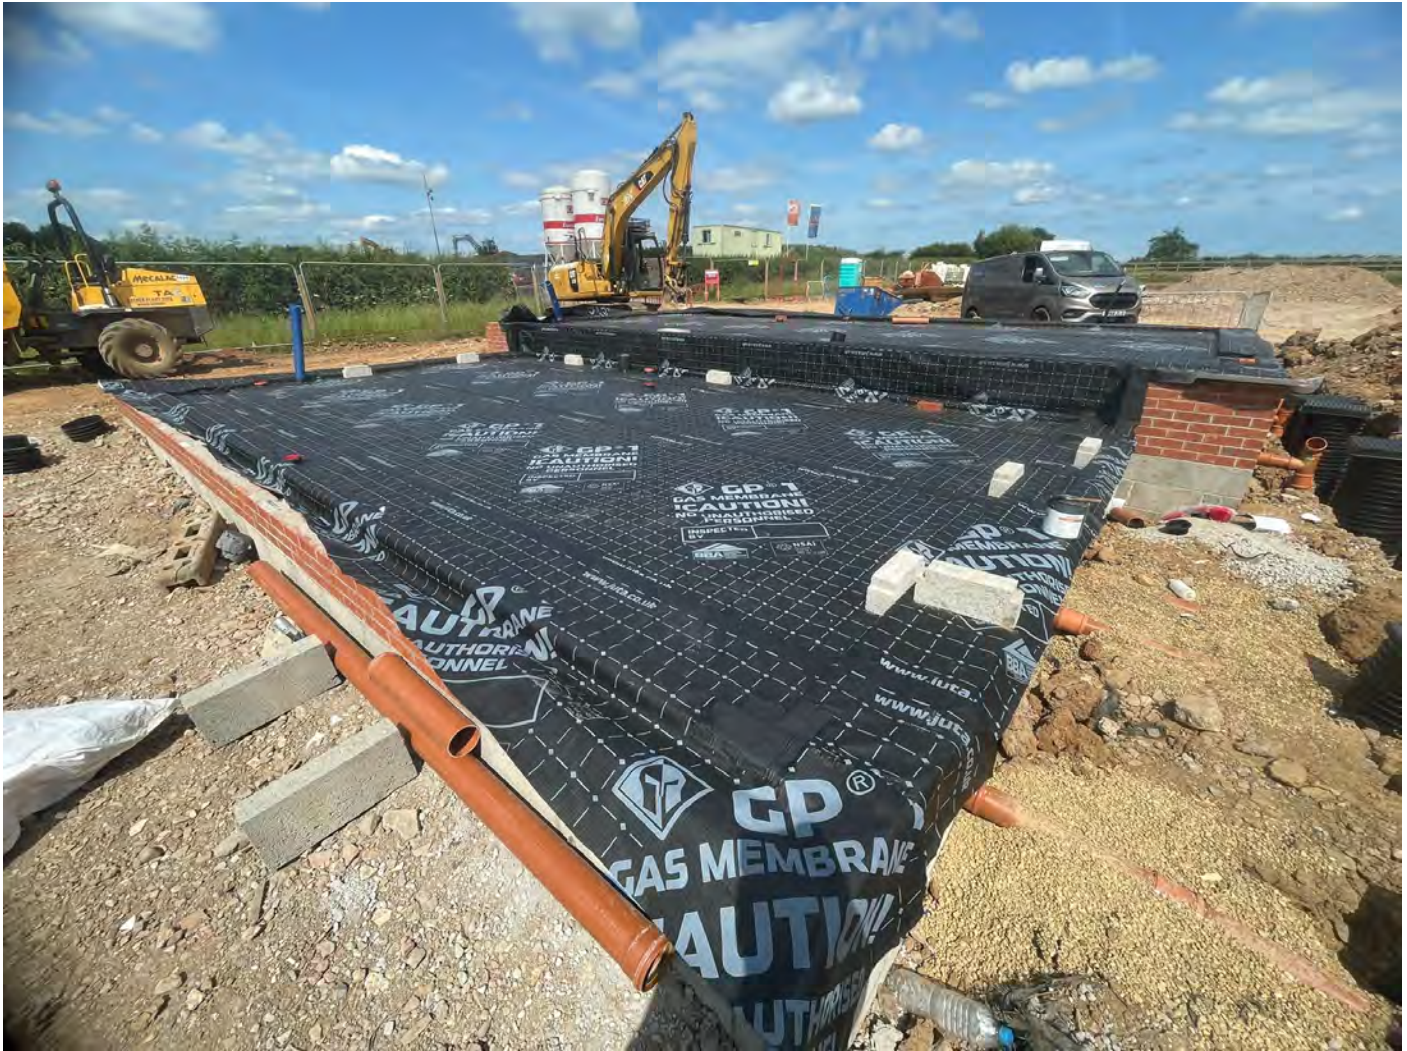
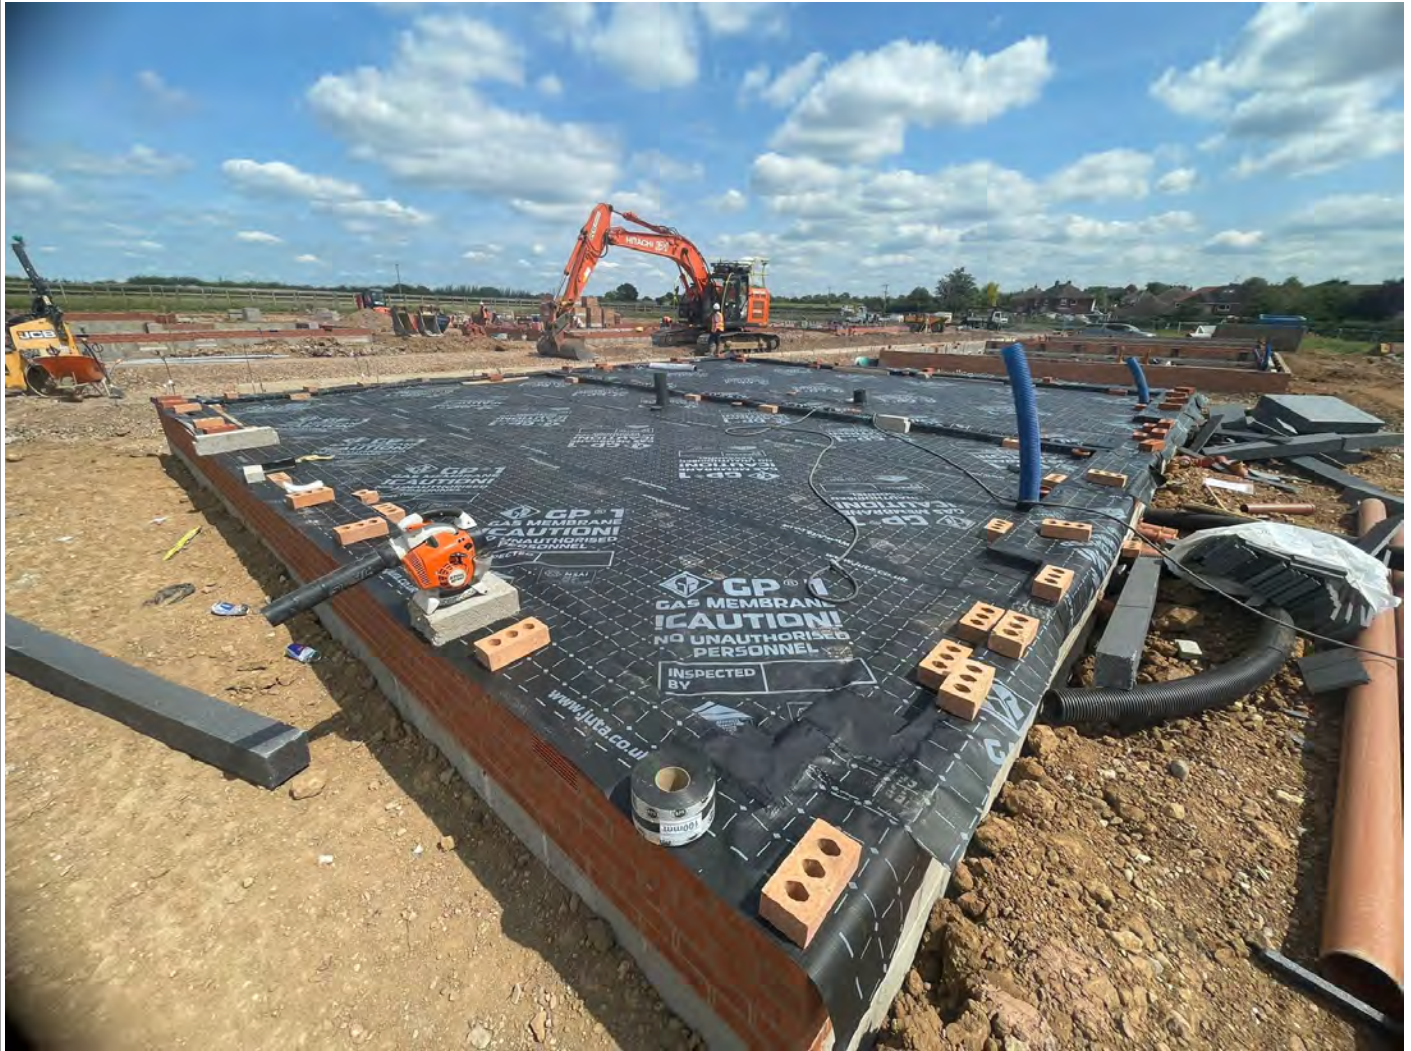
The photograph above displays an overview of the area where today's verification inspection took place on site.

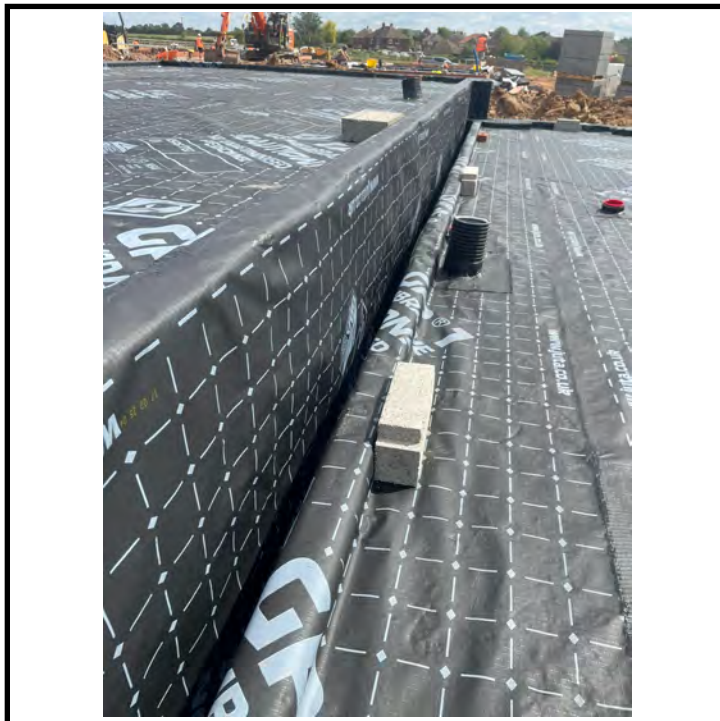
A complete line out of the JUTA GP1 Gas Barrier has been installed across the footprint of plots 1, 2, 3, 4, 35 & 36. The JUTA GP1 Gas Barrier has been installed across substrates, the perimeter walls and also on the dropdown within plots 3 & 4. This has been installed tightly to the dropdown wall as well as creating a

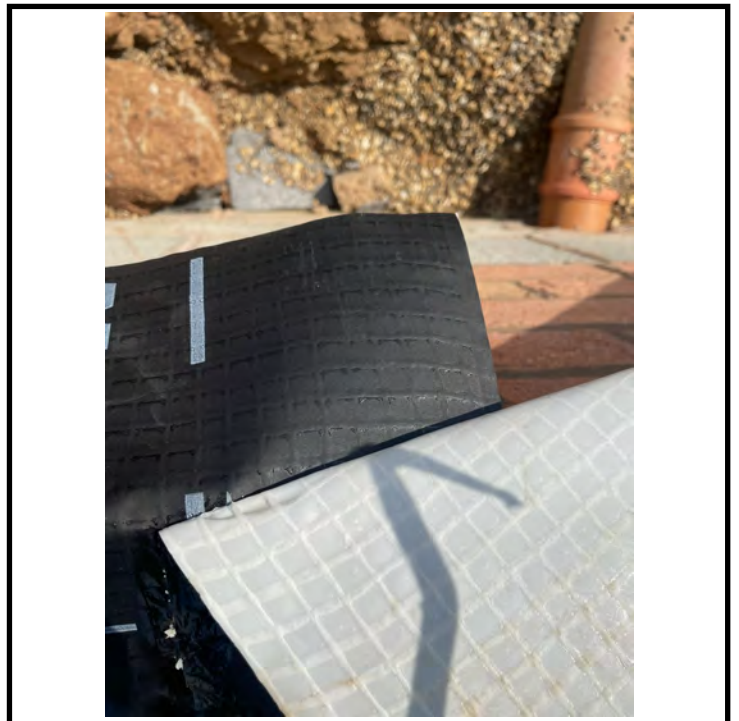
cavity for the groundworkers to place insulation at a later date. All lap joints between the adjacent sheets of JUTA GP1 Gas Barrier have been overlapped a minimum of 100mm and heat welded using a hot air leister and a silicone roller, with adequate pressure applied to ensure a continuous weld is achieved.

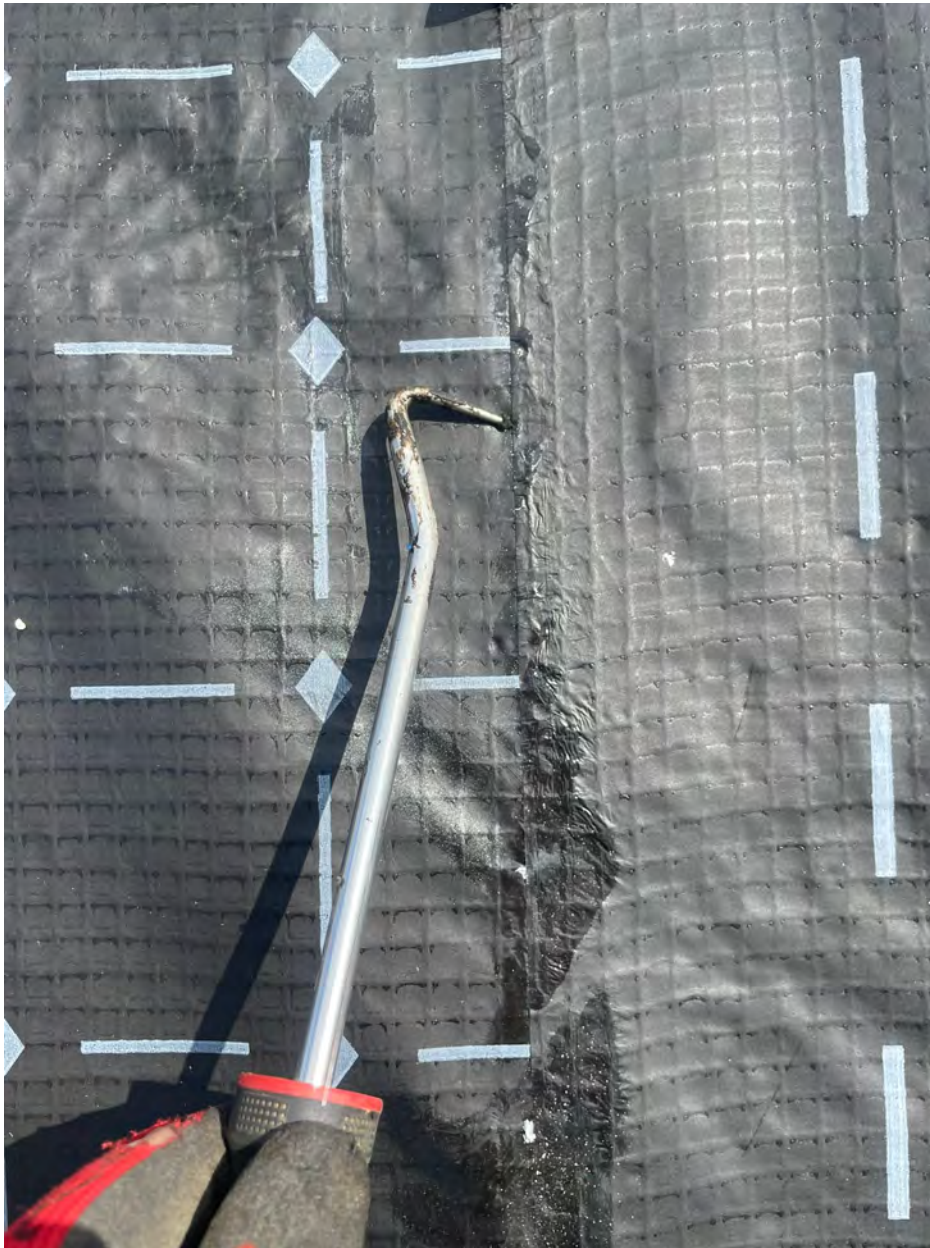
Installed in accordance with manufacturer's specifications. The above photograph displays a mechanical point stress test, also known as a pick and probe test being conducted upon a welded lap joint of the JUTA GP1 Gas Barrier. All lap joints were subjected to thorough mechanical point stress testing and non destructive air lance integrity testing throughout the installation. No faults or defects were identified at the time of the inspection.

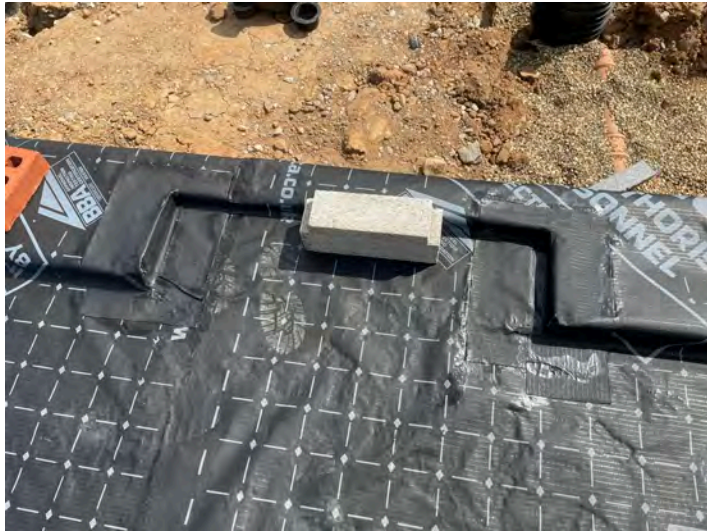
A number of corners and thresholds throughout the referenced plots have been sealed as per manufacturer's specifications and design guidelines. This has been achieved using JUTA GP1 SAM. The JUTA GP1 Gas Barrier has been cut to minimise any voided areas and gaps across the footprint of the referenced

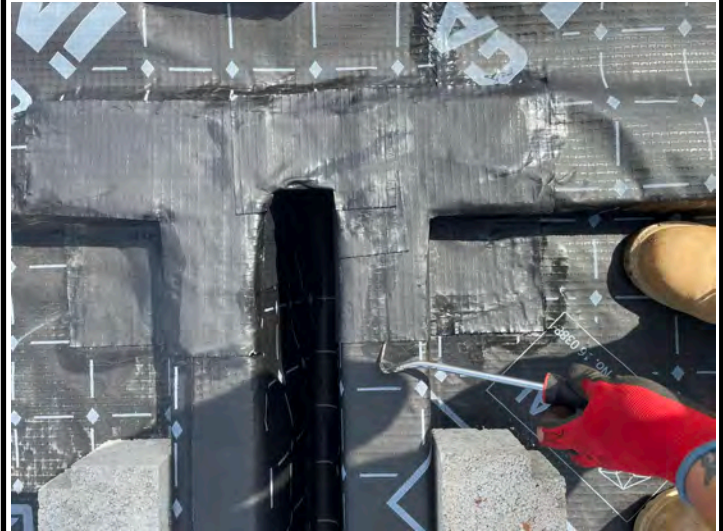
plots. Each corner and threshold junction has been reinforced by heating strips of JUTA GP1 SAM and placing them into position around each corner, onto the JUTA GP1 Gas Barrier. Firm rolled pressure is applied with a silicone roller to aid in the adhesion ensuring the JUTA GP1 SAM has fully bonded.

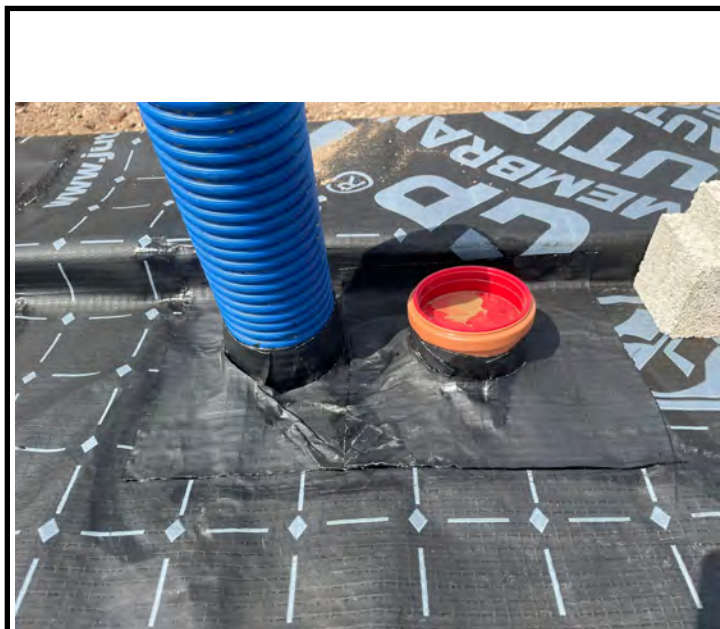
Throughout the installation of the JUTA GP1 Gas Barrier to the referenced plots, there were a number of pipe penetrations that have been sealed in accordance with manufacturer's specifications and design guidelines. This has been achieved using JUTA GP1 SAM, which is a self adhesive membrane.

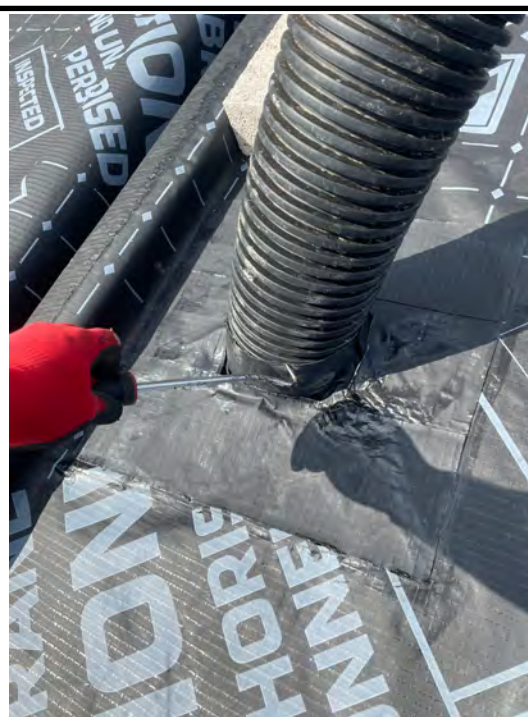
The installers have first cut the JUTA GP1 Gas Barrier tight around the base of each pipe penetration to minimise voided areas. Next, strips of JUTA GP1 SAM are placed intricately in a top hat formation around the pipe penetration and onto the JUTA GP1 Gas Barrier. Heat and rolled pressure is applied to activate the bitumen backing.

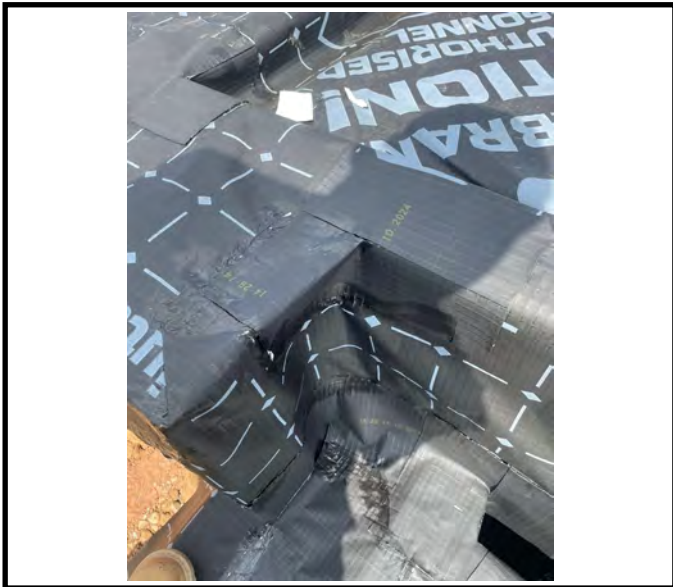
Sealed corner detailing.

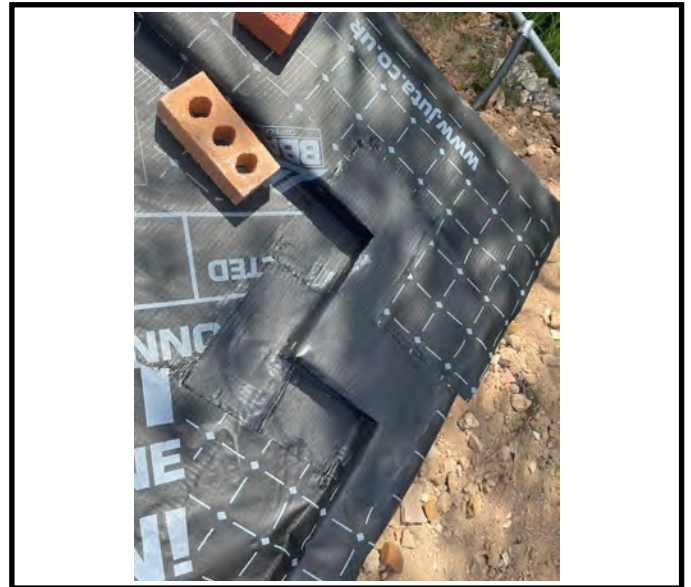
Sealed corner detailing.

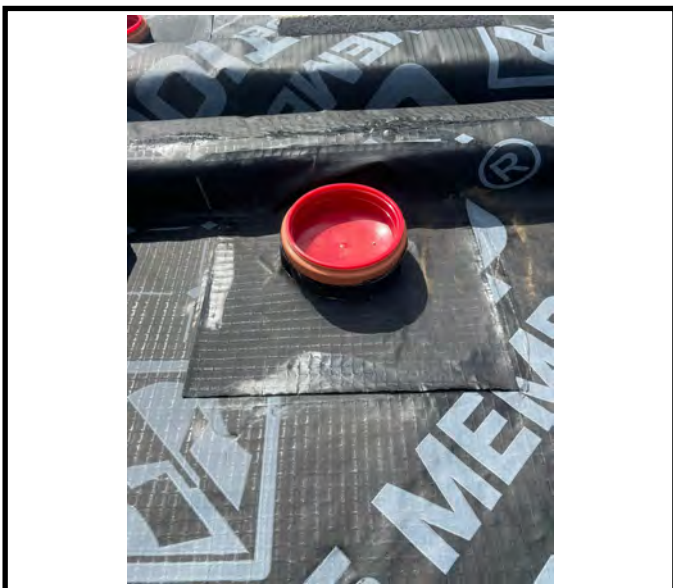
A sealed pipe penetration.

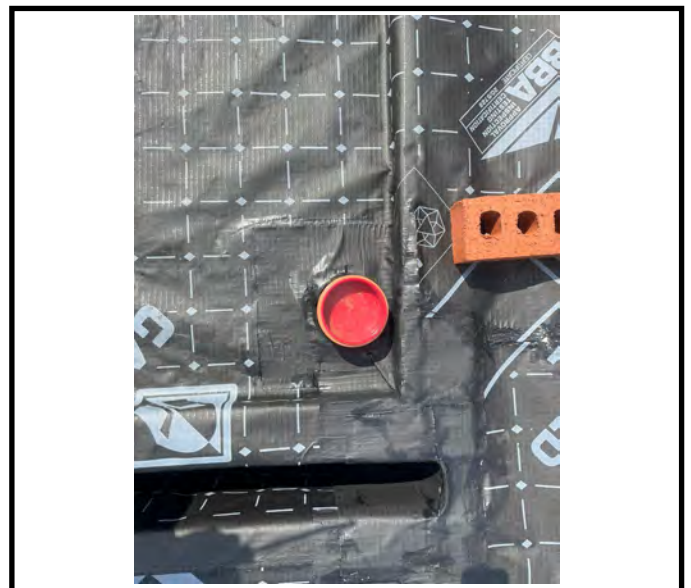
Sealed corner and sealed pipe penetration detailing.

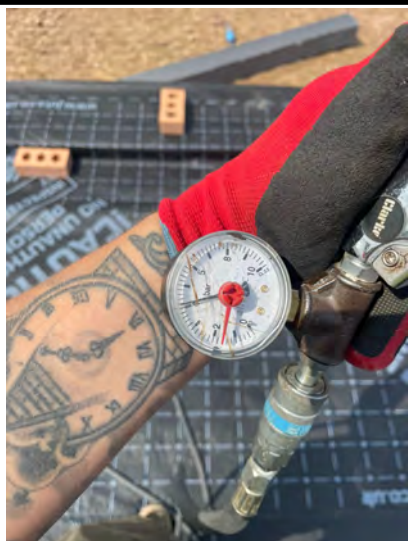
Correct pressure achieved.

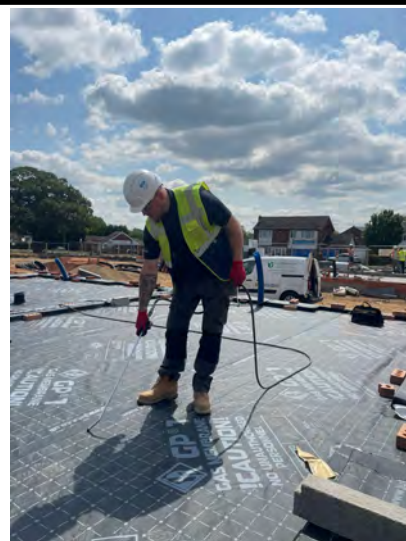
Air lance testing on a welded lap joint.

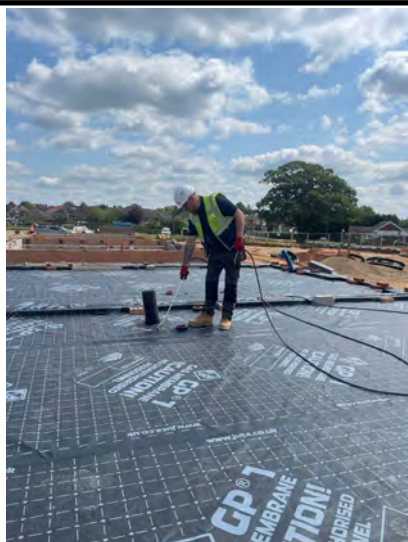
Air lance testing on a pipe penetration.

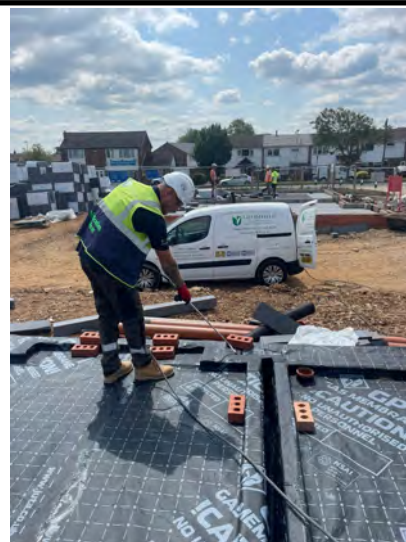
Air lance testing on a sealed corner.
