# GeoShield Verification Report 02

GEO105396

R4 Civils,  
Barlestone,  
Barton Road,  
Osbaston  
Nuneaton,  
CV13 0EU

Plots 41 & 42 - Full Line Out

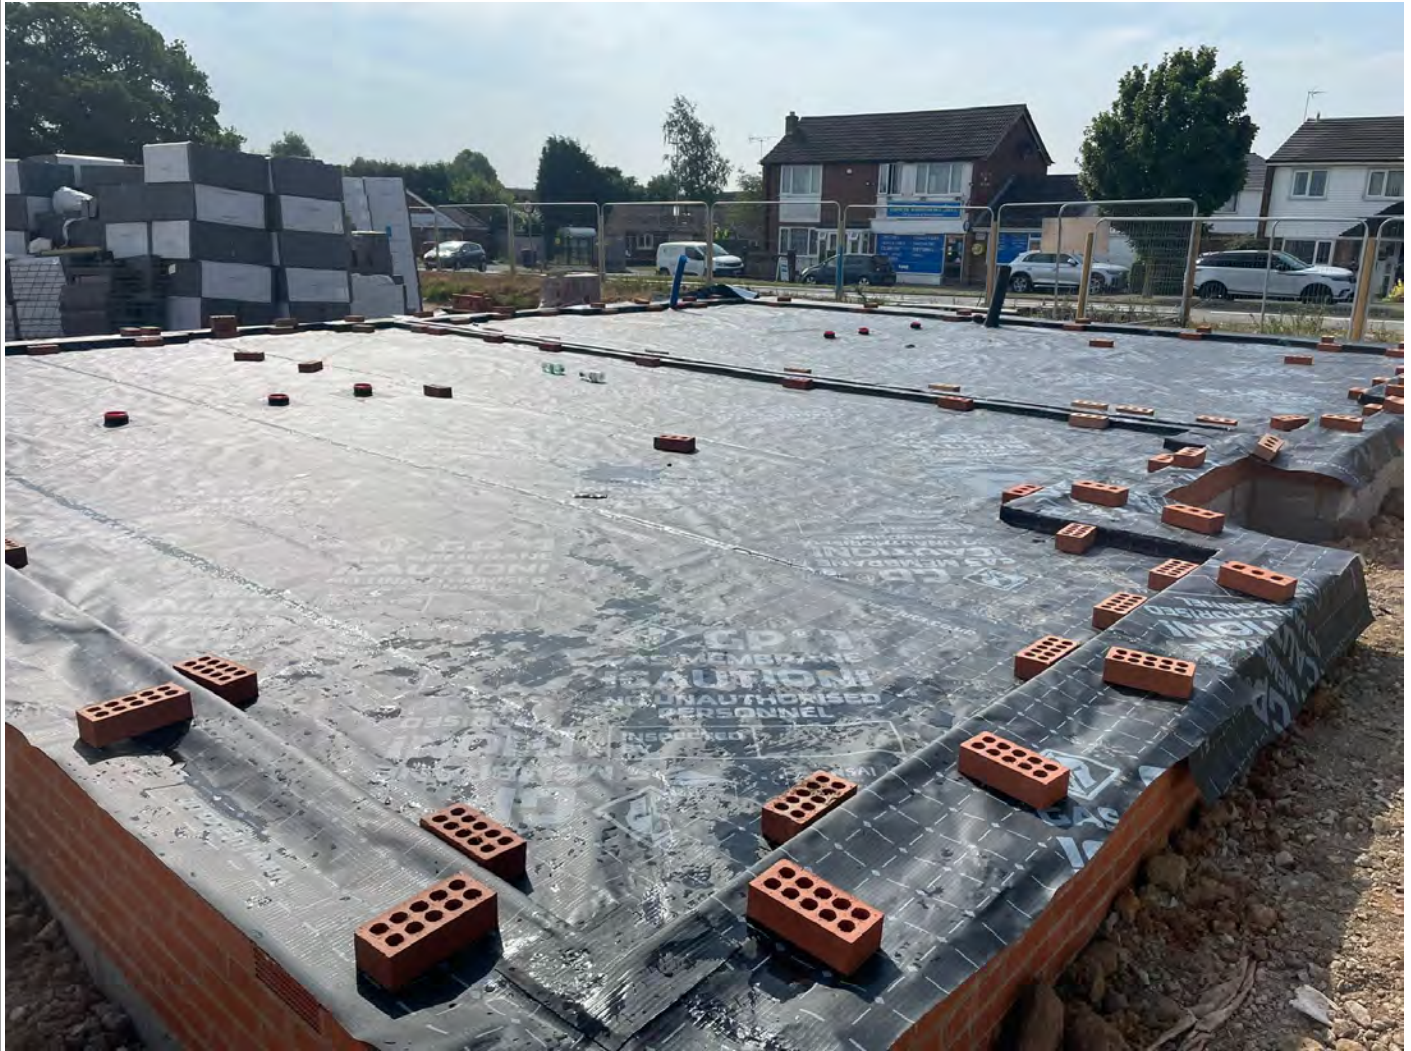
The photograph above displays an overview of the area where today's verification inspection took place on site.

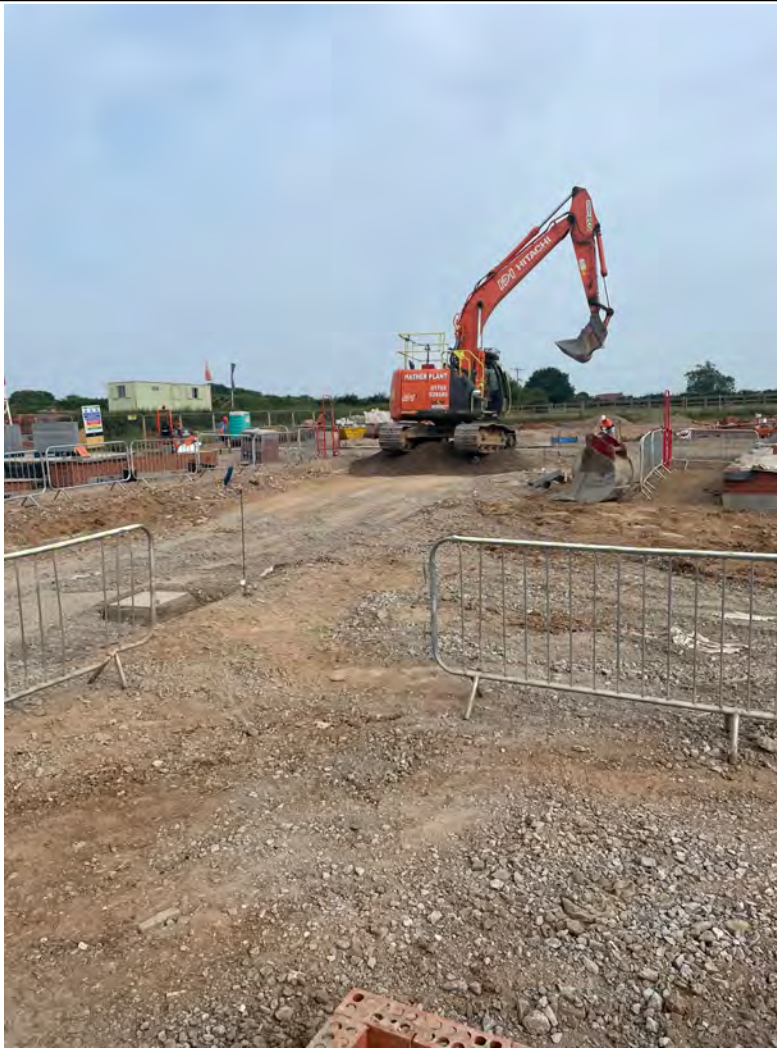
INSPECTED AREA: Plots 41 & 42 - Full Line Out

Air Lance testing could not be carried out due to restricted vehicle access to the area requiring verification today. To mitigate this issue, thorough visual inspections supported by mechanical point stress testing were conducted.

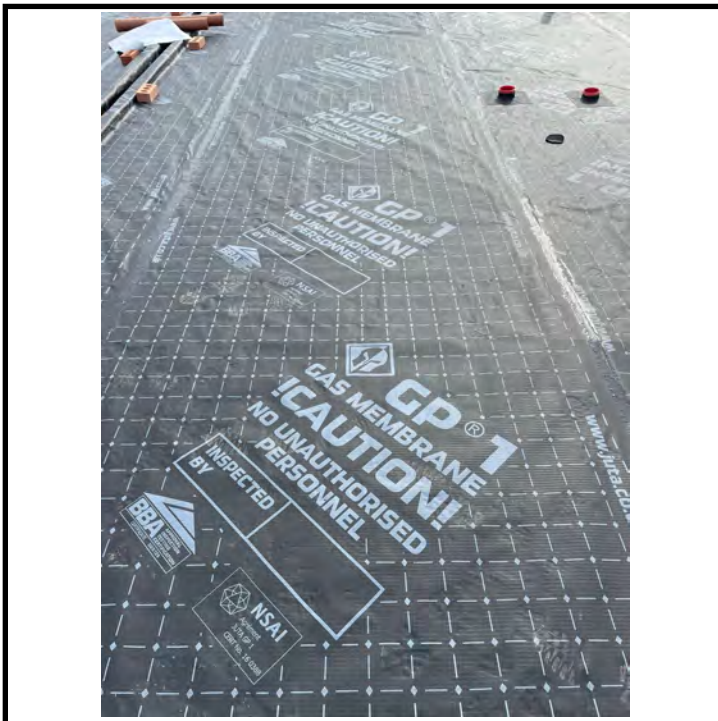
A complete line out of the JUTA GP1 Gas Barrier has been installed across the footprint of plots 41 & 42. The JUTA GP1 Gas Barrier has been lined across the entirety of the plots, including the internal party walls and external cavities to ensure continuity throughout.

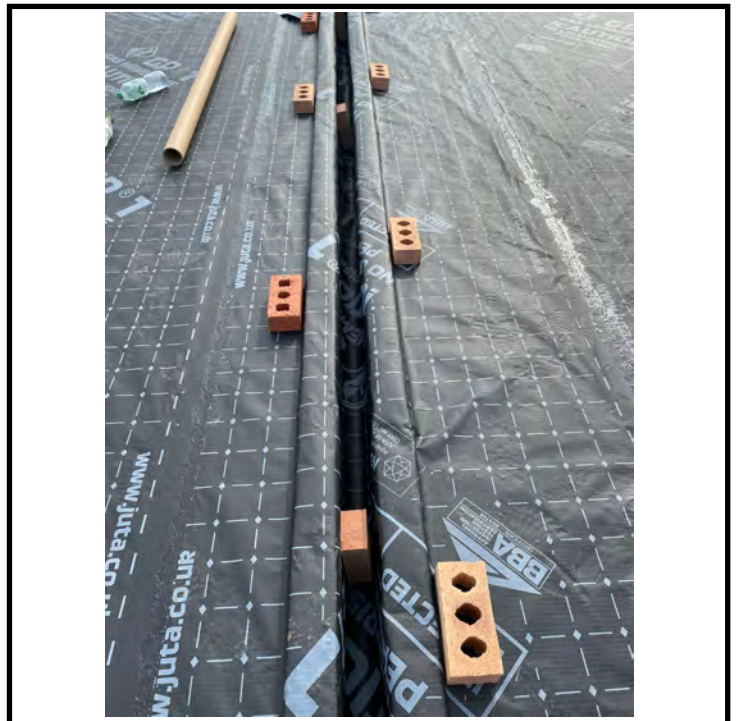
All lap joints between the adjacent sheets of JUTA GP1 Gas Barrier have been overlapped a minimum of 100mm and heat welded using a hot air leister and a silicone roller with adequate pressure applied to ensure a continuous weld is achieved. Installed in accordance with manufacturer's specifications.

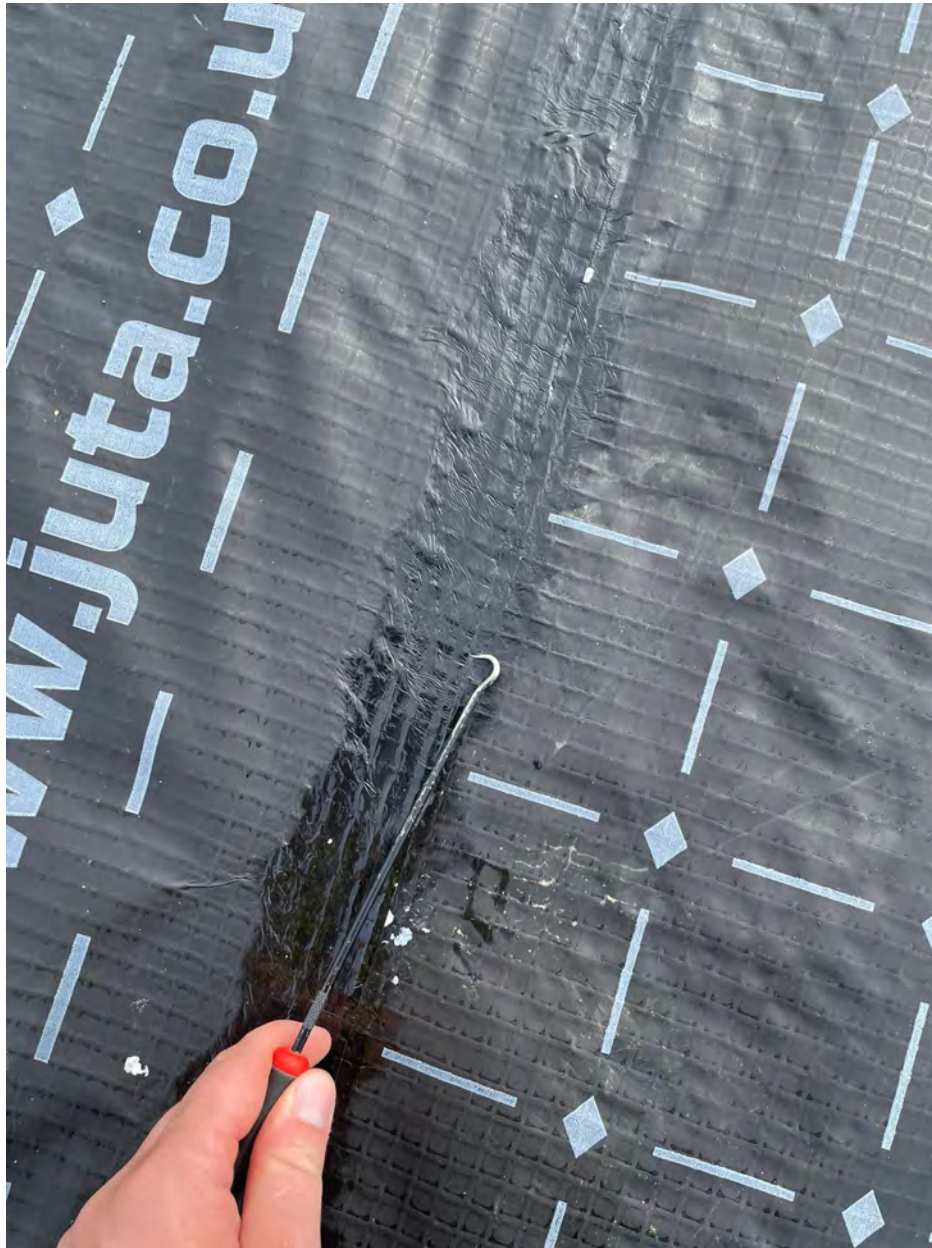
The above photograph displays a mechanical point stress test, also known as a pick and probe test, being conducted upon a welded lap joint of the JUTA GP1 Gas Barrier. All lap joints were subjected to thorough mechanical point stress testing throughout the installation. No faults or defects were identified during today's inspection.

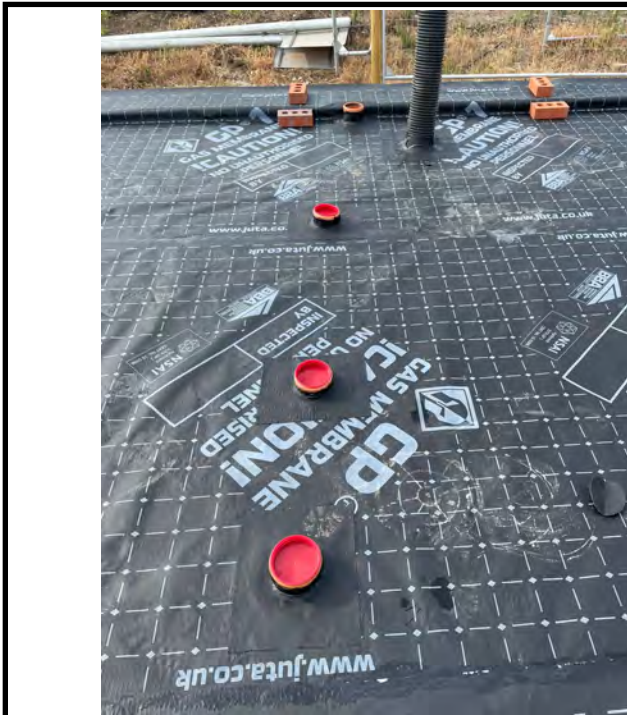
Throughout the installation of the JUTA GP1 Gas Barrier to the referenced plots, there were a number of pipe penetrations that have been sealed in accordance with manufacturer's specifications and design guidelines. This has been achieved using JUTA GP1 SAM which is a self adhesive membrane.

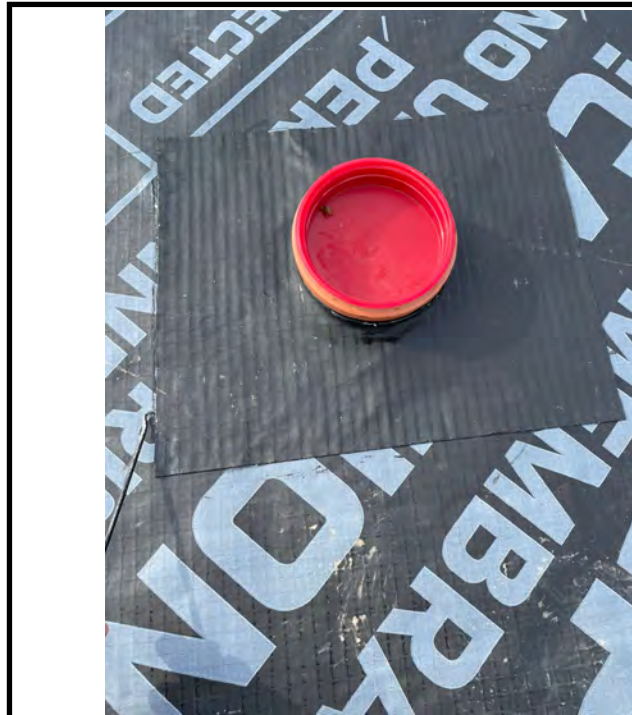
The installers have first cut the JUTA GP1 Gas Barrier tight around the base of each pipe penetration to minimise voided areas. Next, strips of JUTA GP1 SAM are placed intricately in a top hat formation around the pipe penetration and onto the JUTA GP1 Gas Barrier. Heat and rolled pressure is applied to activate the bitumen backing,

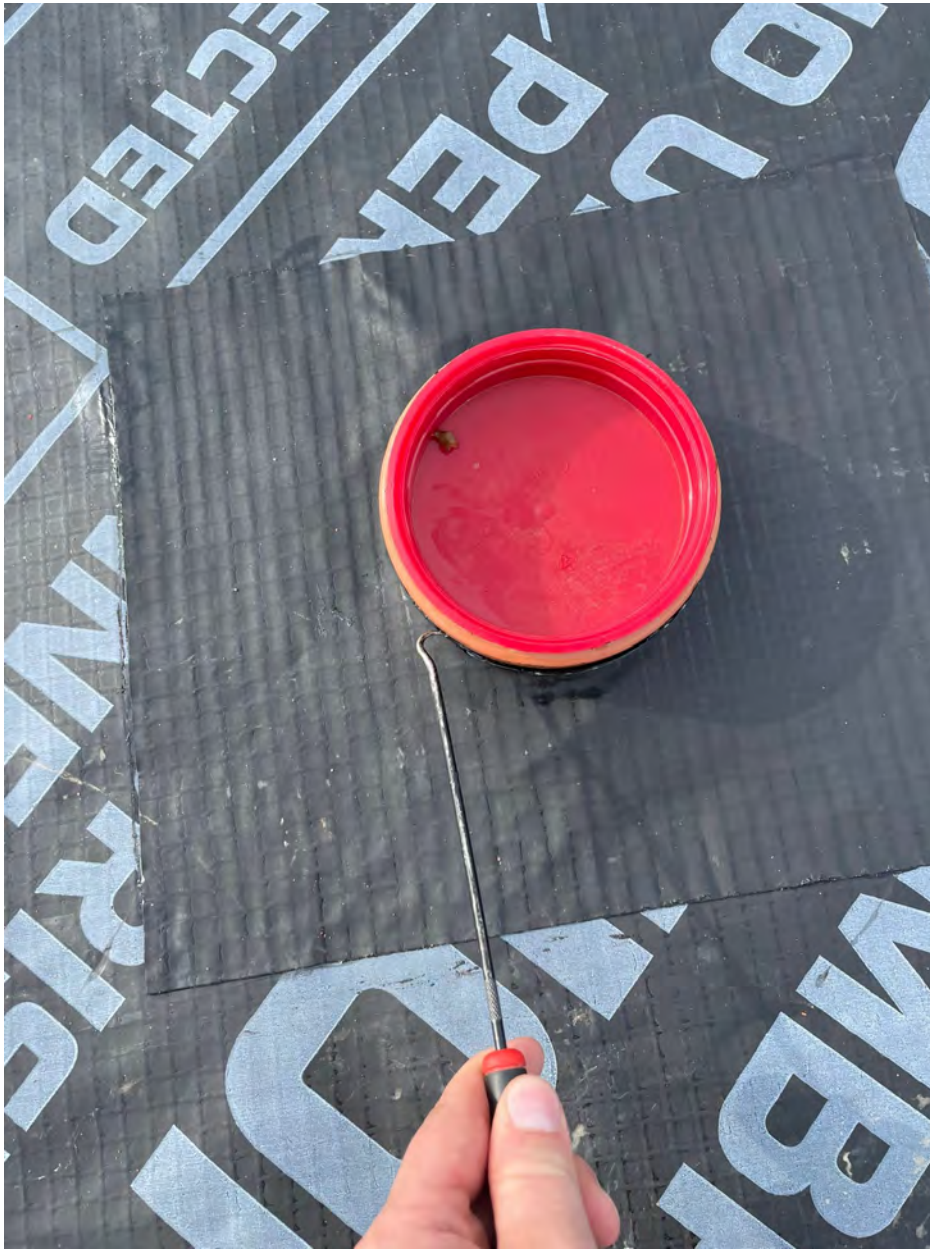
creating a secure bond between the pipe penetration and the JUTA GP1 Gas Barrier. All pipe penetrations throughout the referenced plots were subjected to thorough mechanical point stress testing where a probe was run along all edges of the JUTA GP1 SAM. No faults or defects were identified within the pipe penetration detailing during these testing procedures.

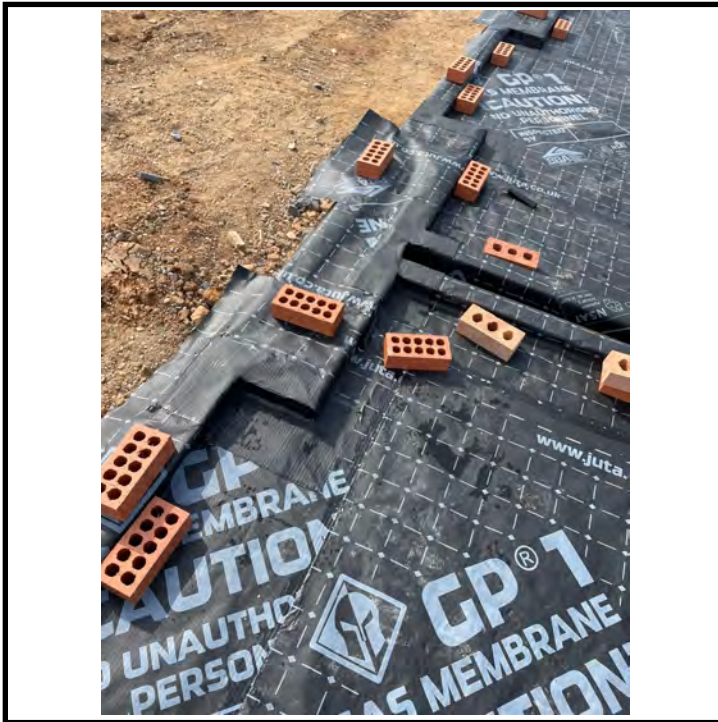
A number of corners and thresholds throughout the referenced plots have been sealed as per manufacturer's specifications and design guidelines. This has been achieved using JUTA GP1 SAM. The JUTA GP1 Gas Barrier has been cut to minimise any voided areas and gaps across the footprint of the referenced

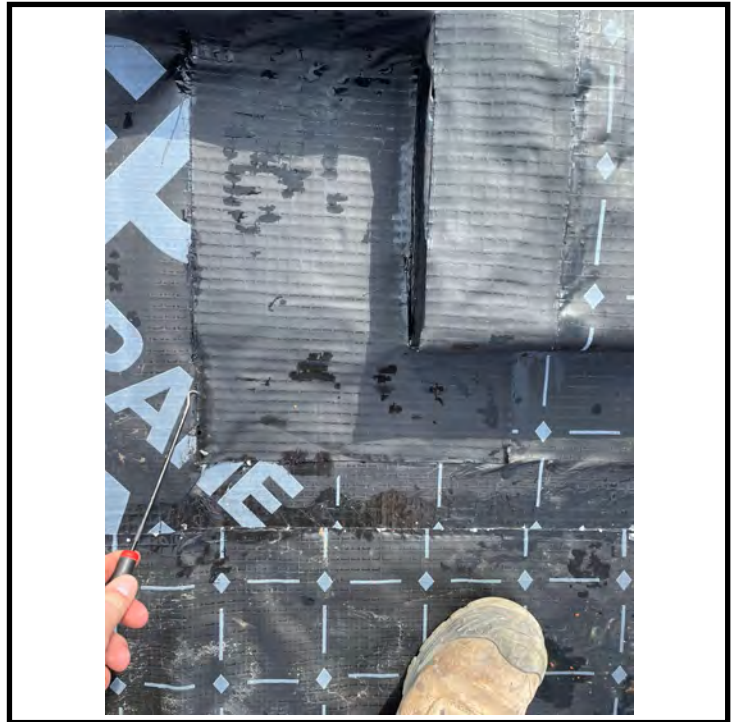
plots. Each corner and threshold junction has been reinforced by heating strips of JUTA GP1 SAM and placing them into position around each corner, onto the JUTA GP1 Gas Barrier. Firm rolled pressure is applied with a silicone roller to aid in the adhesion ensuring the JUTA GP1 SAM has fully bonded.

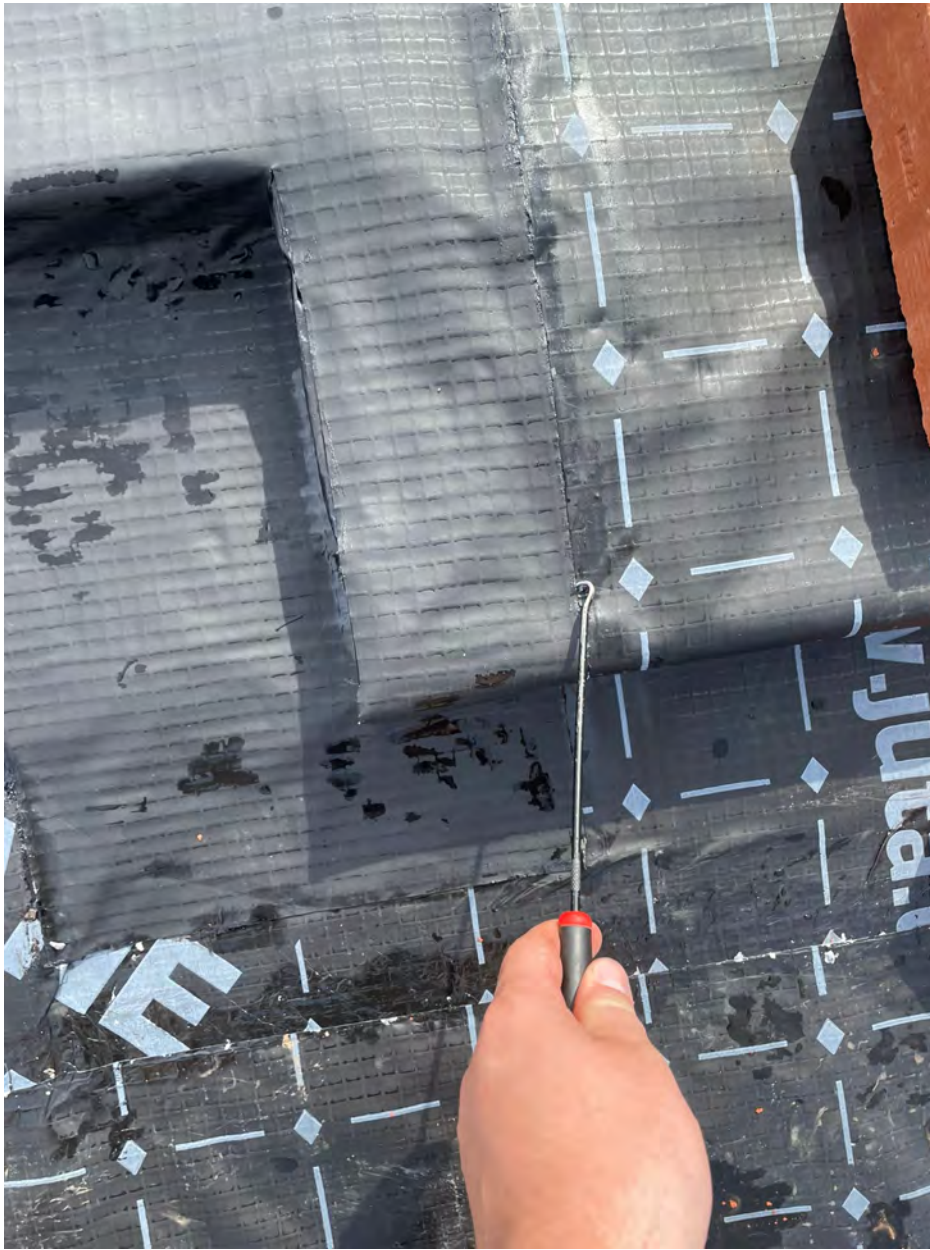
A pick and probe test was conducted upon all edges of JUTA GP1 SAM to validate that a gas tight seal had been achieved between the JUTA GP1 Gas Barrier and the JUTA GP1 SAM on the corner and threshold detailing.

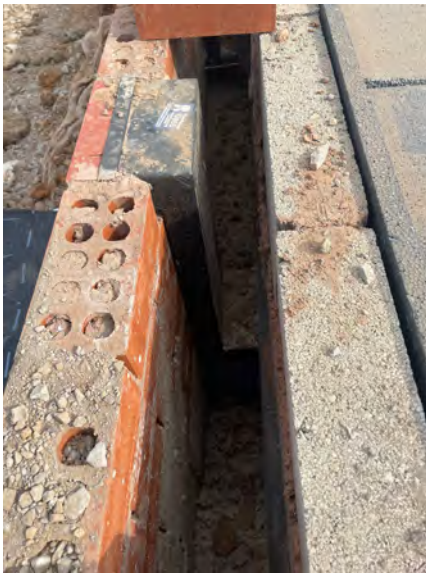
An overview of a vent brick.

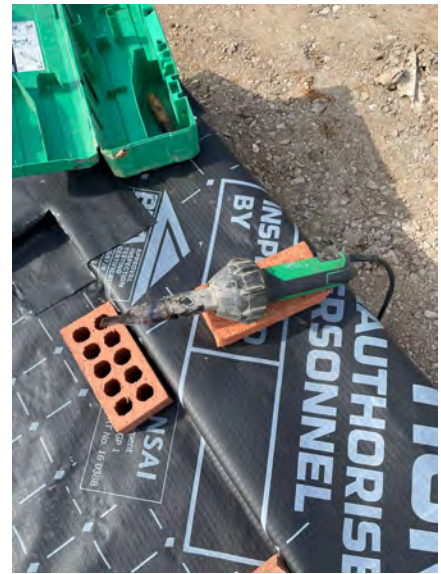
An overview of a hot leister.

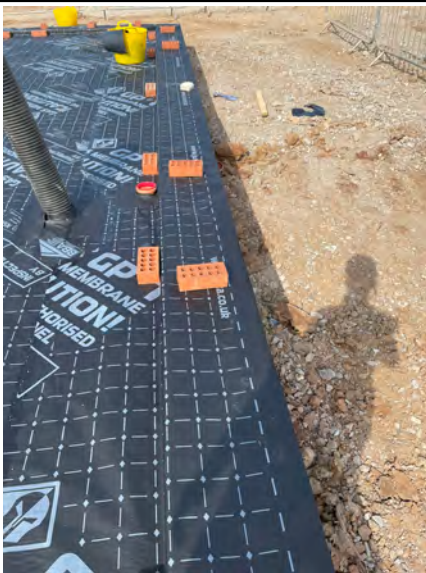
An overview of sealed pipe penetrations.

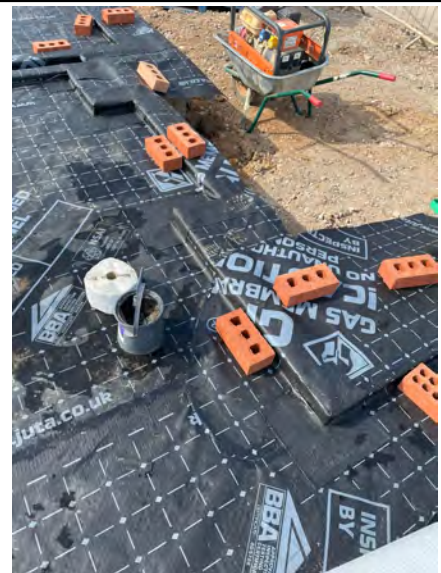
An overview of sealed corner detailing.
