# GeoShield Verification Report 03

GEO105396

R4 Civils,  
Barlestone,  
Barton Road,  
Osbaston  
Nuneaton,  
CV13 0EU

Plots 37, 38, 39 & 40 - Full Line Out

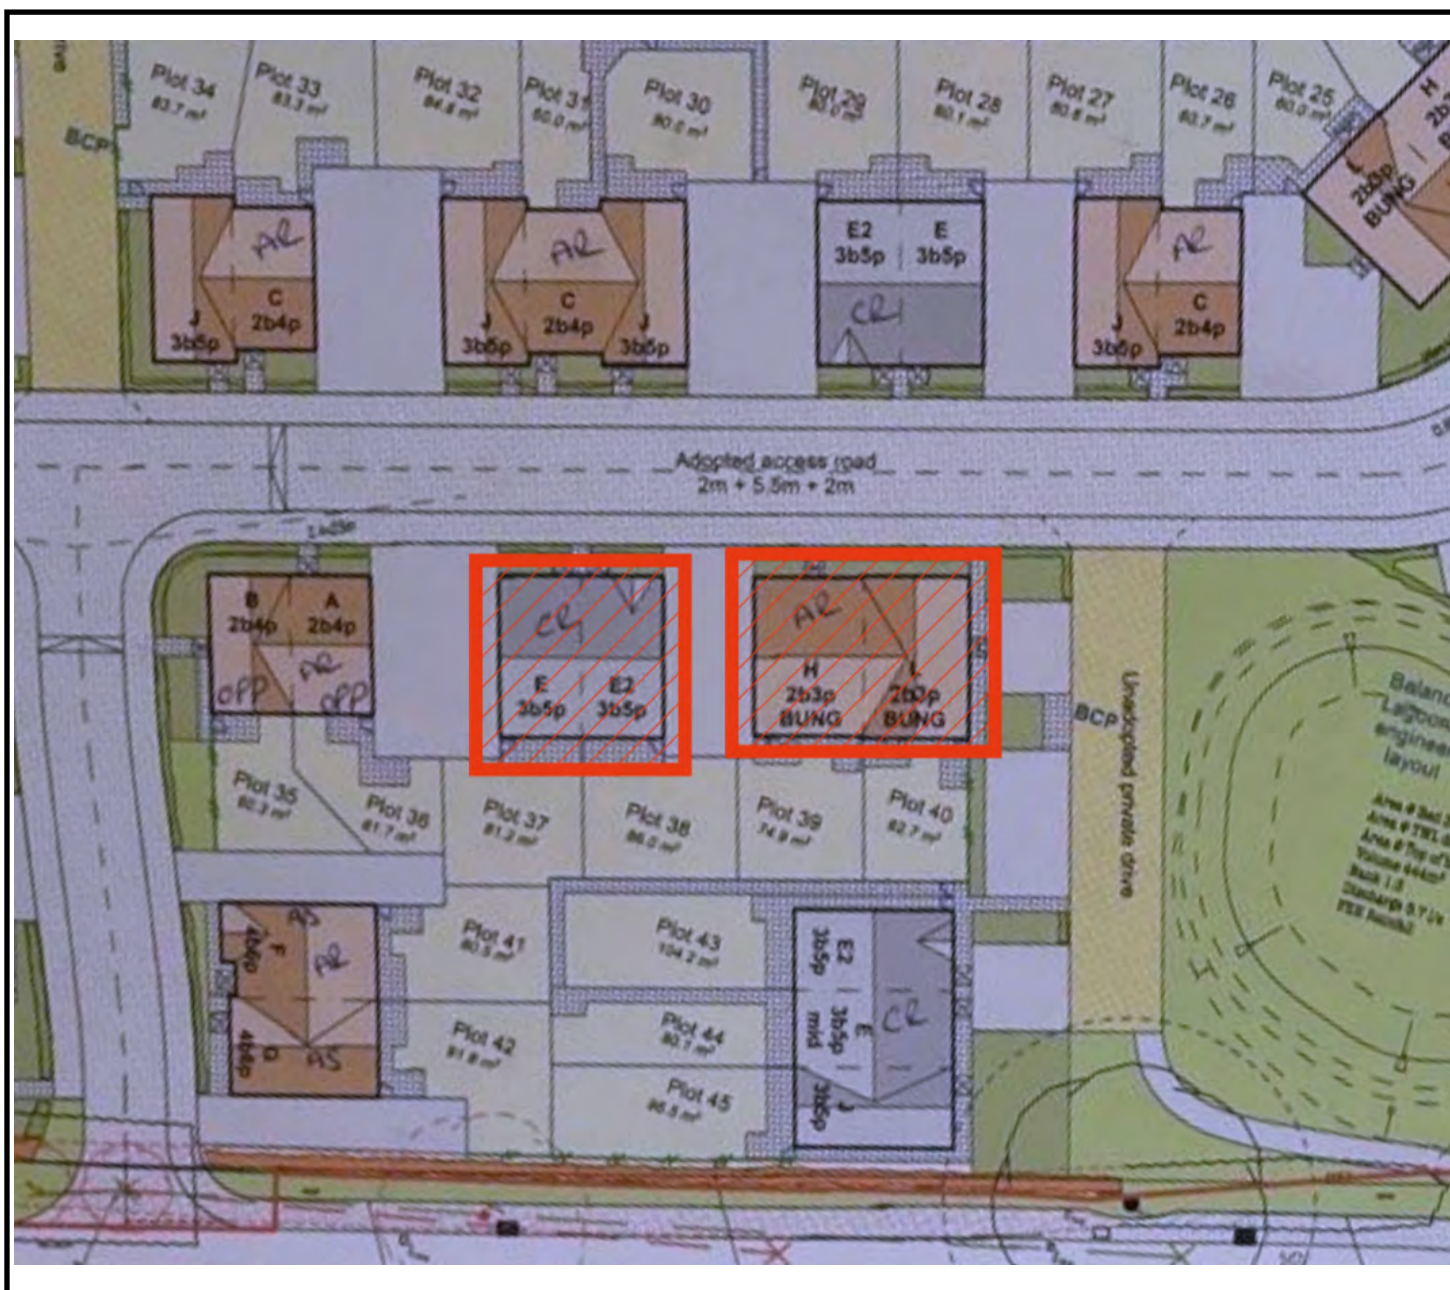
The photograph above shows a plan layout of the site. The areas highlighted in red show plots 37, 38, 39, 40 where the verification inspection took place on site today.

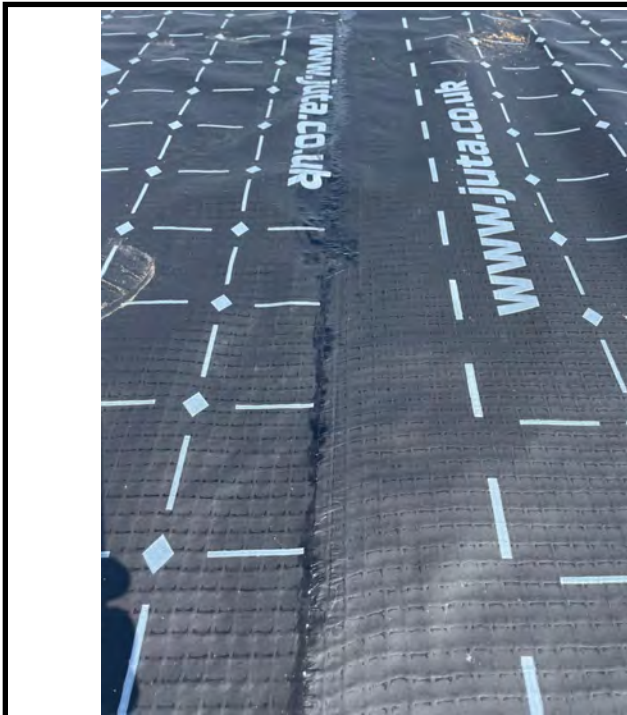
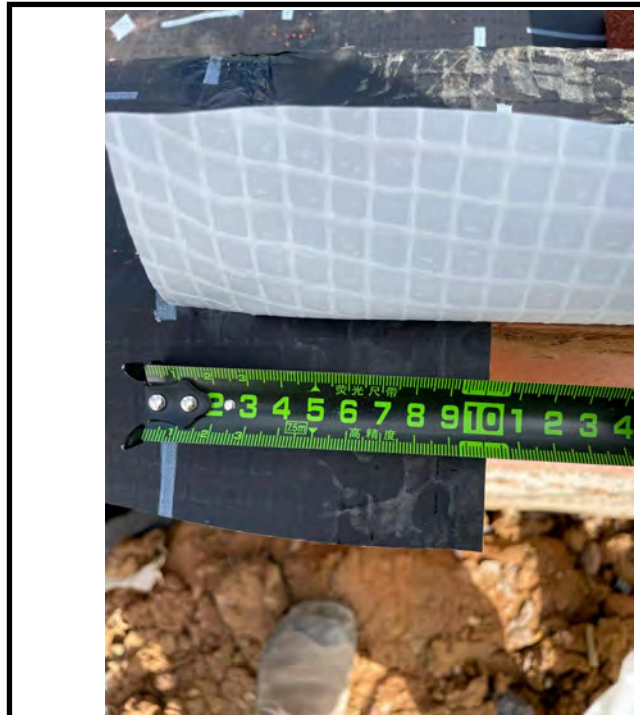
## VERIFICATION ITEM ONE

A complete line out of the JUTA GP1 Gas Barrier has been installed across the footprint of plots 37, 38, 39 & 40. The JUTA GP1 Gas Barrier has been lined across the entirety of the plots, including the internal party walls and external cavities to ensure continuity throughout. All lap joints between

the adjacent sheets of JUTA GP1 Gas Barrier have been overlapped a minimum of 100mm and heat welded using a hot air leister and a silicone roller with adequate pressure applied to ensure a continuous weld is achieved. Installed in accordance with manufacturer's specifications.

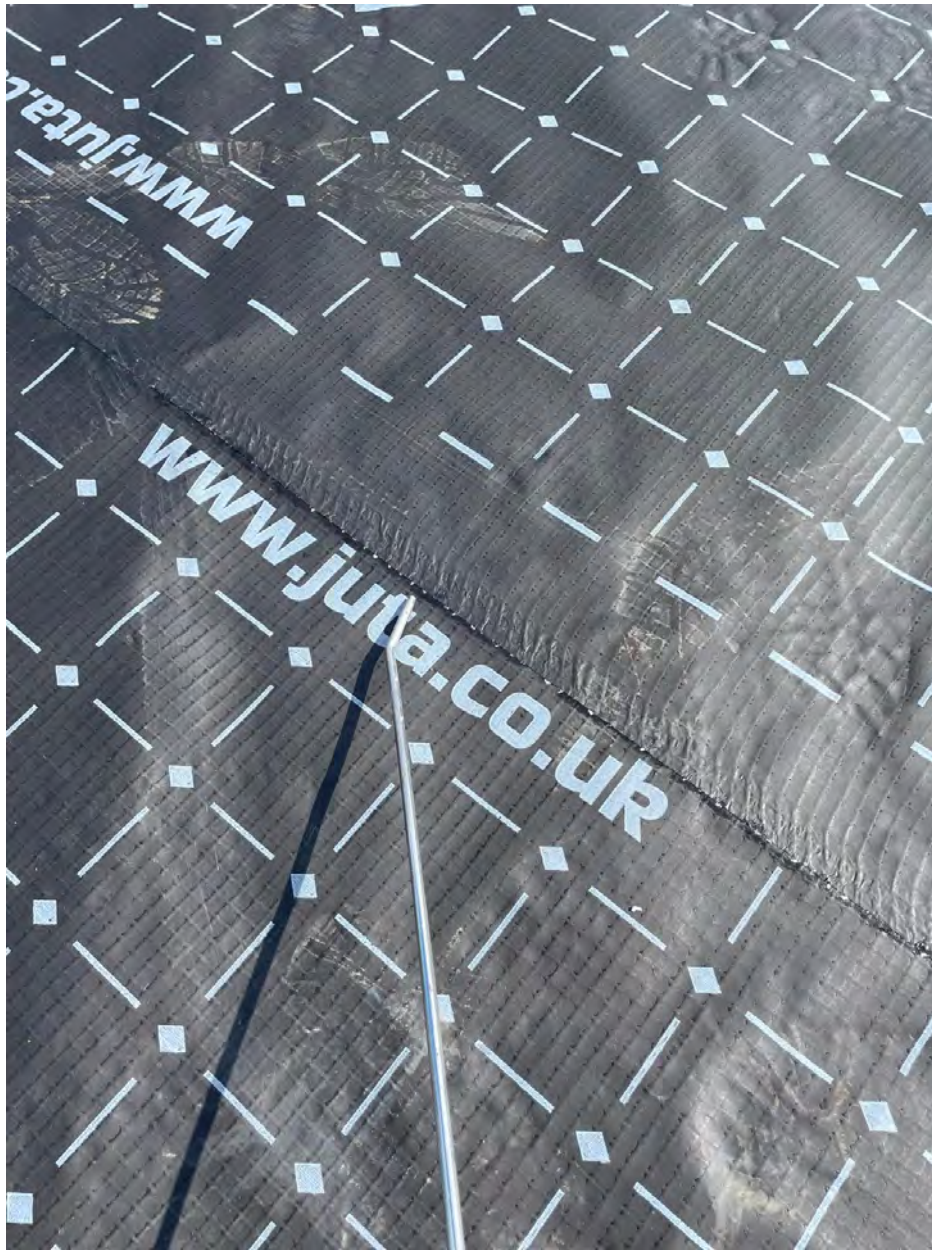
All lap joints were subjected to thorough mechanical point stress testing and non destructive air lance integrity testing throughout the installation. No miswelded lap joints were identified at the time of the inspection, however upon a visual inspection one small hole in the membrane was identified and successfully remediated on site in the presence of GeoShield.

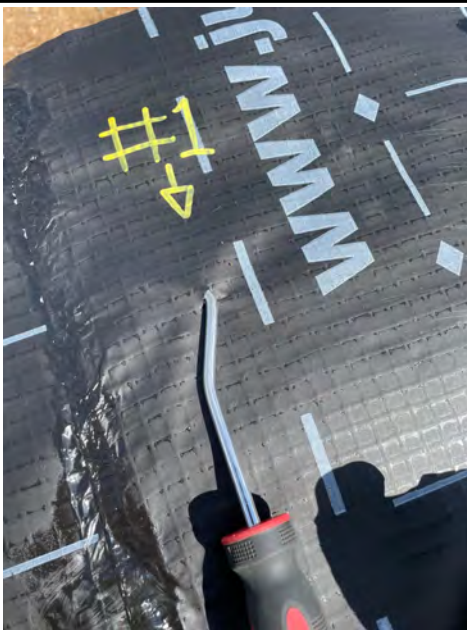
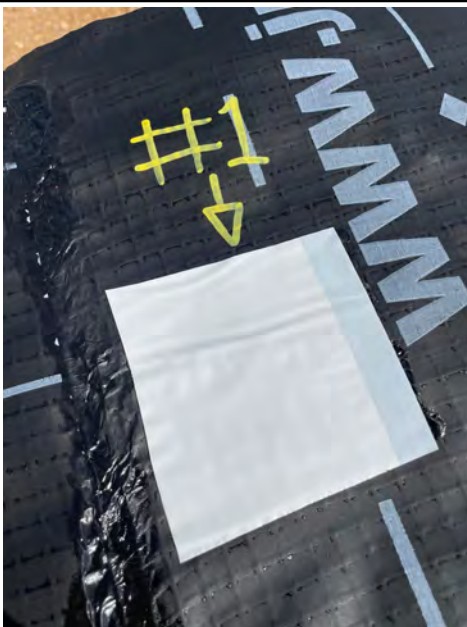
### Faults Identified and Remediated

As mentioned earlier in this report, thorough visual inspections, supported by mechanical point stress testing were conducted upon all aspects of the installation. One small fault in the outer leaf of the JUTA GP1 Gas Barrier was identified. The fault was brought to the attention of the installers and remediated

One small hole in the outer leaf of the JUTA GP1 Gas Barrier was identified. This was successfully remediated on site in the presence of GeoShield, using patches of JUTA GP SAM.

one site in the presence of GeoShield. The installers opted to remediate the faults by applying 150mm patches of JUTA GP SAM over the affected area. Heat and firm rolled pressure ensured the JUTA GP SAM had fully bonded. A thorough mechanical point stress test was conducted on the remedial works and identified no faults.

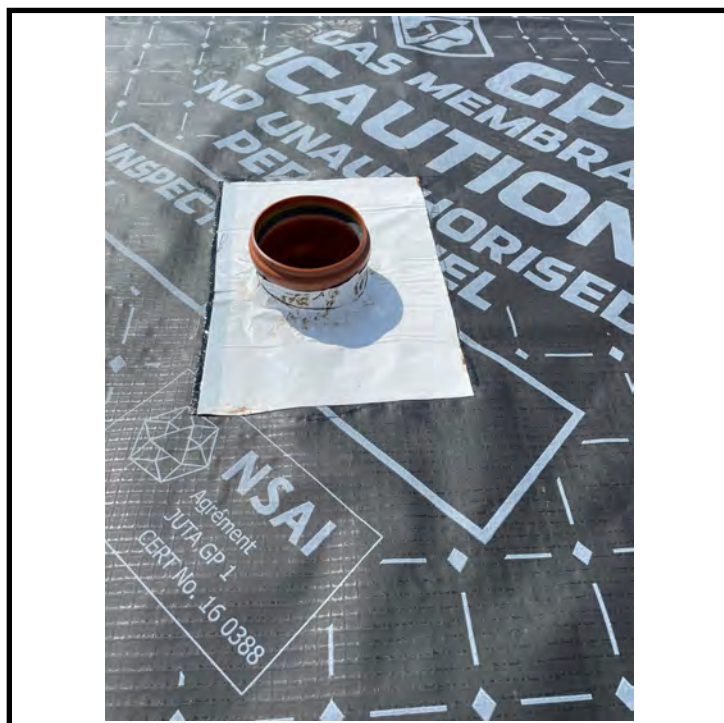
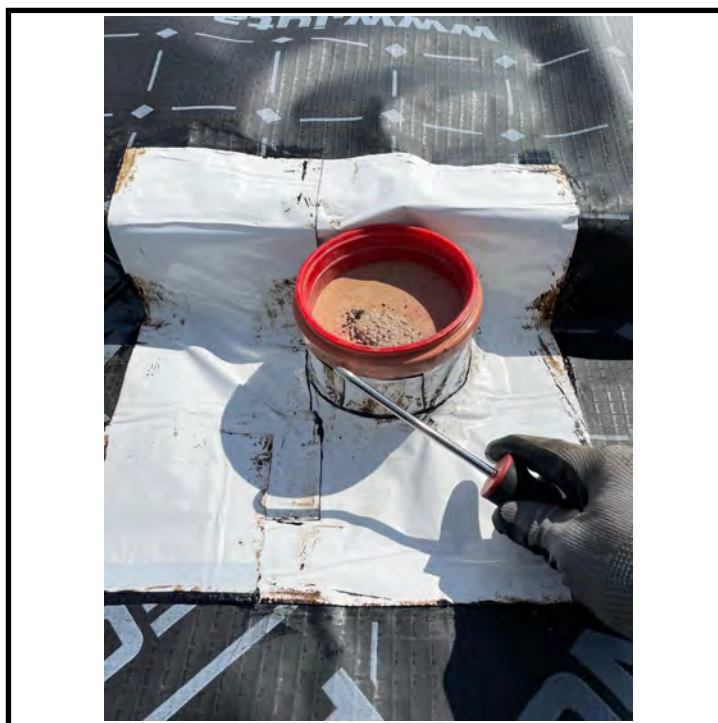
## VERIFICATION ITEM TWO

Throughout the installation of the JUTA GP1 Gas Barrier to the referenced plots, there were a number of pipe penetrations that have been sealed in accordance with manufacturer's specifications and design guidelines. This has been achieved using JUTA GP SAM which is a self adhesive membrane.

The installers have first cut the JUTA GP1 Gas Barrier tight around the base of each pipe penetration to minimise voided areas. Next, strips of JUTA GP SAM are placed intricately in a top hat formation around the pipe penetration and onto the JUTA GP1 Gas Barrier. Heat and rolled pressure is applied to activate the bitumen backing.

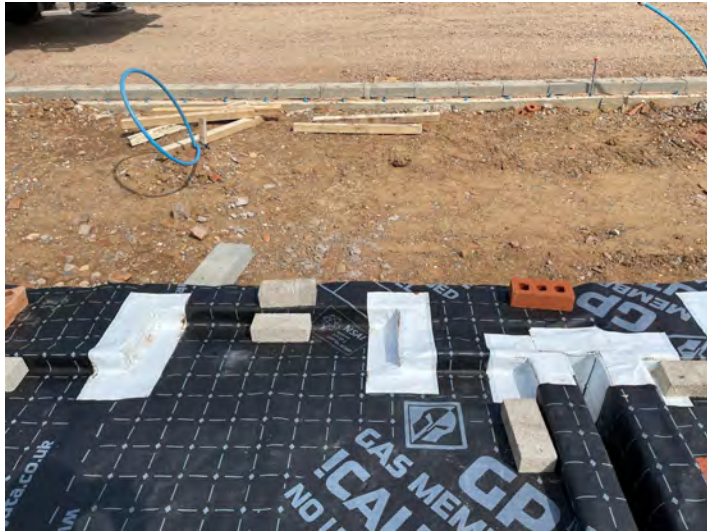
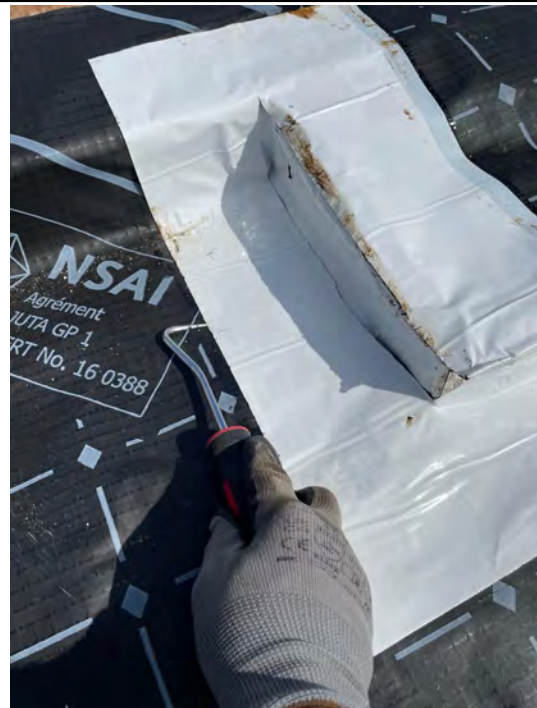
## VERIFICATION ITEM THREE

A number of corners and thresholds throughout the referenced plots have been sealed as per manufacturer's specifications and design guidelines. This has been achieved using JUTA GP SAM. The JUTA GP1 Gas Barrier has been cut to minimise any voided areas and gaps across the footprint of the referenced

plots. Each corner and threshold junction has been reinforced by heating strips of JUTA GP SAM and placing them into position around each corner, onto the JUTA GP1 Gas Barrier. Firm rolled pressure is applied with a silicone roller to aid in the adhesion ensuring the JUTA GP SAM has fully bonded.

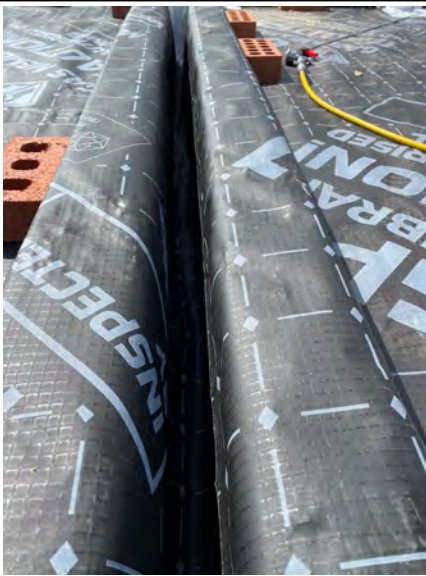
The JUTA GP1 Gas Barrier has been installed tight to the perimeter walls and across the cavities.

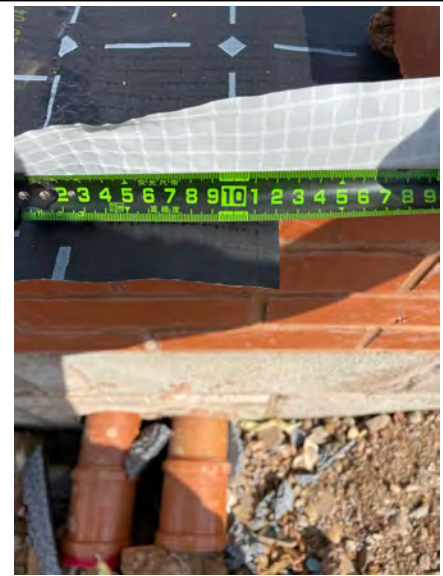
Sufficient overlap achieved.

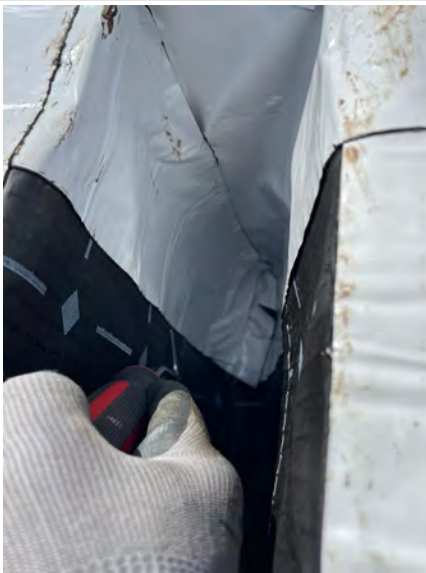
A pick and probe test being carried out.

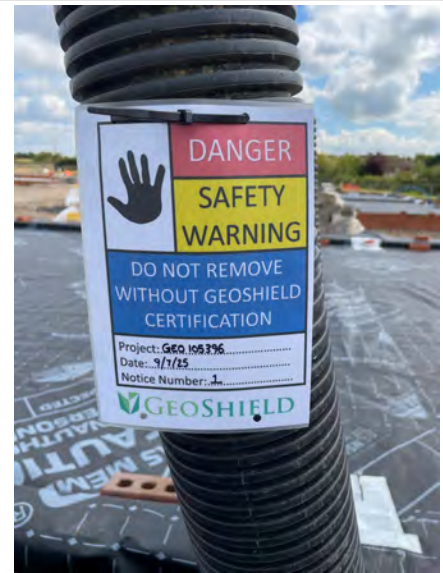
Safety warning attached to a pipe penetration.

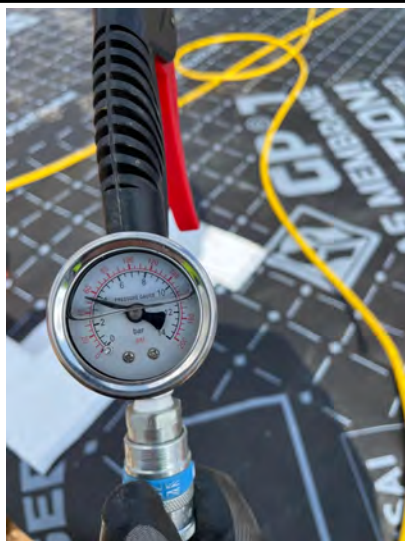
Correct pressure achieved.

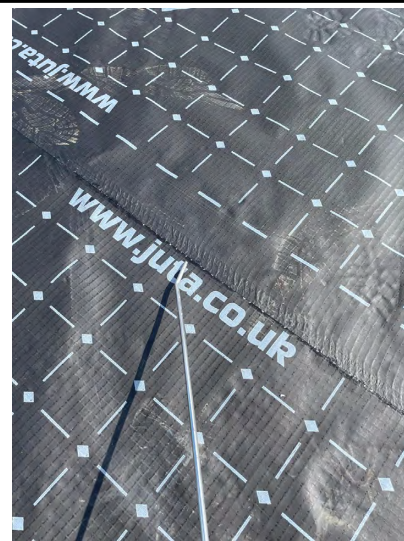
Air lance test on a welded lap.

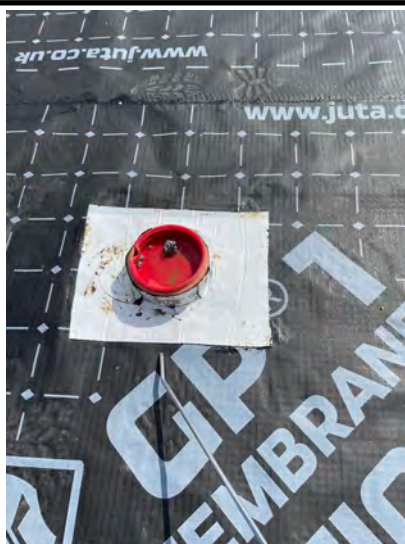
Air lance test on a pipe penetration.

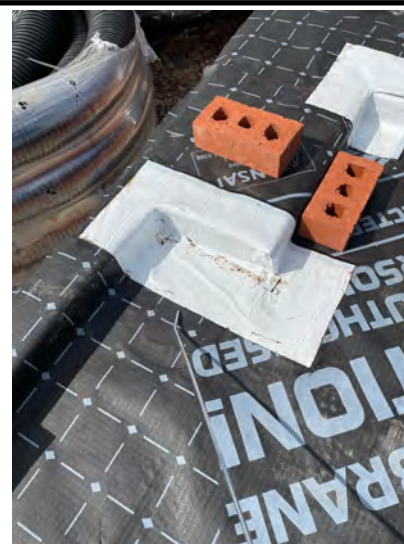
Air lance test on a sealed corner.
