# GeoShield Verification Report 4

GEO105396

R4 Civils,  
Barlestone,  
Barton Road,  
Osbaston  
Nuneaton,  
CV13 0EU

Plots 26, 27, 28, 29, 30, 31, 32, 33 & 34 - Full Line Out

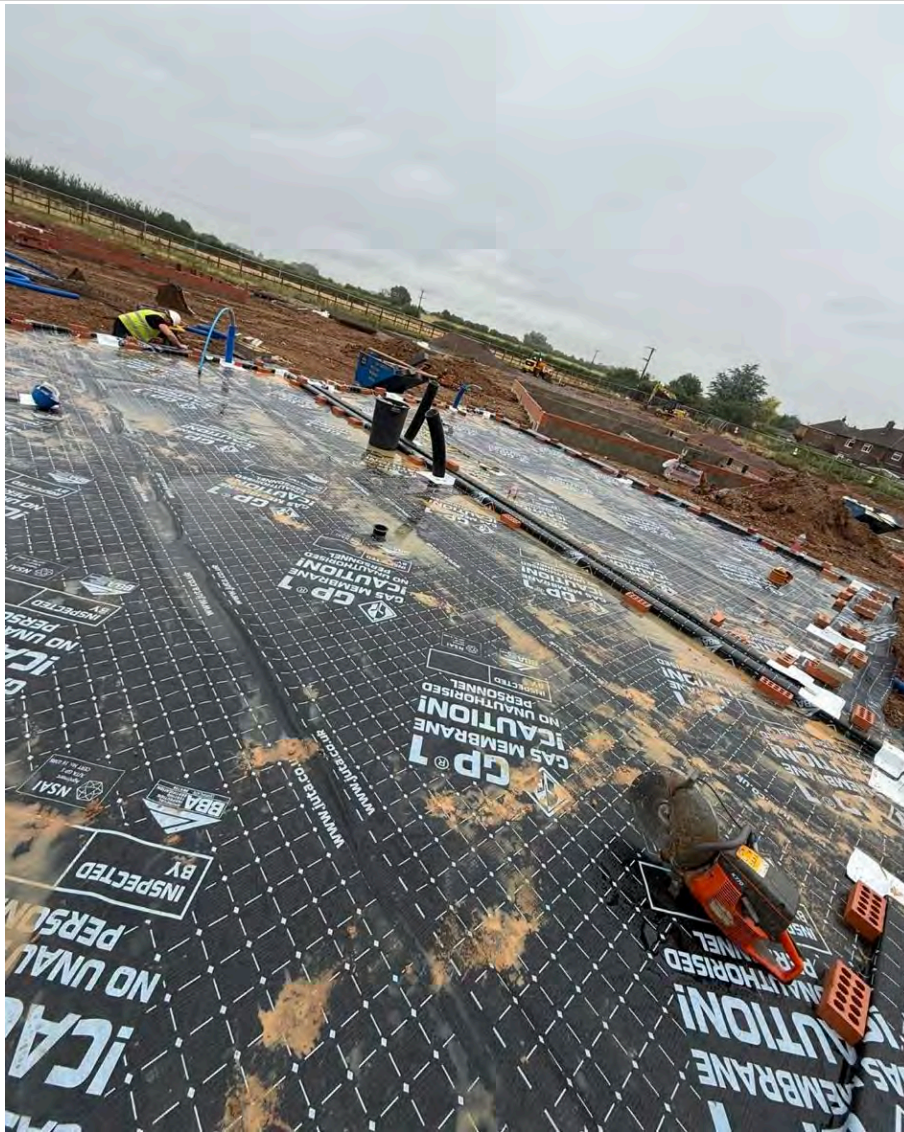
The photograph above displays an overview of Plots 26 & 27 where today's verification inspection took place on site.

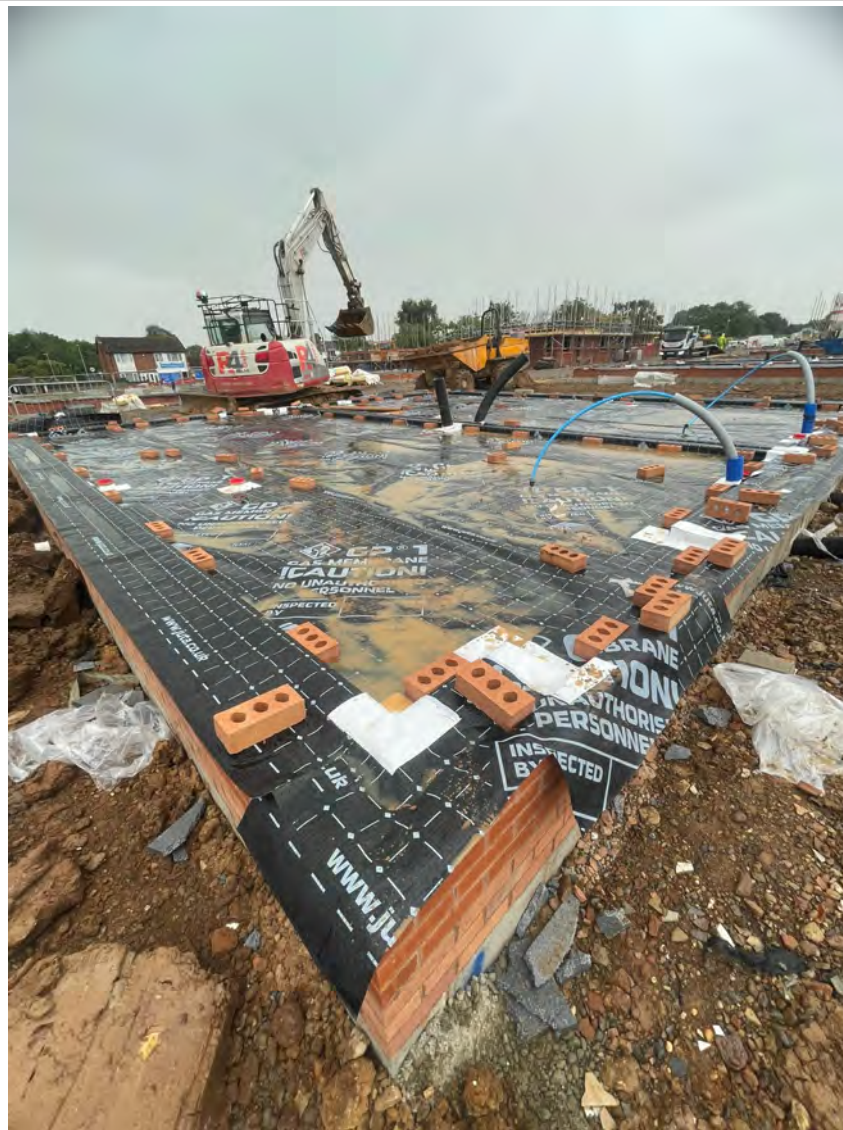
The photograph above displays an overview of Plots 28 & 29 where today's verification inspection took place on site.

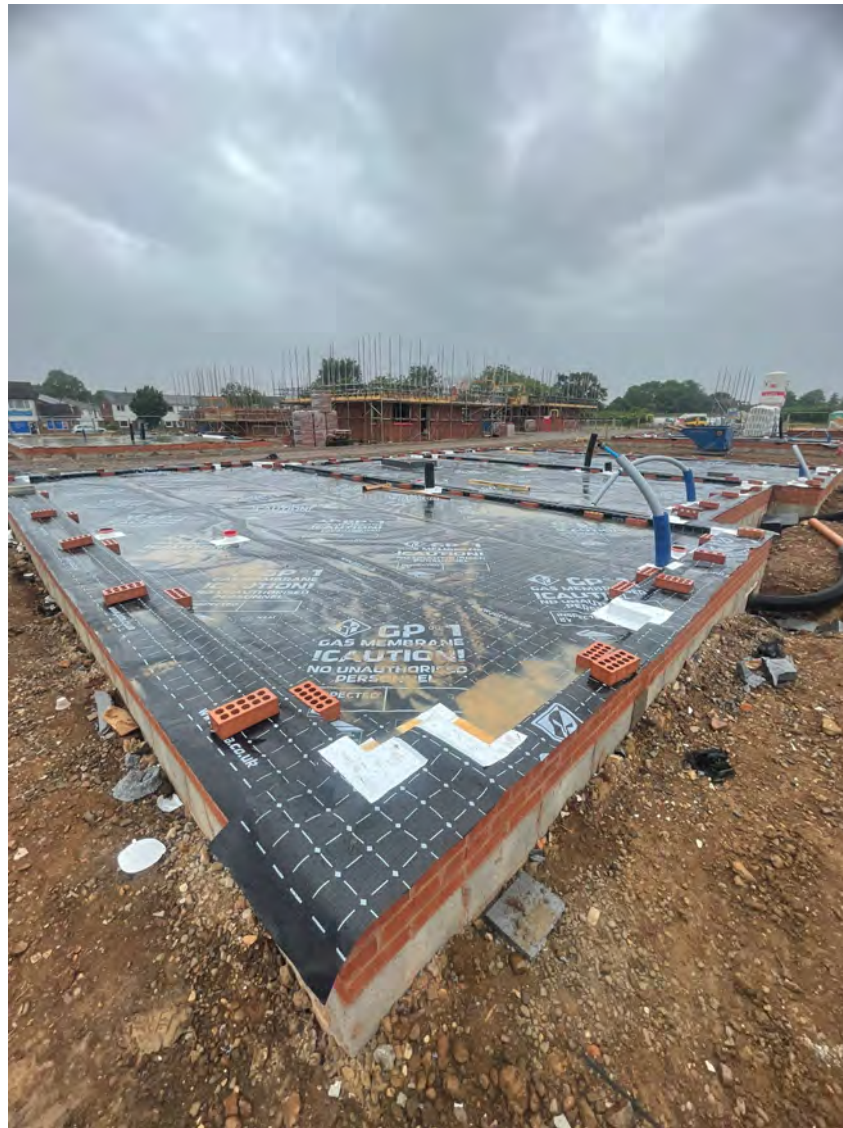
The photograph above displays an overview of Plots 30, 31 & 32 where today's verification inspection took place on site.

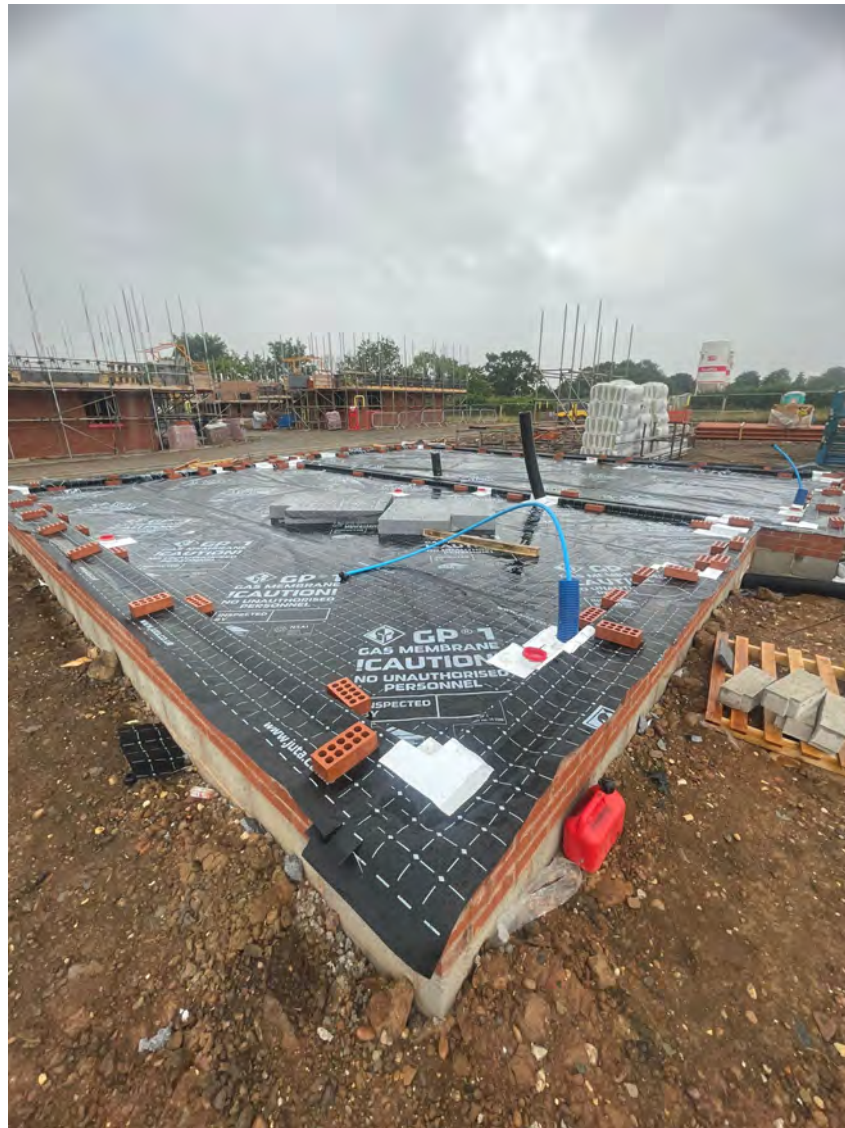
The photograph above displays an overview of Plots 33 & 34 where today's verification inspection took place on site.

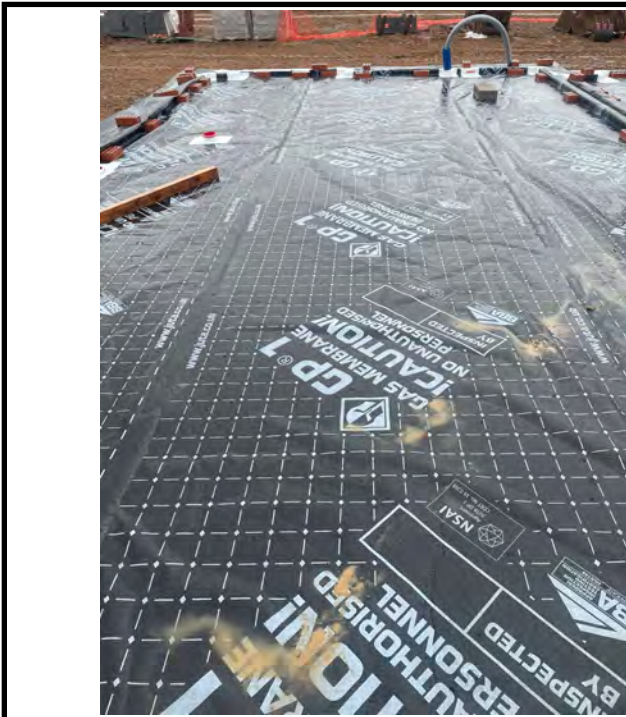
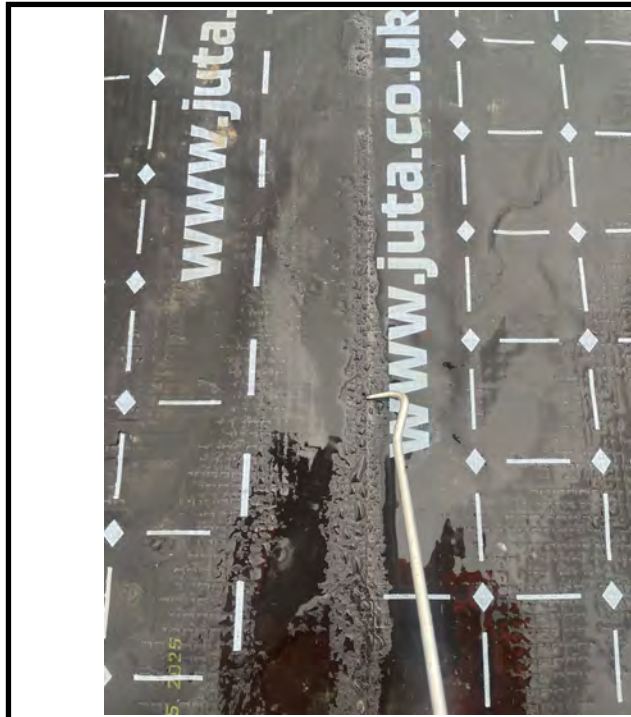
Installation of JUTA GP1 Gas Barrier - Lap Joints

A complete line out of the JUTA GP1 Gas Barrier has been installed across the footprint of Plots 26, 27, 28, 29, 30, 31, 32, 33 & 34, upon an insulated block and beam ventilated sub floor void. The JUTA GP1 Gas Barrier has been lined out across the entirety of the plots, including the internal party walls, ensuring it overlaps

the external cavity to the outer leaf brickwork. All lap joints between the adjacent sheets of JUTA GP1 Gas Barrier have been overlapped a sufficient amount, and heat welded using a hot air leister and silicone roller with adequate pressure applied to ensure a continuous gas resistant seal is achieved.

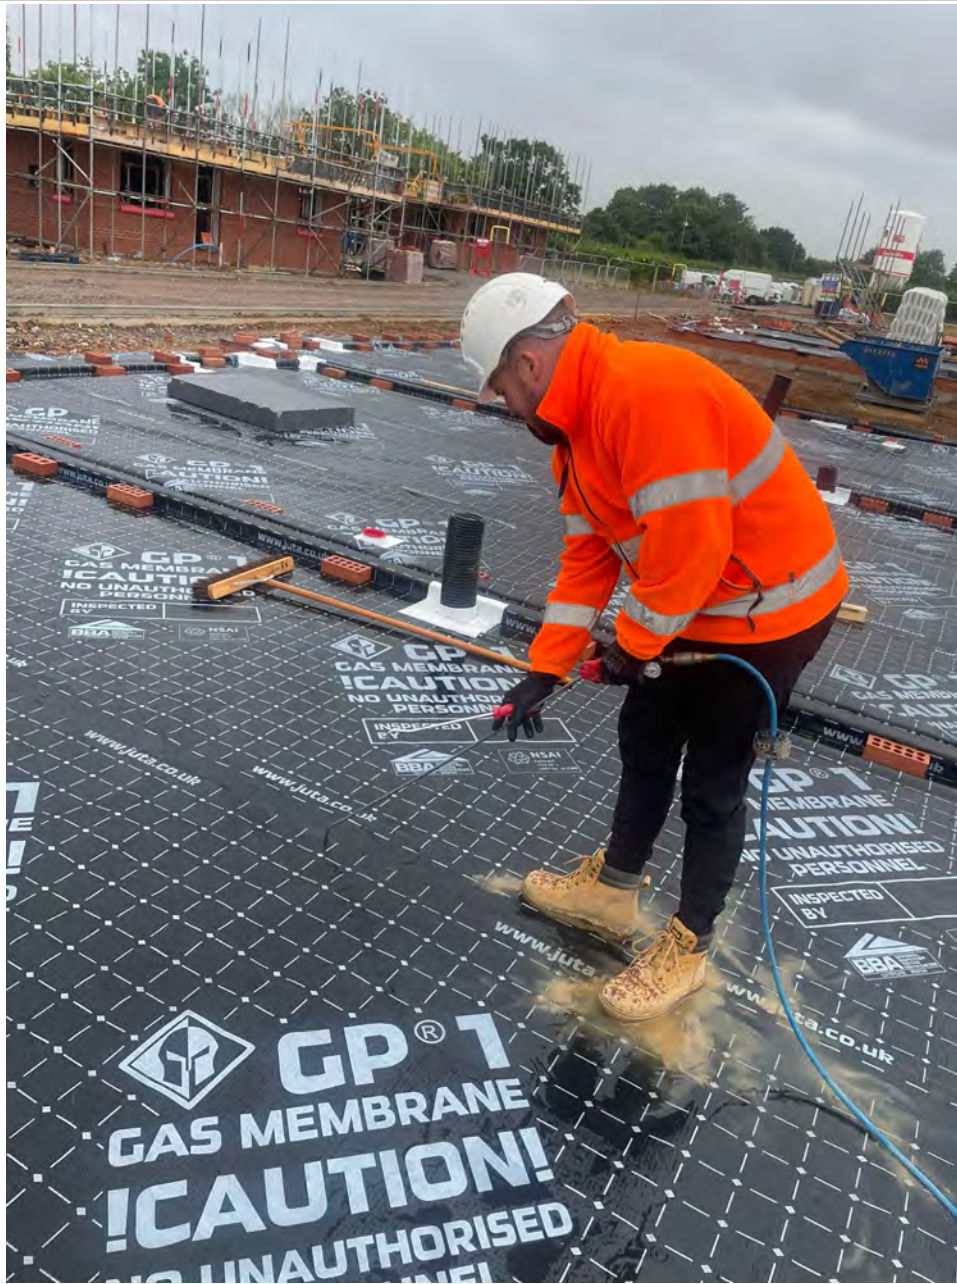
The above photograph displays a non destructive air lance integrity test being conducted upon a welded lap joint of the JUTA GP1 Gas Barrier. Thorough visual inspections, supported by non destructive air lance integrity testing and mechanical point stress testing conducted upon all overlaps, identified three miswelded lap joints. Tested and verified in accordance with CIRIA 735.

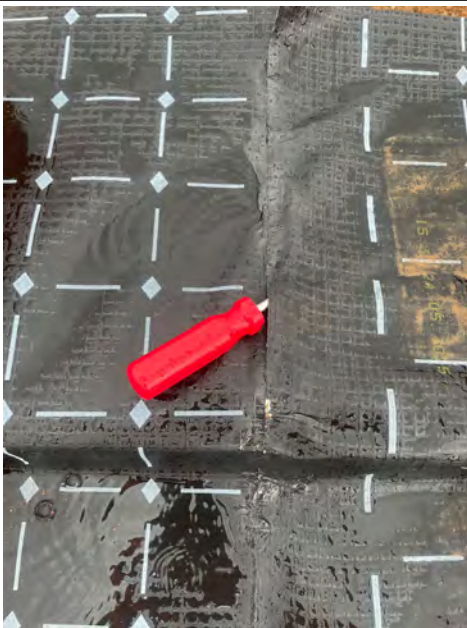
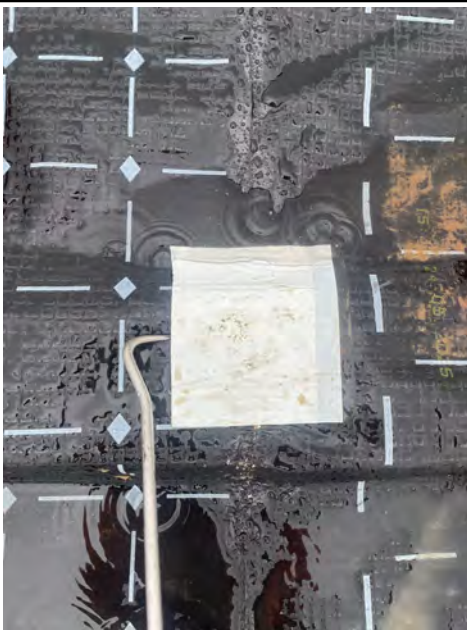
### Miswelds Identified & Remediated

As mentioned, three miswelds were identified during the testing procedures conducted today.

The miswelds were brought to the attention of the installers and remediated during the verification visit in the presence of GeoShield.

The specialist installers from Omega Lining Solutions opted to remediate the faults by applying a 150mm patch of JUTA GP SAM over the affected area, with heat and rolled pressure applied to ensure a secure bond was achieved. No further faults were identified during the re-testing of the remedial works.

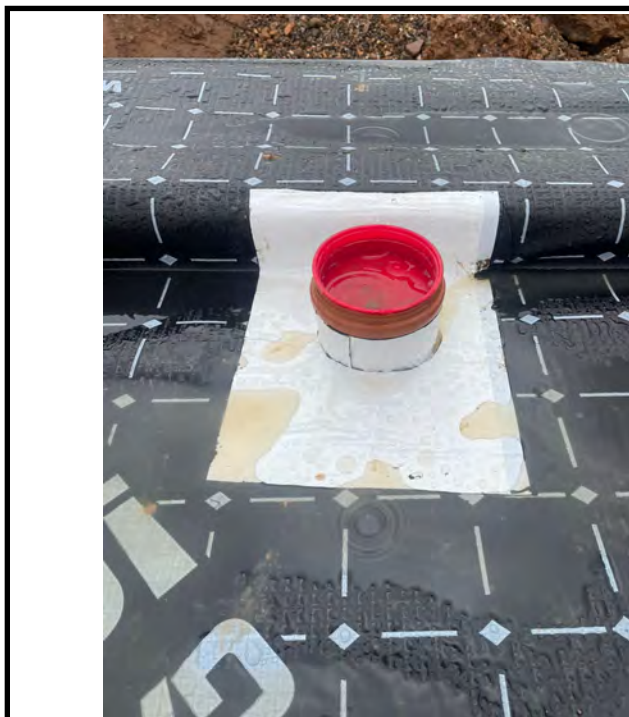
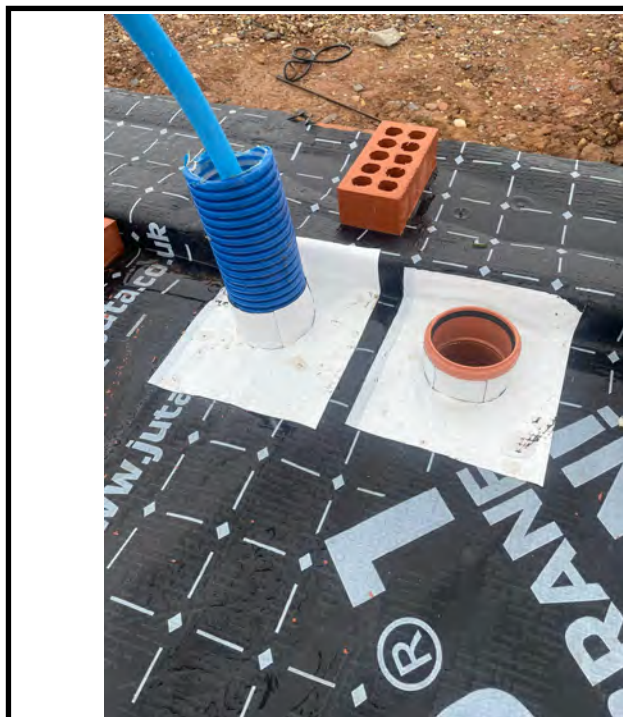
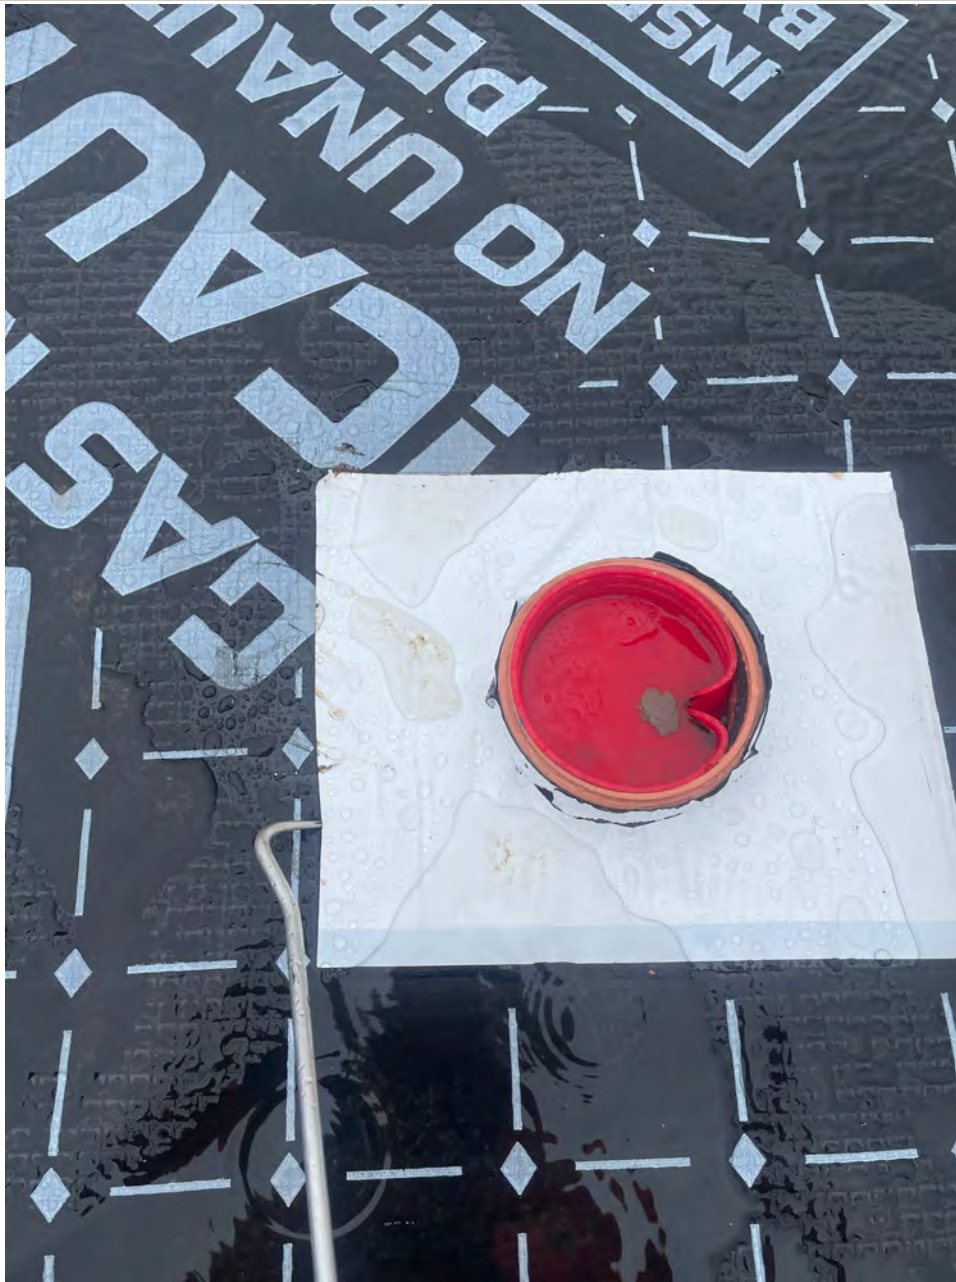
### Pipe Penetrations

Throughout the complete line out installation of the JUTA GP1 Gas Barrier to the referenced plots, there were a number of pipe penetrations that have been sealed in accordance with manufacturer's specifications and design guidelines. This has been achieved using JUTA GP SAM, which is a gas resistant self adhesive

membrane. The installers have first cut the JUTA GP1 Gas Barrier tight around the base of each pipe penetration to minimise voided areas. Next, patches of JUTA GP SAM are placed intricately in a petal formation around the pipe penetration and onto the JUTA GP1 Gas Barrier, with a 300mm square of JUTA GP SAM placed

over the top to form a top hat detail. Heat and rolled pressure are applied to activate the bitumen backing, creating a secure bond between the pipe penetration and the JUTA GP1 Gas Barrier. All pipe penetrations throughout the referenced plots were subjected to thorough visual inspection and mechanical point stress testing, where a probe was run along all edges of the JUTA GP SAM detailing. No faults were identified.

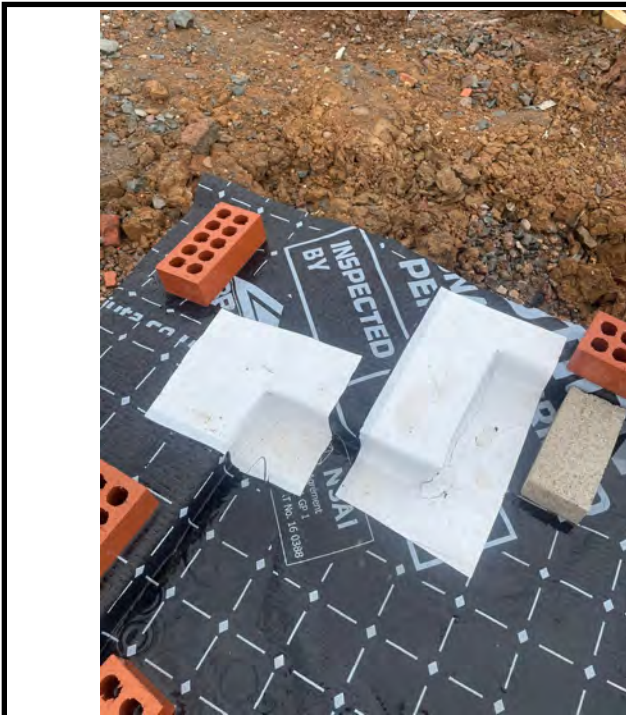
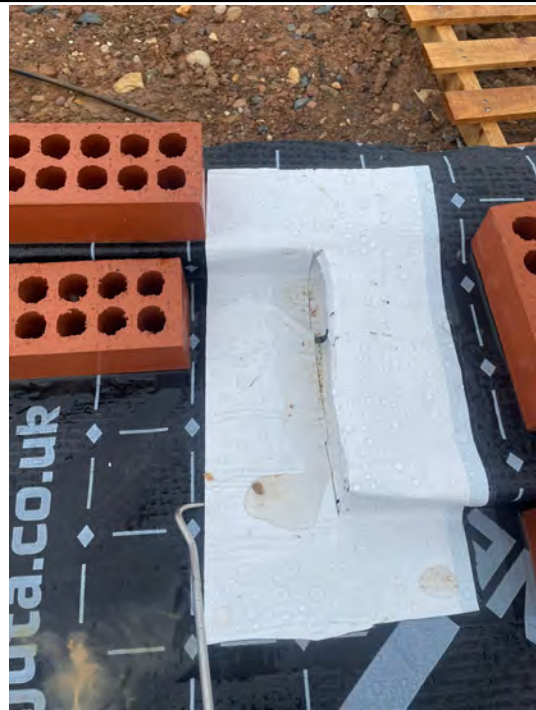
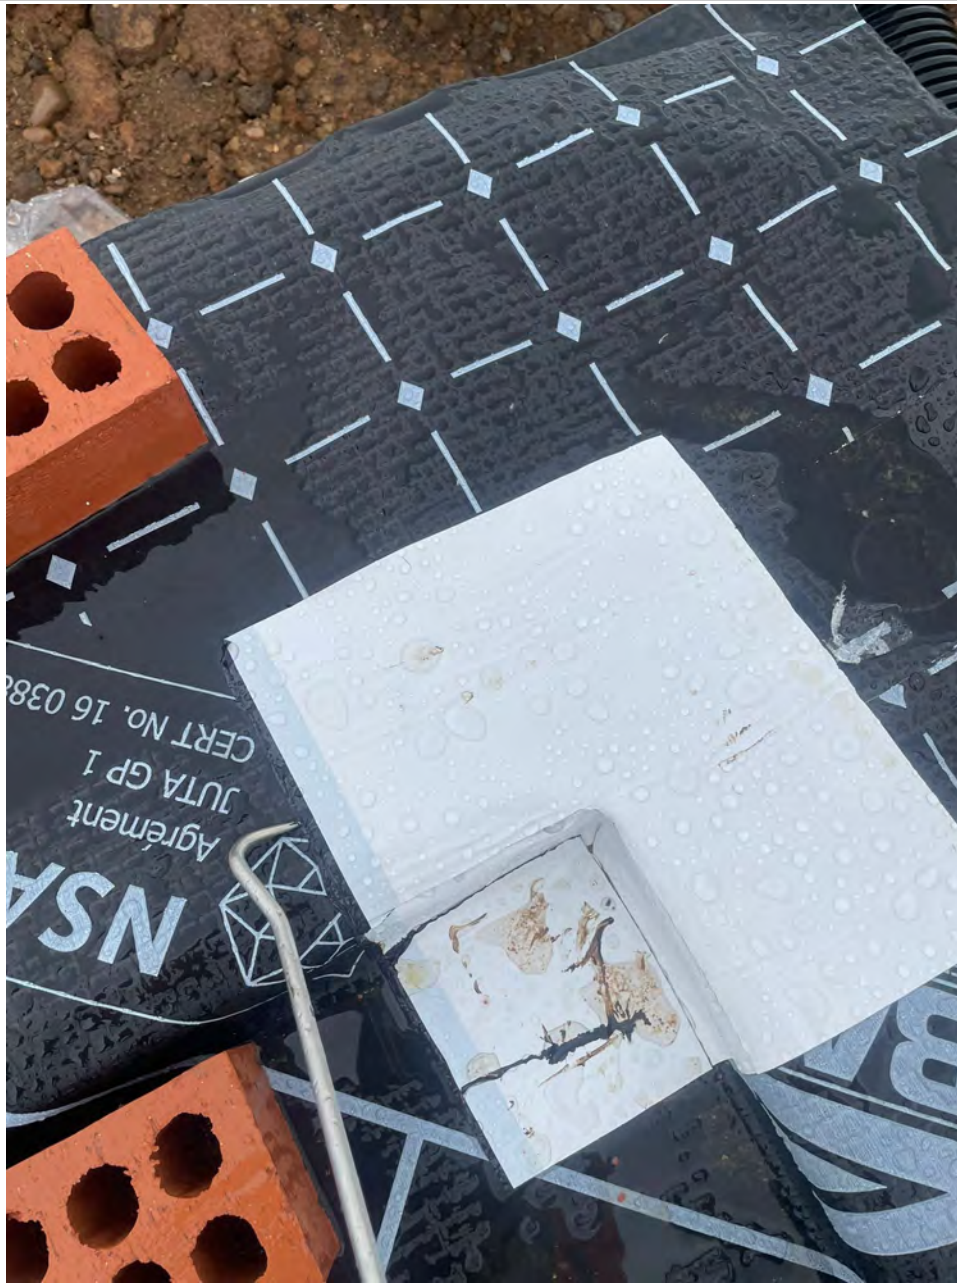
### Corner & Threshold Detailing

A number of corners and thresholds throughout the referenced plots have also been sealed as per manufacturer's specifications and design guidelines. This has been achieved using JUTA GP SAM. Where the JUTA GP1 Gas Barrier has been cut to minimise voided areas and gaps across the footprint of the plots, each

corner and threshold junction has been reinforced by heating strips of JUTA GP SAM and placing into position around each corner and threshold, onto the JUTA GP1 Gas Barrier. Firm rolled pressure is applied with a silicone roller to aid in the adhesion, ensuring the JUTA GP SAM has fully bonded.

As with the pipe penetrations, a probe was run along all edges of the JUTA GP SAM within the corner & threshold detailing to validate that a continuous gas resistant seal had been achieved throughout. No faults or defects were identified with the corners and thresholds during the testing procedures.

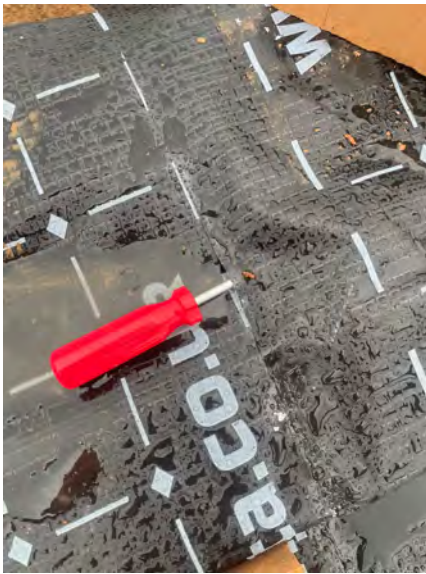
A misweld identified.

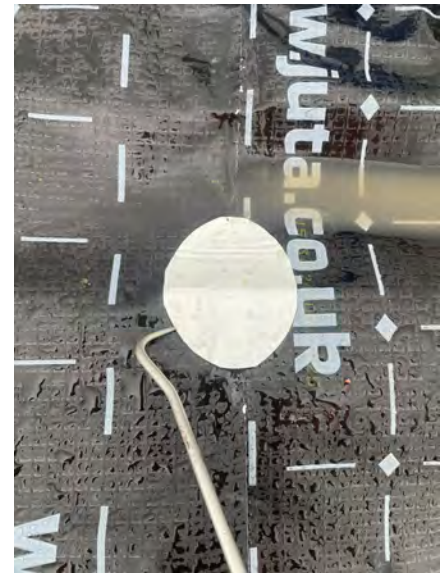
A mechanical point stress test being conducted upon a misweld remediated using a patch of JUTA GP SAM.

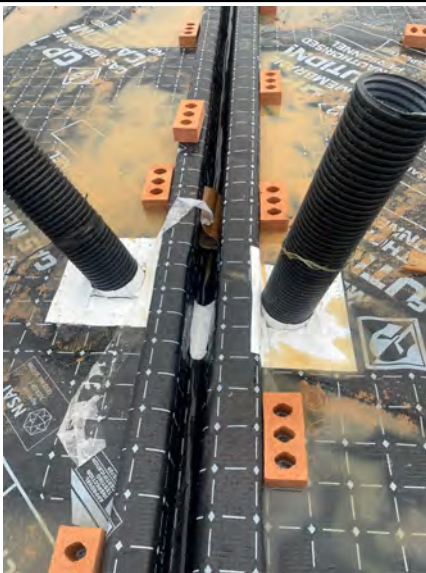
The JUTA GP1 Gas Barrier crosses the internal cavity to ensure continuity throughout.

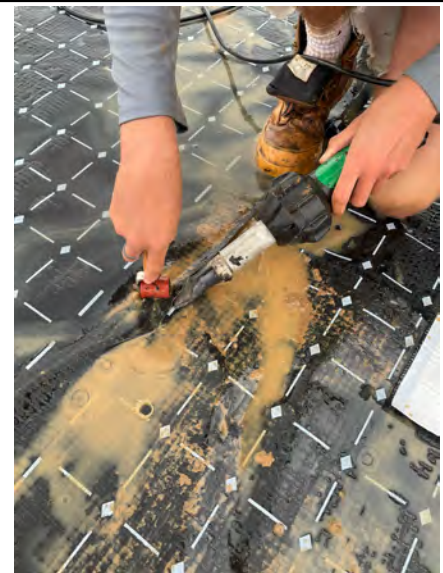
The installer heat welding an overlap between the adjacent sheets of JUTA GP1 Gas Barrier.

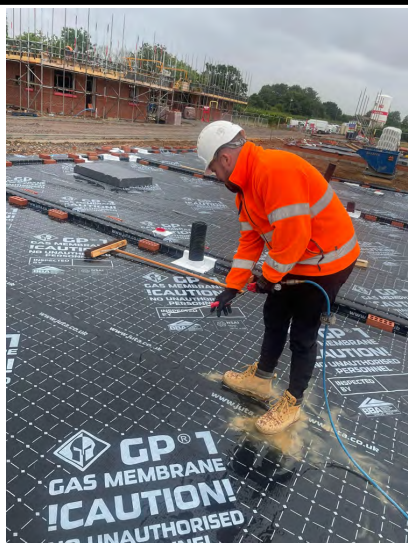
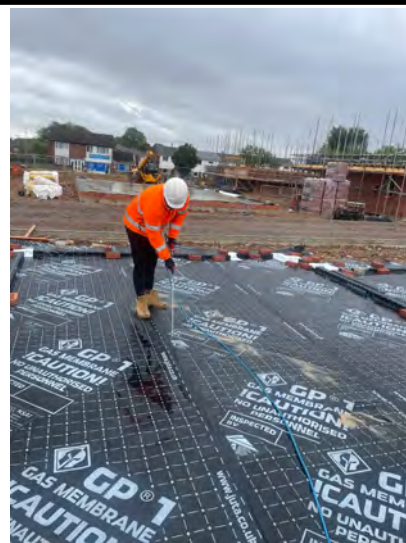
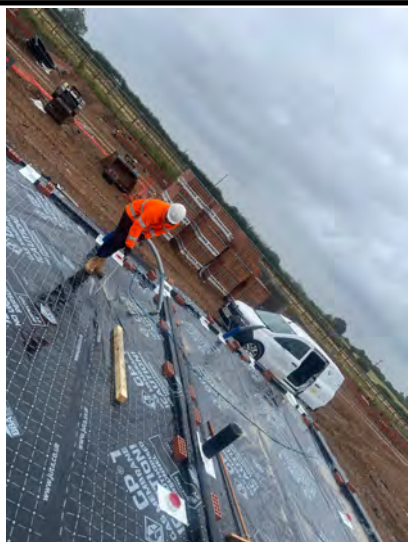
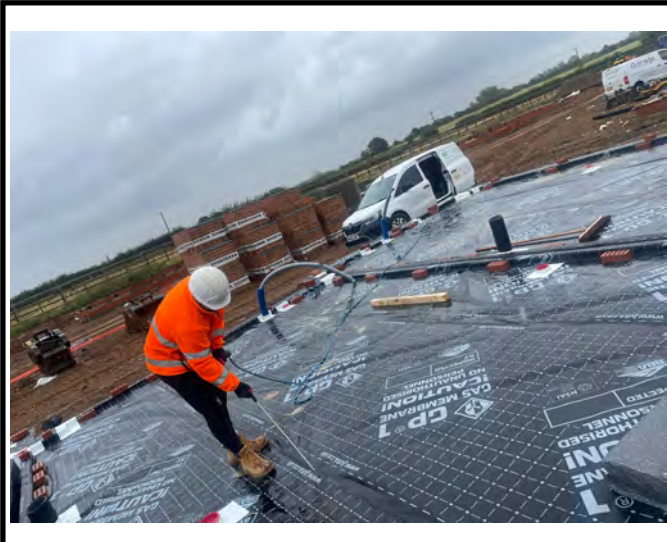
Air lance test on a welded lap.
