# GeoShield Verification Report 5

GEO105396

R4 Civils,  
Barlestone,  
Barton Road,  
Osbaston  
Nuneaton,  
CV13 0EU

Plots 12, 13, 14, 15, 16, 17, 18, 19, 20, 21, 22, 23, 24, 25, 43, 44 & 45 - Full Line Out

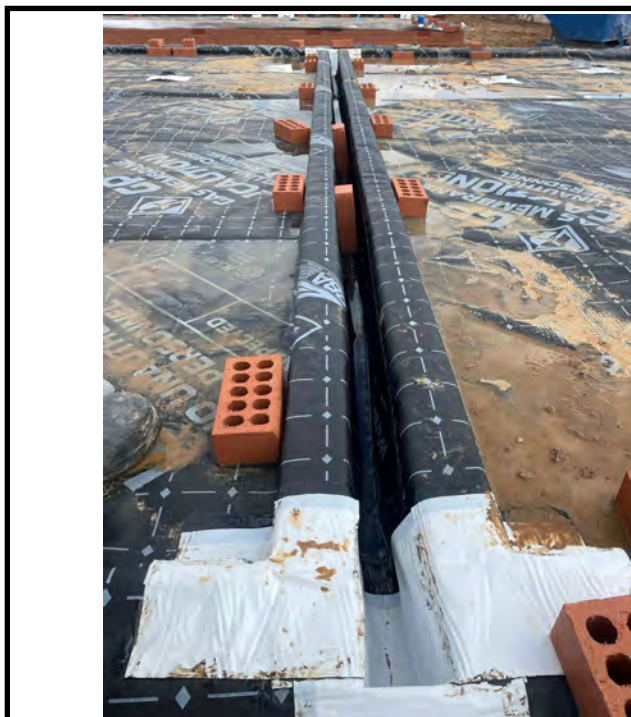
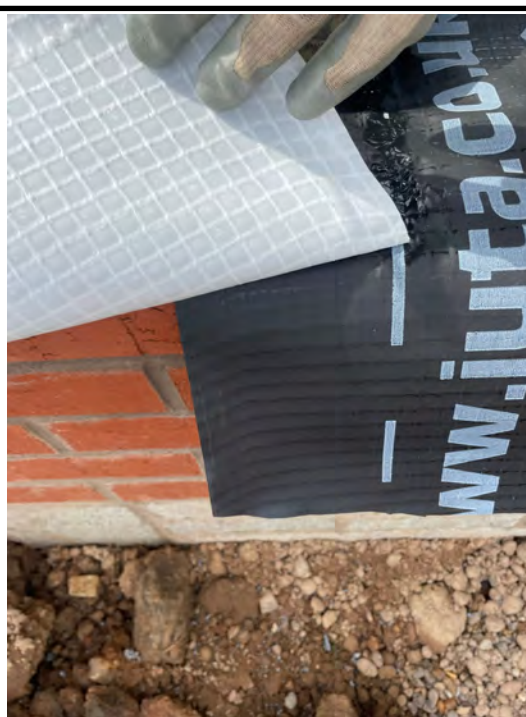
A complete line out of the JUTA GP1 Gas Barrier has been installed across the footprint of the referenced plots, upon an insulated block and beam ventilated sub floor void. The JUTA GP1 Gas Barrier has been lined out across the entirety of the plots, including the internal party walls, ensuring it overlaps

the external cavity to the outer leaf brickwork. All lap joints between the adjacent sheets of JUTA GP1 Gas Barrier have been overlapped a minimum of 100mm and heat welded using a hot air leister and silicone roller with adequate pressure applied to ensure a continuous gas resistant seal is achieved.

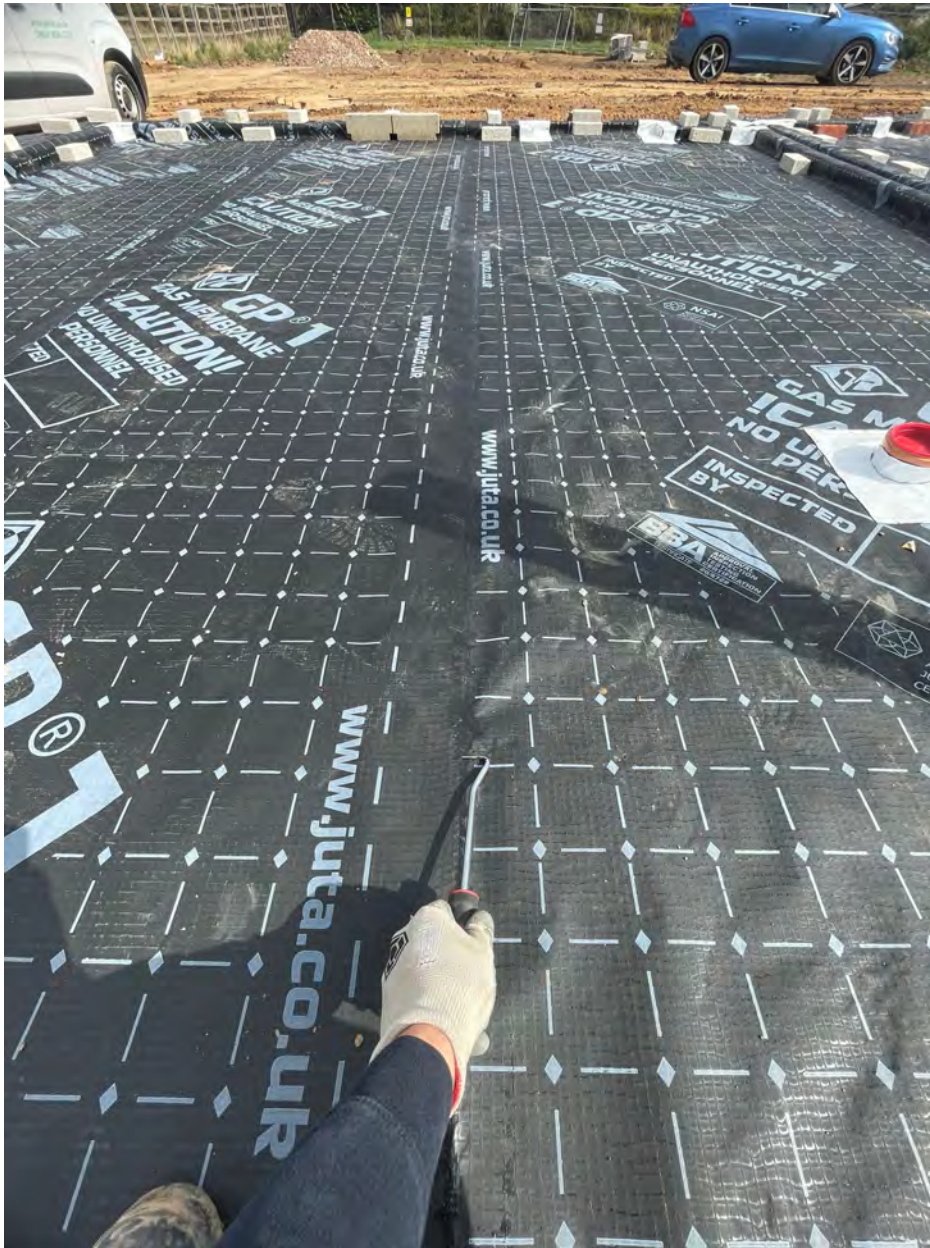
The above photograph displays a mechanical point stress test (also known as a pick and probe test) being conducted upon a welded lap joint of the JUTA GP1 Gas Barrier. Thorough visual inspections, supported by non destructive air lance integrity testing and mechanical point stress testing conducted upon all overlaps, identified one miswelded lap joint.

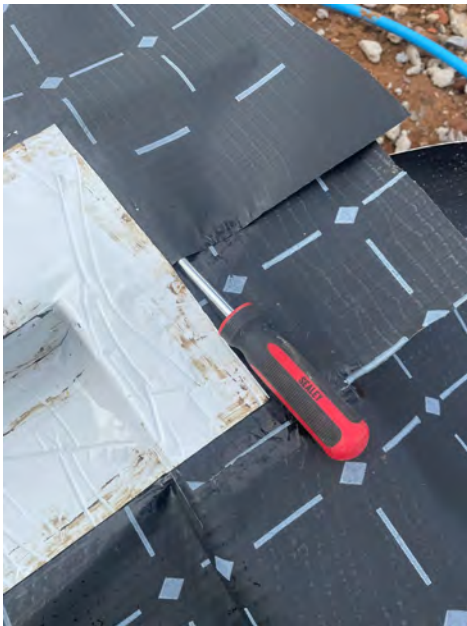
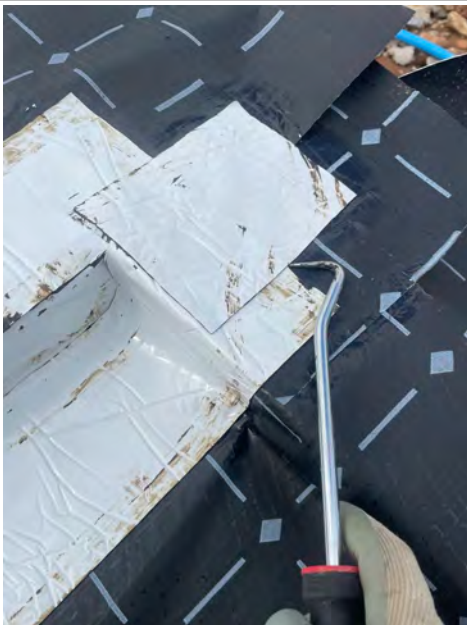
### Misweld Identified and Remediated

As mentioned above whilst carrying out air lance testing across the welded laps, one fault was identified. This was brought to the attention of the installers and remediated on site in the presence of GeoShield.

The installers opted to remediate the fault by applying a 150mm patch of JUTA GP SAM over the affected area. Heat and firm rolled pressure was applied to ensure the JUTA GP SAM had fully bonded. A thorough mechanical point stress test was conducted on the remedial works and identified no faults.

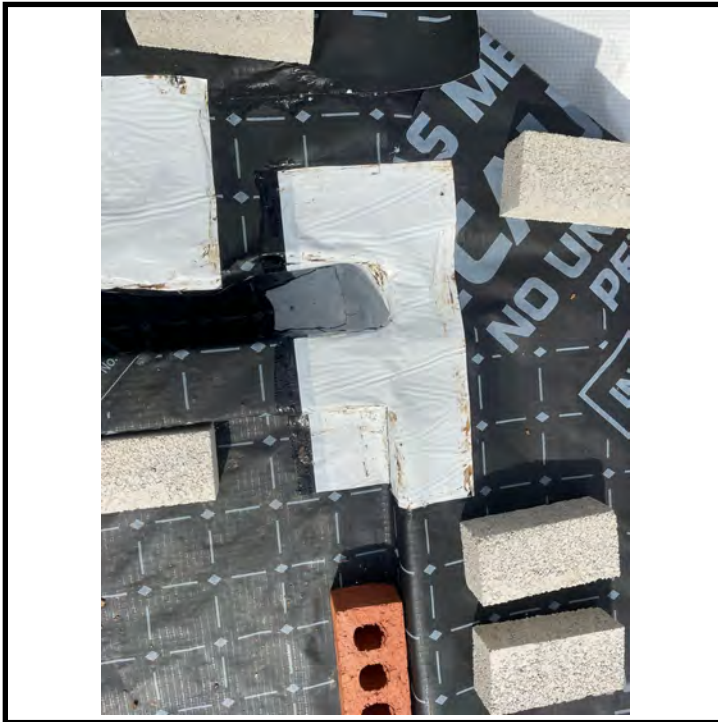
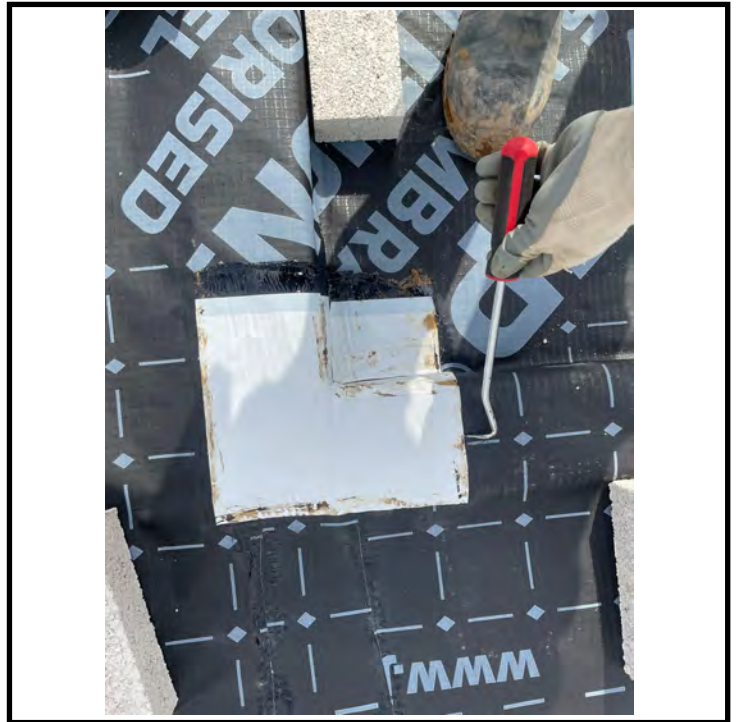
A number of corners and thresholds throughout the referenced plots have been sealed as per manufacturer's specifications and design guidelines. This has been achieved using JUTA GP SAM. The JUTA GP1 Gas Barrier has been cut to minimise any voided areas and gaps across the footprint of the referenced

plots. Each corner and threshold junction has been reinforced by heating strips of JUTA GP SAM and placing them into position around each corner, onto the JUTA GP1 Gas Barrier. Firm rolled pressure is applied with a silicone roller to aid in the adhesion, ensuring the JUTA GP SAM has fully bonded.

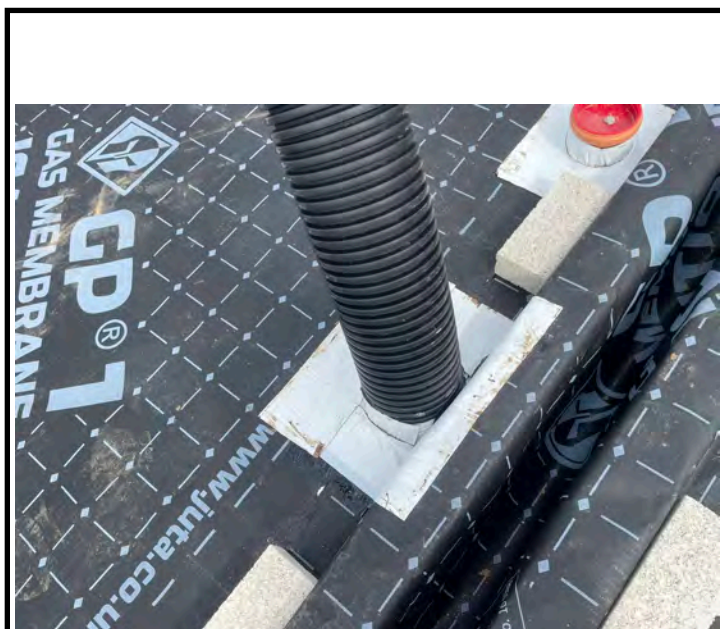
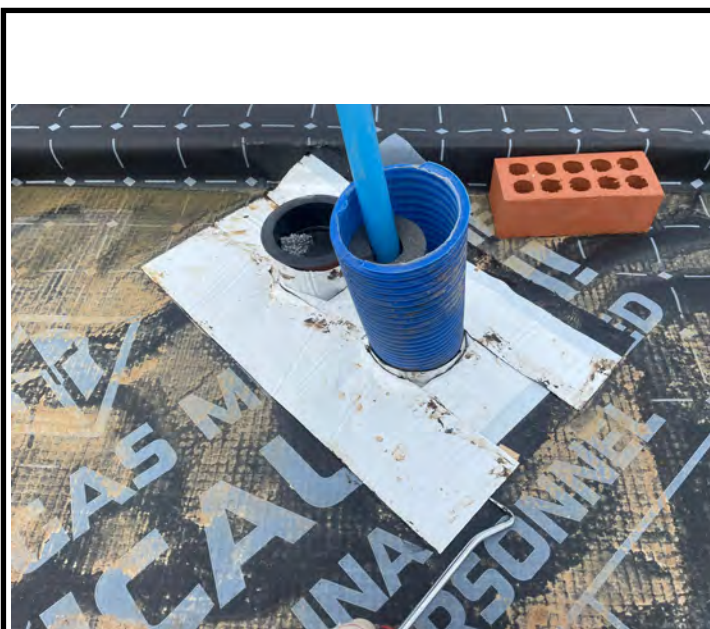
Throughout the installation of the JUTA GP1 Gas Barrier to the referenced plots, there were a number of pipe penetrations that have been sealed in accordance with manufacturer's specifications and design guidelines. This has been achieved using JUTA GP SAM, which is a self adhesive membrane.

The installers have first cut the JUTA GP1 Gas Barrier tight around the base of each pipe penetration to minimise voided areas. Next, strips of JUTA GP SAM are placed intricately in a top hat formation around the pipe penetration and onto the JUTA GP1 Gas Barrier. Heat and rolled pressure is applied to activate the bitumen backing.

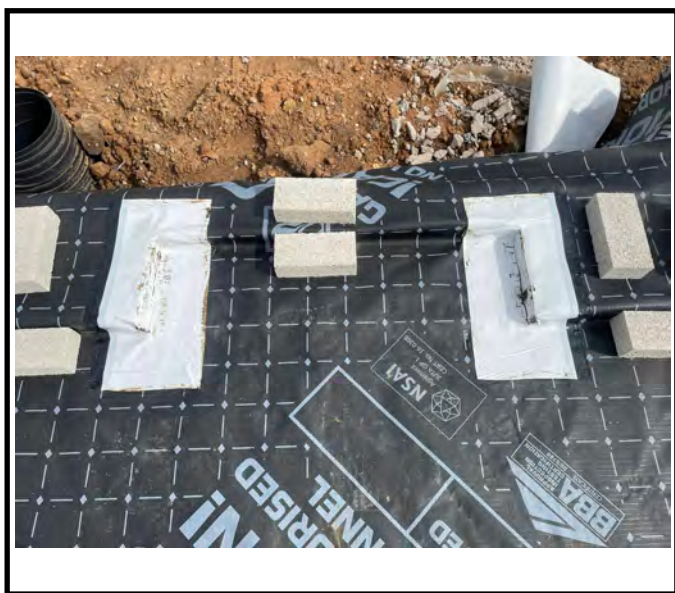
Sealed door threshold.

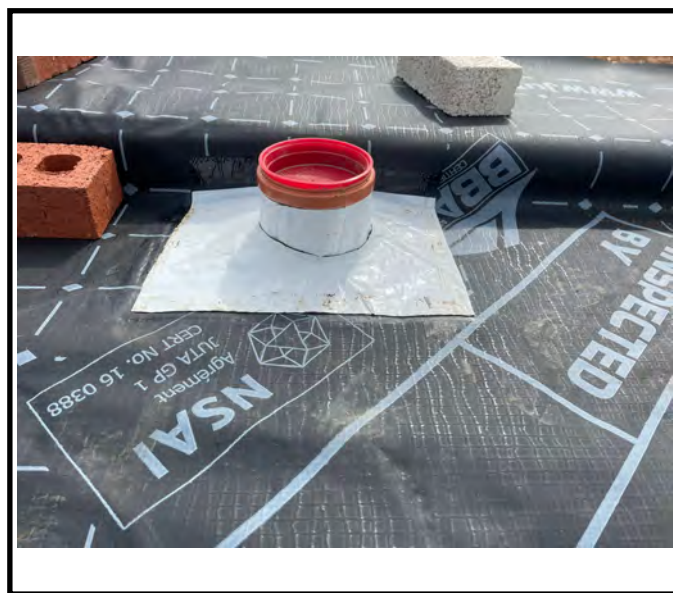
A sealed pipe penetration.

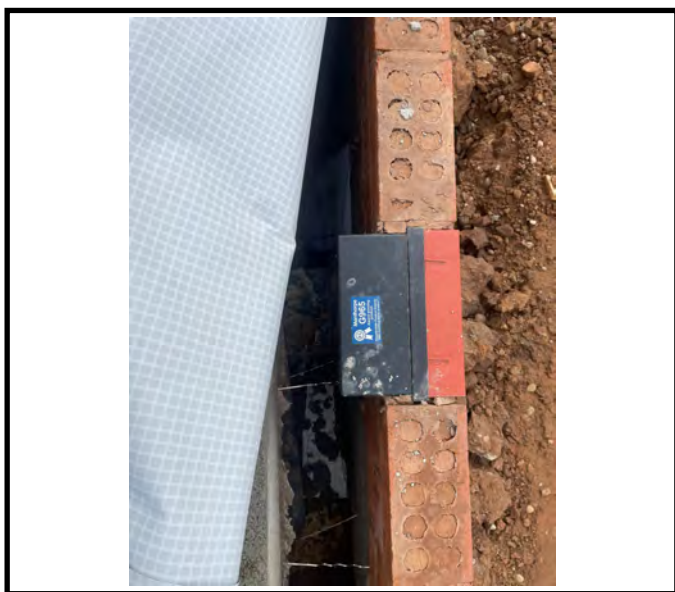
An overview of the telescopic vent connected to the air brick.

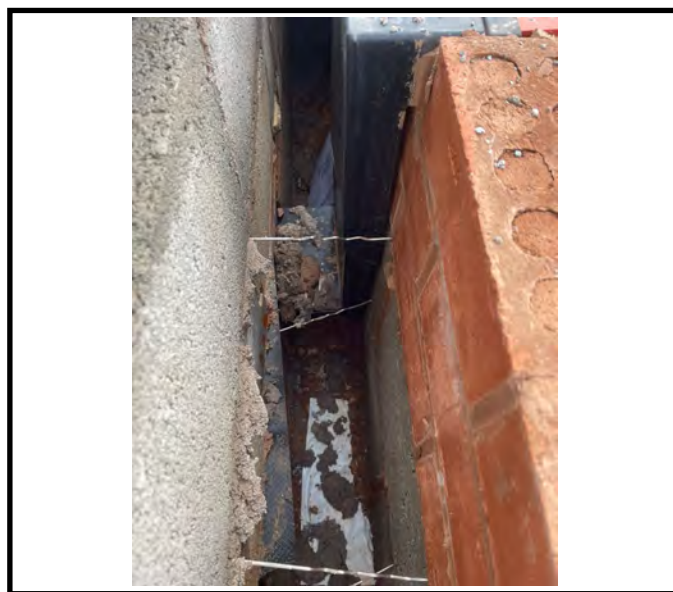
An overview down the cavity wall showing the telescopic vent connecting to the sub floor void.

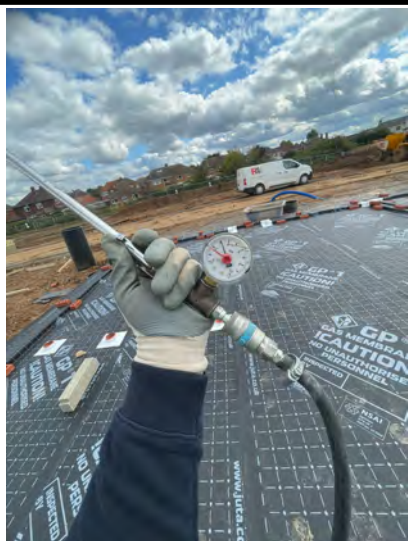
Correct pressure achieved.

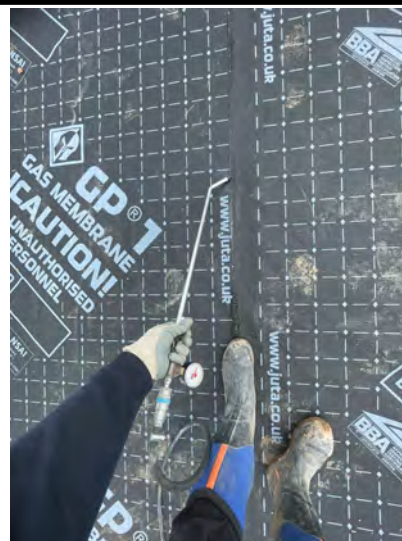
Air lance testing on a welded lap.

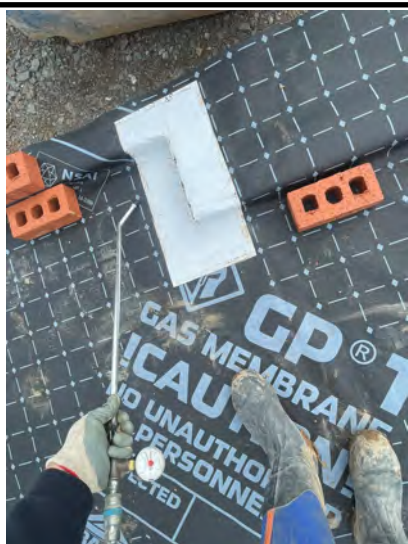
Air lance test on a sealed corner.

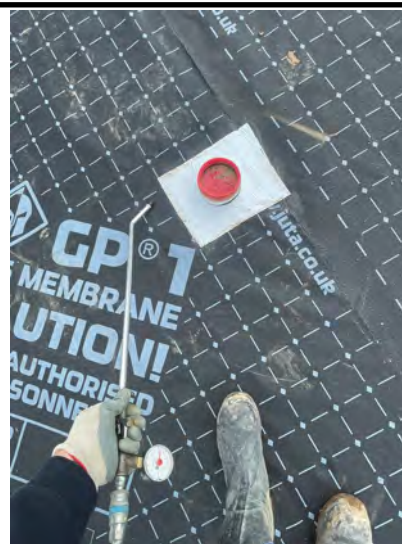
Air lance test on a pipe penetration.
