# GeoShield Verification Report 6

GEO105396

R4 Civils,  
Barlestone,  
Barton Road,  
Osbaston  
Nuneaton,  
CV13 0EU

Plots 8, 9, 10, 11, 50, 51, 52, 53, 54 & 55 - Full Line Out

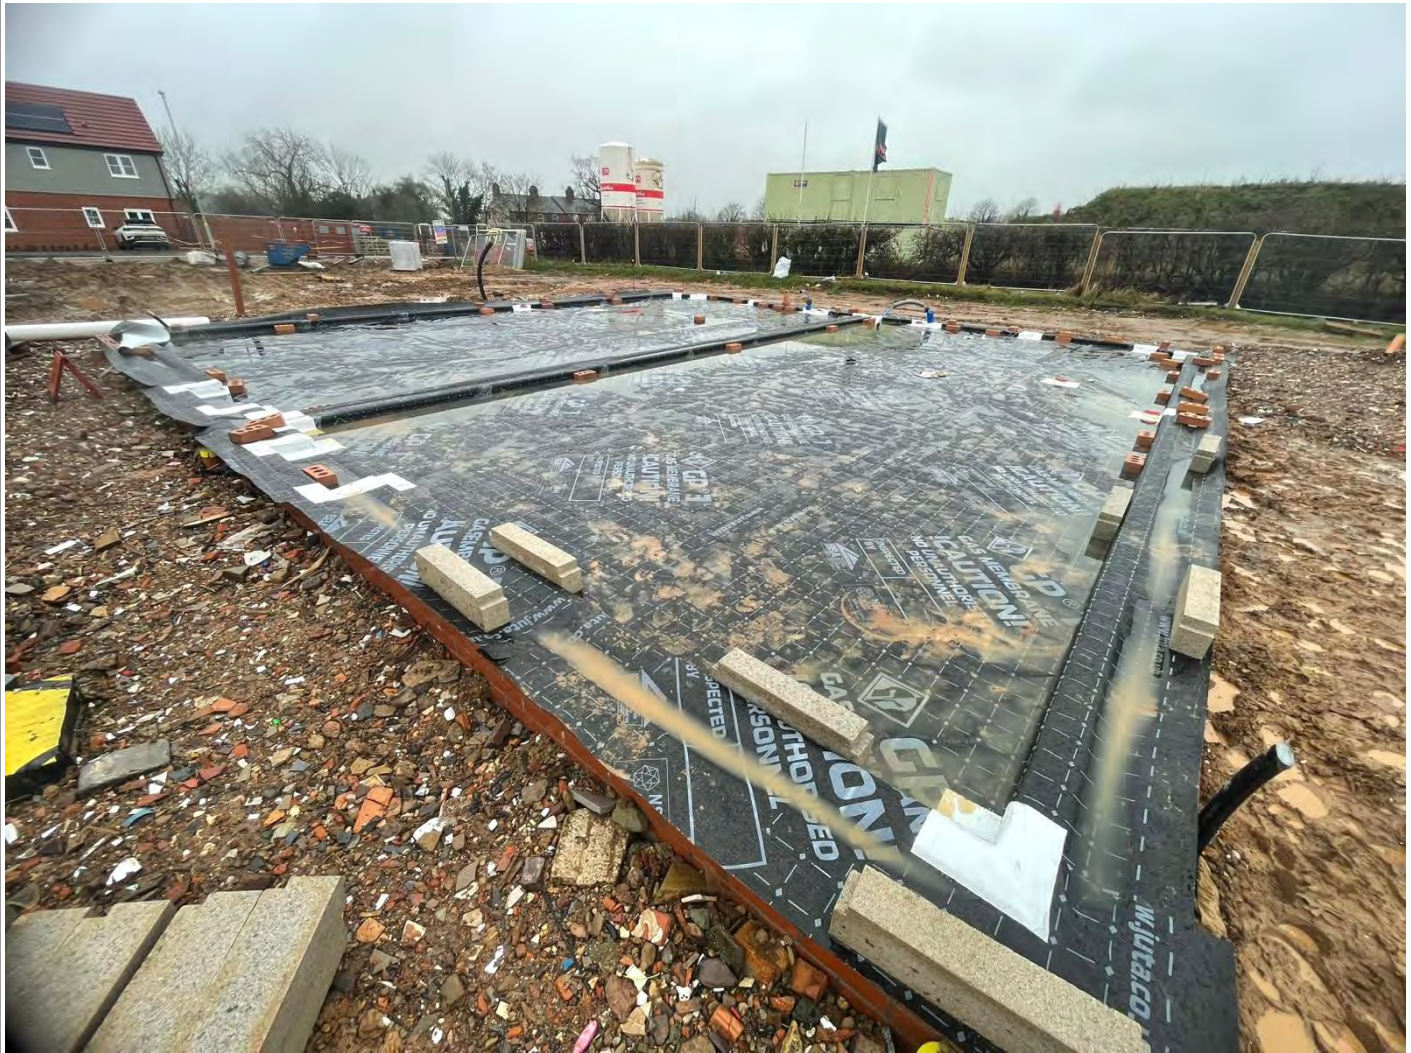
The photograph above displays an overview of Plots 8 & 9 where today's verification inspection took place on site.

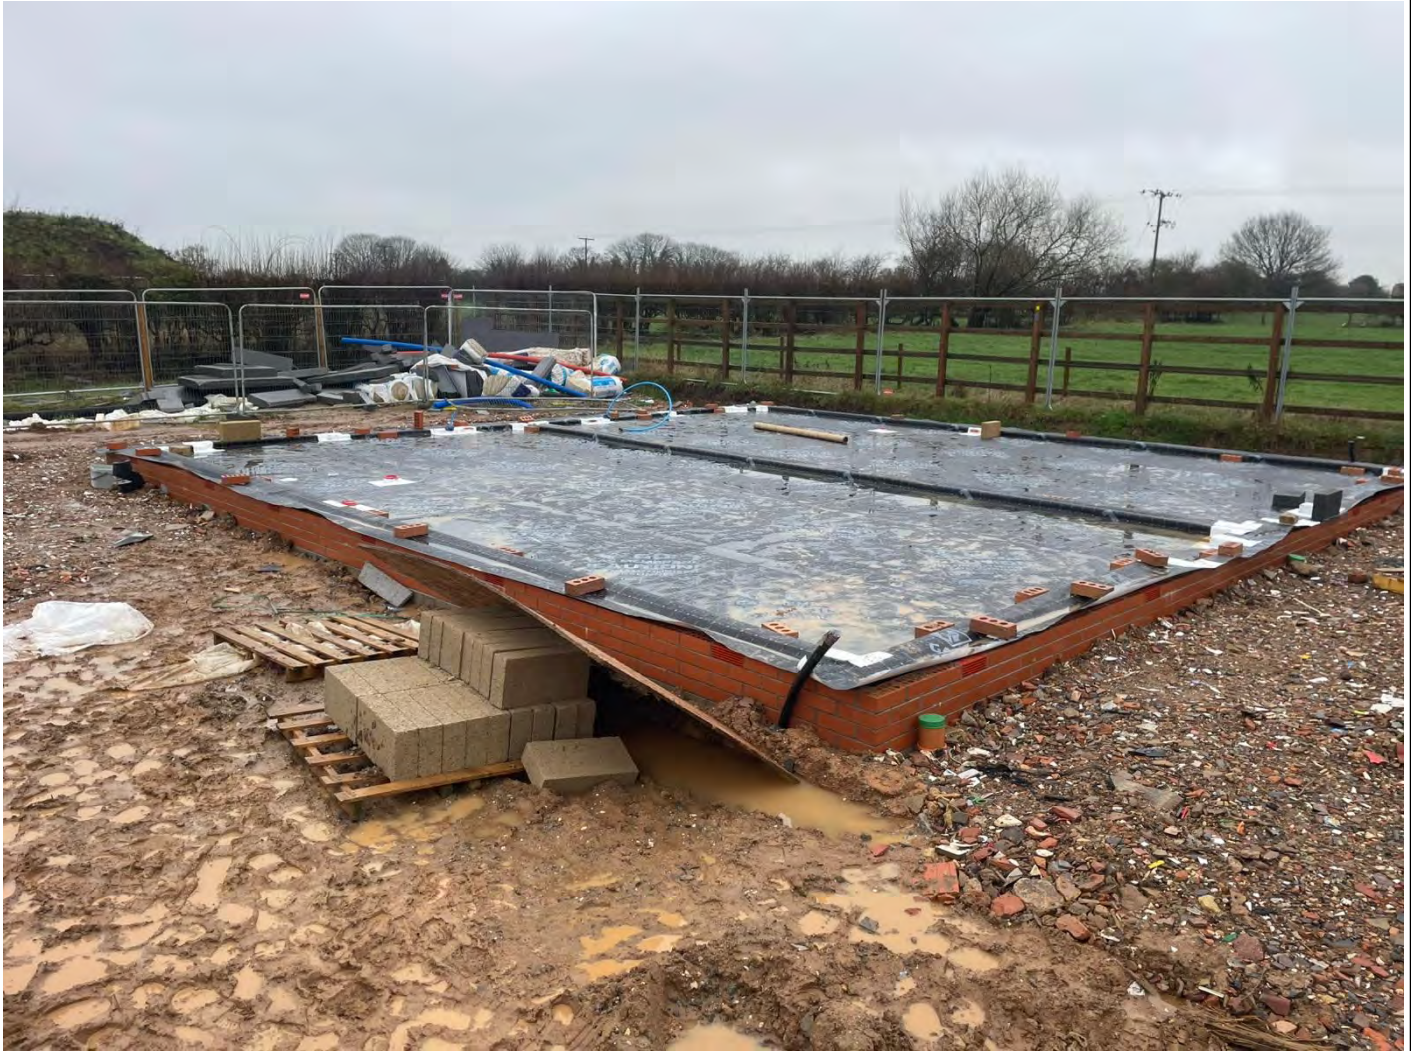
The photograph above displays an overview of Plots 10 & 11 where today's verification inspection took place on site.

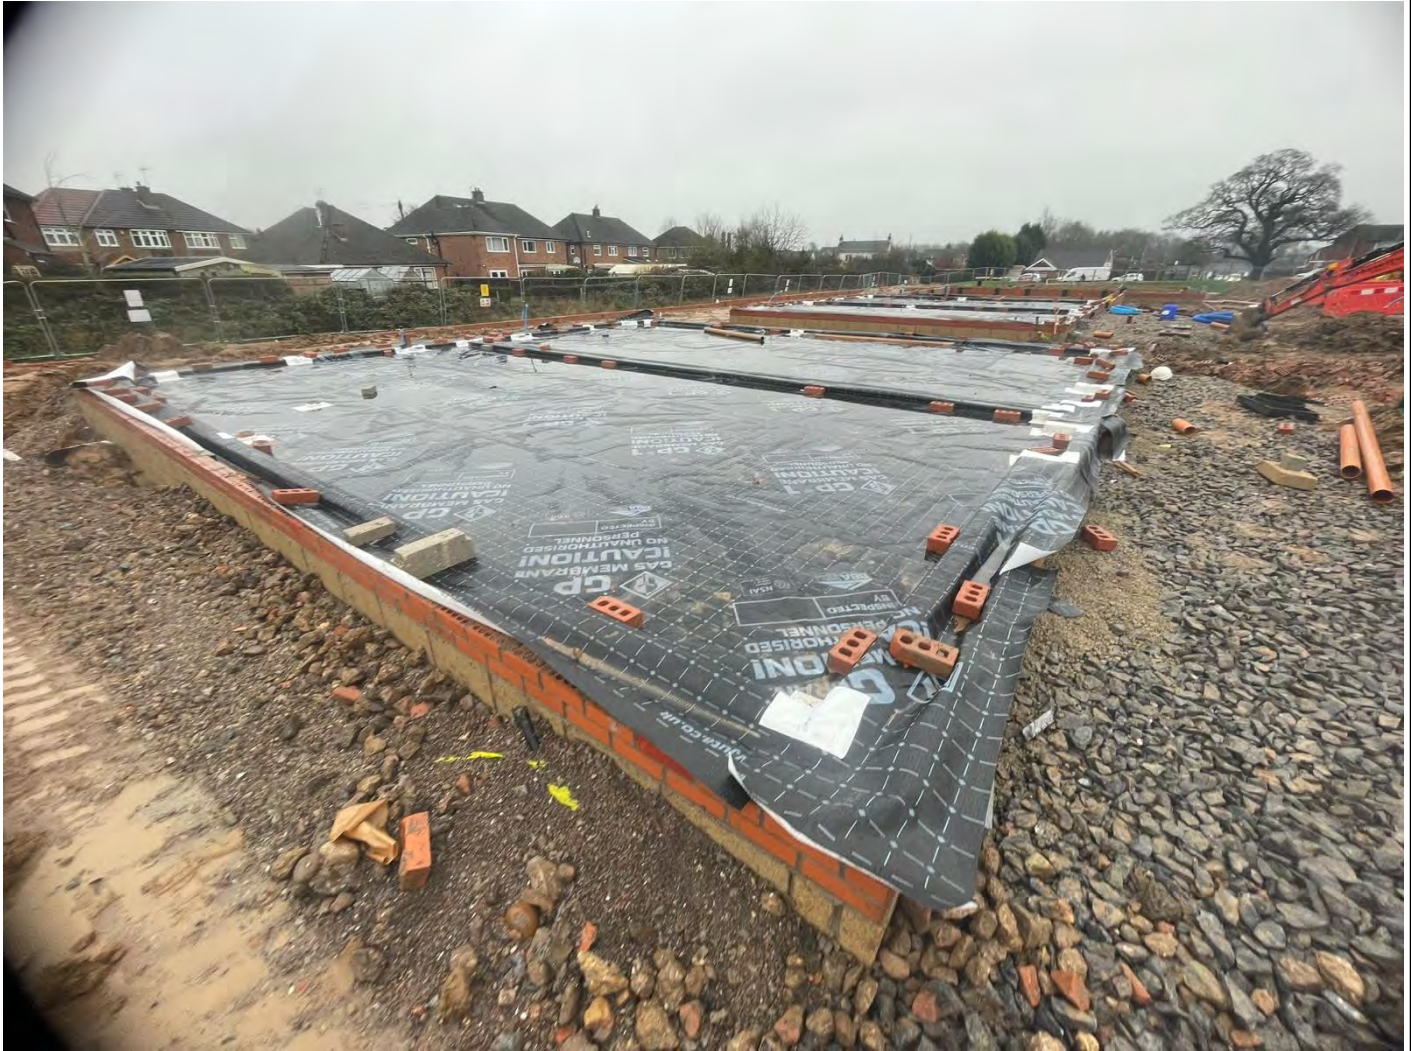
The photograph above displays an overview of Plots 50 & 51 where today's verification inspection took place on site.

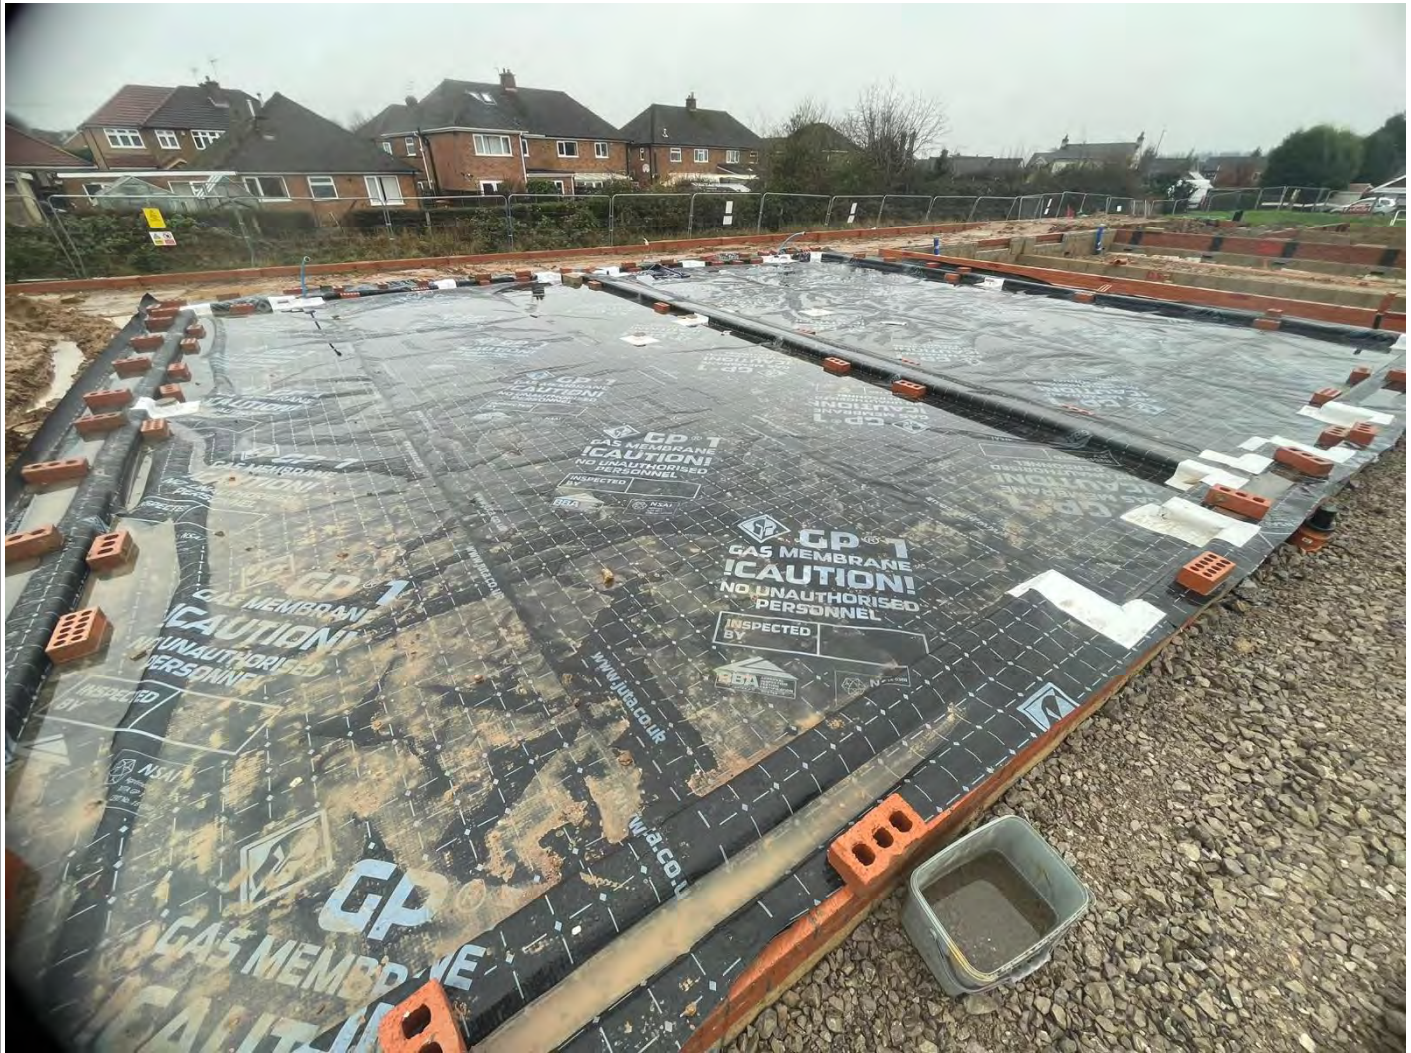
The photograph above displays an overview of Plots 52 & 53 where today's verification inspection took place on site.

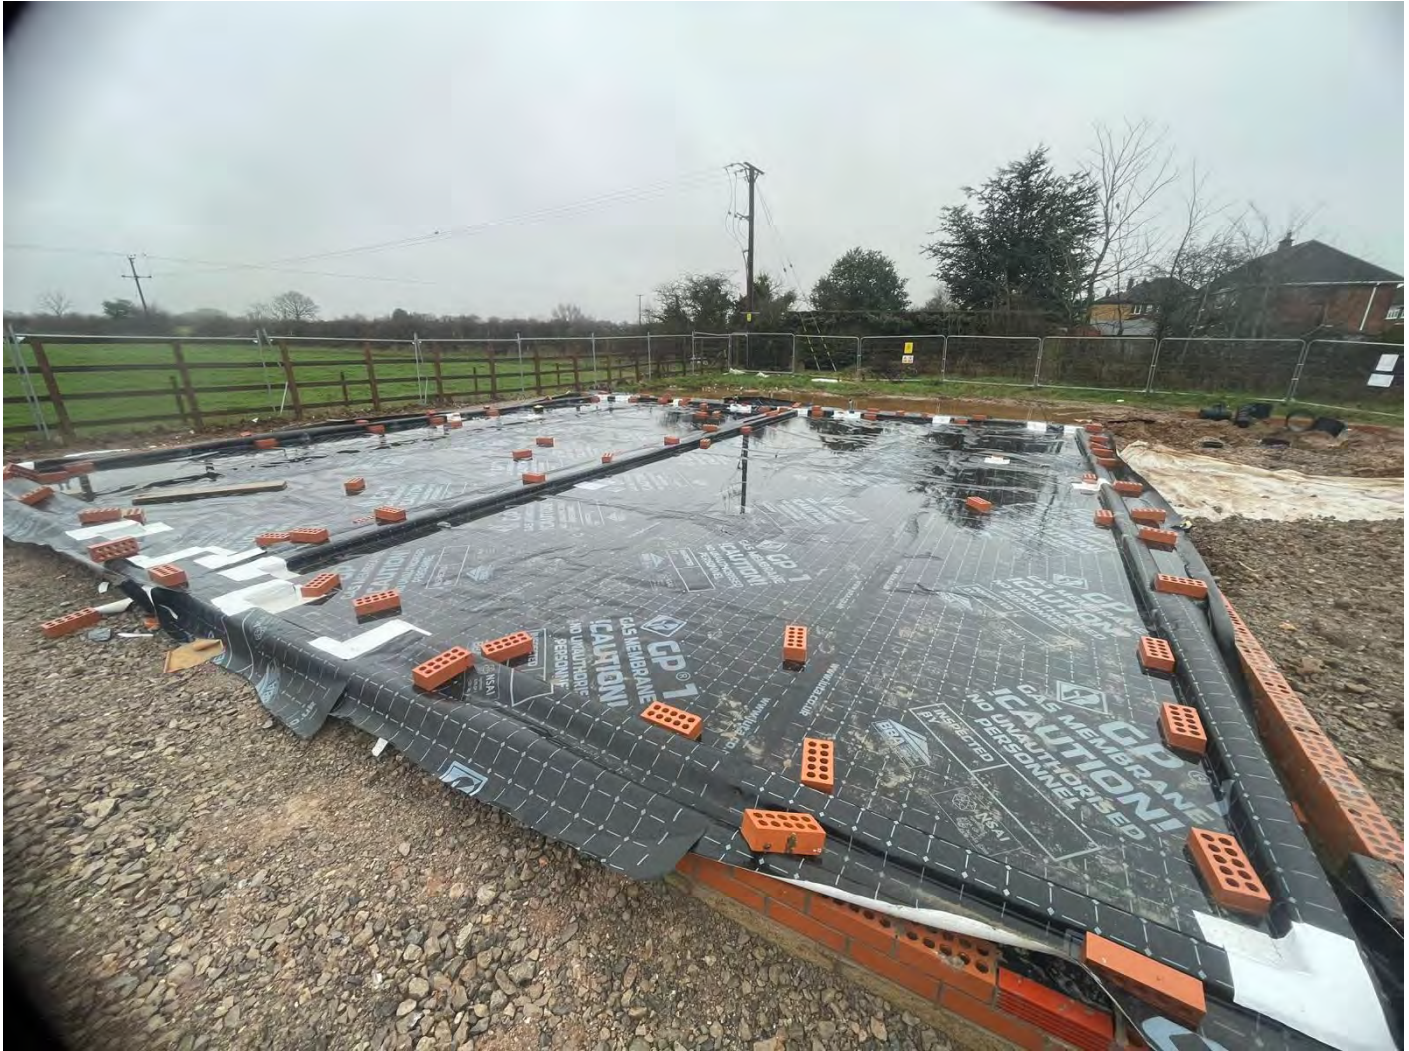
The photograph above displays an overview of Plots 54 & 55 where today's verification inspection took place on site.

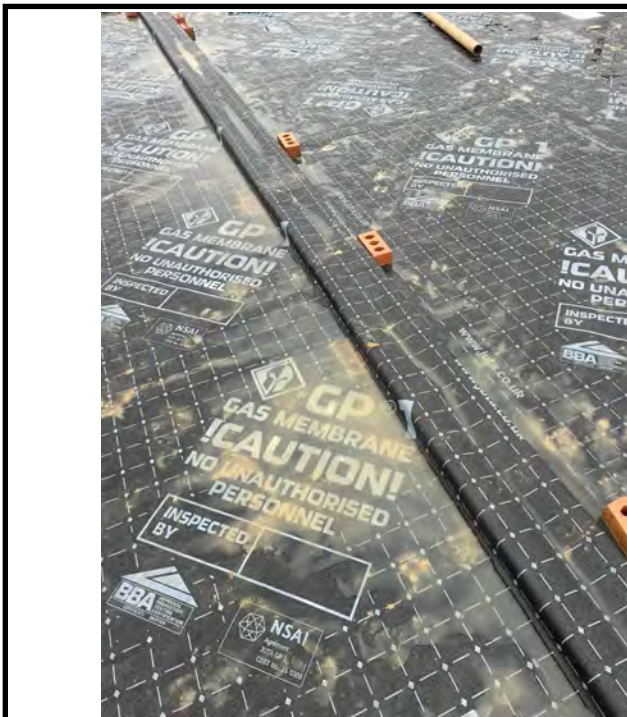
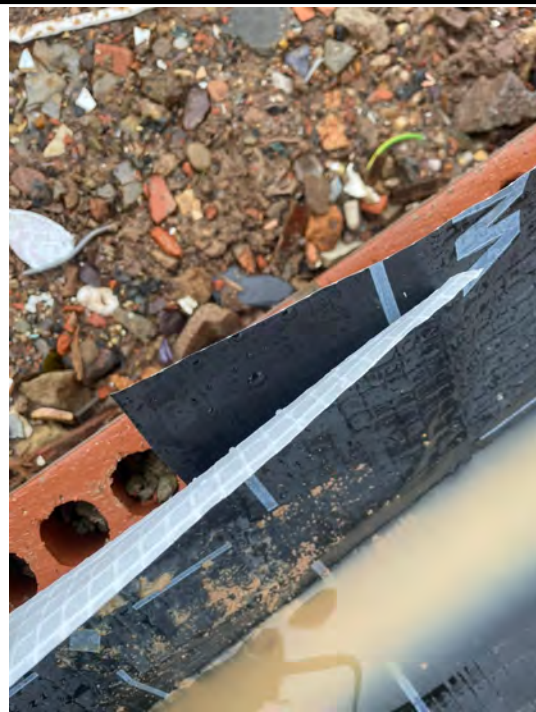
### Installation of JUTA GP1 Gas Barrier - Lap Joints

A complete line out of the JUTA GP1 Gas Barrier has been installed across the footprint of Plots 8, 9, 10, 11, 50, 51, 52, 53, 54 & 55, upon an insulated block and beam ventilated sub floor void. The JUTA GP1 Gas Barrier has been lined out across the entirety of the plots, including the internal party walls, ensuring it overlaps

the external cavity to the outer leaf brickwork. All lap joints between the adjacent sheets of JUTA GP1 Gas Barrier have been overlapped a sufficient amount, and heat welded using a hot air leister and silicone roller with adequate pressure applied to ensure a continuous gas resistant seal is achieved.

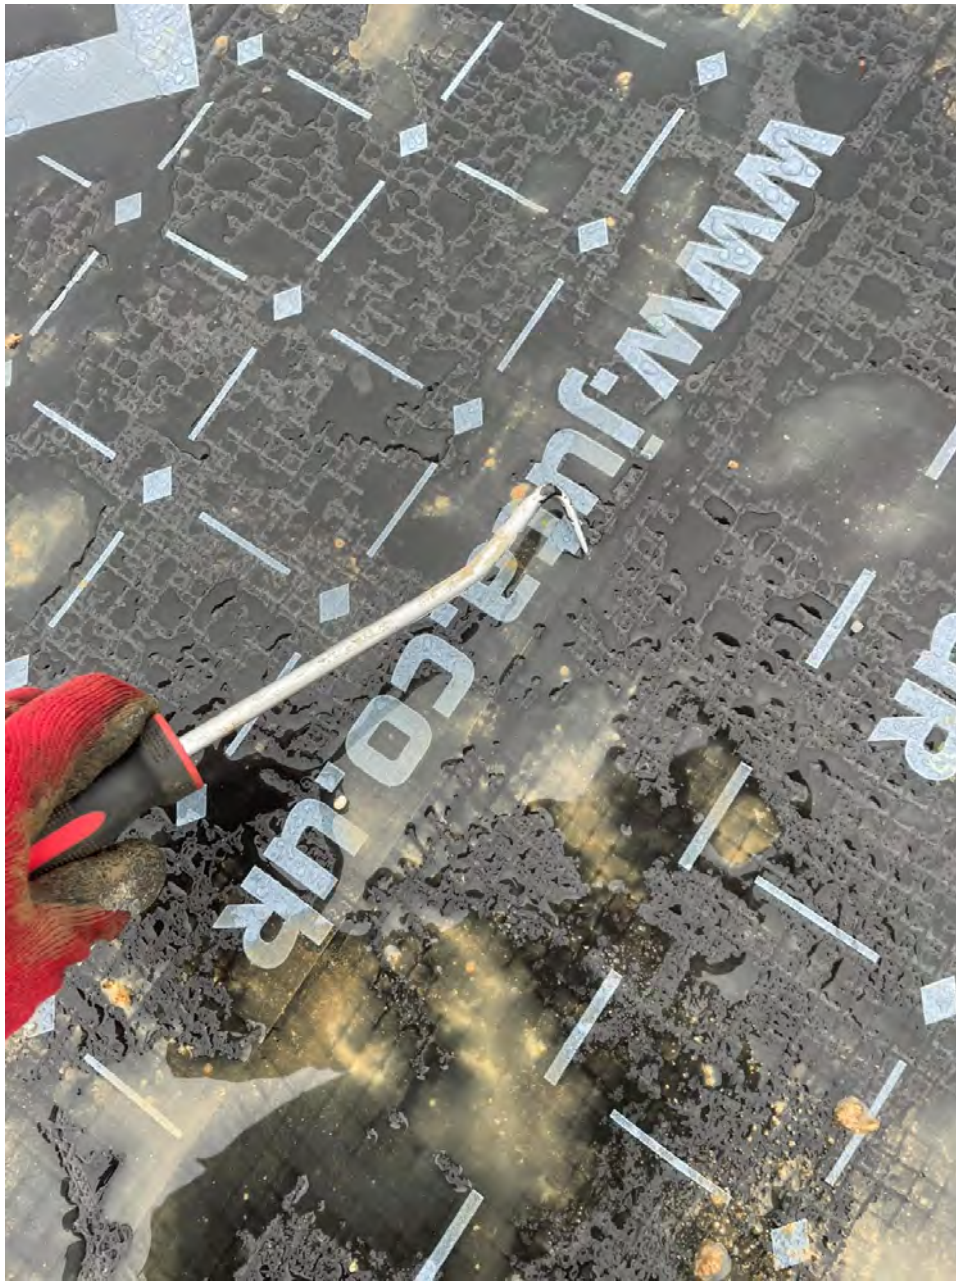
The above photograph displays a mechanical point stress test being conducted upon a welded lap joint of the JUTA GP1 Gas Barrier. Thorough visual inspections, supported by non destructive air lance integrity testing and mechanical point stress testing conducted upon all overlaps, identified no faults or defects.

Tested and verified in accordance with CIRIA 735.

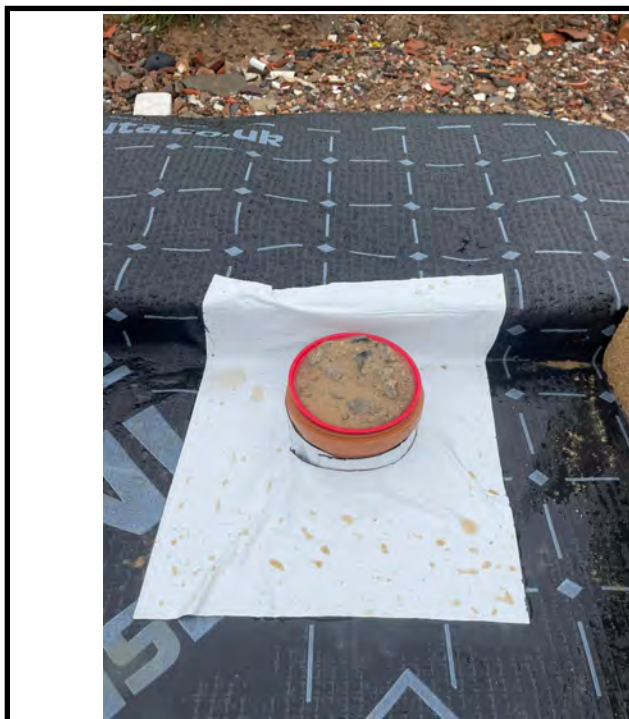
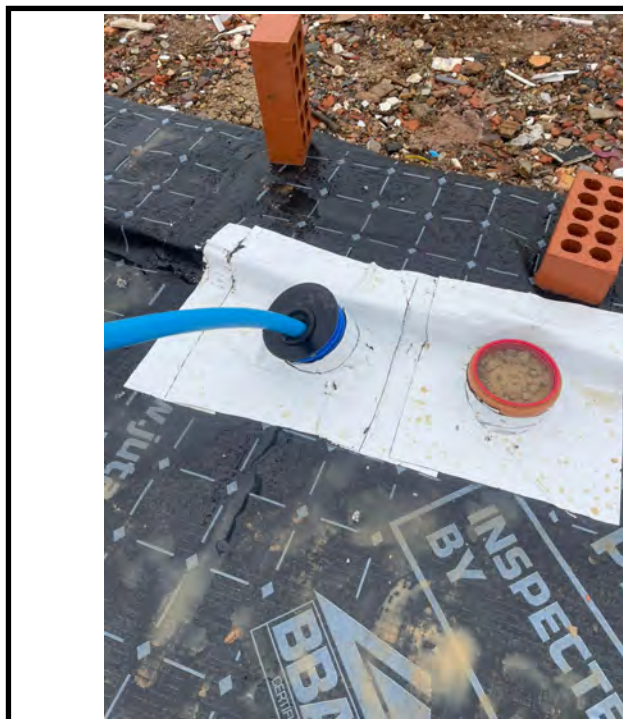
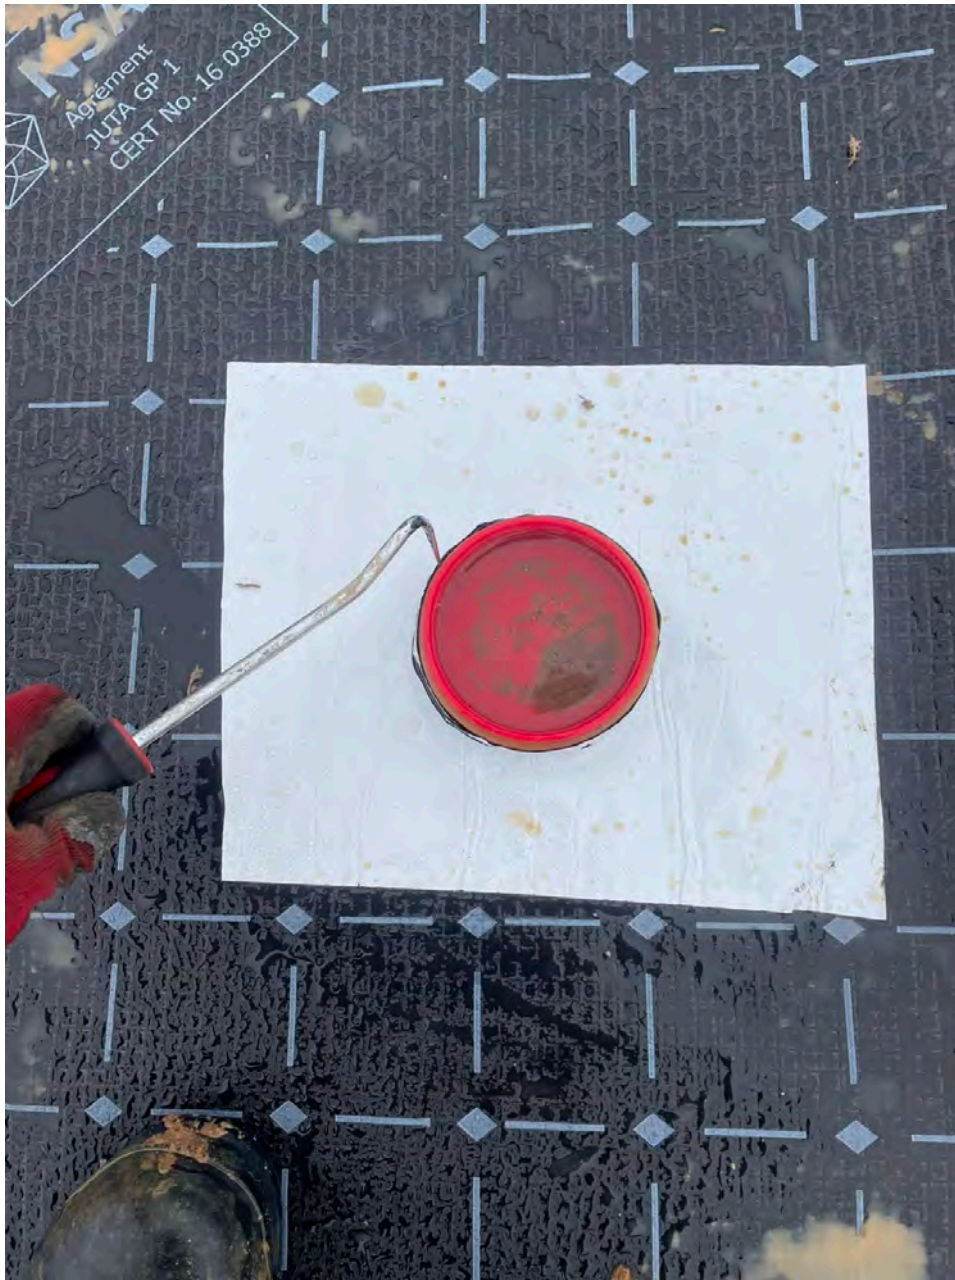
### Pipe Penetrations

Throughout the complete line out installation of the JUTA GP1 Gas Barrier to the referenced plots, there were a number of pipe penetrations that have been sealed in accordance with manufacturer's specifications and design guidelines. This has been achieved using JUTA GP SAM, which is a gas resistant self adhesive

membrane. The installers have first cut the JUTA GP1 Gas Barrier tight around the base of each pipe penetration to minimise voided areas. Next, patches of JUTA GP SAM are placed intricately in a petal formation around the pipe penetration and onto the JUTA GP1 Gas Barrier, with a 300mm square of JUTA GP SAM placed

over the top to form a top hat detail. Heat and rolled pressure is applied to activate the bitumen backing, creating a secure bond between the pipe penetration and the JUTA GP1 Gas Barrier. All pipe penetrations throughout the referenced plots were subjected to thorough mechanical point stress testing and non destructive air lance integrity testing. No faults or defects were identified at the time of the inspection.

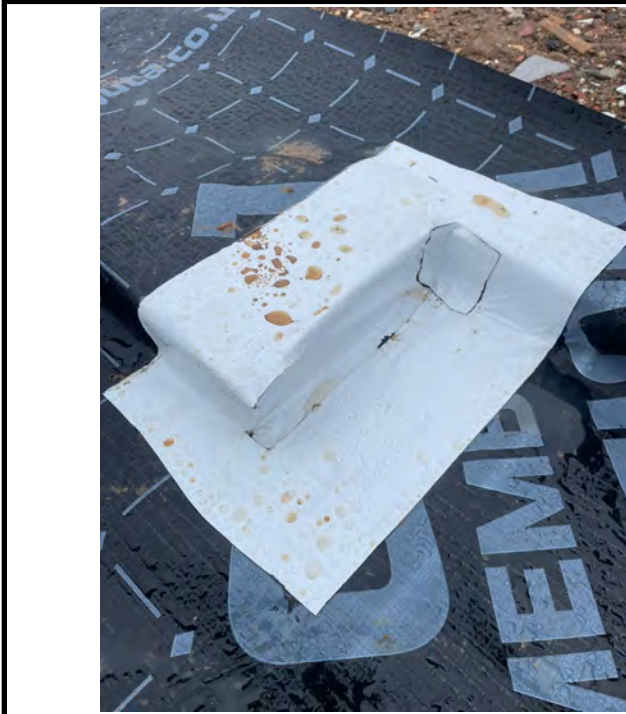
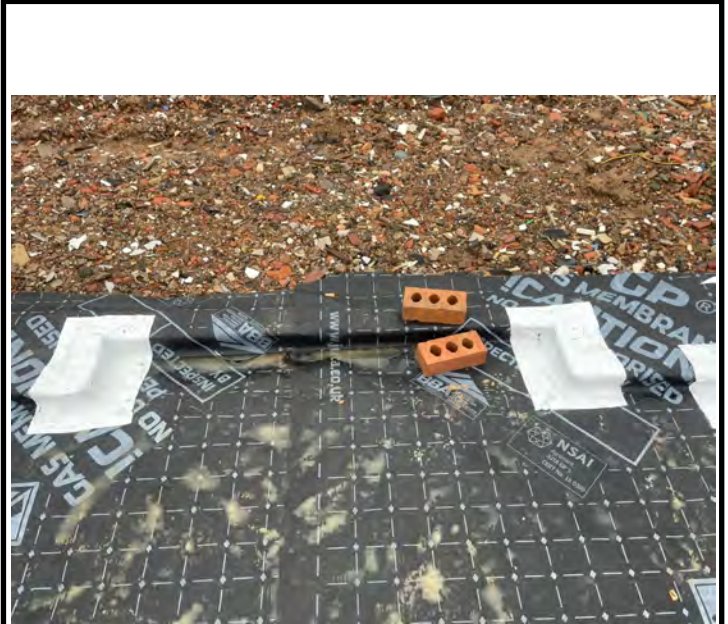
### Corner & Threshold Detailing

A number of corners and thresholds throughout the referenced plots have also been sealed as per manufacturer's specifications and design guidelines. This has been achieved using JUTA GP SAM. Where the JUTA GP1 Gas Barrier has been cut to minimise voided areas and gaps across the footprint of the plots, each

corner and threshold junction has been reinforced by heating strips of JUTA GP SAM and placing into position around each corner and threshold, onto the JUTA GP1 Gas Barrier. Firm rolled pressure is applied with a silicone roller to aid in the adhesion, ensuring the JUTA GP SAM has fully bonded.

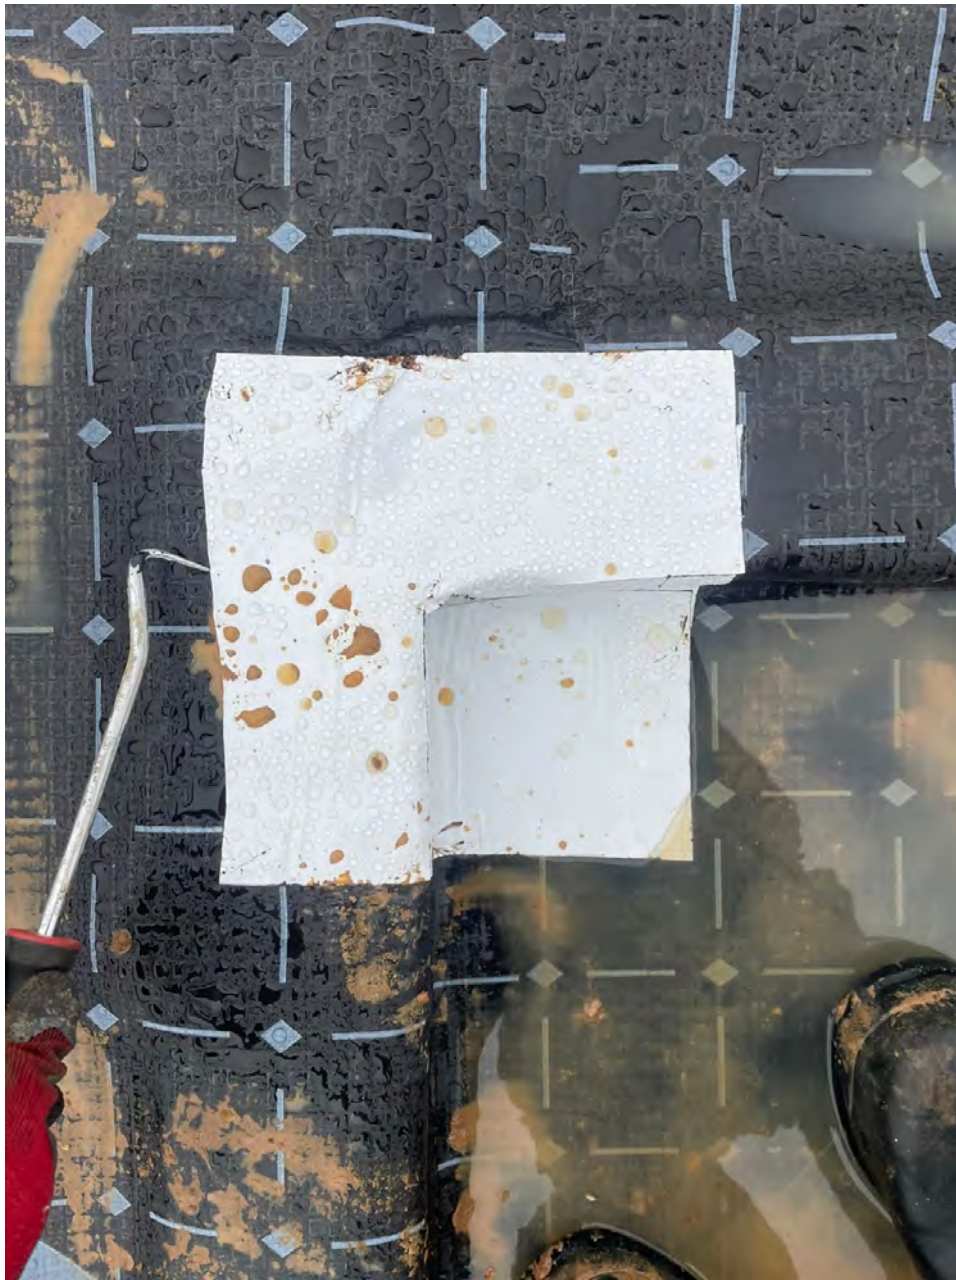
As with the pipe penetrations, a probe and an air lance were run along all JUTA GP SAM corner detailing to validate that a gas tight seal had been achieved throughout. No faults or defects were identified. A complete adhesion has been achieved. Tested and verified in accordance with CIRIA 735.

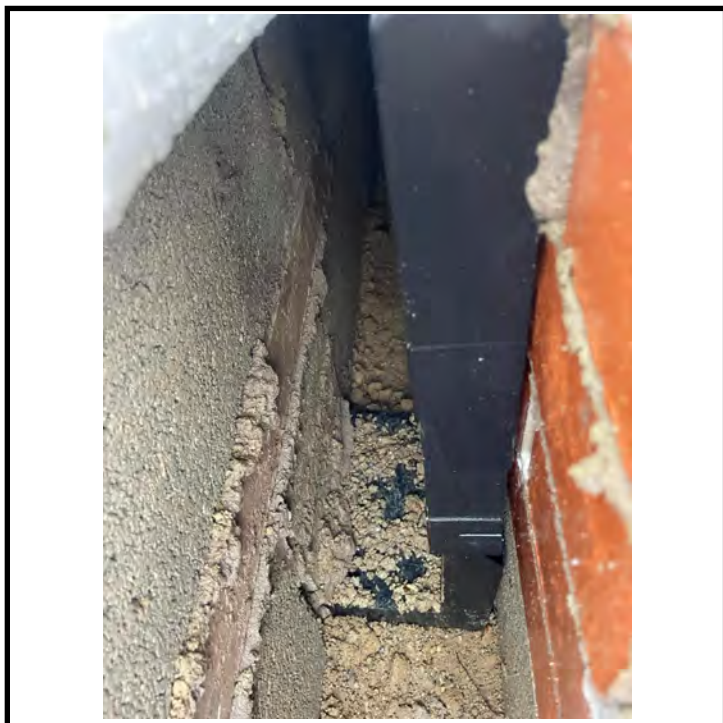
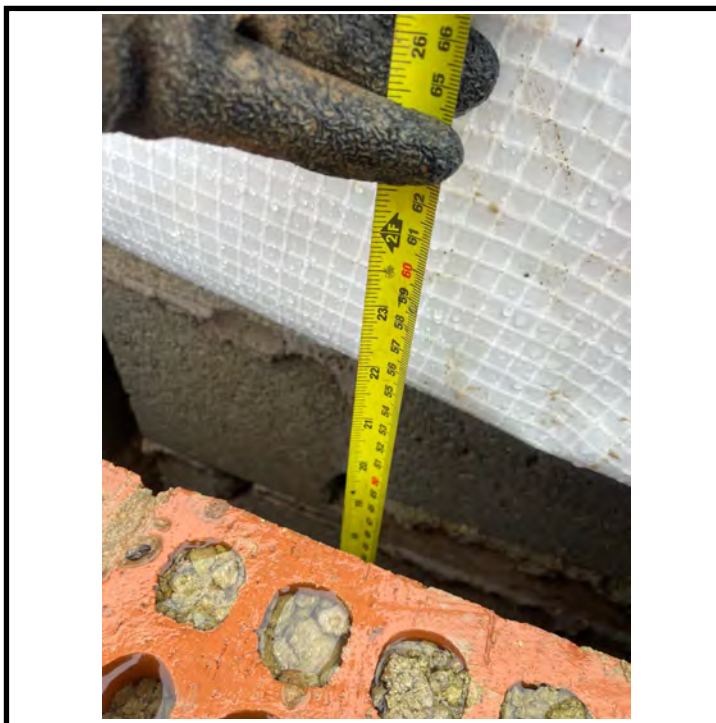
### Sub Floor Ventilation

The initial protection to harmful ground gases migrating into the building is the sub floor void underneath the block and beam foundation. This protection measure essentially vents the ground gases from beneath the block and beam foundation out through the ventilation air bricks.

The first image shows the periscope ventilation sleeve leading from the sub-floor void, which has been connected to an air brick built into the perimeter face brickwork. The second image shows the sub floor void depth to be more than sufficient for this project.

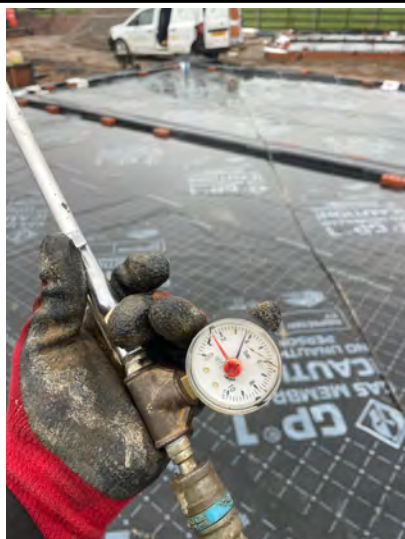
Correct pressure achieved.

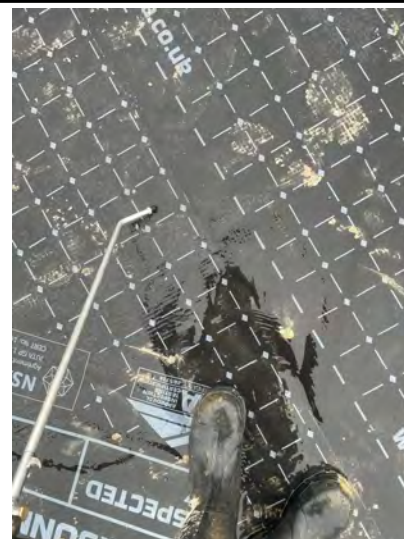
Air lance test on a welded lap.

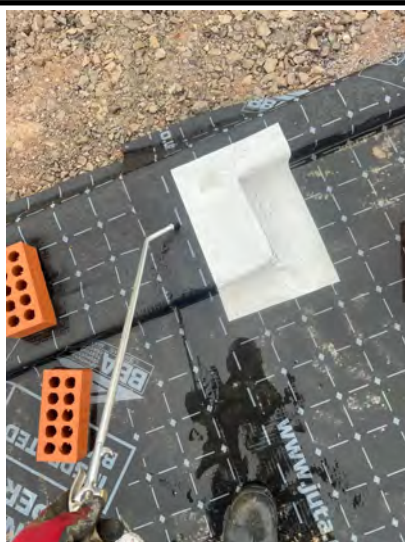
Air lance test on a sealed corner.

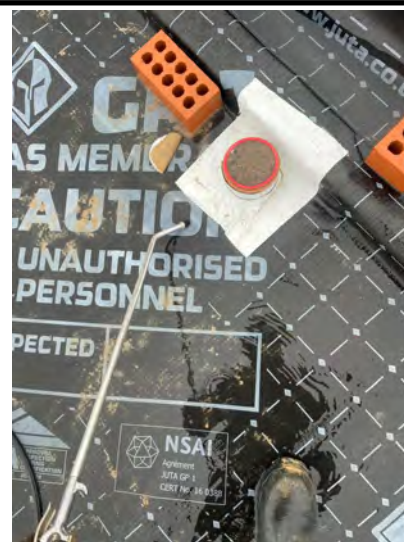
Air lance test on a pipe penetration.
