# GeoShield Verification Report 7

GEO105396

R4 Civils,  
Barlestone,  
Barton Road,  
Osbaston  
Nuneaton,  
CV13 0EU

Plots 46, 78, 48 & 49 - Full Line Out

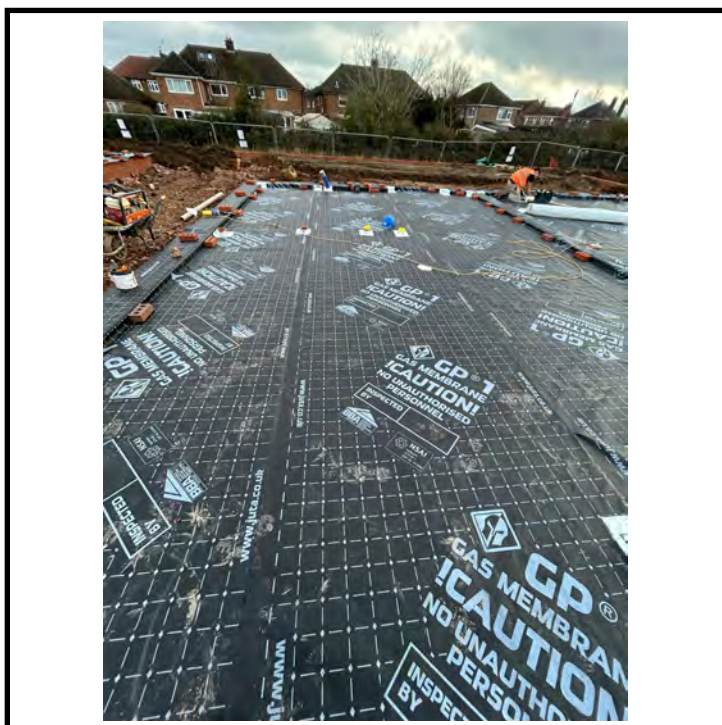
A complete line out of the JUTA GP1 Gas Barrier has been installed across the footprint of Plots 46, 47, 48 & 49, upon an insulated block and beam ventilated sub floor void. The JUTA GP1 Gas Barrier has been lined out across the entirety of the plots, including the internal party walls, ensuring it overlaps

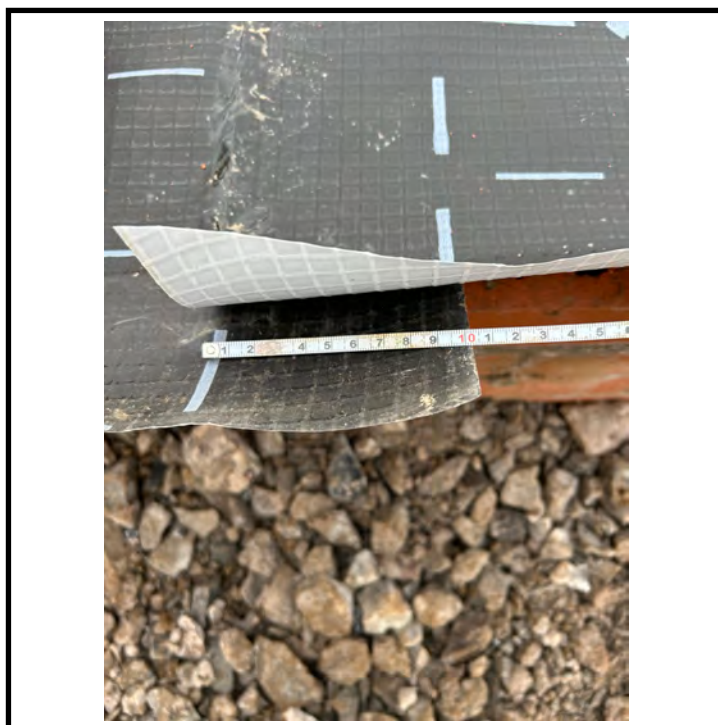
the external cavity to the outer leaf brickwork. All lap joints between the adjacent sheets of JUTA GP1 Gas Barrier have been overlapped a minimum of 100mm, and heat welded using a hot air leister and silicone roller with adequate pressure applied to ensure a continuous gas resistant seal is achieved.

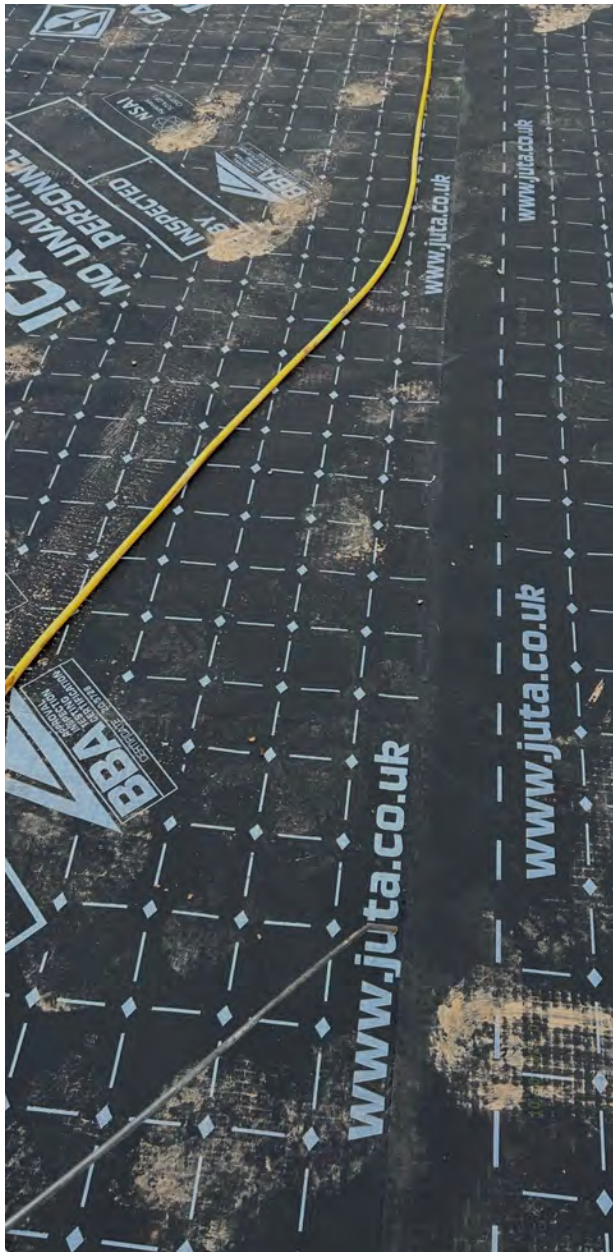
Thorough visual inspections, supported by non destructive air lance integrity testing and mechanical point stress testing conducted upon all overlaps, identified three miswelded lap joints which were successfully remediated.  
Tested and verified in accordance with CIRIA 735.

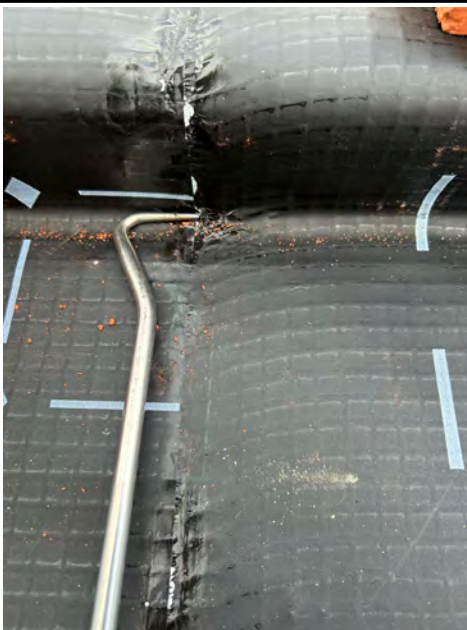
As mentioned, three miswelded lap joints were identified during the testing procedures conducted today. The faults were brought to the attention of the installers and remediated on site in the presence of GeoShield.

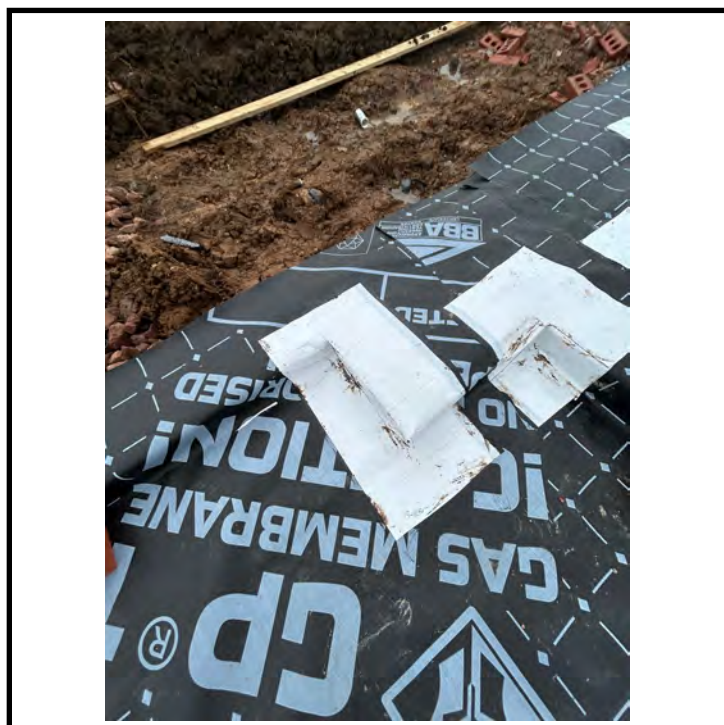
Each corner and threshold junction has been reinforced by heating strips of JUTA GP SAM and placing them into position around each corner, onto the JUTA GP1 Gas Barrier. Firm rolled pressure is applied with a silicone roller to aid in the adhesion ensuring the JUTA GP SAM has fully bonded.

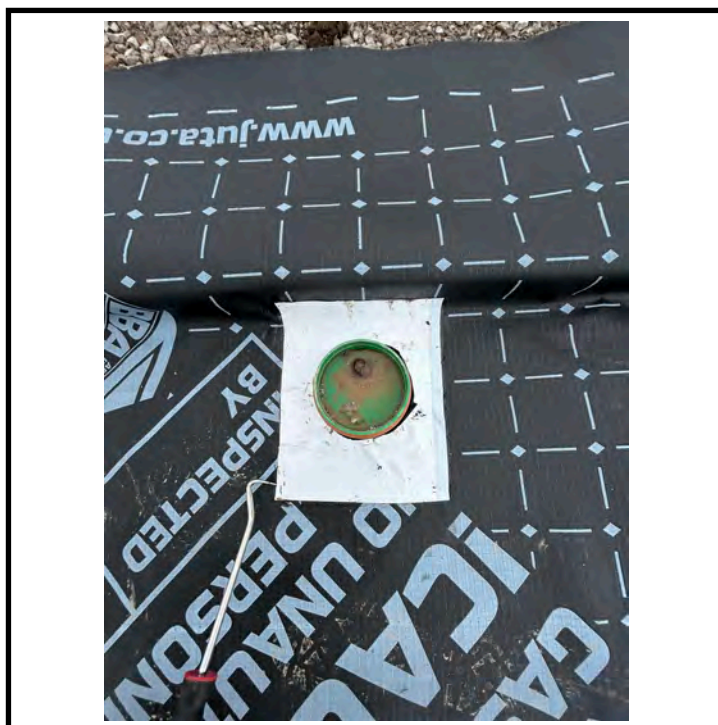
For the pipe penetrations, the installers have first cut the JUTA GP1 Gas Barrier tight around the base of each pipe penetration to minimise voided areas. Next, strips of JUTA GP SAM are placed intricately in a top hat formation around the pipe penetration and onto the JUTA GP1 Gas Barrier. Heat and rolled pressure is

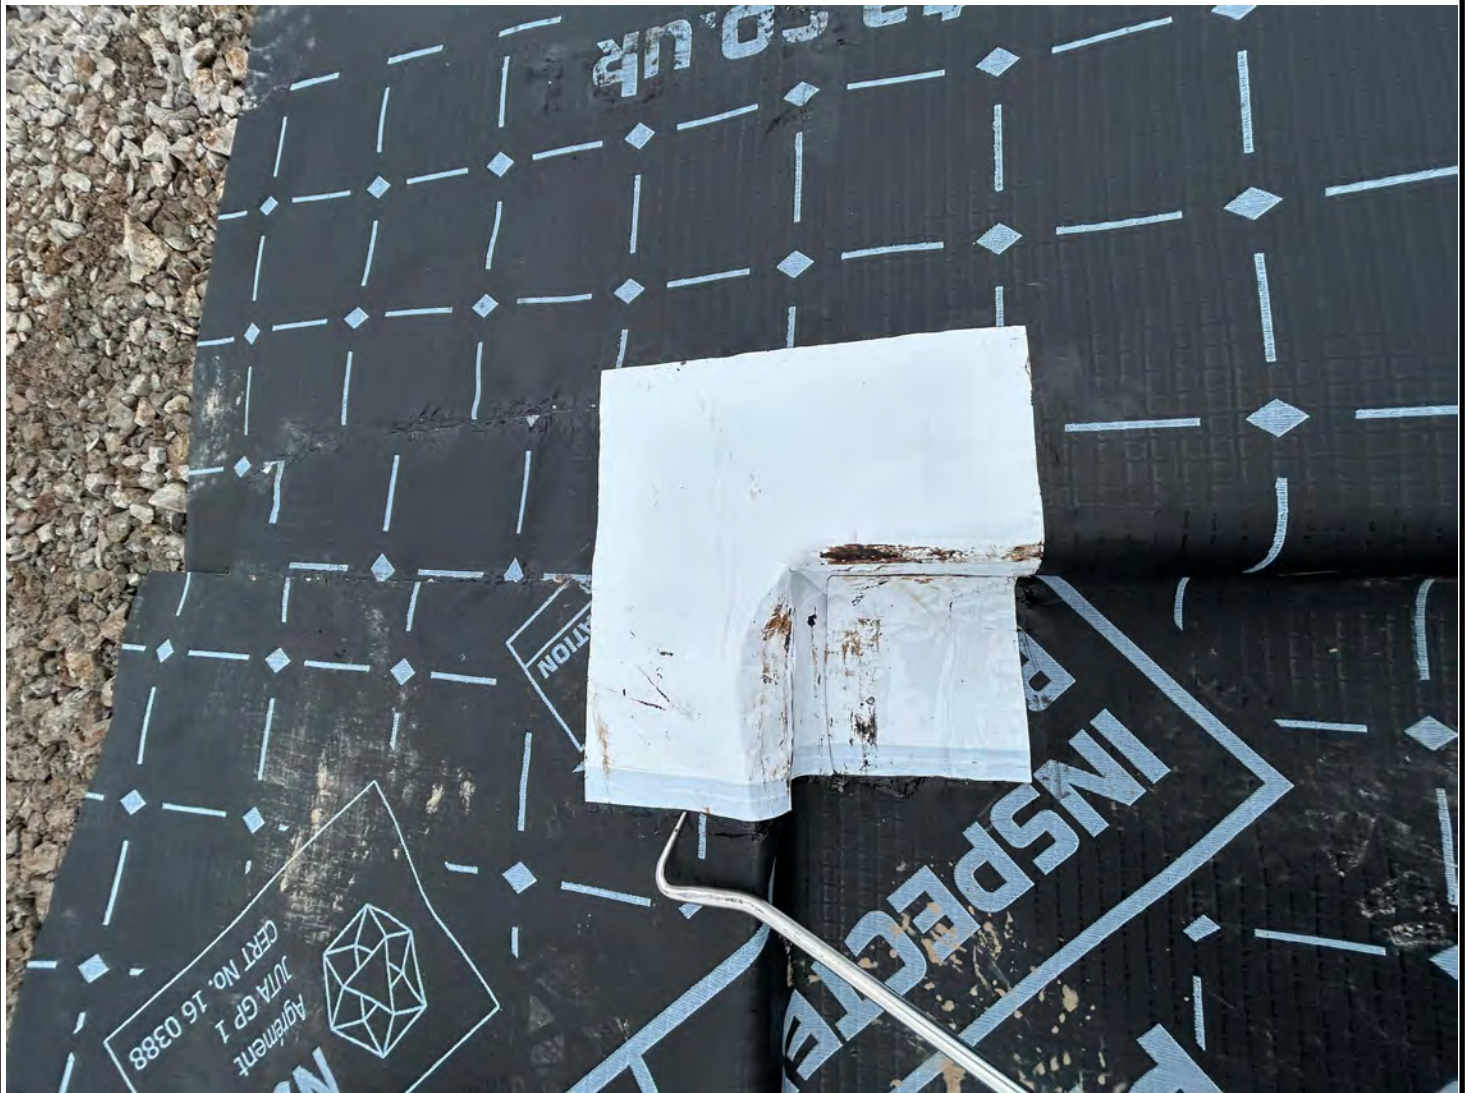
applied to activate the bitumen backing, creating a secure bond between the pipe penetration and the JUTA GP1 Gas Barrier. All pipe penetrations, corners and thresholds throughout were subjected to a thorough visual inspection, followed by mechanical point stress testing. No faults or defects were identified within the pipe penetrations, corners and thresholds during these testing procedures.

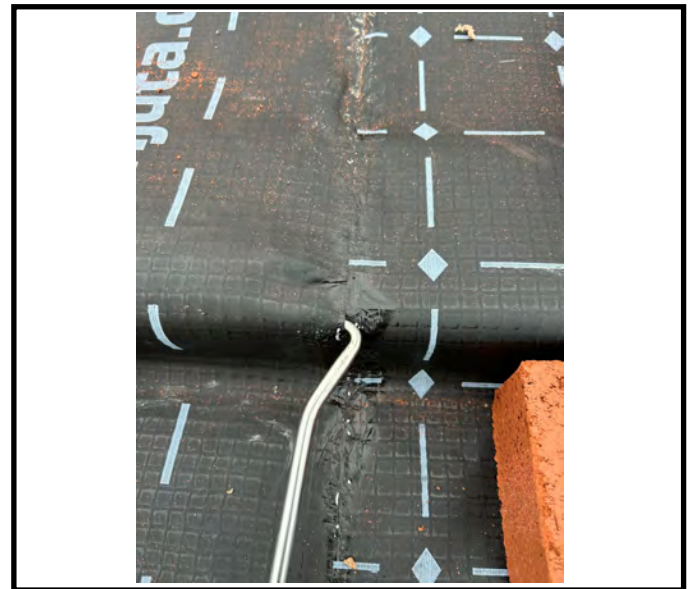
Misweld identified.

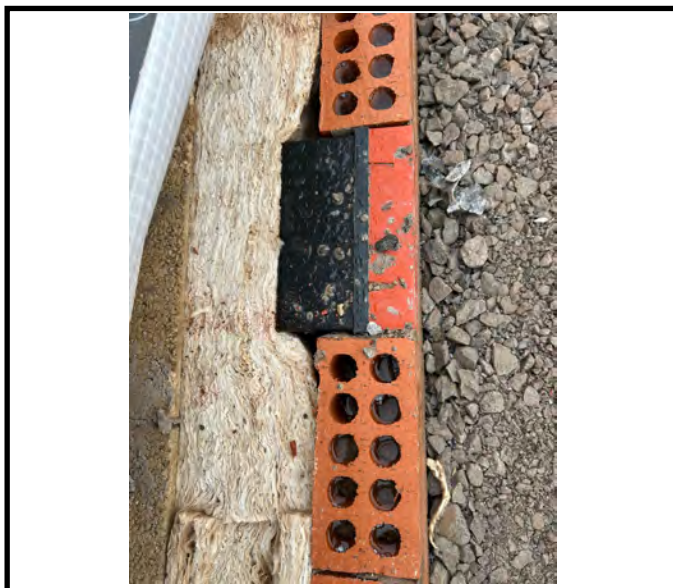
An overview of a periscopic vent connecting to an air brick.
