# GeoShield Verification Report 8

GEO105396

R4 Civils,  
Barlestone,  
Barton Road,  
Osbaston  
Nuneaton,  
CV13 0EU

Plots 5, 6 & 7 - Full Line Out

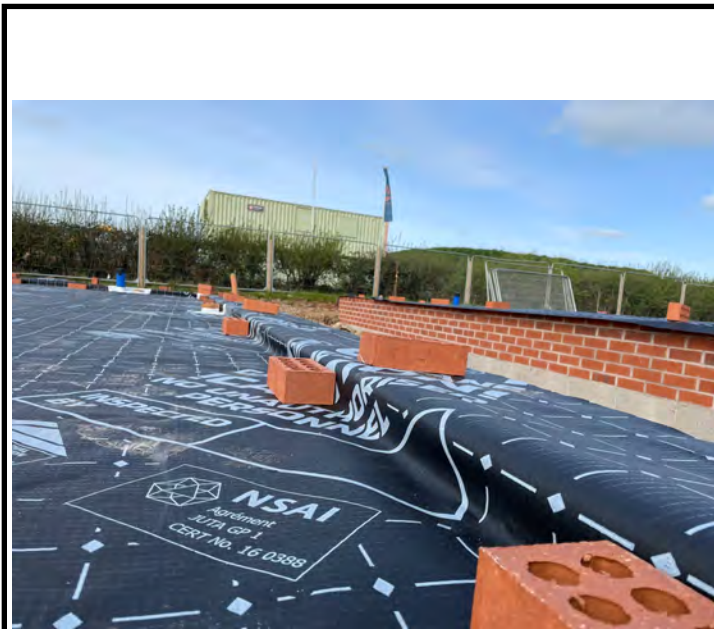
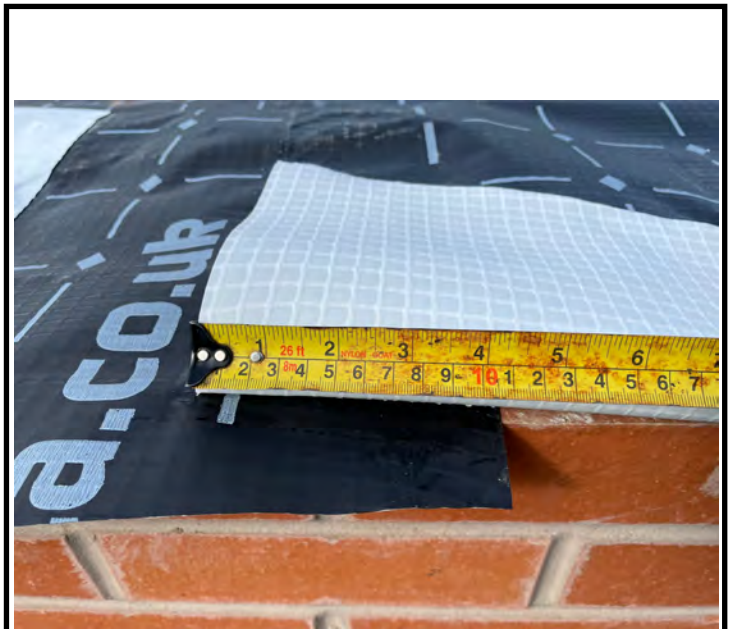
Installation of JUTA GP1 Gas Barrier - Lap Joints

A complete line out of the JUTA GP1 Gas Barrier has been installed across the footprint of Plots 5, 6 & 7, upon an insulated block and beam ventilated sub floor void. The JUTA GP1 Gas Barrier has been lined out across the entirety of the plots, including the internal party walls, ensuring it overlaps the external cavity to

the outer leaf brickwork. All lap joints between the adjacent sheets of JUTA GP1 Gas Barrier have been overlapped a sufficient amount, and heat welded using a hot air leister and silicone roller with adequate pressure applied to ensure a continuous gas resistant seal is achieved.

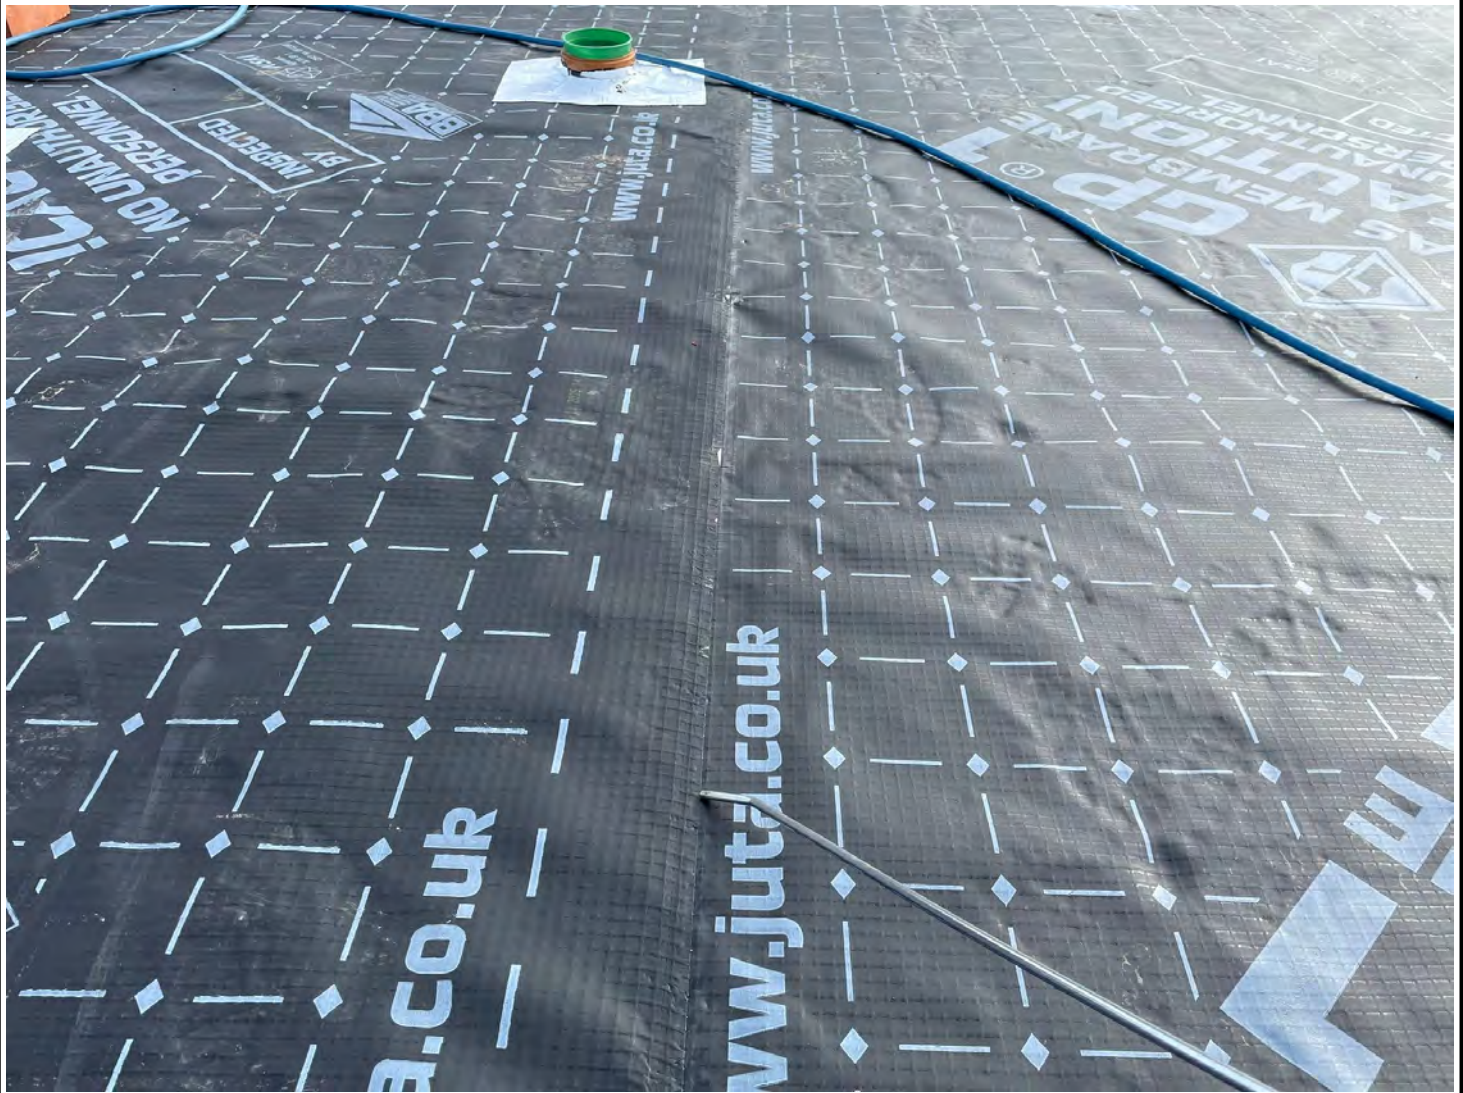
The above photograph displays a non destructive air lance integrity test being conducted upon a welded lap joint of the JUTA GP1 Gas Barrier. Thorough visual inspections, supported by non destructive air lance integrity testing conducted upon all overlaps, identified three faults.

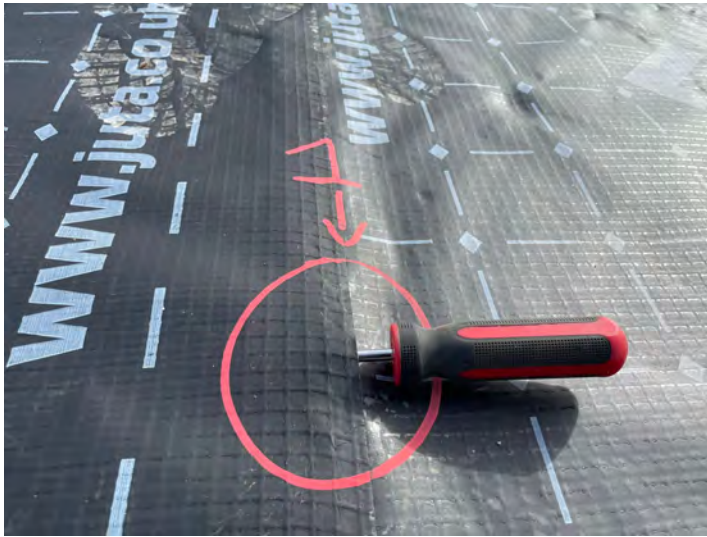
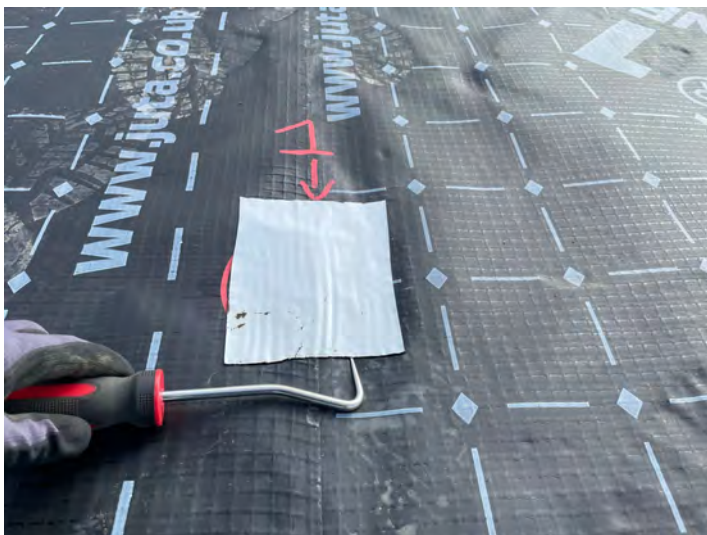
### Faults Identified & Remediated

As mentioned, three faults were identified during the testing procedures conducted upon all aspects of the installation. The faults were brought to the attention of the installers and remediated during the visit, in the presence of GeoShield.

The faults were remediated by applying 150mm patches of JUTA GP SAM over the affected areas with heat and rolled pressure applied to activate the bitumen backing. No further faults or defects were identified during the testing of the remedial work.

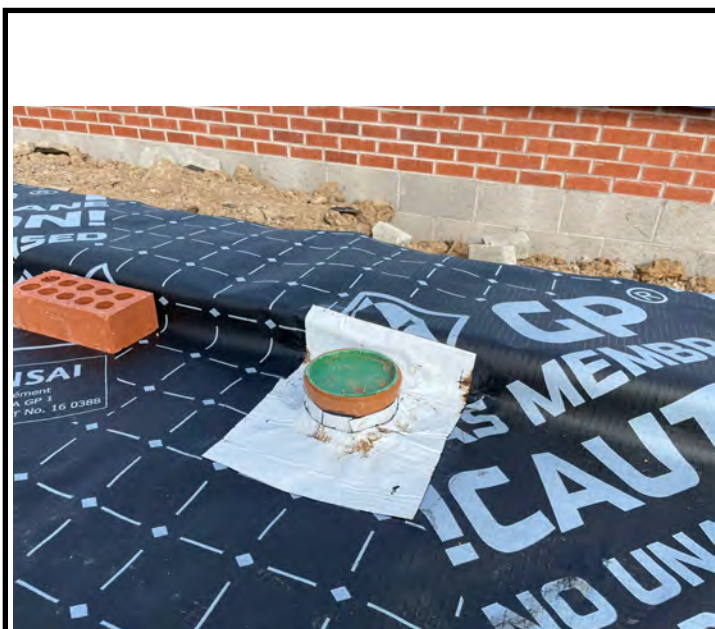
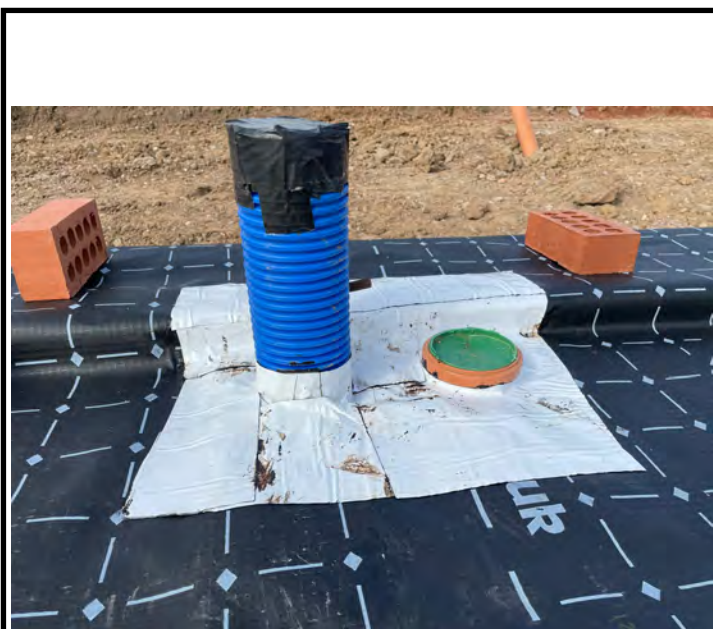
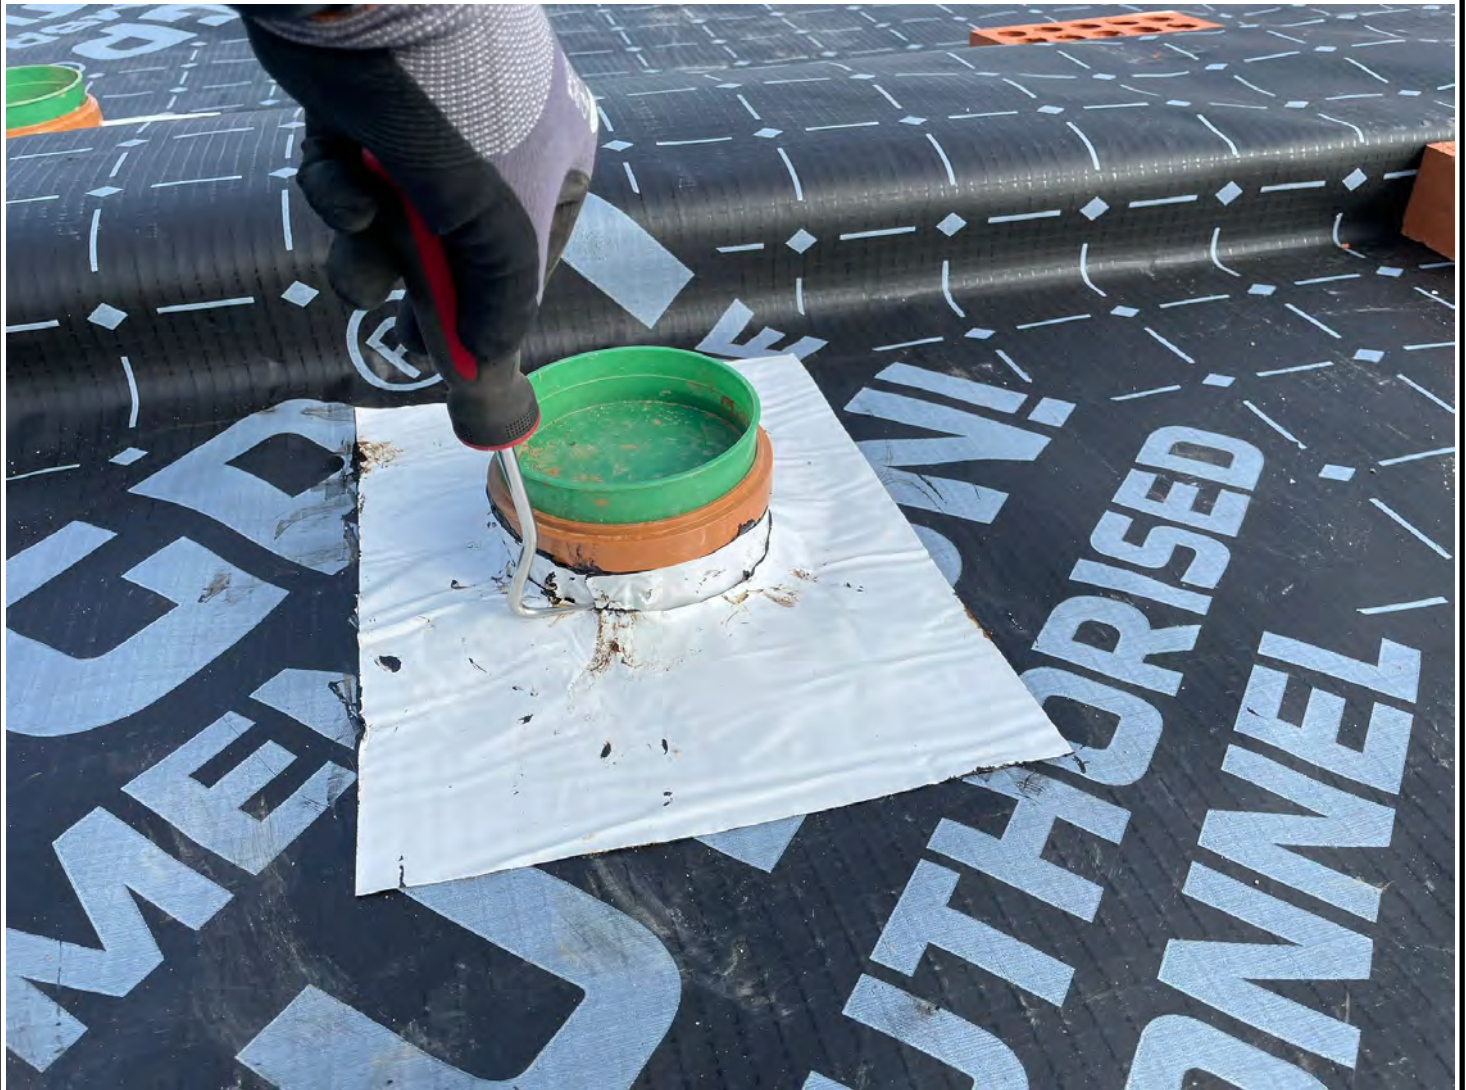
### Pipe Penetrations

Throughout the complete line out installation of the JUTA GP1 Gas Barrier to the referenced plots, there were a number of pipe penetrations that have been sealed in accordance with manufacturer's specifications and design guidelines. This has been achieved using JUTA GP SAM, which is a gas resistant self adhesive

membrane. The installers have first cut the JUTA GP1 Gas Barrier tight around the base of each pipe penetration to minimise voided areas. Next, patches of JUTA GP SAM are placed intricately in a petal formation around the pipe penetration and onto the JUTA GP1 Gas Barrier, with a 300mm square of JUTA GP SAM placed

over the top to form a top hat detail. Heat and rolled pressure is applied to activate the bitumen backing, creating a secure bond between the pipe penetration and the JUTA GP1 Gas Barrier. All pipe penetrations throughout the referenced plots were subjected to thorough mechanical point stress testing and non destructive air lance integrity testing. No faults or defects were identified at the time of the inspection.

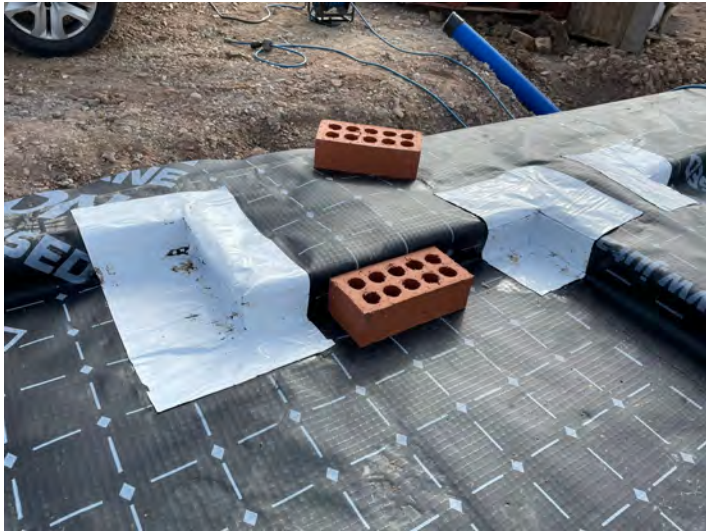
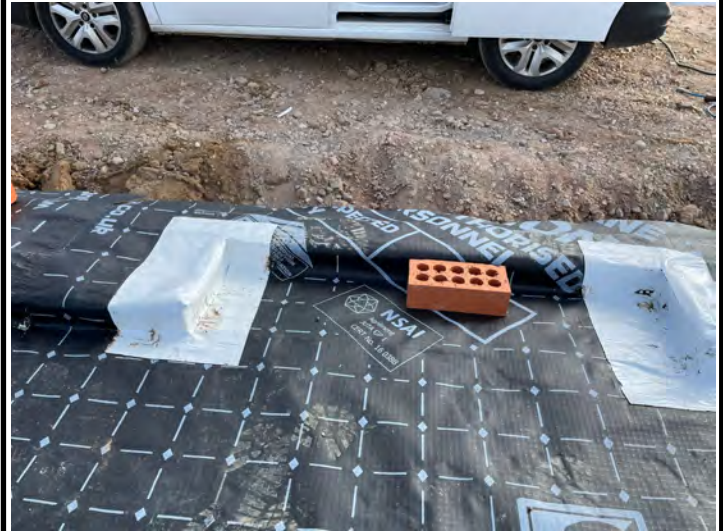
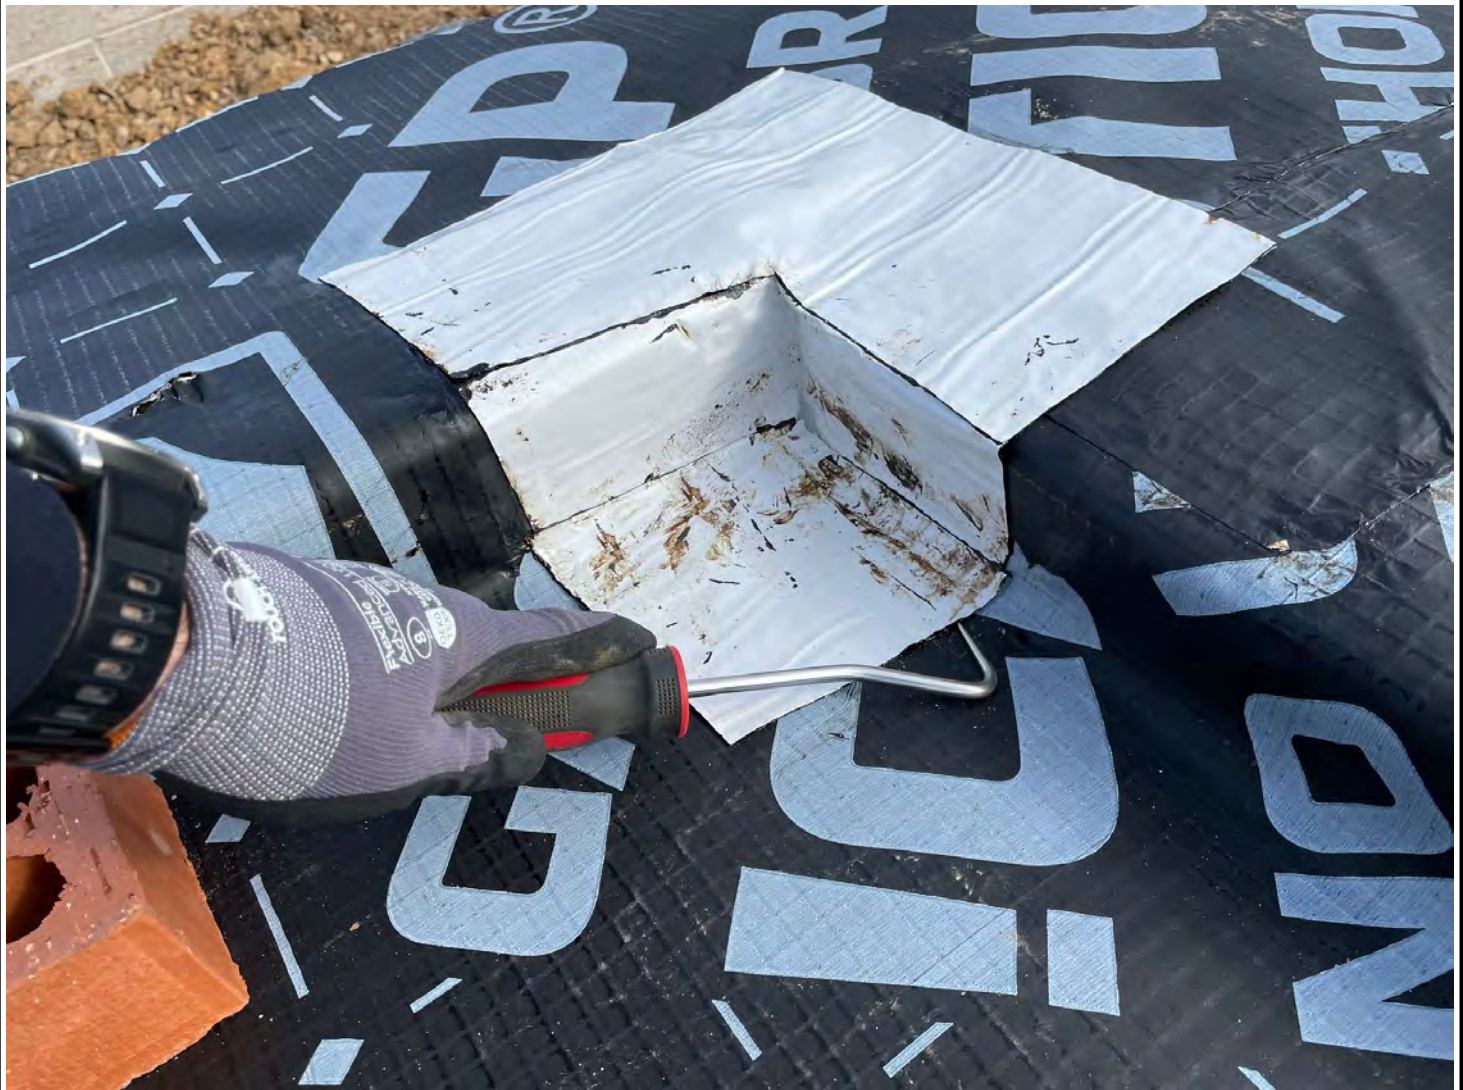
### Corner & Threshold Detailing

A number of corners and thresholds throughout the referenced plots have also been sealed as per manufacturer's specifications and design guidelines. This has been achieved using JUTA GP SAM. Where the JUTA GP1 Gas Barrier has been cut to minimise voided areas and gaps across the footprint of the plots, each

corner and threshold junction has been reinforced by heating strips of JUTA GP SAM and placing into position around each corner and threshold, onto the JUTA GP1 Gas Barrier. Firm rolled pressure is applied with a silicone roller to aid in the adhesion, ensuring the JUTA GP SAM has fully bonded.

As with the pipe penetrations, a probe and an air lance were run along all JUTA GP SAM corner detailing to validate that a gas tight seal had been achieved throughout. No faults or defects were identified. A complete adhesion has been achieved. Tested and verified in accordance with CIRIA 735.

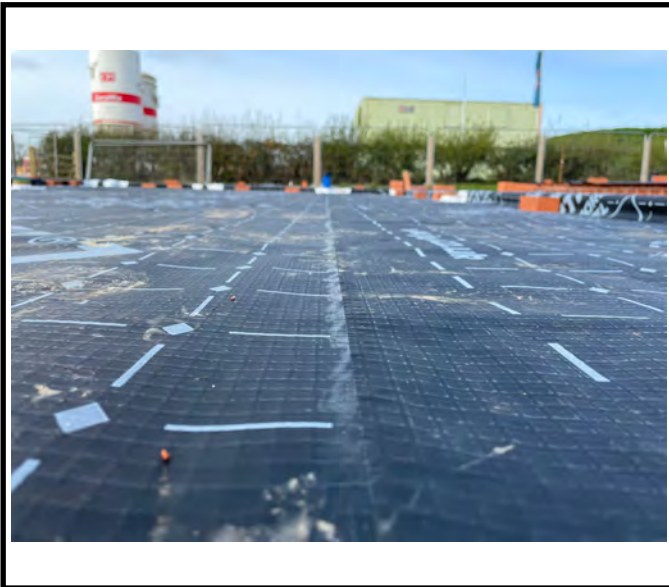
GeoShield safety warning notices placed around details to be sealed internally at a later date.

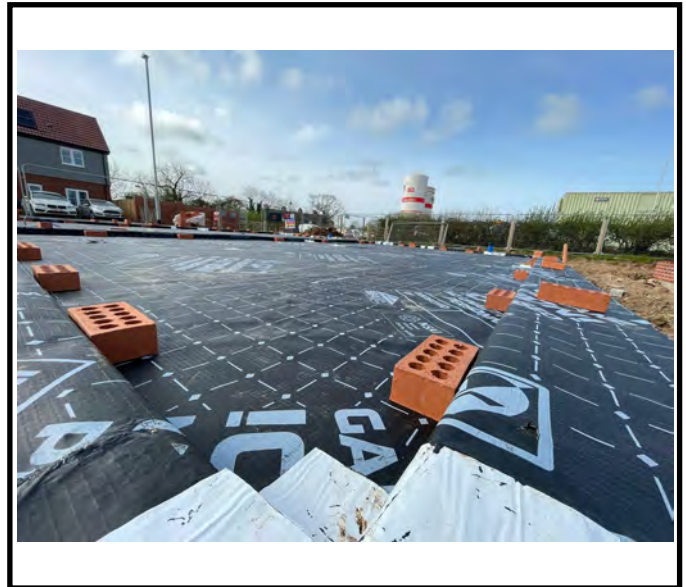
The JUTA GP1 Gas Barrier taken over the external cavity.

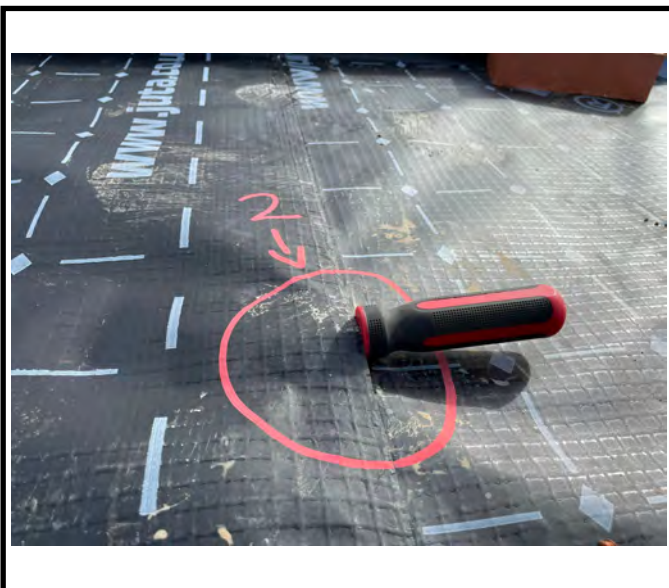
A fault identified.

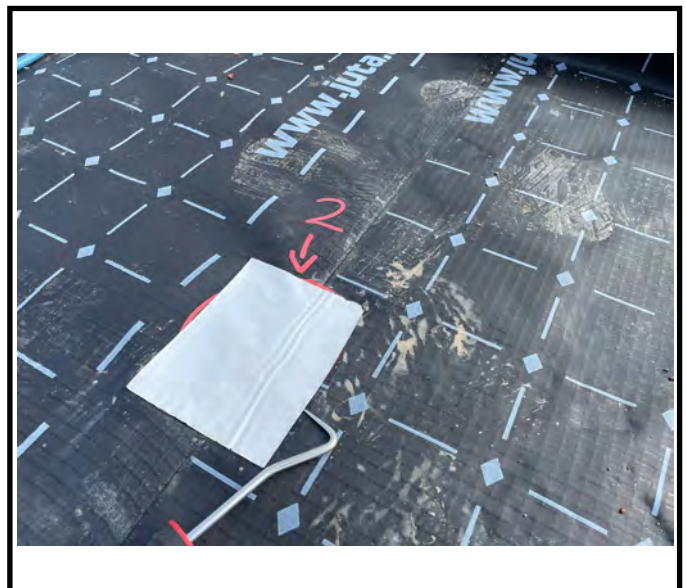
A mechanical point stress test being conducted upon the remediated fault.

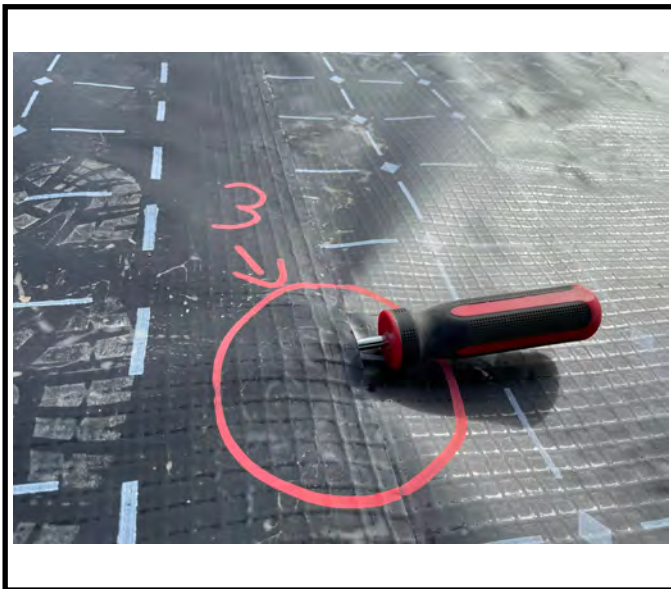
A fault identified.

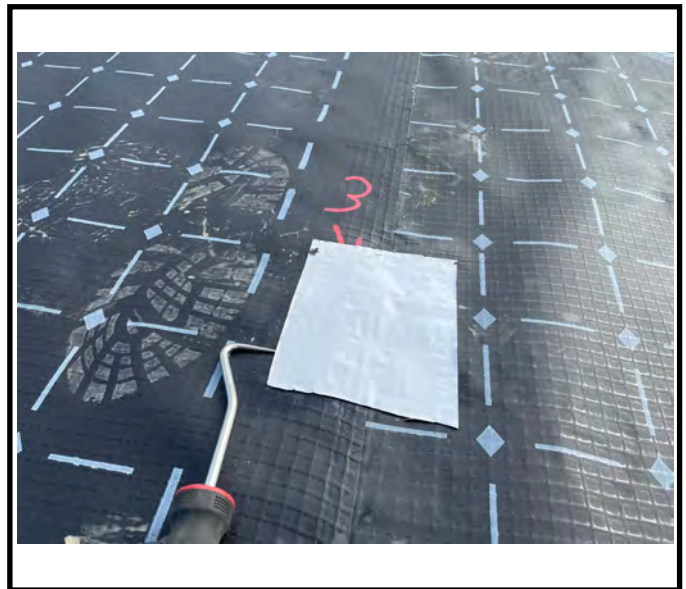
A mechanical point stress test being conducted upon the remediated fault.
