| Project | The Cock Inn, Sibson | | | | | | | | |
| Title | Phase 1 - First floor - Proposed structural repairs | | | | | | | | |
| Document Reference | K04172 - GCA - XX - XX - DR - S - 0005 - S01 - P02 | | | | | | | | |

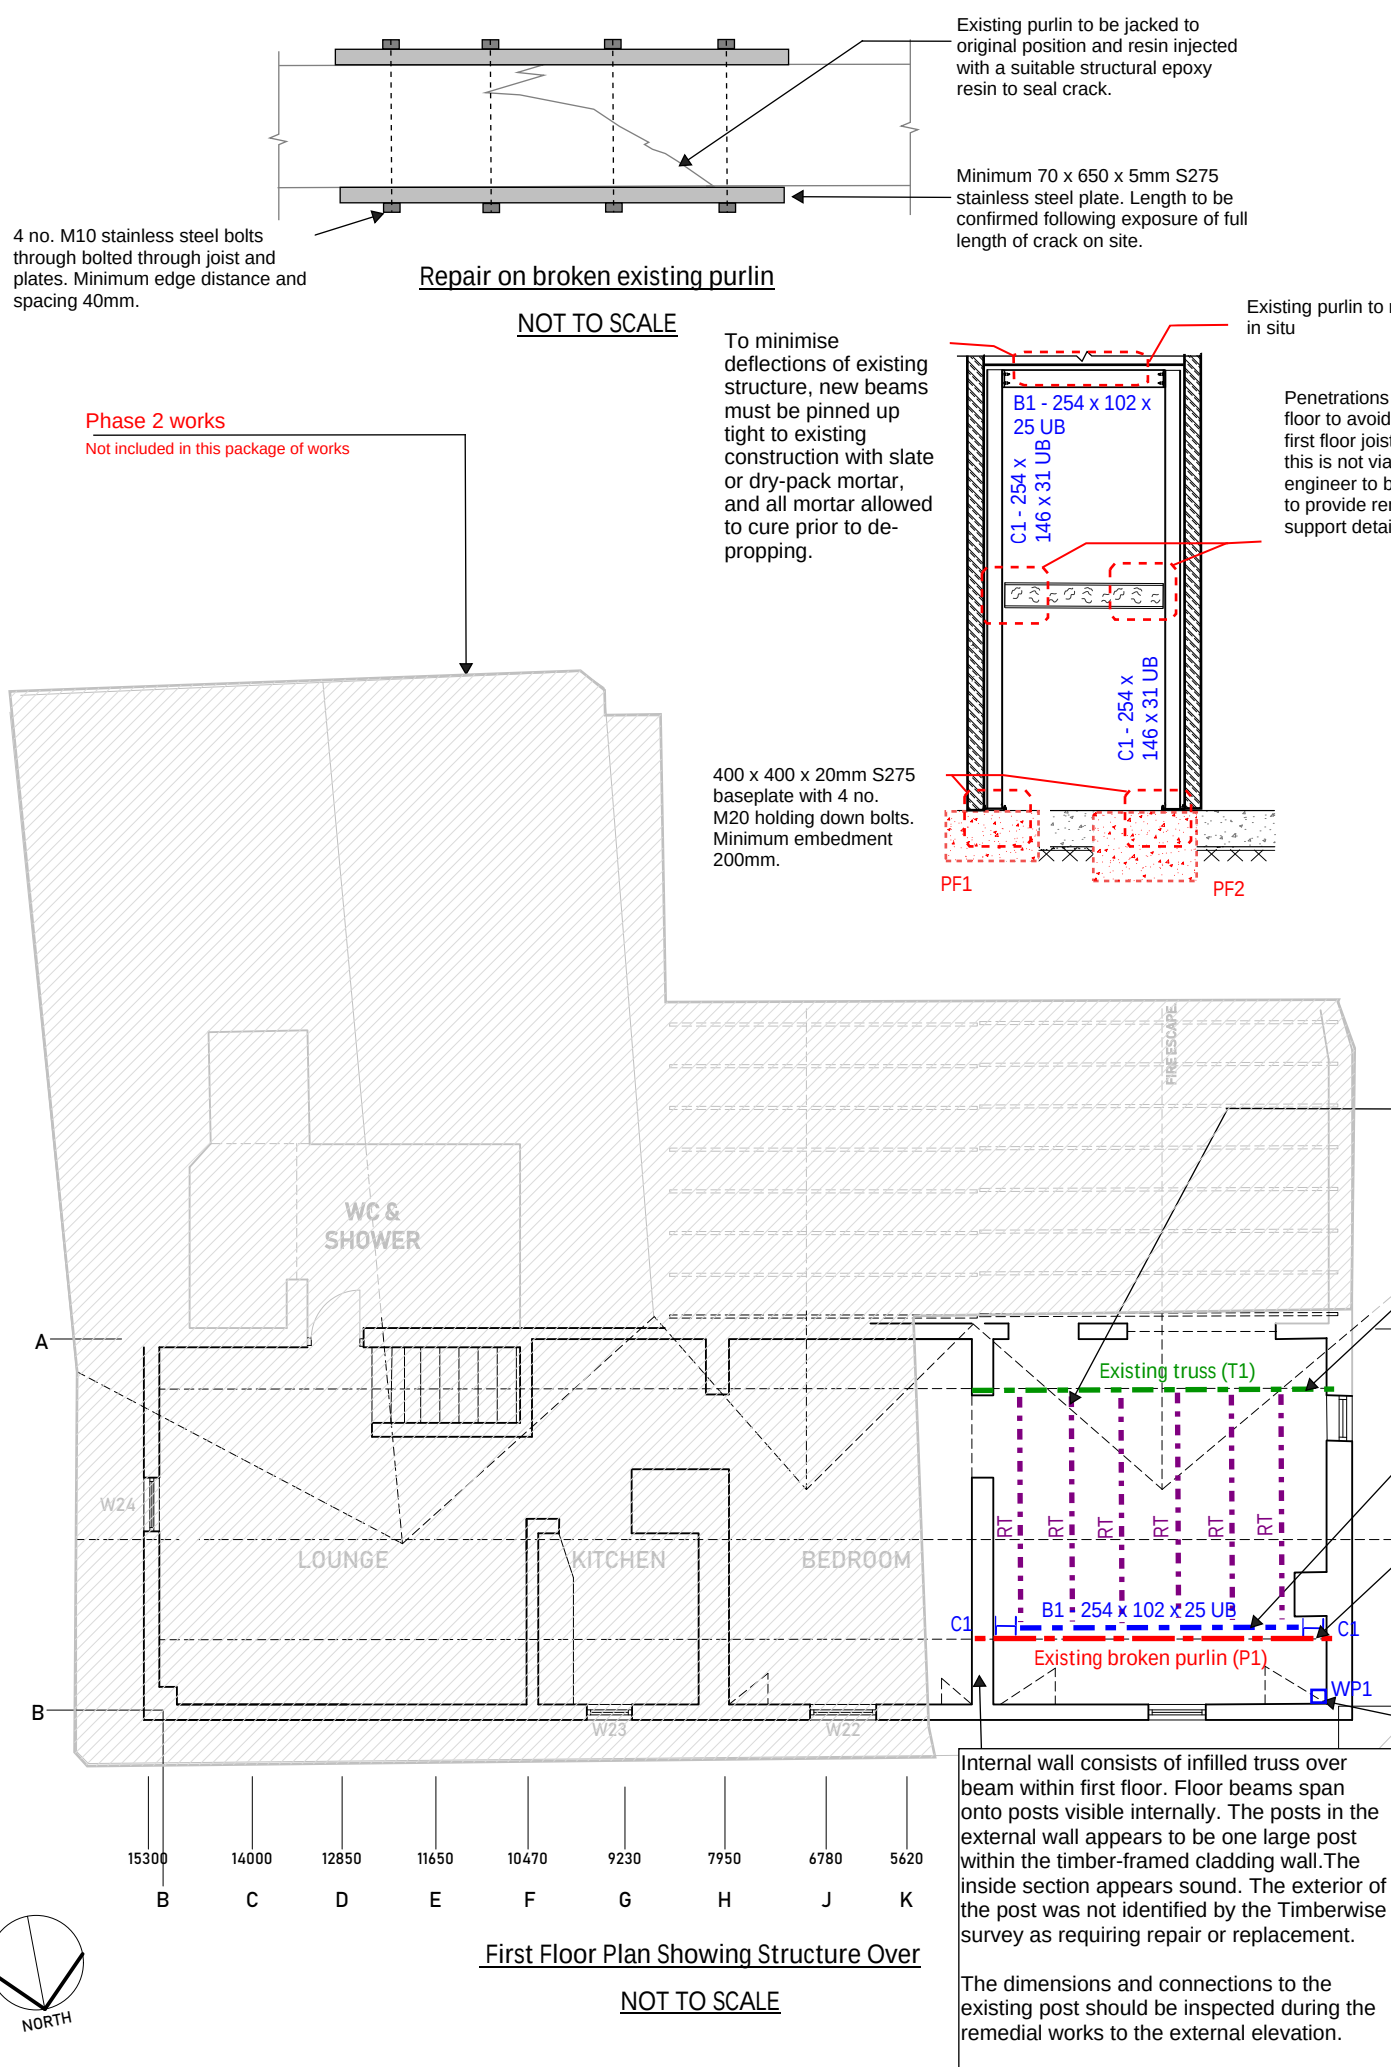
Ties required to reduce horizontal thrust on external walls.

Existing timber truss/braced purlin providing support to roof elements over.

Existing broken timber purlin to be repaired.

Timber purlin has split at mid span, placing excessive horizontal force on external wall. Existing purlin section size is not sufficient to carry the roof loads. A new steel beam is proposed to replace the function of the timber purlin and prevent thrust on wall.

Internal wall consists of infilled truss over beam within first floor. Floor beams span onto posts visible internally. The posts in the external wall appears to be one large post within the timber-framed cladding wall. The inside section appears sound. The exterior of the post was not identified by the Timberwise survey as requiring repair or replacement.

Ceiling to be opened up locally to inspect existing ceiling joist detail.

40 x 195 D30 at 600mm centres or similar to suit cut roof sections and setting out, bolted or skew nailed or screwed to existing roof sections.

The dimensions and connections between the ceiling joists and cut roof sections should be inspected during the remedial works.

Proposed new beam to replace function of existing purlin.

Beam to be supported on new steel posts (254x146x31UB S355)

New windpost: Subject to further timber testing of corner post, an alternative solution utilising a steel wind post may be preferable to full replacement of corner timbers. 100 x 100 x 8 SHS wind post should be fixed to wall at 300mm centres max to the external walls, and tied to the existing floor and roof structure.

The dimensions and connections to the existing post should be inspected during the remedial works to the external elevation.
