## **Level 2 Historic Building Record**

**The Old Rectory, Rectory Lane, Market Bosworth, Leicestershire**

**January 2024**

| Report type | Level 2 Historic Building Record | |

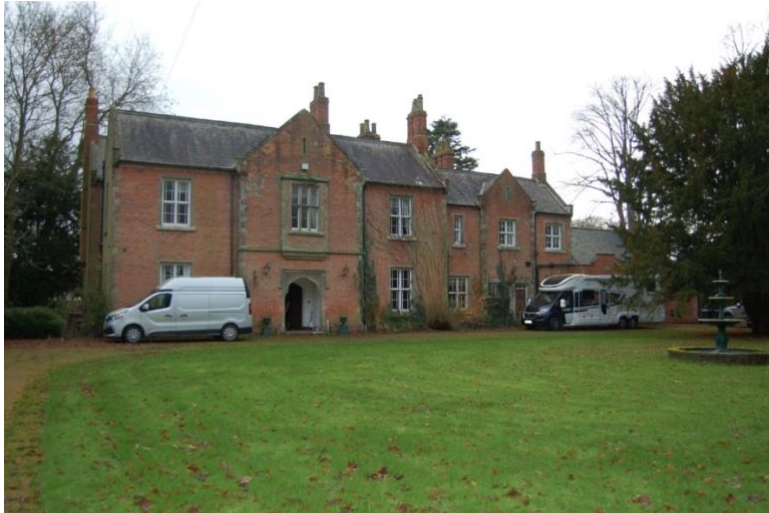
- 4.4. The north elevation of the old rectory is of red brick with stone dressings to the windows and doorways, coping stones to the gables and quoins to the projecting bays. It is of six bays in a 3:3 arrangement with projecting gabled bay to the centre of each set of three bays. Windows to the ground and first floors of the east wing are timber cross mullion windows with margin glazing bars. The exception is the window to the central projecting bay, which is a three light stone mullion and transom window of a shallow oriel style. To the west (service) wing the windows are similar in style, just slightly smaller cross mullion windows with glazing bars. The main entrance to the projecting gabled bay to the west wing is set back under a four centred stone arch with hoodmould. To the projecting gabled bay to the west wing is a doorway, which

was reconfigured in the 20<sup>th</sup> century when a window was moved and a new doorway was inserted.

Figure 5: Ph (1). The north elevation

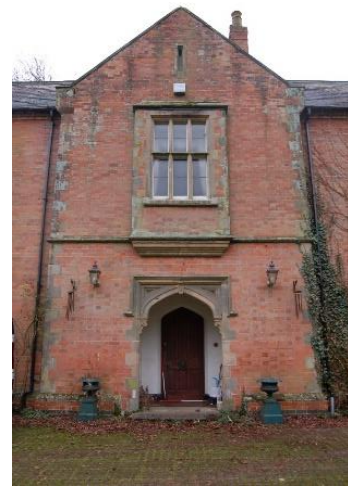
Figure 6: Ph (19). Detail of door to north elevation

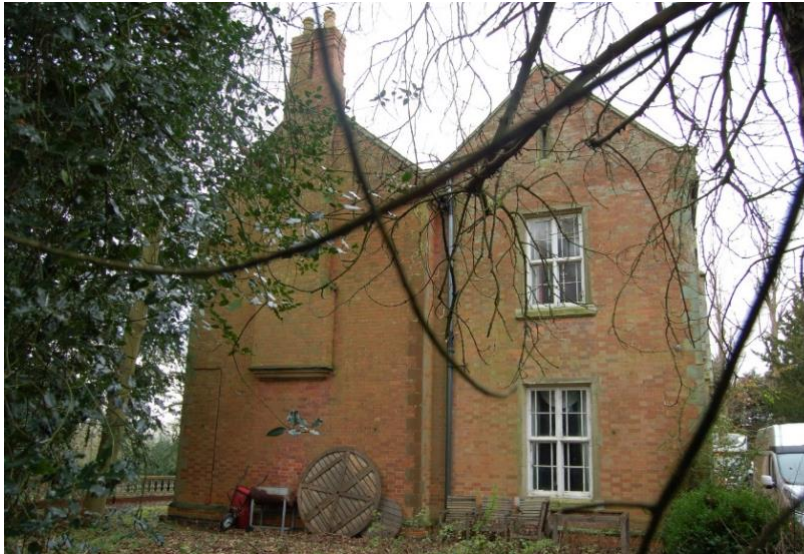
- 4.5. To the east, the elevation is of red brick with stone detailing and presents two gabled bays; the bay to the south projects slightly. There are windows to ground and first floor levels to the northern bay, both of which are cross mullion windows with glazing bars. To the southern bay is a brick chimney which terminates at first floor level with three rows of corbelling.

Figure 9: Ph (4). The east elevation

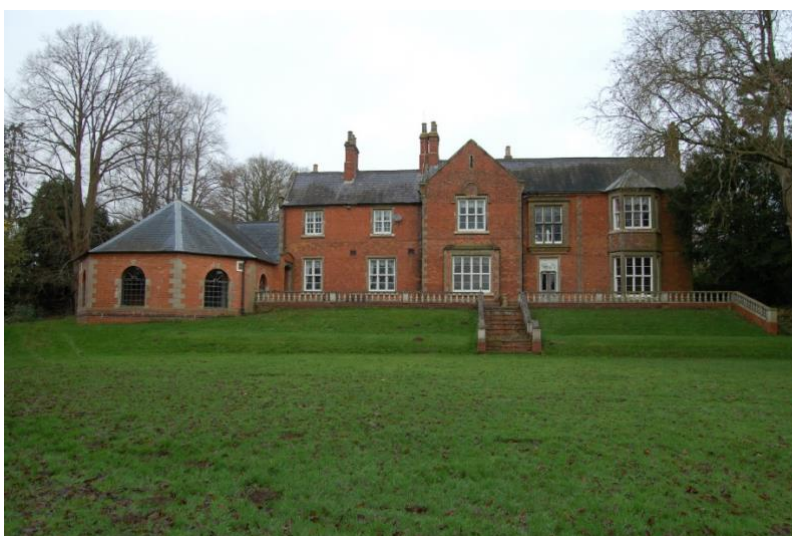
- 4.6. The south elevation is the rear of the property, overlooking the gardens. This elevation does not mirror the design of the northern elevation but is instead asymmetrical in character. Just to the left of the centre is a projecting, gabled bay which divides the east and west wings. To the west of the projecting bay are two bays of the service wing with two windows to ground and first floor levels. These are mullion transom windows to the ground floor and smaller 2-light sashes above, all have glazing bars. The projecting gabled bay has a shallow bay window to the ground floor containing a 4-light mullion transom window, above this at first floor level is a 3-light window underneath a nowy-headed hoodmould. To the east of this, the entrance bay which is recessed slightly, contains the doorway at ground floor level with blocked fanlight. Above the doorway is an oriel window. To the eastern bay is a 2-storey canted bay window.

Figure 11: Ph (2). South elevation

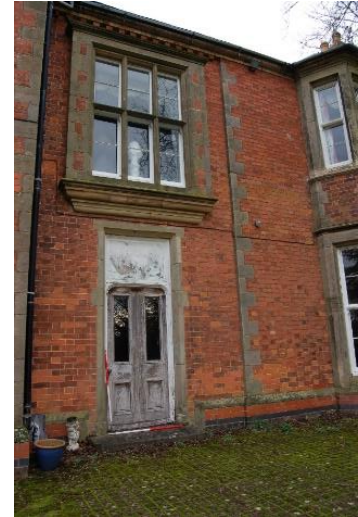
Figure 14: Ph (6). Doorway with  
blocked fanlight, south  
elevation

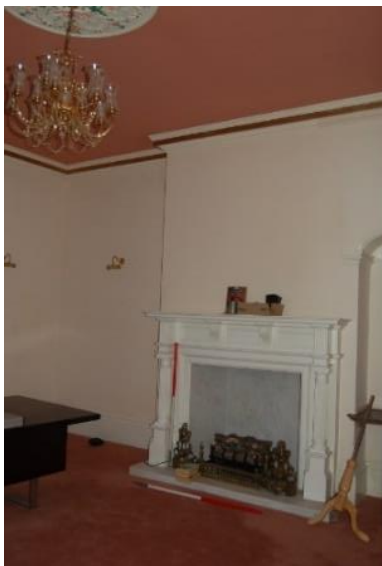
Figure 18: Ph (24). Fireplace to room 1

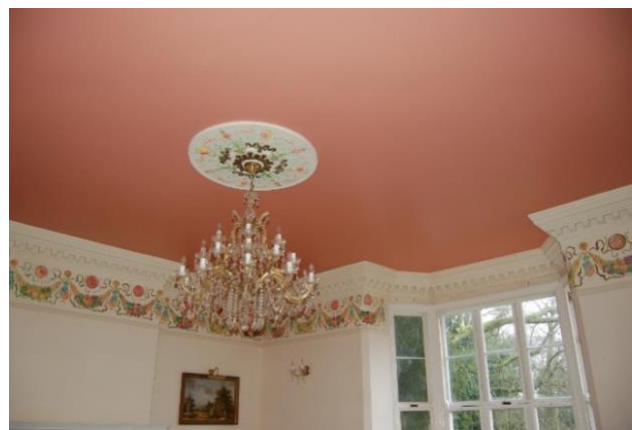
Figure 23: Ph (28). Plasterwork to room 2

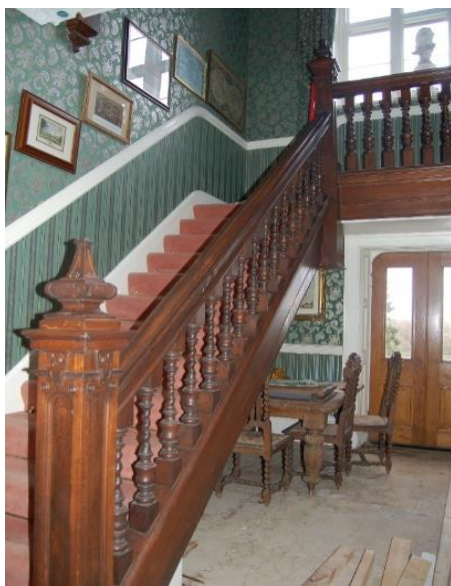
- 4.9. Room 3 is the main entrance hall to the centre of the east wing of the house. It is accessed from the main entrance to the north elevation. This forms the central spine of the living accommodation, providing access to the principal rooms of the ground floor and the main stair to the first-floor bedrooms. The walls are decorated with 20<sup>th</sup> century wallpaper with dado rail. The deep timber skirting board and panelled front door are original features. There is a deep plaster cornice and decorative ceiling rose to the north end of the hallway, which may be later additions, but the moulded plaster arch is an original feature. The floor is the original stone flag floor. The staircase with twisted balusters, panelled newels with ogee finials and pendants is an original feature; however, this has undergone some alteration. There is evidence of replica sections being added and some areas of repair, indicating the stair may have been moved.

Figure 26: Ph (33). The stair to room 3

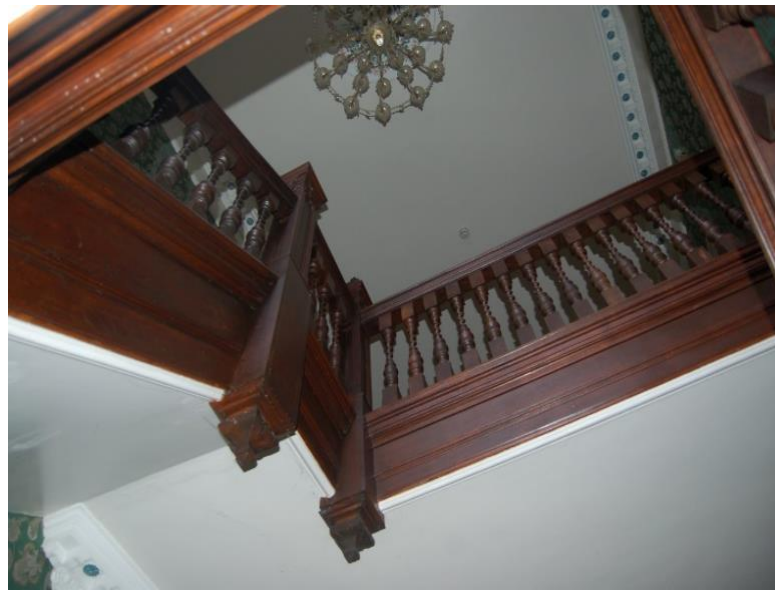
Figure 27: Ph (35). Stair and landing to room 3
