## Tree Survey

Land at Little Lane, Desford, Leicester, LE9 9GP

Produced for:  
Spinney Homes Ltd

Ref: TS-LittleLane\_Desford/01

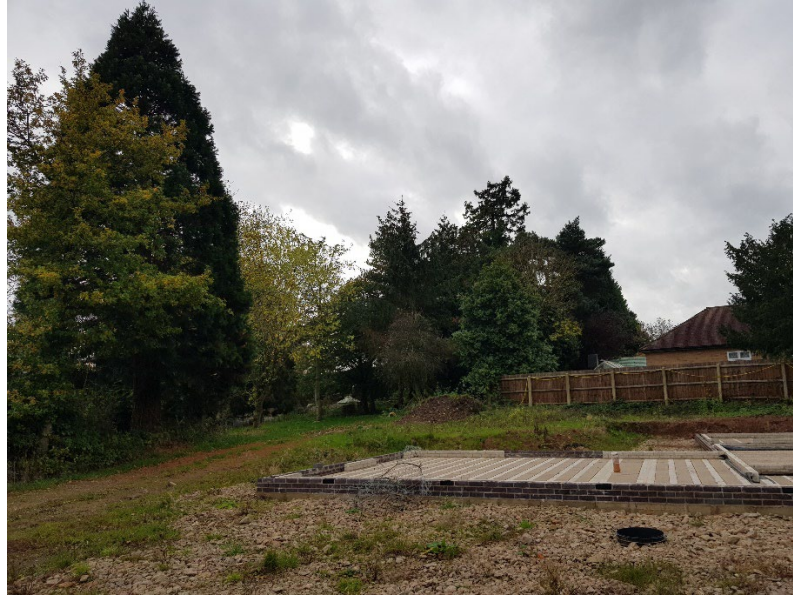
Photograph 1

- 6.1 ***The Site -Description:*** The site is situated on the north-eastern edge of Desford. There are trees primarily on the edges (photographs 1). Foundations for a house (photograph 2) with planning permission are installed at the centre of the site. Access is available via an existing hard surfaced driveway (photograph 3).
