**ARBORICULTURAL REPORT**  
at  
**Jubilee Villa Care Home**  
**48 Mill Street**  
**Hinckley**  
**Leicestershire**  
**LE9 8DW**

**JCA Ref:**  
21033/AJB

- 1.1.1 This arboricultural report is required by our client as part of an investigation into suspected soil shrinkage subsidence damage at **Jubilee Villa Care Home, 48 Mill Street, Hinckley, Leicestershire, LE9 8DW**.

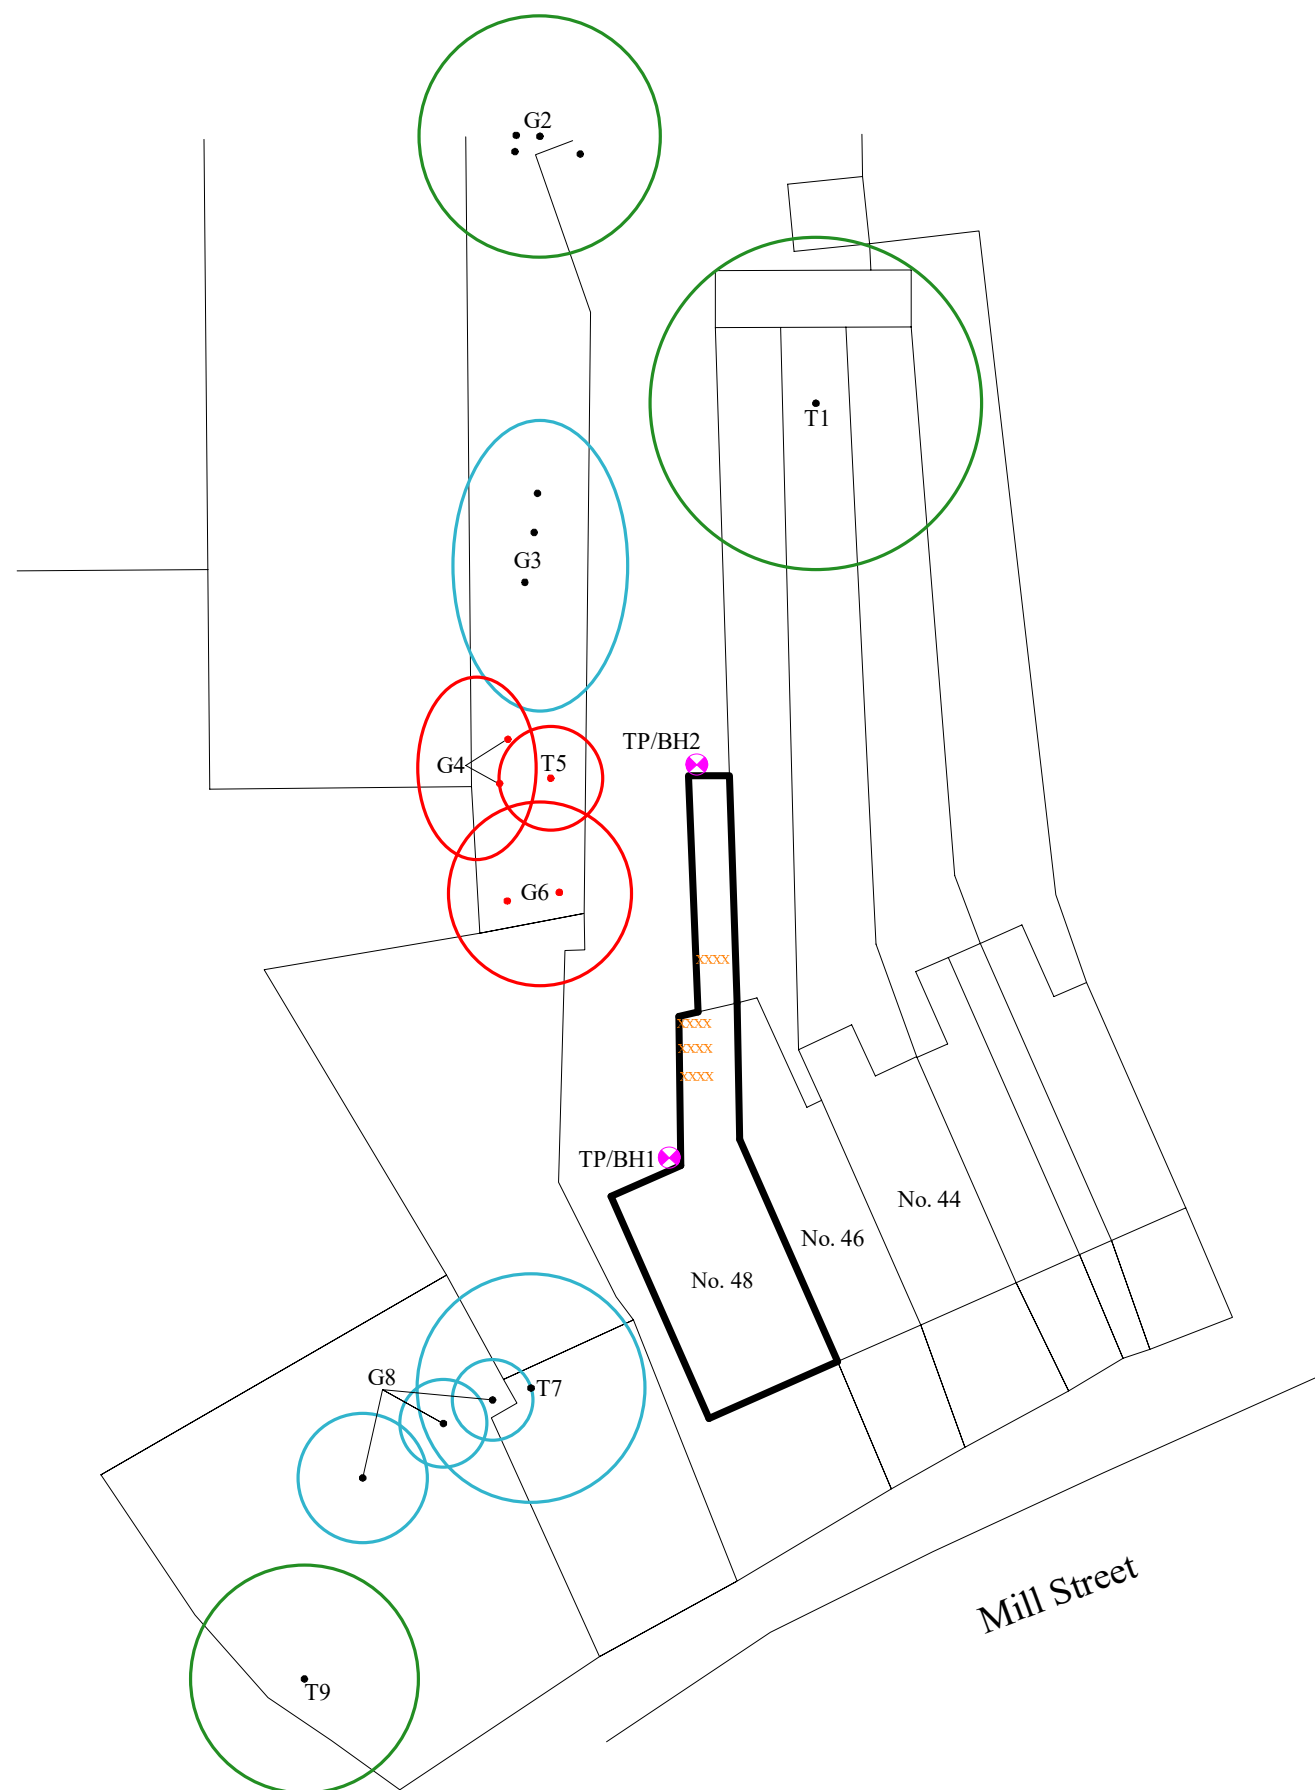
## Appendix 2: Site Plan

- 5.1 Descriptions of the surveyed vegetation and all recommended work are detailed in the tables at **Appendix 1**.
- 5.2 Please refer to the site plan at **Appendix 2** for the locations of the vegetation surveyed and all the relevant site features.

- 6.2 We consider the vegetation identified as **G4, T5** and **T6** to be collectively contributing to the damage observed at the subject property. We have therefore recommended that **G4, T5** and **T6** be removed to ground level and the stumps treated to prevent regrowth.
