## **Arboricultural Impact Assessment & Draft Arboricultural Method Statement**

**Client:** Invicta Universal

**Site:** Little Lane, Desford, Leicestershire.

**Ref:** AIA-25-01-001

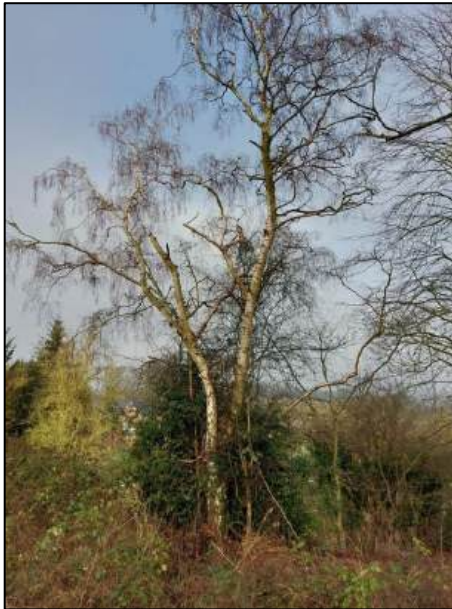
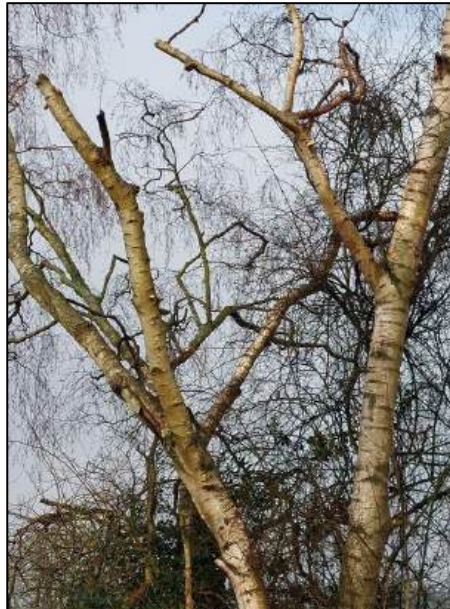
- 3.3. The proposal will require the removal of four trees, one group and two part groups to facilitate the proposal.
- 3.4. One tree T003 Birch and Group G003 Apple (below) are recommended for removal regardless of the development.

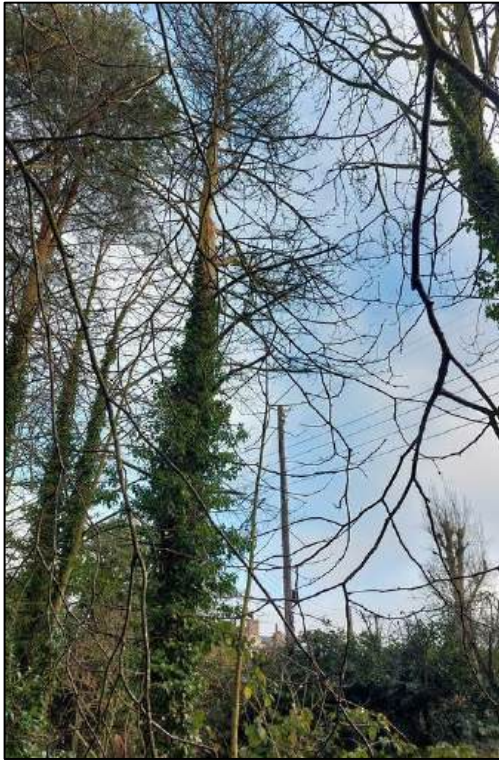
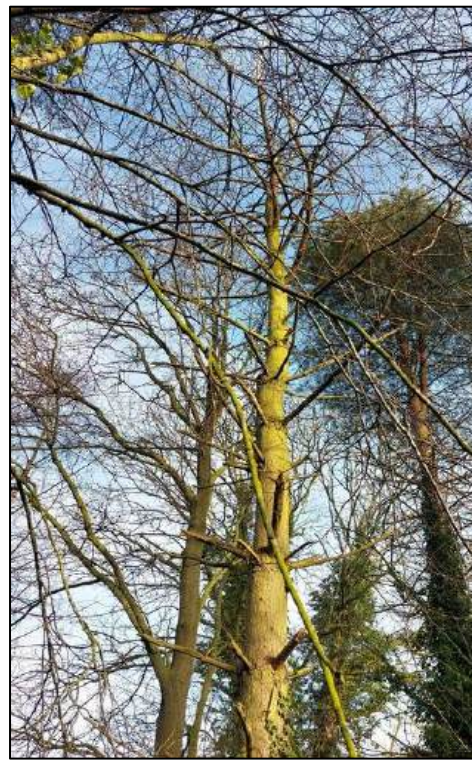
- 3.6. Two other trees mature Scots Pines are recommended regardless of the development T005 and T006 (below).

| T005 | Tree | Scots pine | Pinus sylvestris | 18 | 360 | 1 | 3 | 3 | 3 | 3 | 2 | 2 | Dead | Poor | Poor | Dedining condition 80% dead | Remove regardless of proposal | <10 years | U | 55 | 4 | | | | | | |
| T006 | Tree | Scots pine | Pinus sylvestris | 18 | 370 | 1 | 3 | 3 | 3 | 3 | 2 | 2 | Dead | Poor | Poor | Dedining condition 80% dead | Remove regardless of proposal | <10 years | U | 64 | 5 | | | | | | |

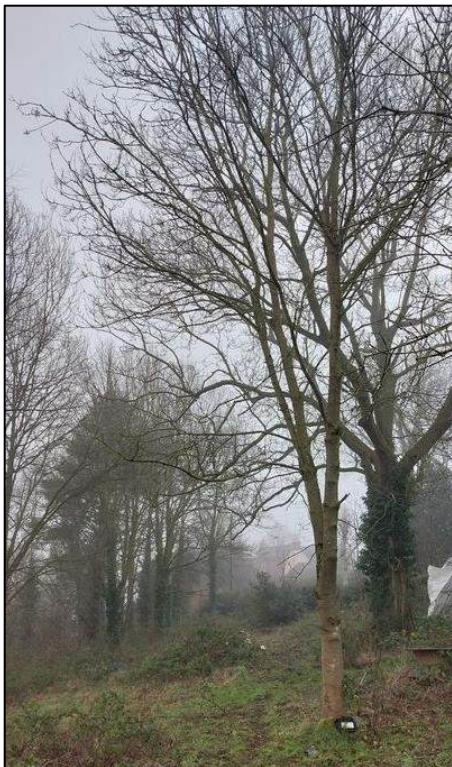
- 3.7. One tree an early mature Ash (Below) is of moderate quality T002 and is required to facilitate the proposal.

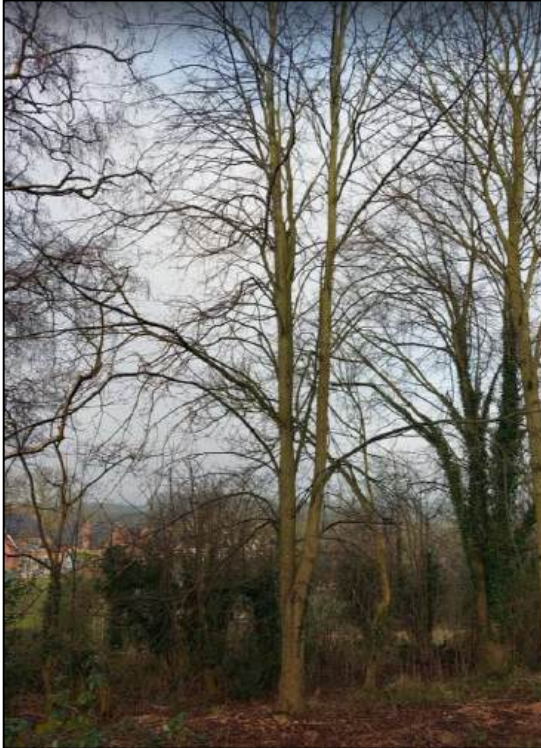
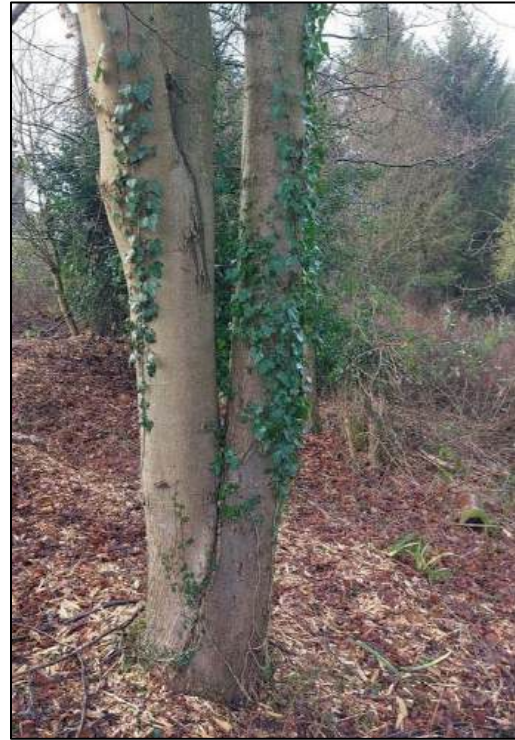
- 3.9. The other tree T004 Lime (Below) is of low quality due to poor unions and is recommended due to the proximity to the proposed dwelling, and to allow creation of open garden space.

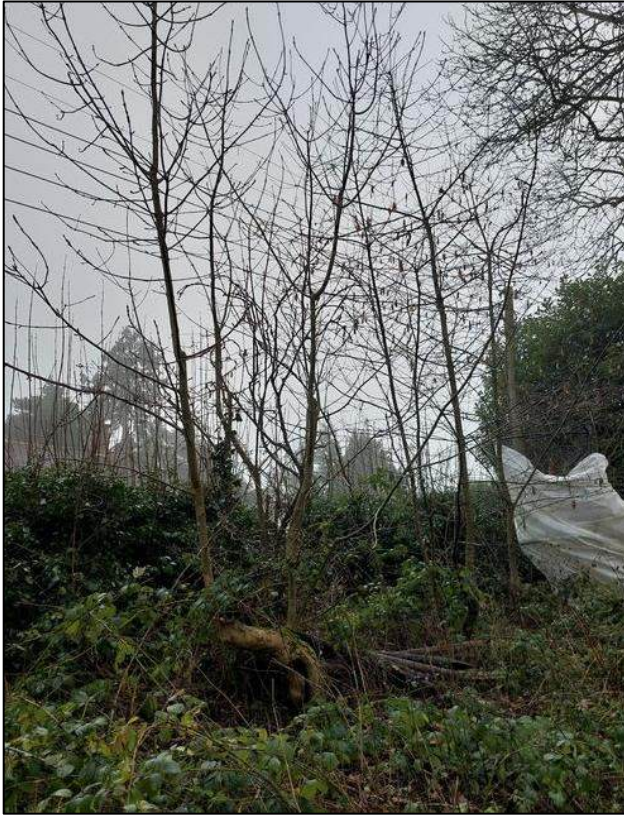
- 3.13. The trees required to be removed from two groups G002 and G006 are of low quality and form having been heavily reduced or coppiced previously.
- 3.14. Trees to be removed in G002 are coppiced young ash (below)

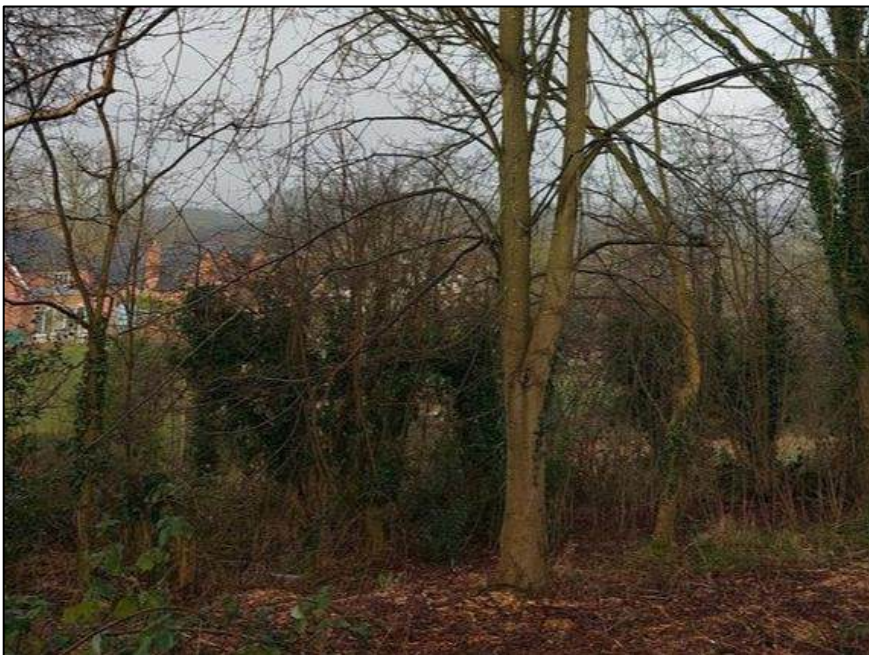
- 3.15.
- 3.16. Trees in G004 to be removed are self-set sycamore and ash, as well as coppice hazel and hawthorn (below).
