Our Ref: CL2592/SBS/sbs

Re: Structural Report on the Old Forge, Park Street, Market Bosworth.

Our brief is to inspect the existing building and to note defects, with a view to conversion to a hotel or multi occupancy building. During conversion, several walls are to be removed and/or modified.

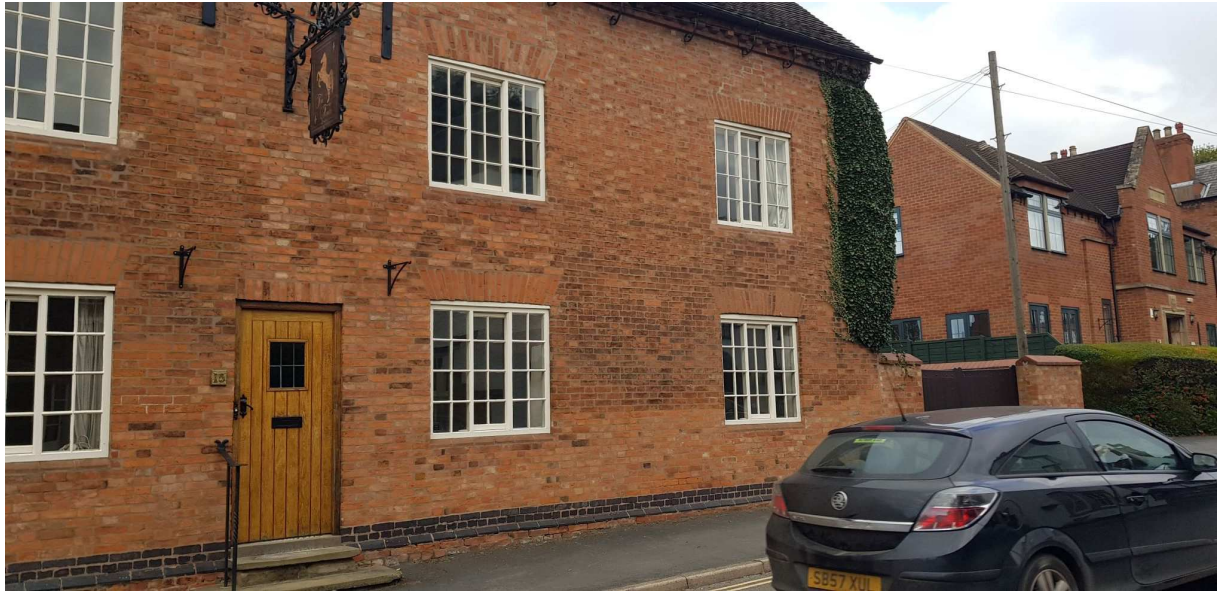
The Front elevation has suffered from some vertical and lateral movement, with several minor cracks present. It does appear that there has been much movement mainly to the front wall of the property, evidence can be seen by the various cracks and bulging brickwork.

The front elevation wall to main building, has bulged outwards and has several cracks along its length. Refer to photos. The wall appears to bulge over window openings, again possibly historic.

Photo 1 Main House Front Elevation

- The general movement over door and window heads to front elevation is more difficult to eliminate. It is suggested that a good tying in of the floors to walls would reduce movement, and hence prior to re-pointing brickwork, Helifix Bow Tie HD gable tie bars can be installed which are drilled through bed joints, into internal timbers, then resin bonded to wall, and pointed over.

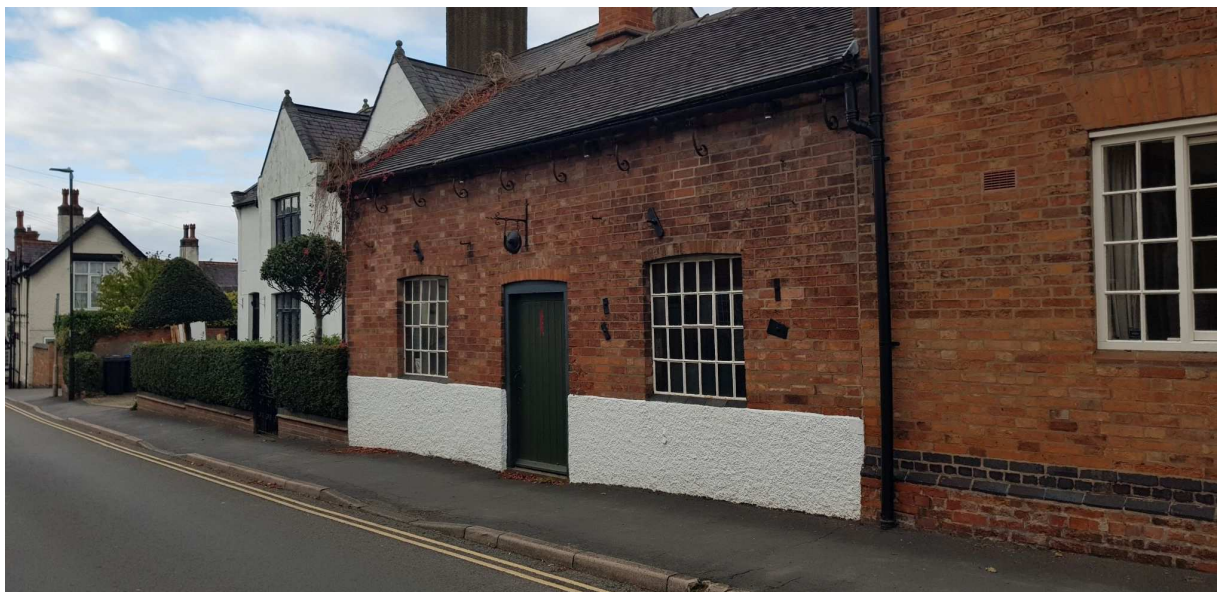
Extensive movement to front wall, with bulging and cracked brickwork. The whole wall in places appears to have deflected outwards, and has moved from its bed-joints.

Photo 2 Forge Front Elevation

- The masonry walls have moved to Forge building. It is assumed that in order to maintain the character of the building, rebuilding of any masonry cannot be considered, hence to stabilise the masonry in the front and rear walls of the Forge, the roof structure needs to be fully tied to walls. Therefore it is recommended that the wall plate is to be fully strapped down to walls at maximum 1.0m centres, and the rafters fully fixed to the wall plate, with galvanised nail/angle plates. These straps to have 900mm legs, and the quantity increased where the bulging and offset masonry is worst. In addition any gable ends must also be tied to wall with steel straps or similar. All cracks internal and external need to be repointed, with a similar mortar used when originally built.

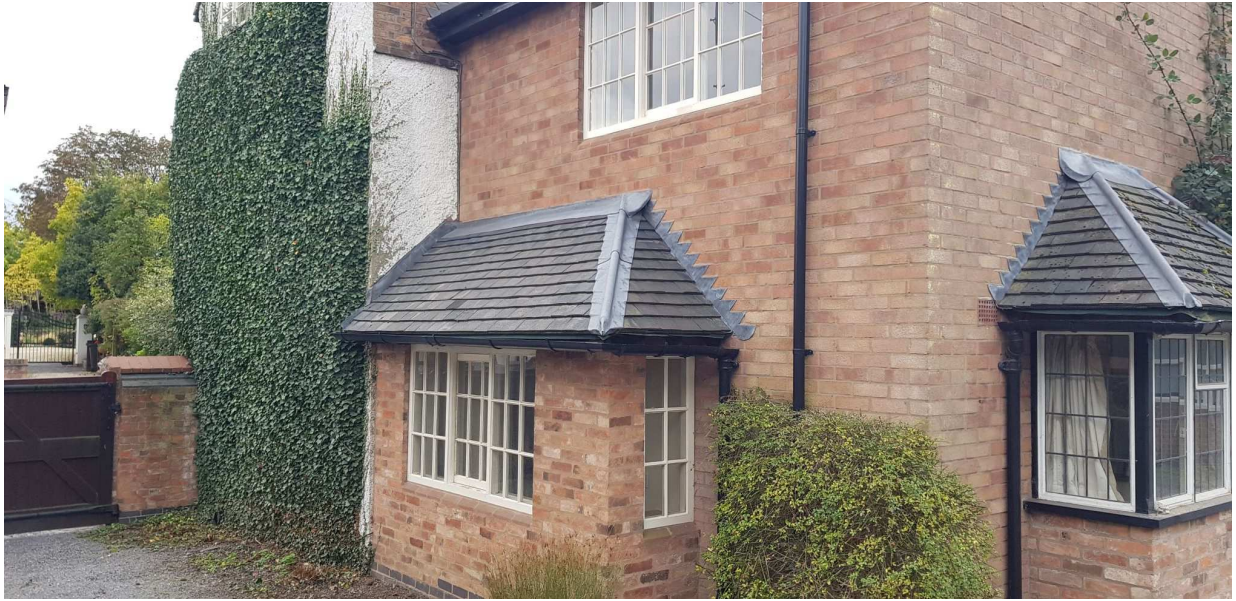
This elevations appears to be in reasonable condition with no specific cracks noted, part rendered though much is covered by Ivy and hence could not be viewed.

Photo 3 Side Elevation

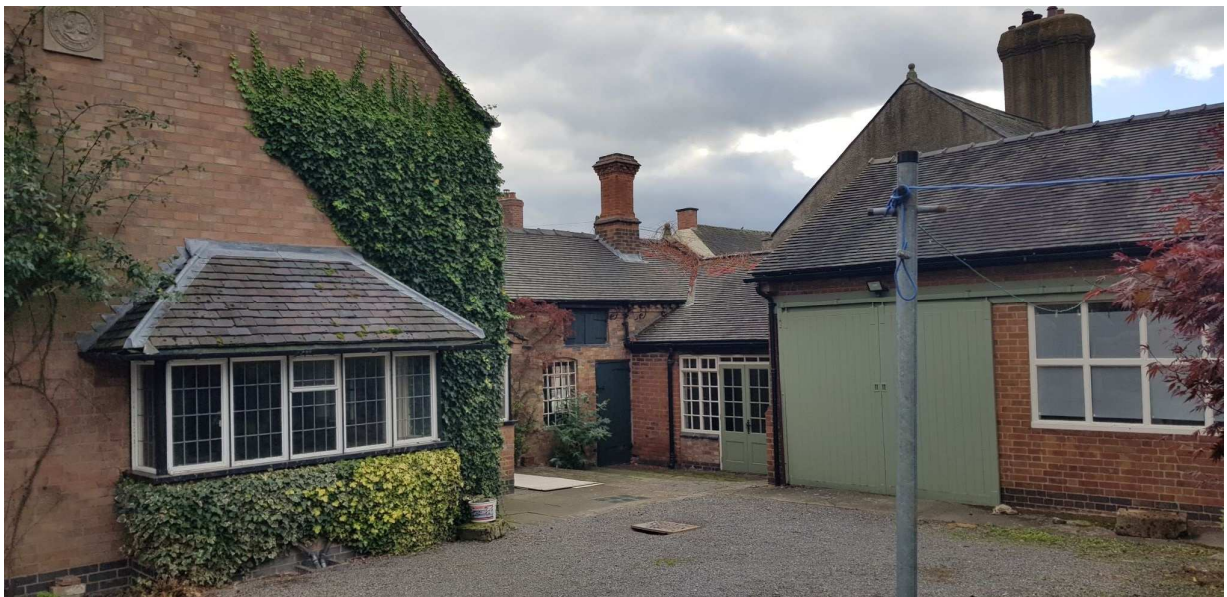
Again Ivy is present preventing a full examination. Slight bulge in masonry over rear door. Slight crack near rear door at corner.

Photo 4 Rear Elevation

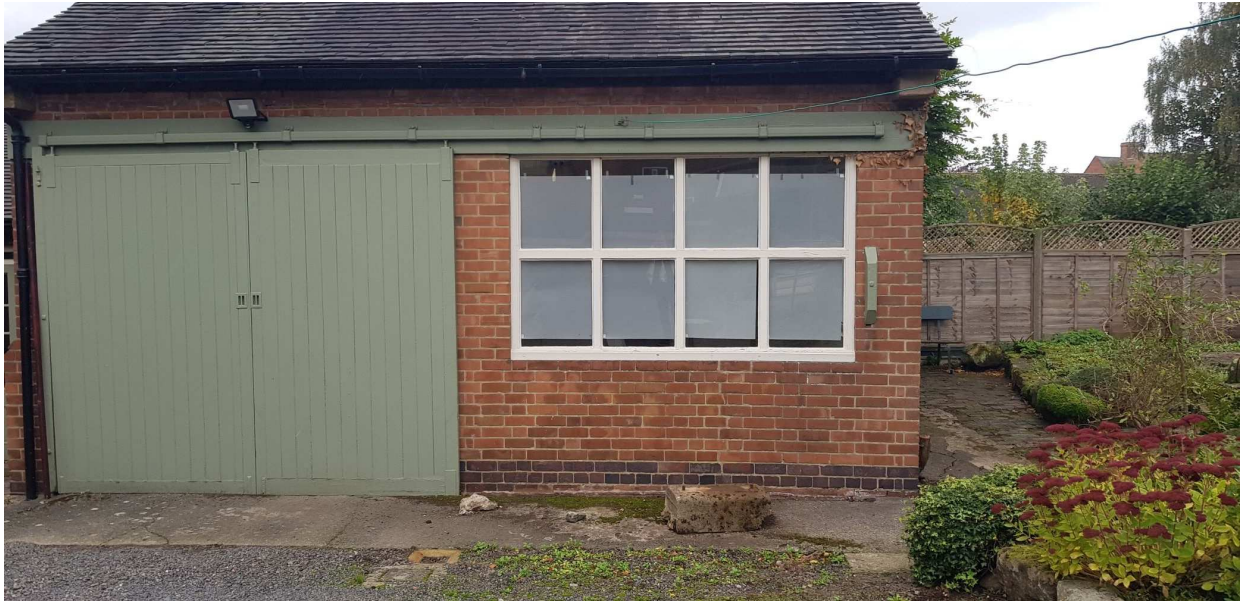
Photo 5 Rear Workshop Building Side  
Elevation

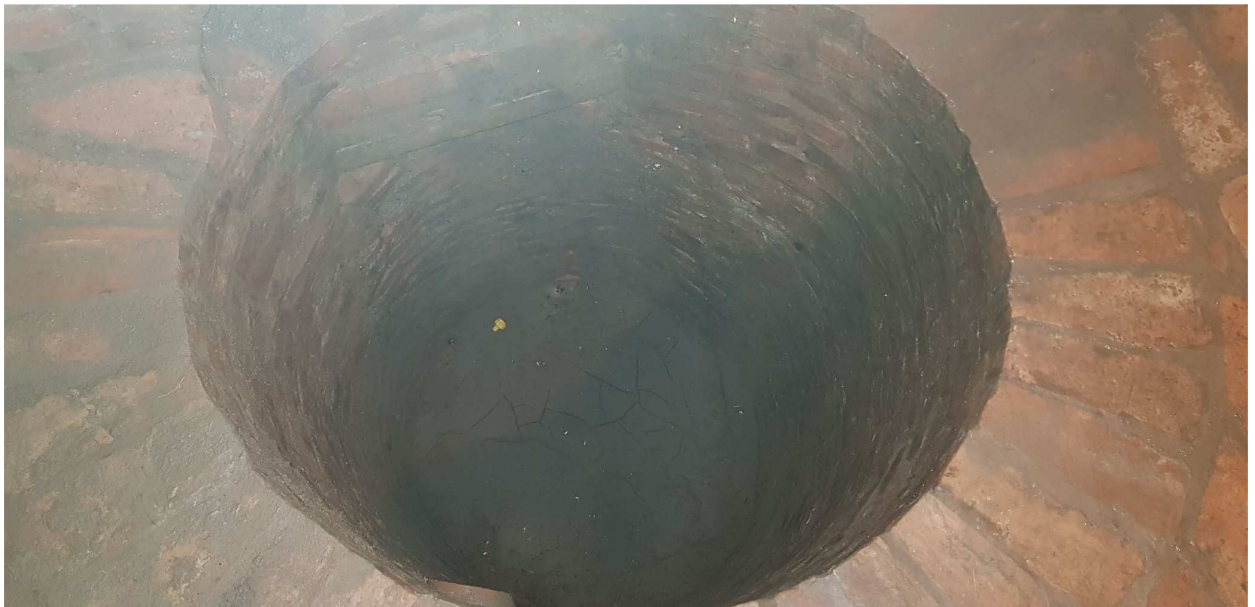
Existing pipe, possibly storm water appears to drain into well, though well itself appeared fairly dry at bottom.

Photo 6 Well in Basement-Note drain pipe  
into Well

- Carry out drainage survey (if not already done). Repair any defects
- Consider removing any cement based mortar that has been used over existing lime based mortar, and replace with lime based mortar, in order to prevent further brick damage. This needs to be carried out by a masonry restoration specialist, in order to not damage any further existing brickwork.

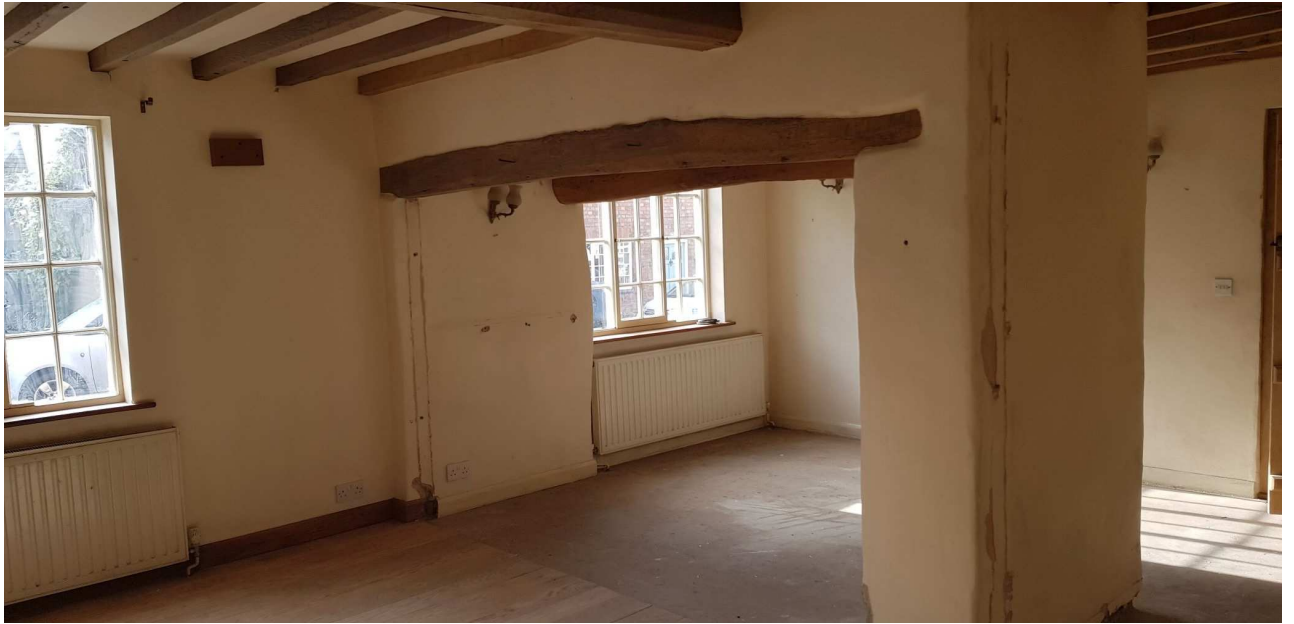
Photo 7 Timber Beams in Kitchen

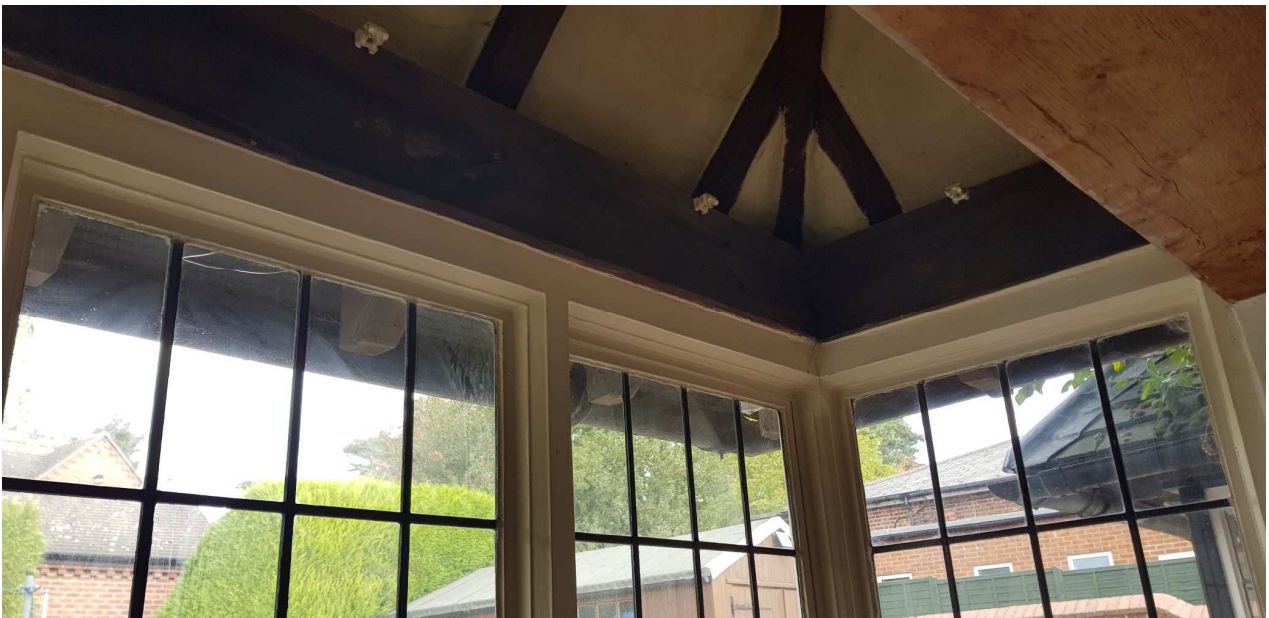
The main house rear elevation being more a later extension appears to be in good order, it should be noted that bay windows appear to incorporate a structural frame, hence any replacement of windows would require the structural frame to be considered.

Photo 8 Structural Timber Framing to Bay Windows

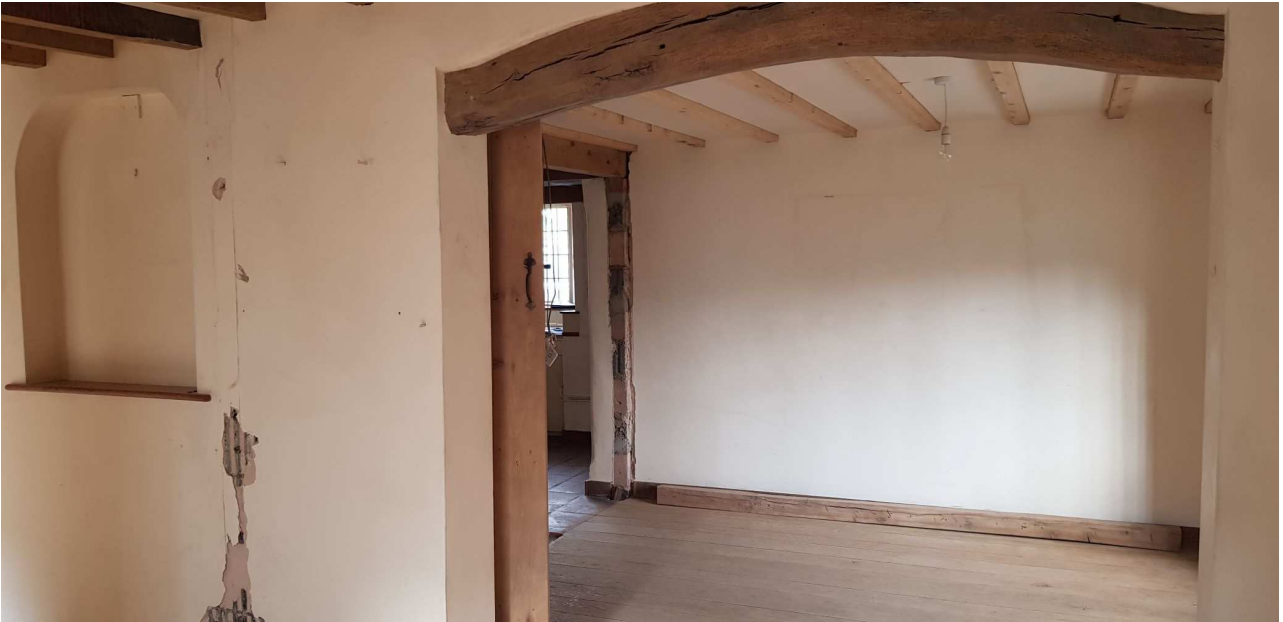
Rear rooms off Kitchen/Diner referenced G2, splitting present in Oak beams over supporting first floor. First floor/ceiling joists over are not level and slope to down one side. The wall by fire place of out plumb up to 30mm over 1.2m height.

Photo 9 Split Timber Beam in Kitchen

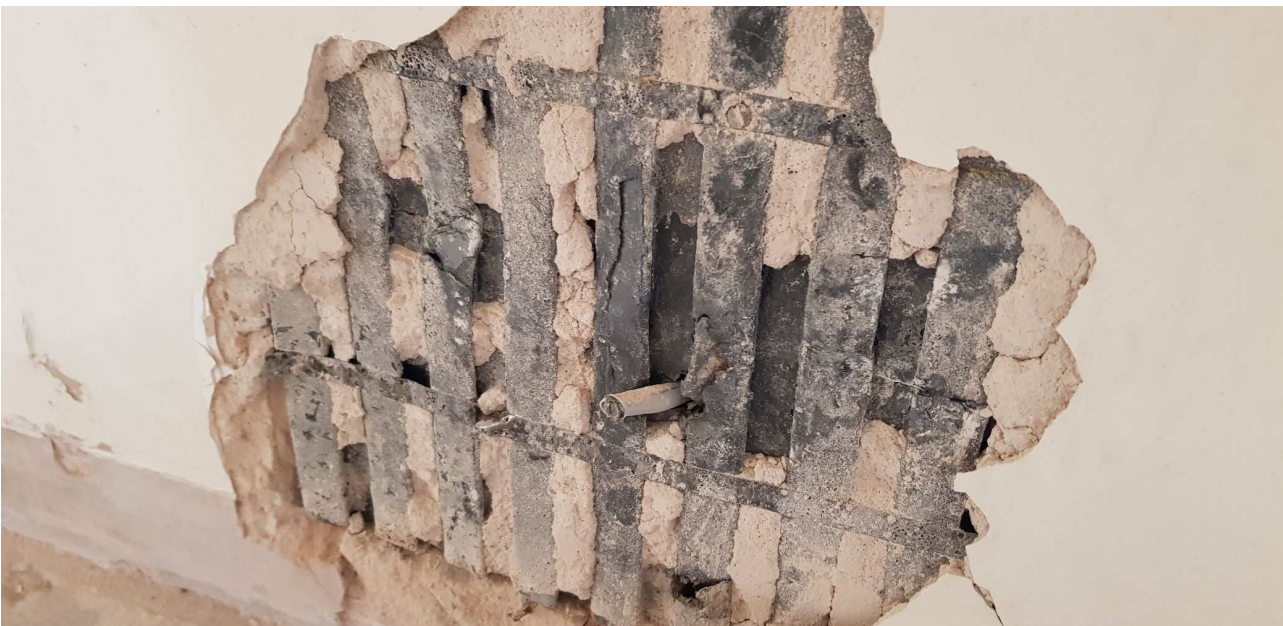
Entrance leads into Kitchen/Diner referenced area G1. Bay Windows appear to be more modern later (to original build) alterations or extensions, and are of structural timber framed construction. Generally walls and ceiling are in reasonable condition. Minor crack present in wall near sink. Exposed Oak timber beam over supporting first floor has minor splitting.

Photo 10 Damage to Wall in Kitchen

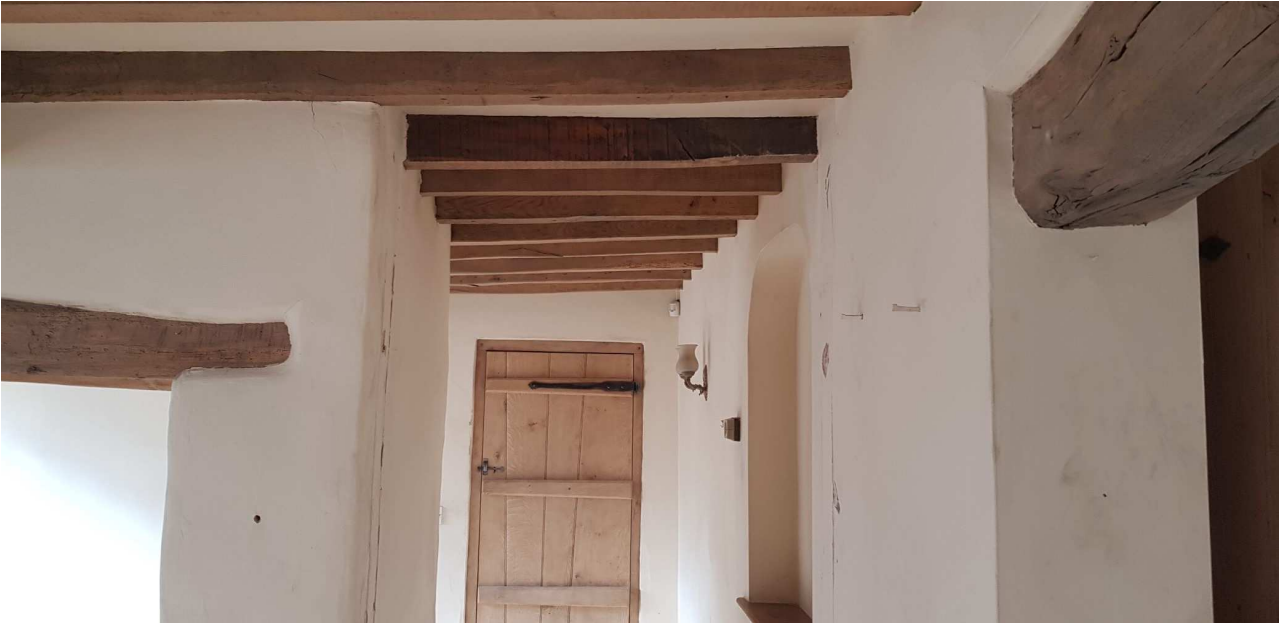
Photo 11 Sloping Ceiling in Kitchen

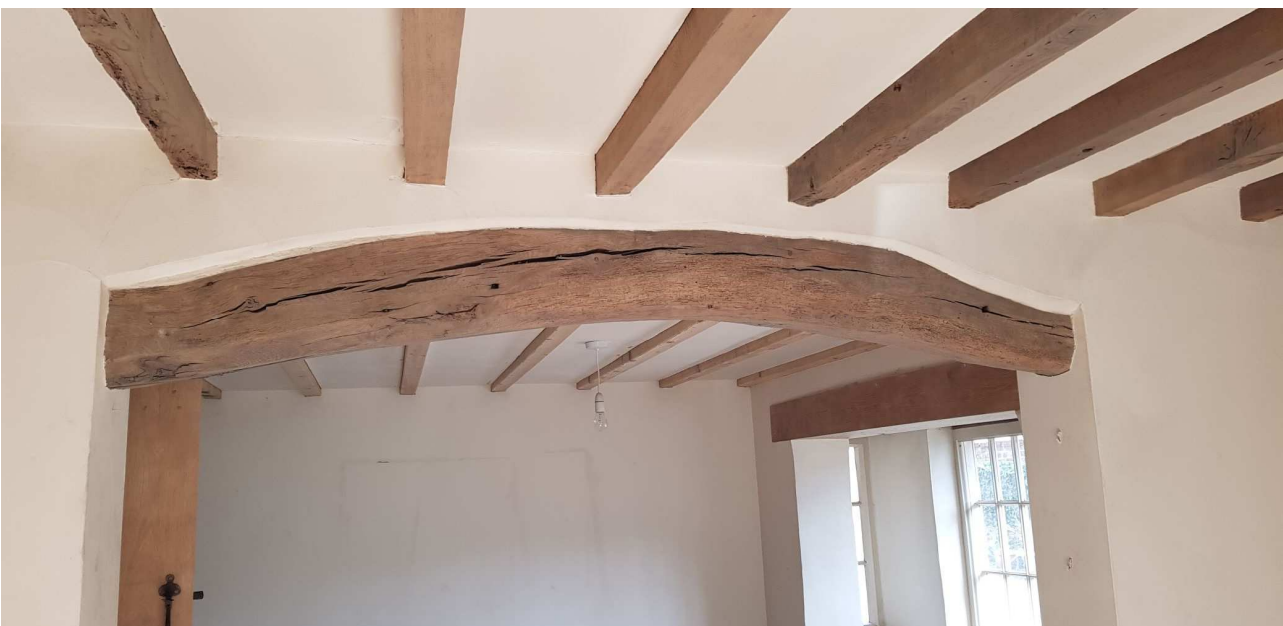
Photo 12 First Floor Split Arch Over

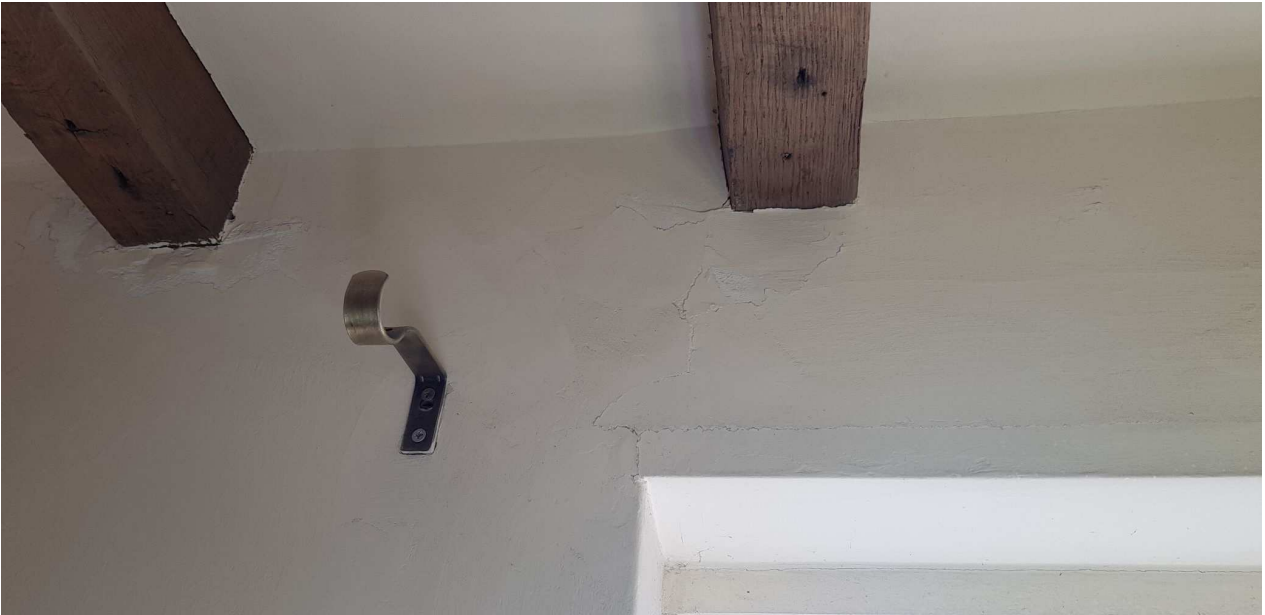
Staircase from rear entrance kitchen leads up to first floor landing and corridor leading to first floor rooms. Reference F2. This landing has considerable slope across it, (which is reflected in the kitchen ceiling under below. Slope of around 50mm for a length of 1.2m. this floor in particular slopes local to staircase area. Generally no cracks noted in walls, but small diagonal crack to corner of window. Vertical crack noted above timber beam near top of staircase.

Photo 13 First Floor Crack Near Landing Window

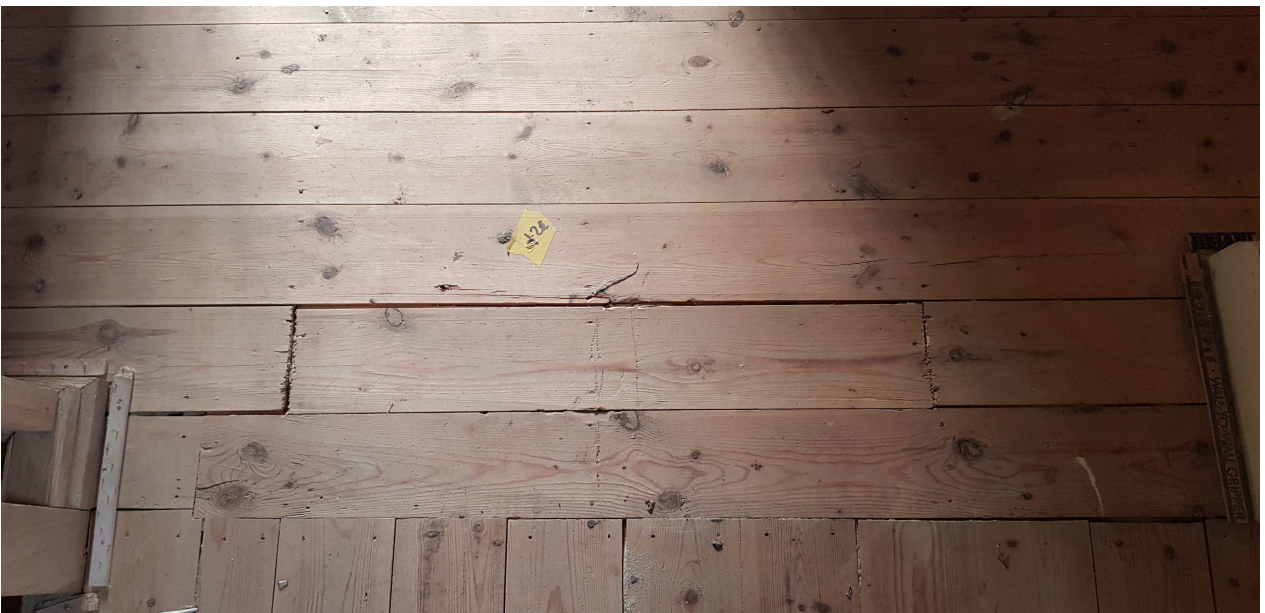
The first floor has a wider joint between boards on the landing area, again indicating some lateral movement of the 'old' part of the house.

Photo 14 First Floor Opening of Floor Board Joints

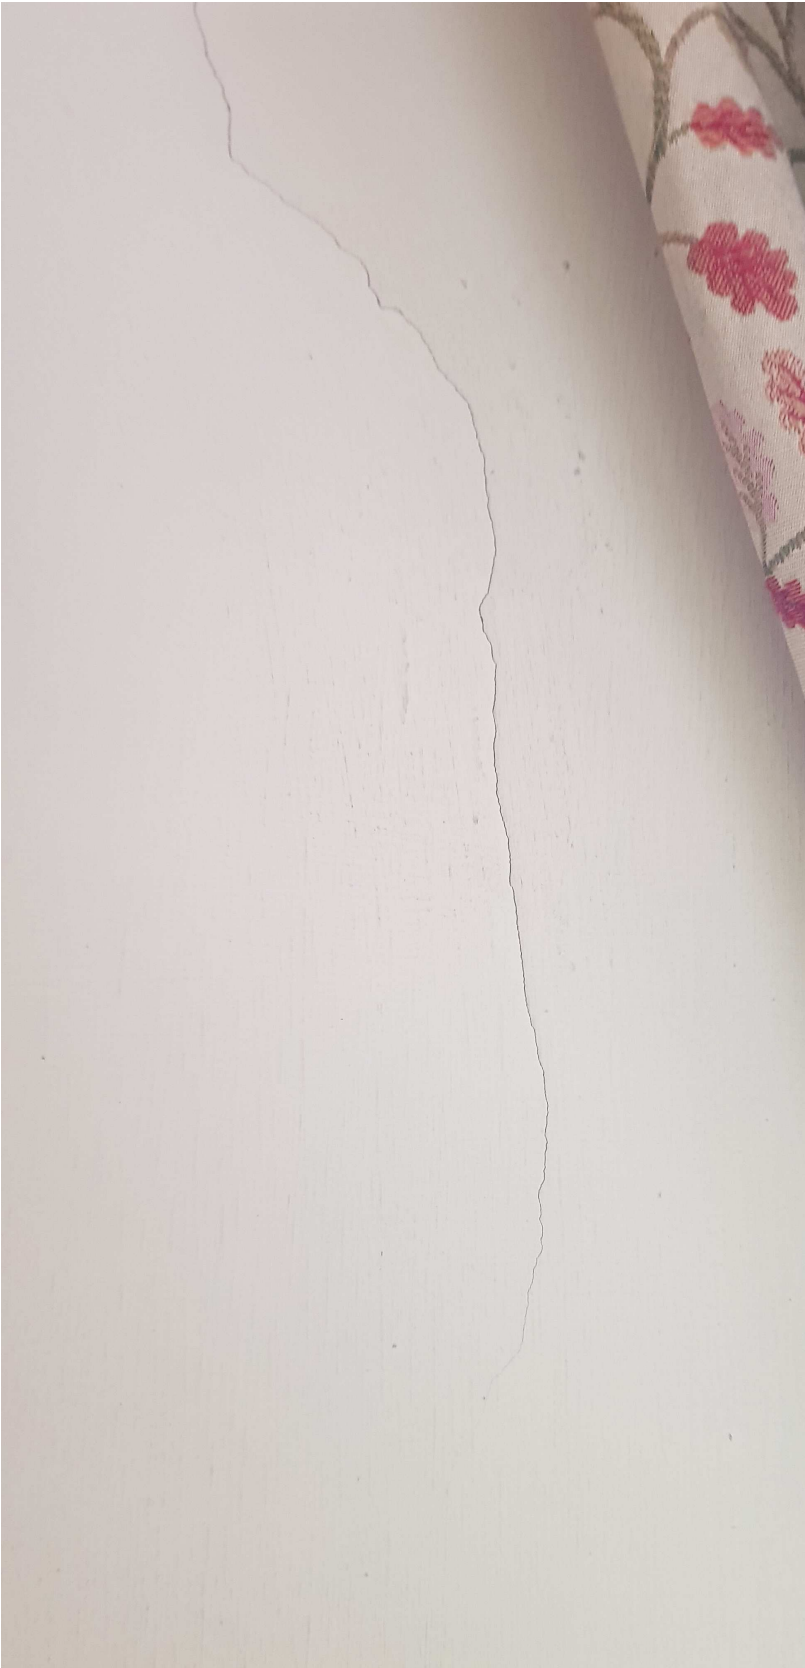
Photo 15 First Floor Minor Cracks in Wall

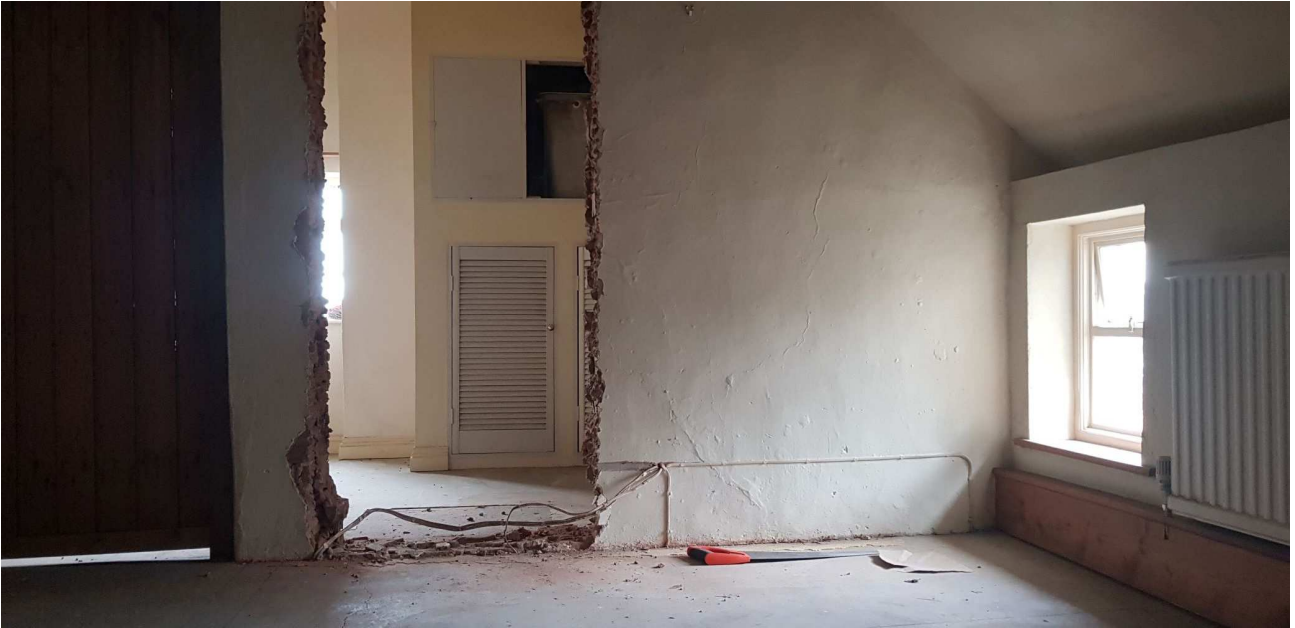
Minor diagonal cracks are present in corner. A new opening has already been cut in existing masonry wall. Floor consists of timber floor joists with concrete topping on timber. Cracks are present throughout concrete topping.

Photo 16 Second Floor Alterations Started

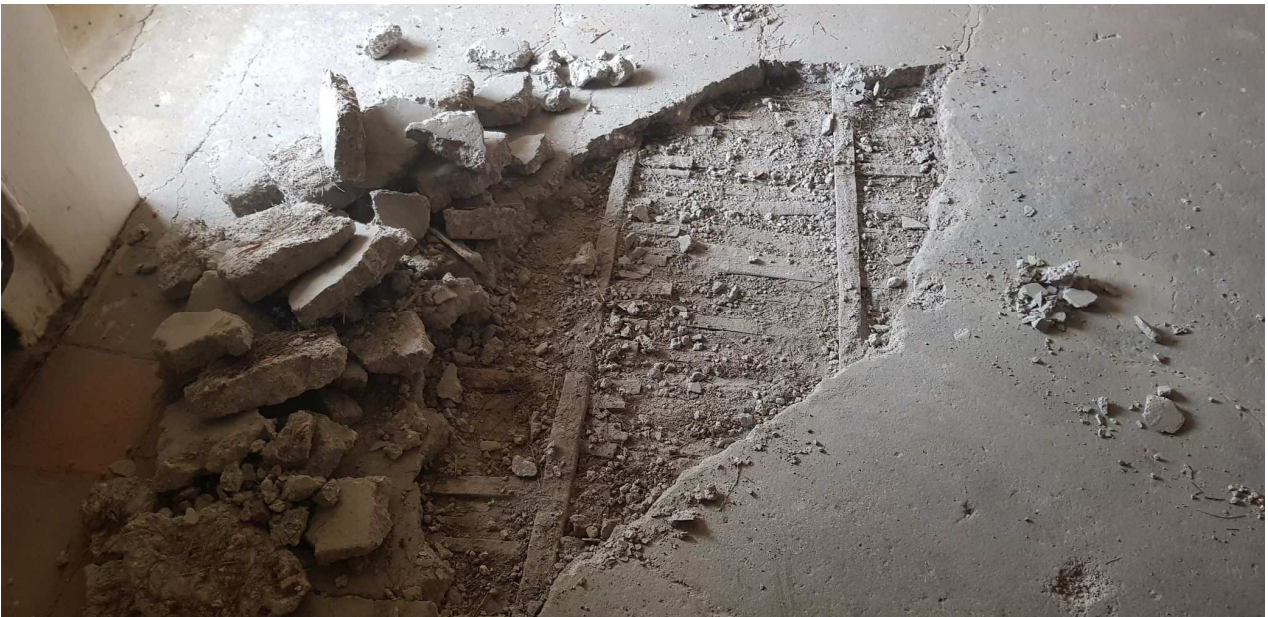
The second floor presently has a concrete topping to the timber. This concrete topping or screed has de-bonded and is breaking up in many places, a patch had been removed at time of inspection.

Photo 17 Damage to Floor-Note Unusual  
Concrete Topping

- All heavy weights hanging from Forge walls should be removed.
- It should be noted that out of level floors and masonry cannot be recovered. The second floor screed needs to be removed in its entirety and replaced with a correct thickness timber floor covering, to span between floor joists.

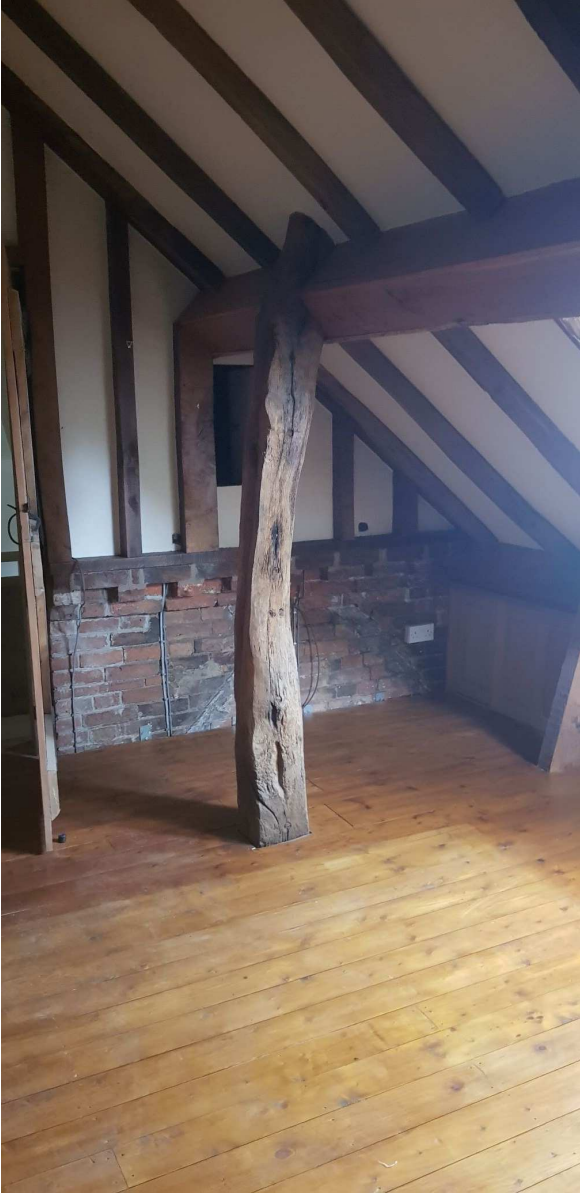
Structural timber props are present supporting roof over.(possibly props are part of a roof truss)

Photo 18 Second Floor Existing Timber Posts

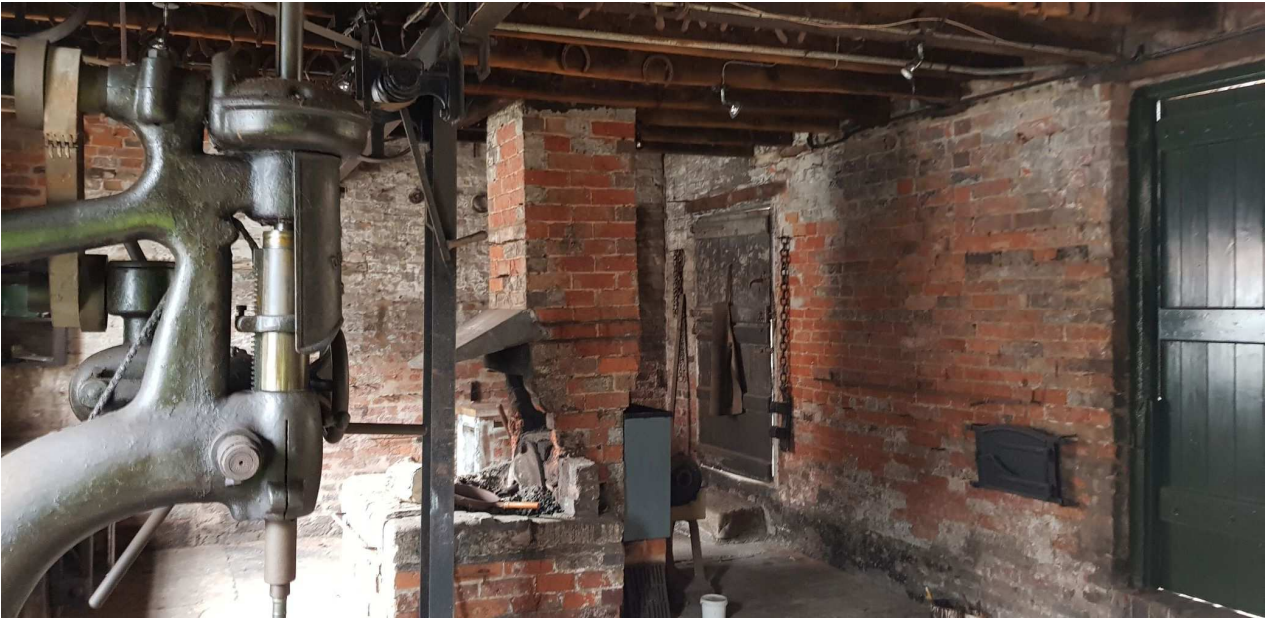
Photo 19 Internal View of Old Forge

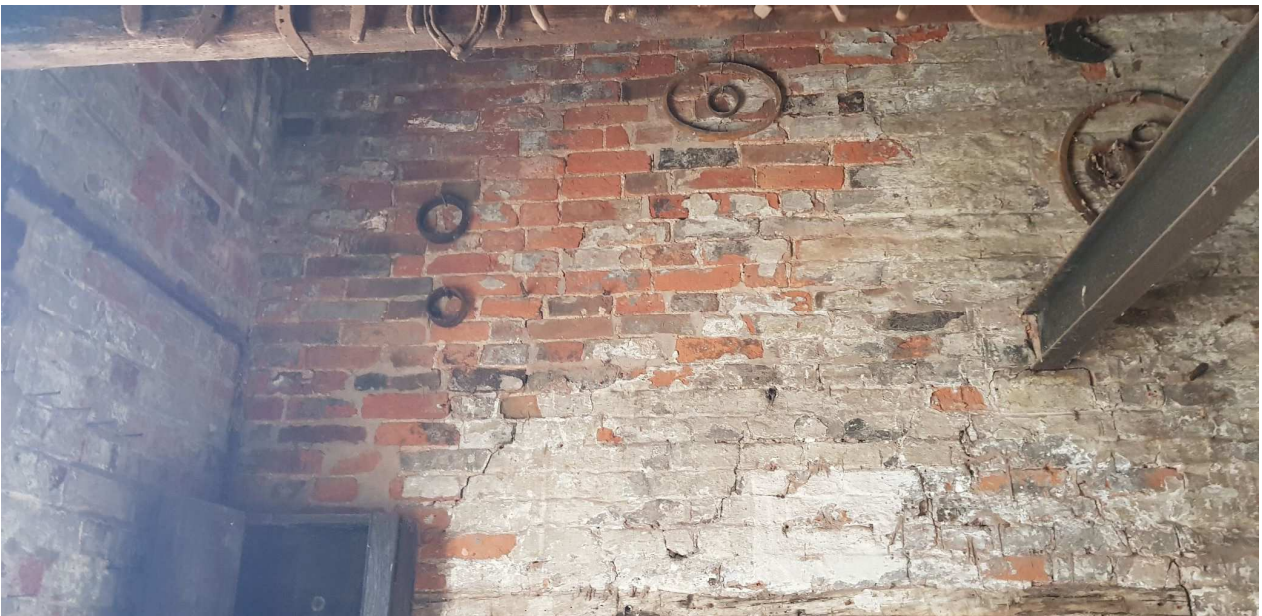
Ground Floor Forge Building/workshop including Mezzanine, Reference G6, this building is constructed of solid brick walls, and is attached to main house, though no door is present directly between the two. Ground floor walls are generally in poor condition, with areas of cracked brickwork, lateral movement of the brickwork, bulging brickwork, particularly to rear wall and over front entrance. Several steel tie rods have previously been installed which is likely an attempt to prevent lateral movement of the brickwork.

Photo 20 Old Forge Poor Brickwork Generally

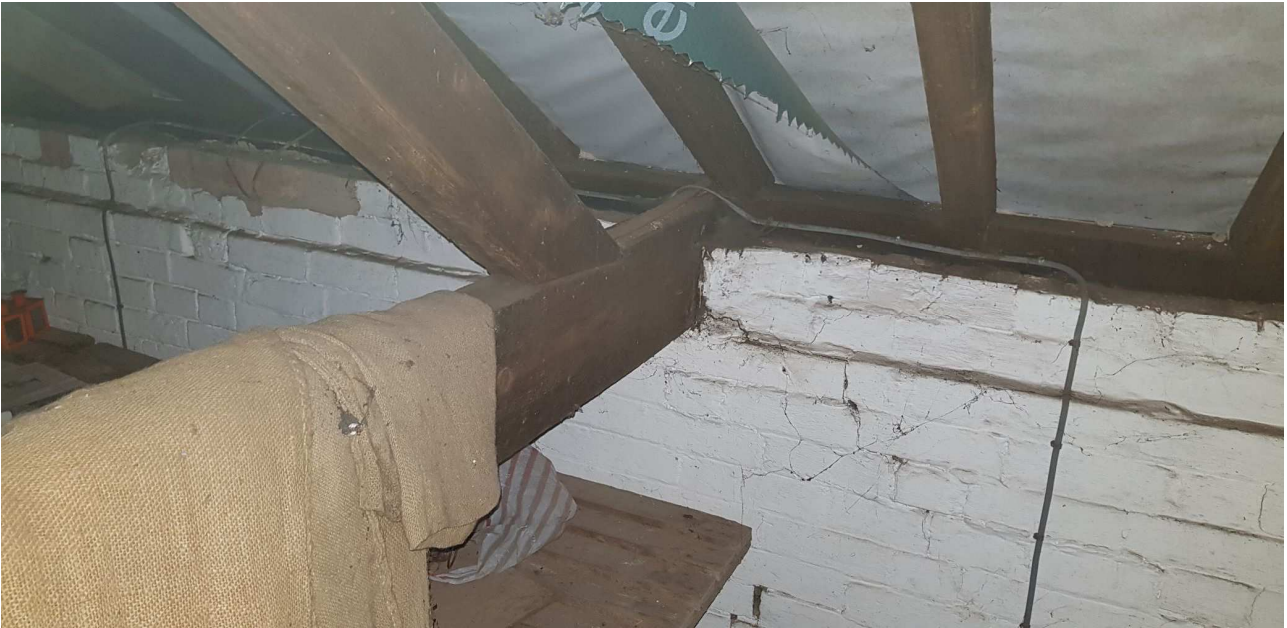
Eaves brickwork to front wall under timber wall plate has moved outwards. A steep timber stair is present to mezzanine. Mezzanine joists appear to be in good condition. Underside of roof appears old but reasonable condition.

Photo 21 Old Forge Movement at Both Eaves

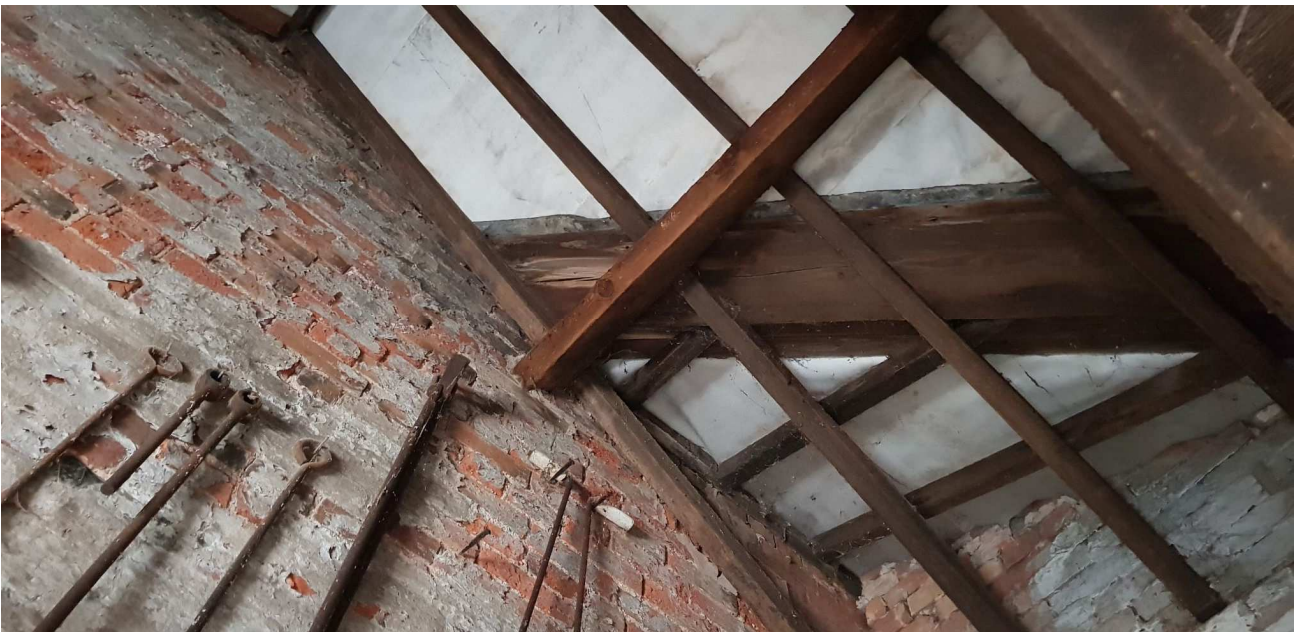
Brickwork to internal corners to external side wall is in particularly poor condition

Photo 22 Old Forge Poor Brickwork to End Wall

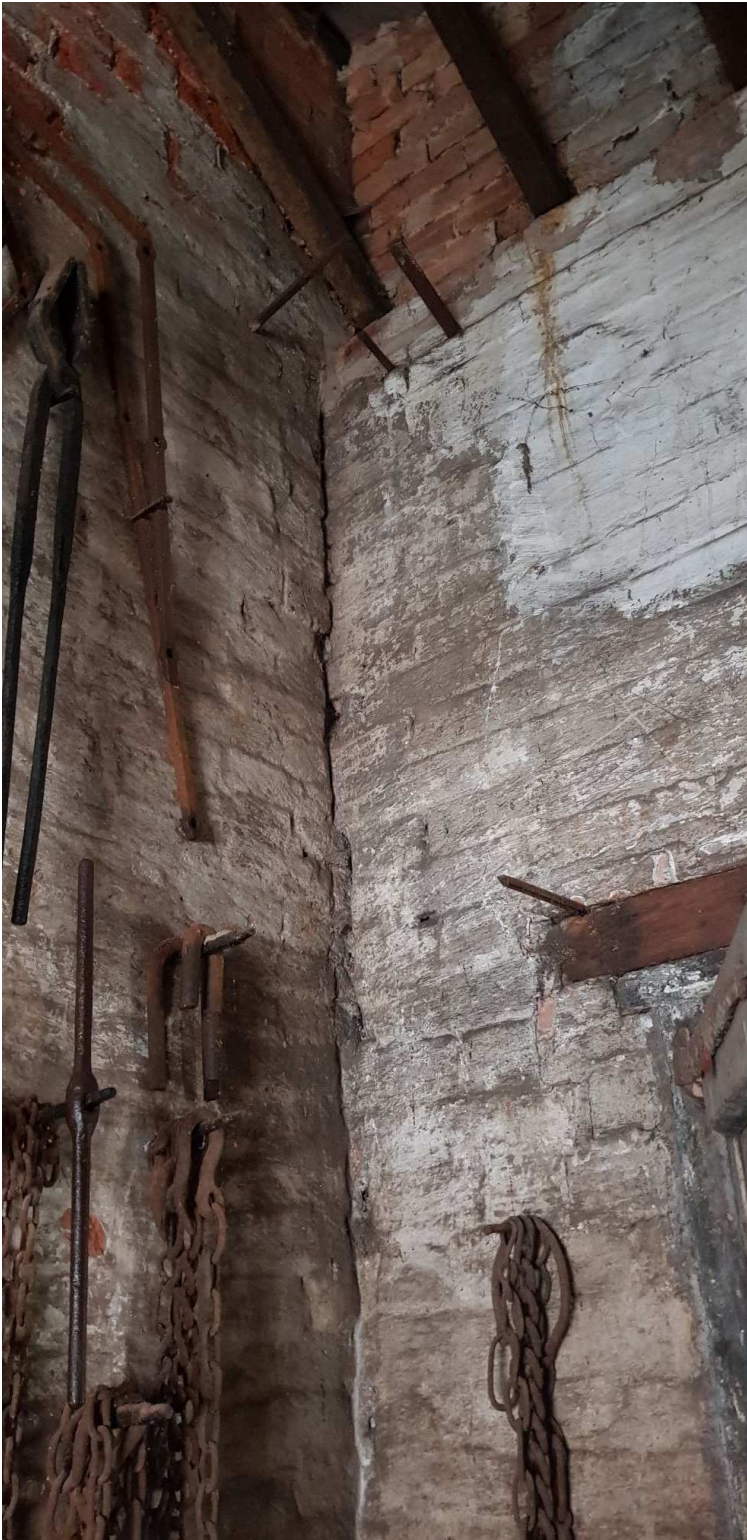
Internally the one end of the forge, the bonding of masonry is particularly poor with a large, wide vertical crack in the corner junction, which effectively de-bonds the two masonry walls at right angles to each other.

Photo 23 Old Forge Large Crack in Masonry to Internal Corner

- Internal corners of the forge walls have poor tying together and this must be corrected, use 30x5 galvanised straps at 900 vertical centres with 750 legs across corners. If this room is to have exposed brickwork and hence modern straps unsightly, then an alternative would be to use wrought iron effect banding or corner plate to tie walls together. A similar bespoke fabricated wrought iron could also be used to tie down wall plate.

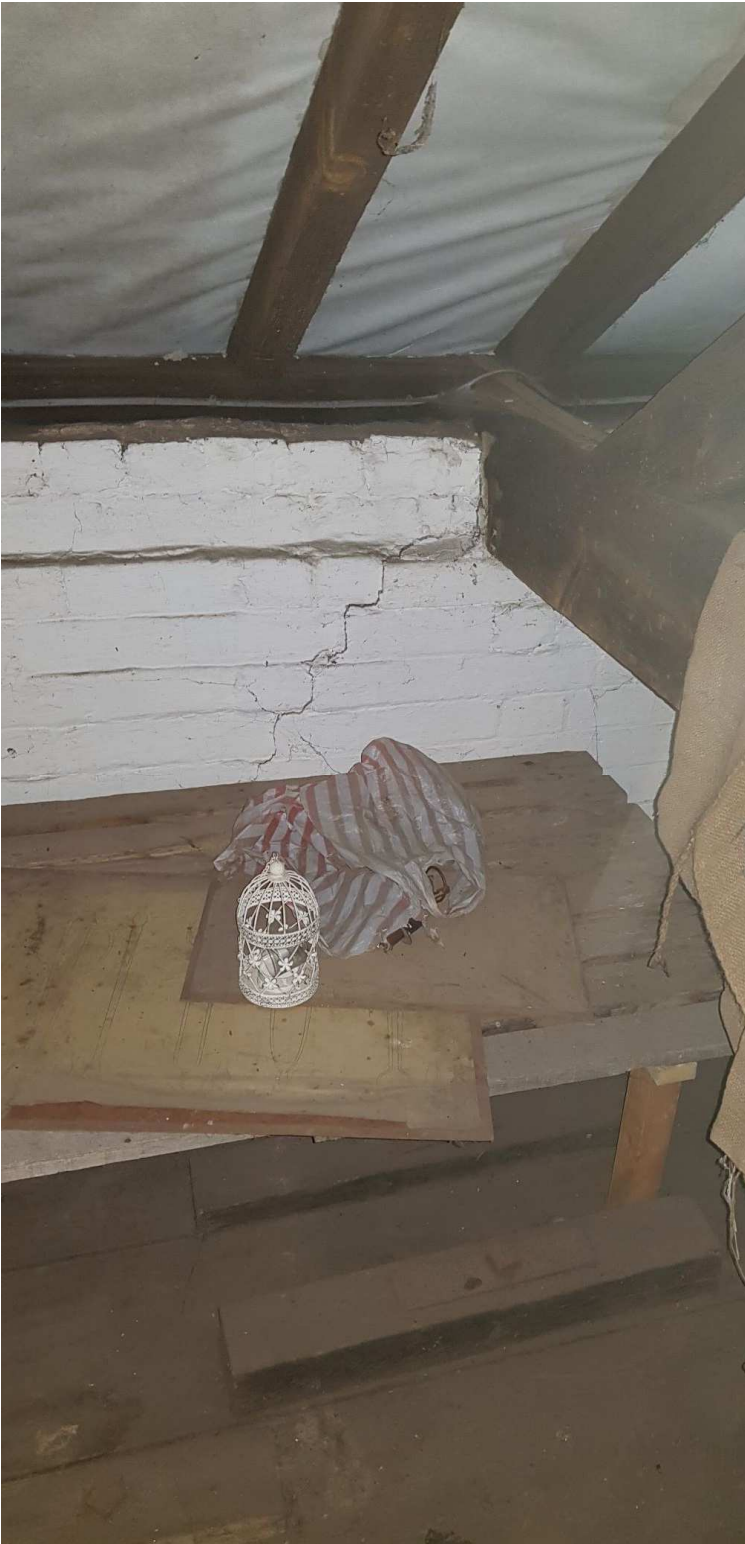
Photo 24 Old Forge Movement in Masonry

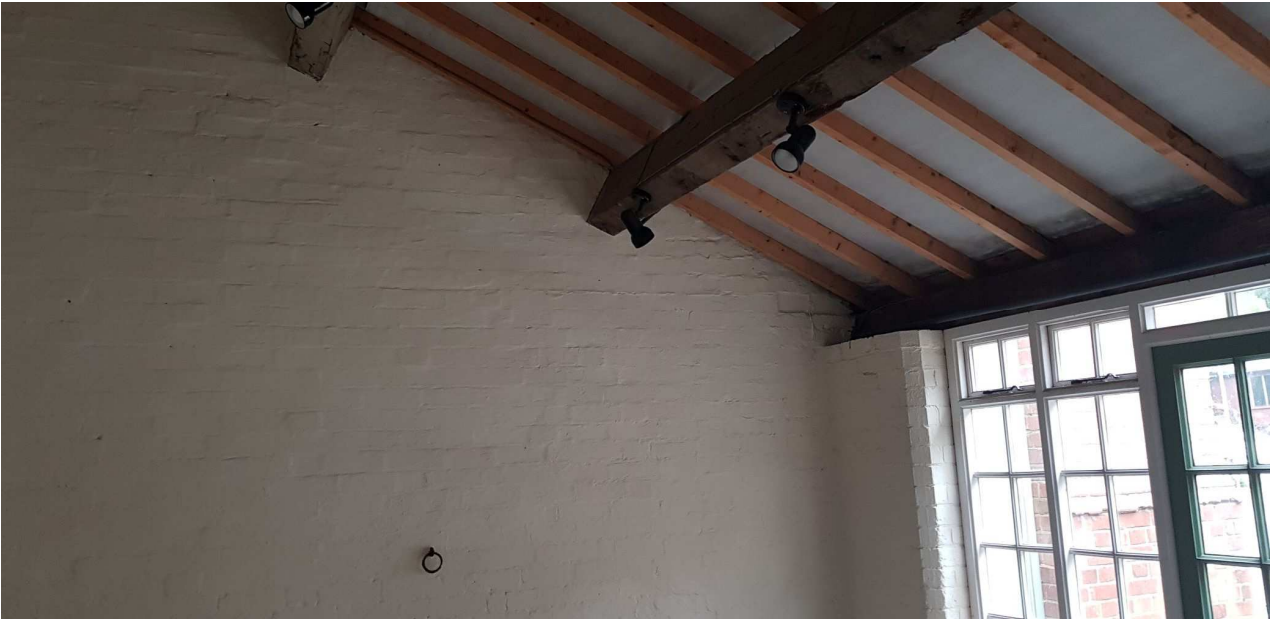
Photo 25 Room Next to Old Forge Minor Cracks
