Our Ref: CL2592/SBS/sbs

Re: Structural Report on the Old Forge, Park Street, Market Bosworth.

Our brief is to inspect the existing building and to note defects, with a view to conversion to a hotel or multi occupancy building. During conversion, several walls are to be removed and/or modified.

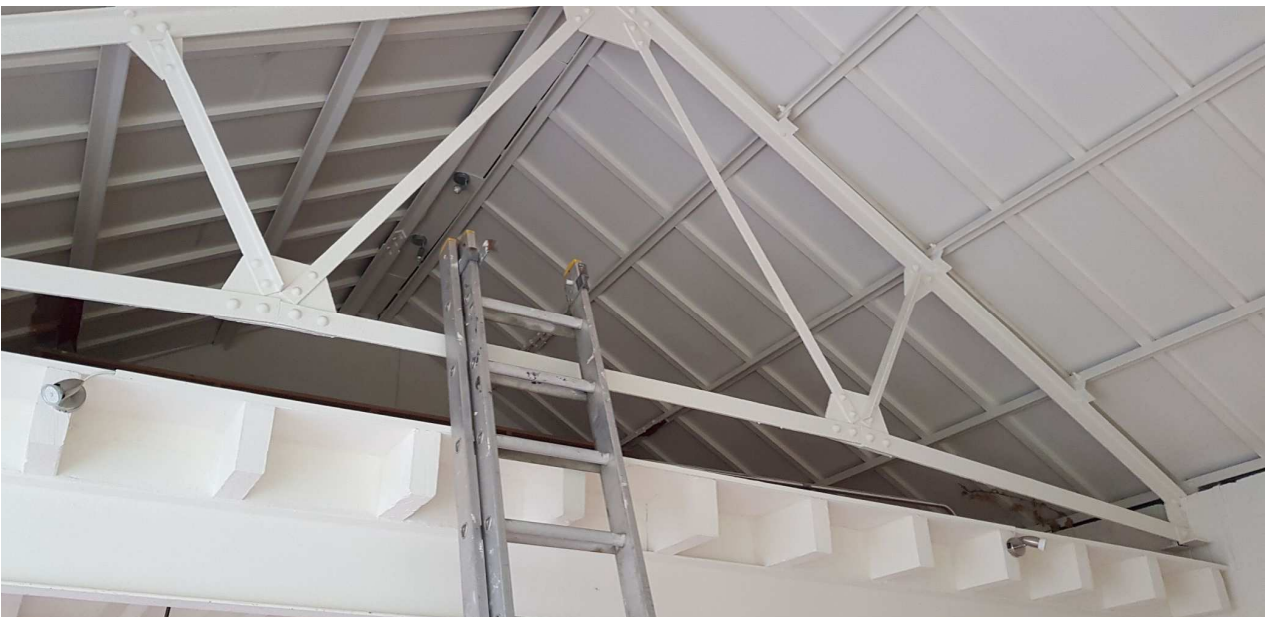
Roof, walls and mezzanine floor generally in good condition.

Photo 26 End Workshop with Mezzanine-Good Condition

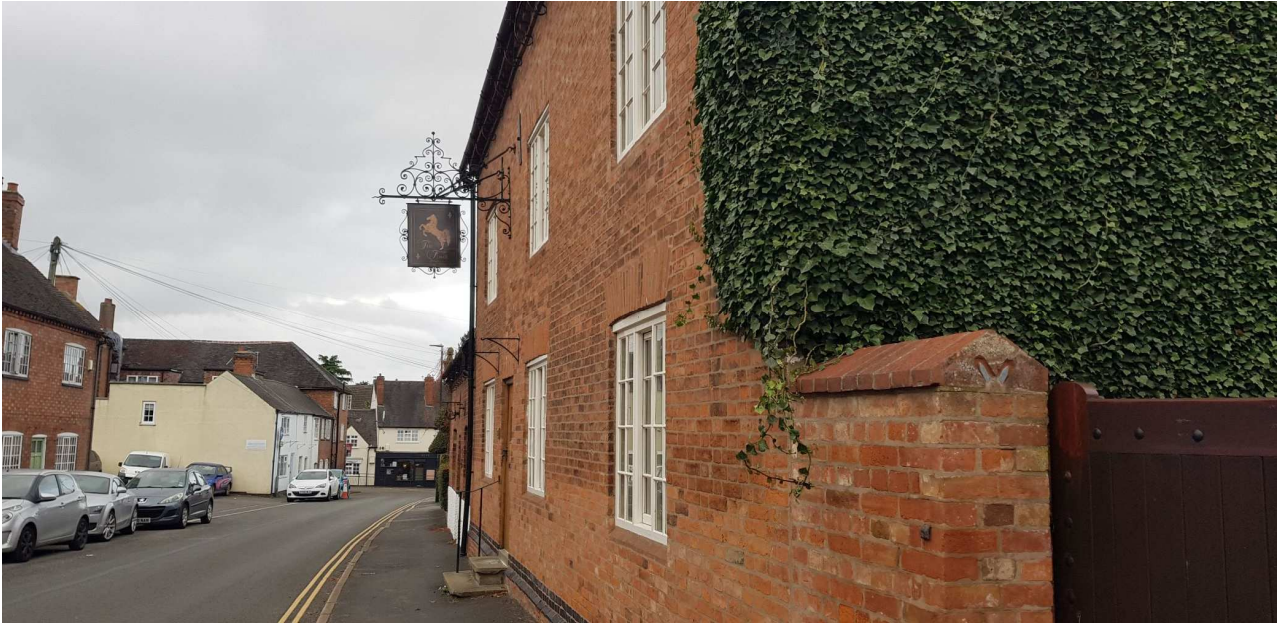
Photo 27 Front Elevation, Main House

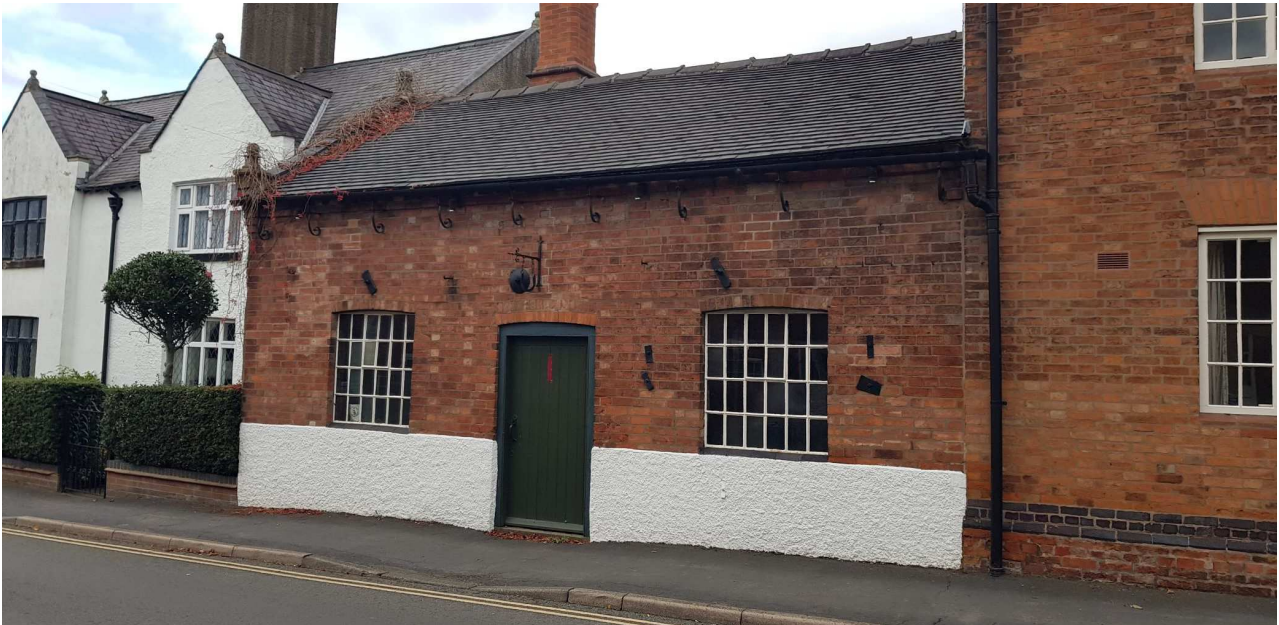
Photo 28 Front Elevation , Forge

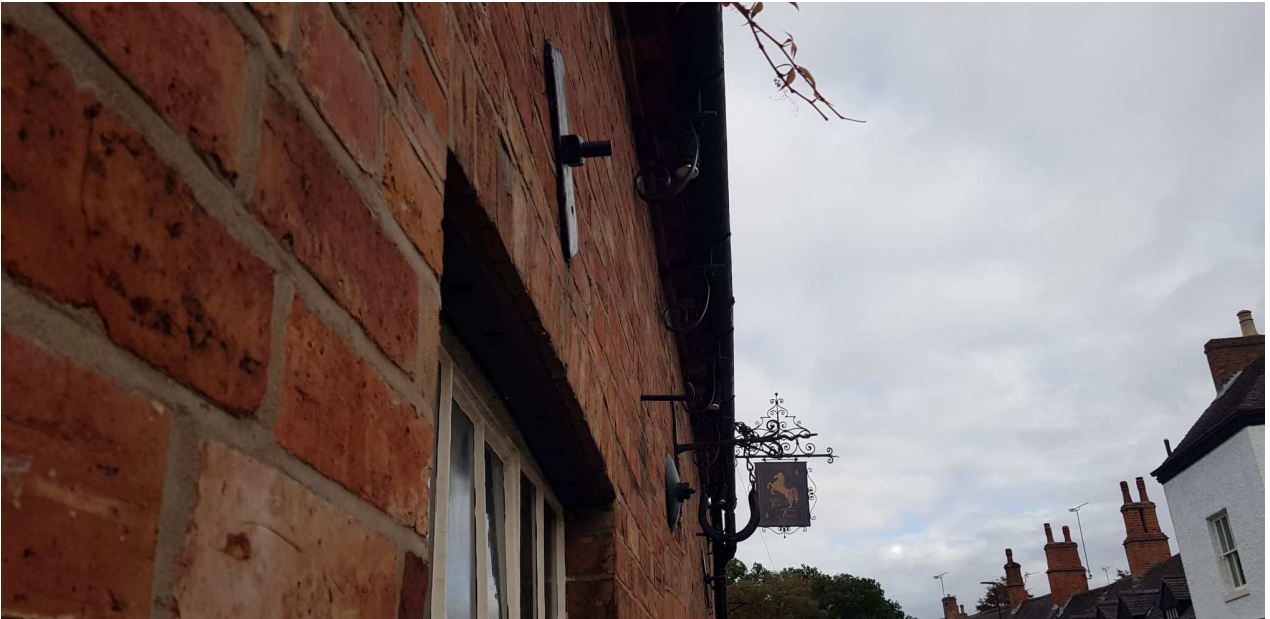
Machinery has been attached to front wall, which is likely to have increased the bulging of the wall.

The Forge building is in poor condition with cracked and bulging front and rear walls. Steel rods are present tying the front and rear walls. The existing steel tie rods appear not to have prevented movement of the front and rear. Cracks are present local to roof truss end bearings, there is masonry movement at the roof truss bearings, and little tying in of roof timbers to brickwork. The front wall has disjointed bed joints,

Photo 29 Forge Tie Rod and Hanging Machinery Tie Plates

- All heavy weights hanging from Forge walls should be removed.
- It should be noted that out of level floors and masonry cannot be recovered. The second floor screed needs to be removed in its entirety and replaced with a correct thickness timber floor covering, to span between floor joists.

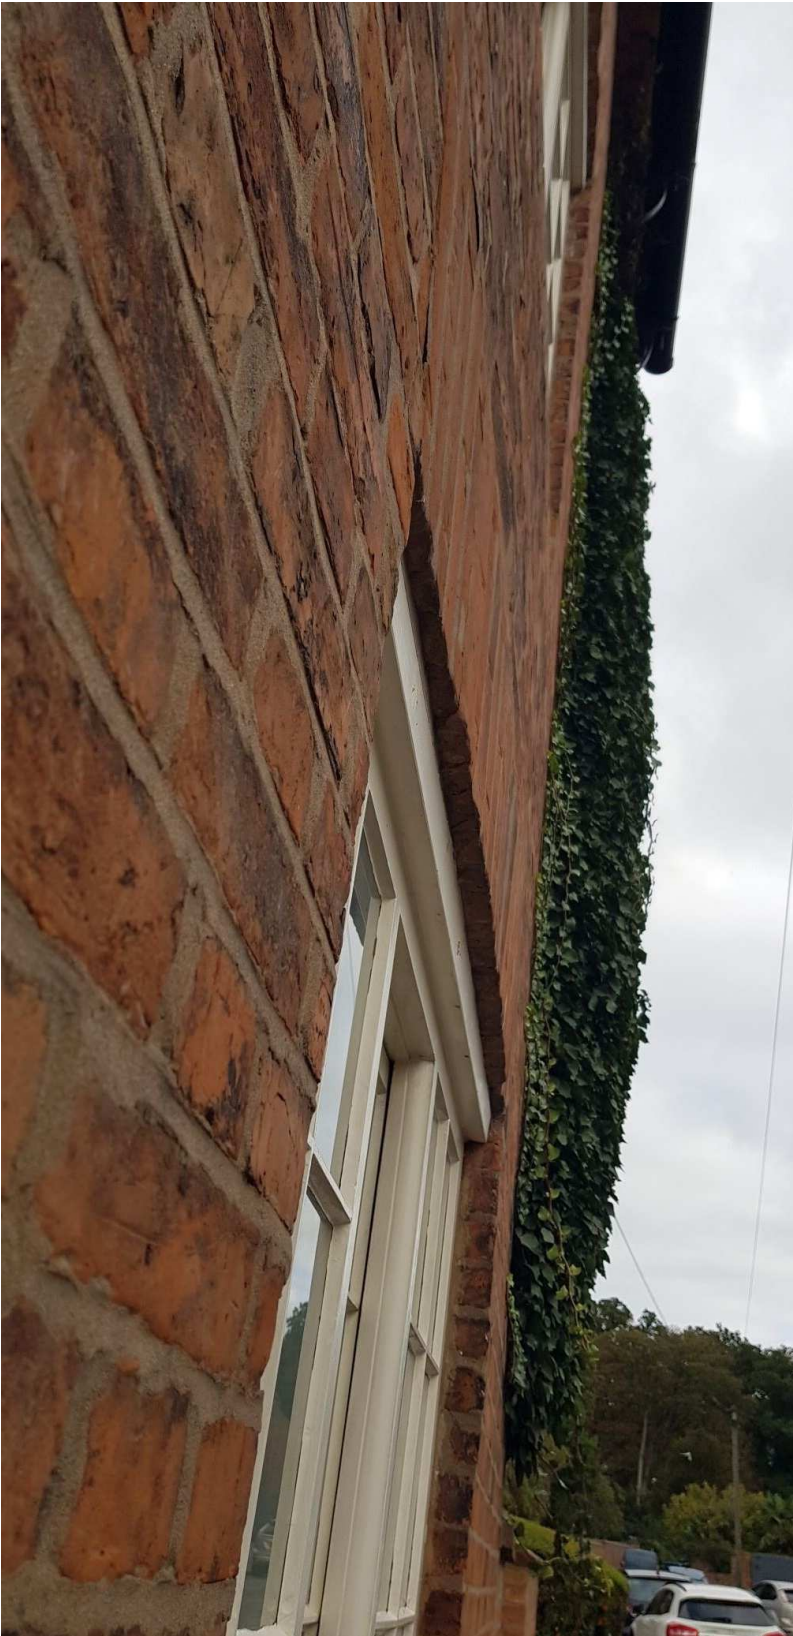
Majority of Solder course over to window heads have some movement

Photo 30 Bulging Masonry to Soldier Course Over Front Windows

- The general movement over door and window heads to front elevation is more difficult to eliminate. It is suggested that a good tying in of the floors to walls would reduce movement, and hence prior to re-pointing brickwork, Helifix Bow Tie HD gable tie bars can be installed which are drilled through bed joints, into internal timbers, then resin bonded to wall, and pointed over.

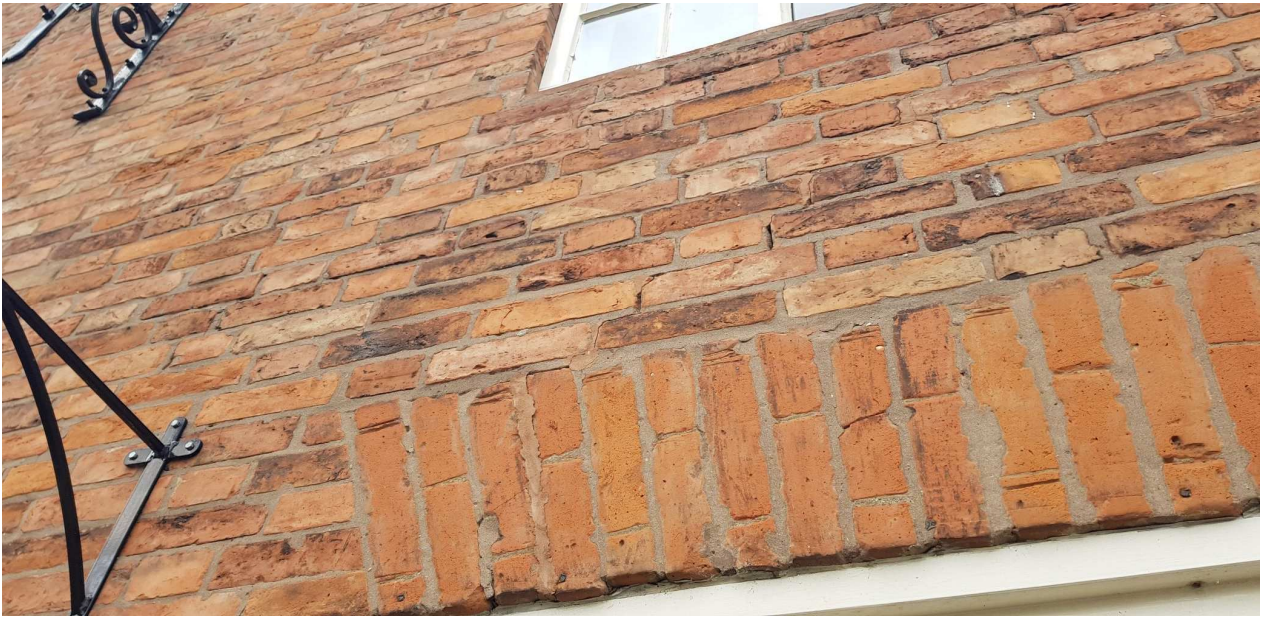
Photo 31 Movement in Masonry Over Front Windows

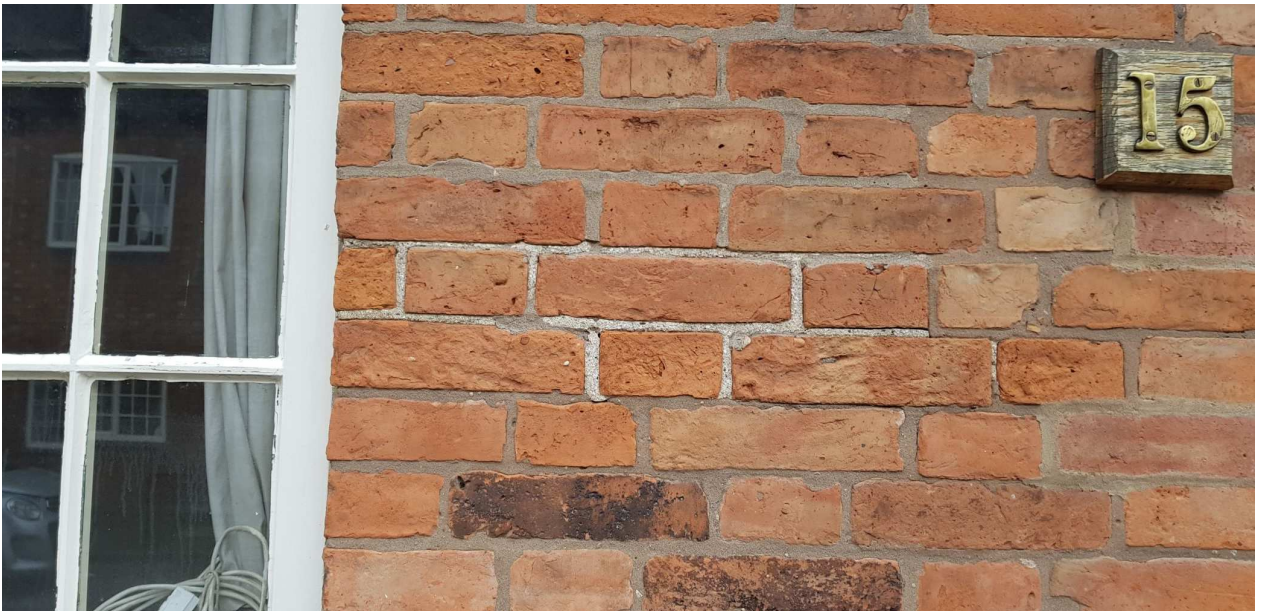
There has been previous mortar repointing that appears to have been carried out with sand/cement mortar rather than normal lime mortar. This can have a detrimental effect on the existing lime mortar.

The mortar generally to the original building appears to be lime based, and re-pointing has been carried out with cement based mortar. This can have negative effect on the brickwork and should be rectified when possible.

Photo 32 Previous Repointing carried out with Sand/Cement Mortar over Lime Based Mortar

- Carry out drainage survey (if not already done). Repair any defects
- Consider removing any cement based mortar that has been used over existing lime based mortar, and replace with lime based mortar, in order to prevent further brick damage. This needs to be carried out by a masonry restoration specialist, in order to not damage any further existing brickwork.

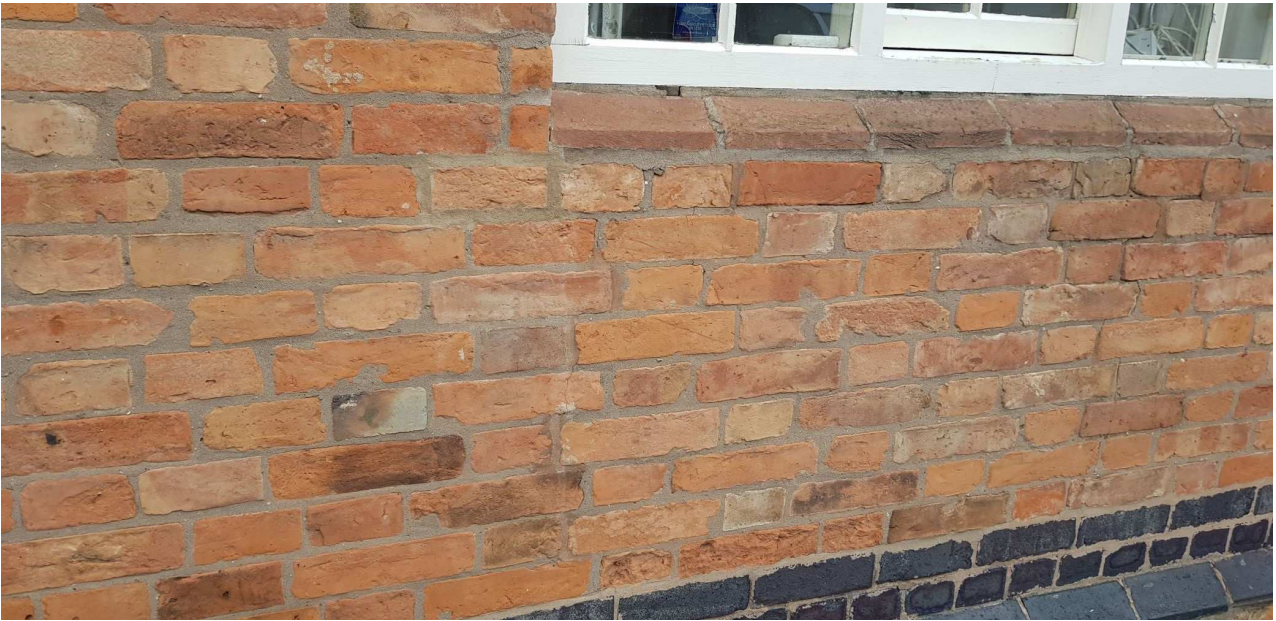
Photo 33 Previous Repointing of Front Wall

- All poor mortar bed-joints must be re-pointed. Where original wall contains lime base mortar, then lime based mortar must be used for re-pointing. It should be noted the later extended area is more likely to be constructed using cement based mortar.

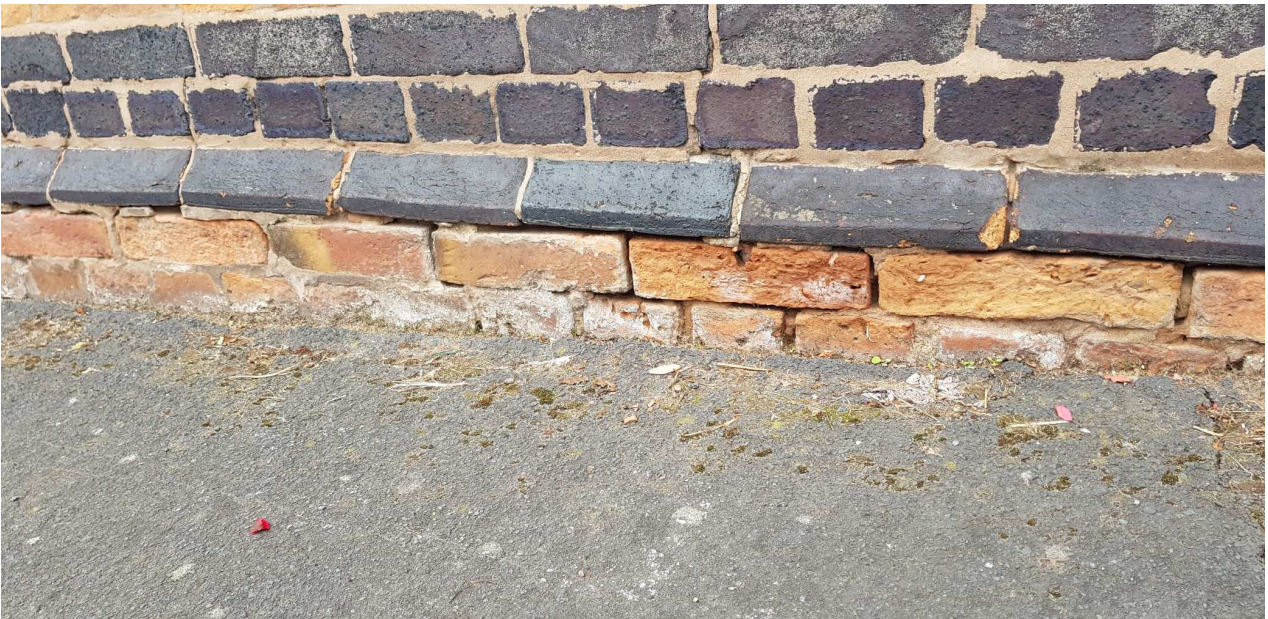
Poor weathered brickwork and mortar joints are present below dpc.

The masonry and mortar below dpc level is in poor condition, likely from splashing of rainwater on the pavement, water freeze/thaw action and possibly caused by the use of cement based mortar over lime mortar.

Photo 34 Poor Condition Masonry and Mortar Below DPC Level to Front Wall

- The poor condition of masonry below the damp proof brick course to front elevation requires repair, to prevent deterioration. Remove any cement base mortar (that is over lime based mortar), re-point with lime based mortar, consider replacing bricks that are too badly damaged. Consider specialist waterproofing coating for bricks up to damp proof course.

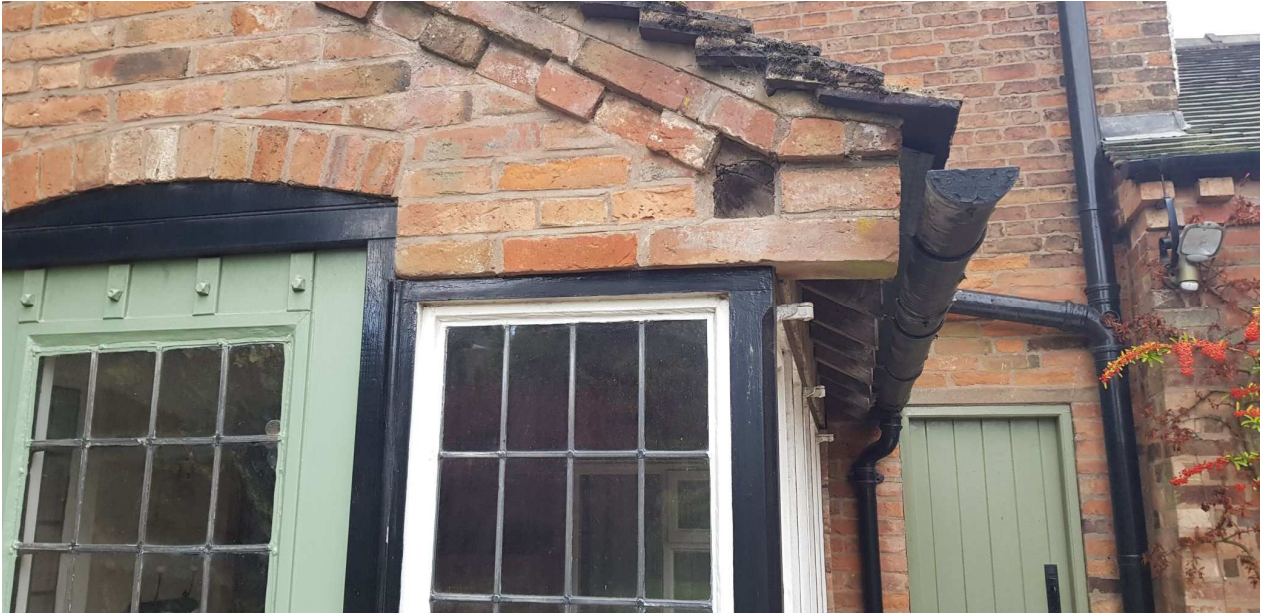
Photo 35 Exposed Structural Timber Framing at Rear
