**SIMPLIFY**  
STRUCTURAL ENGINEERING

7 The Laurels, Markfield, Leicester, LE67 9HA

General Structural Inspection and Report

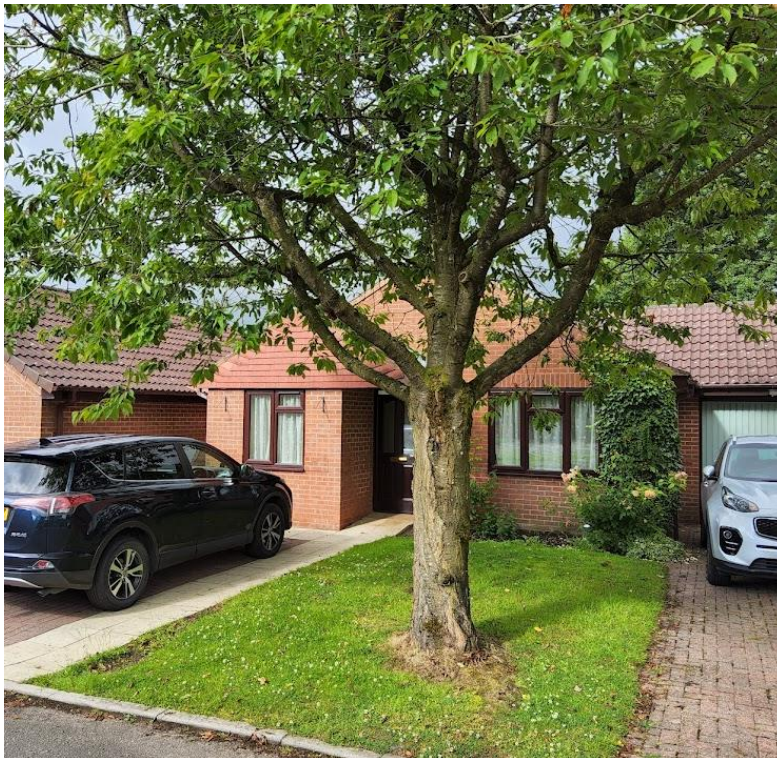
Photo 1 – Front elevation of the property

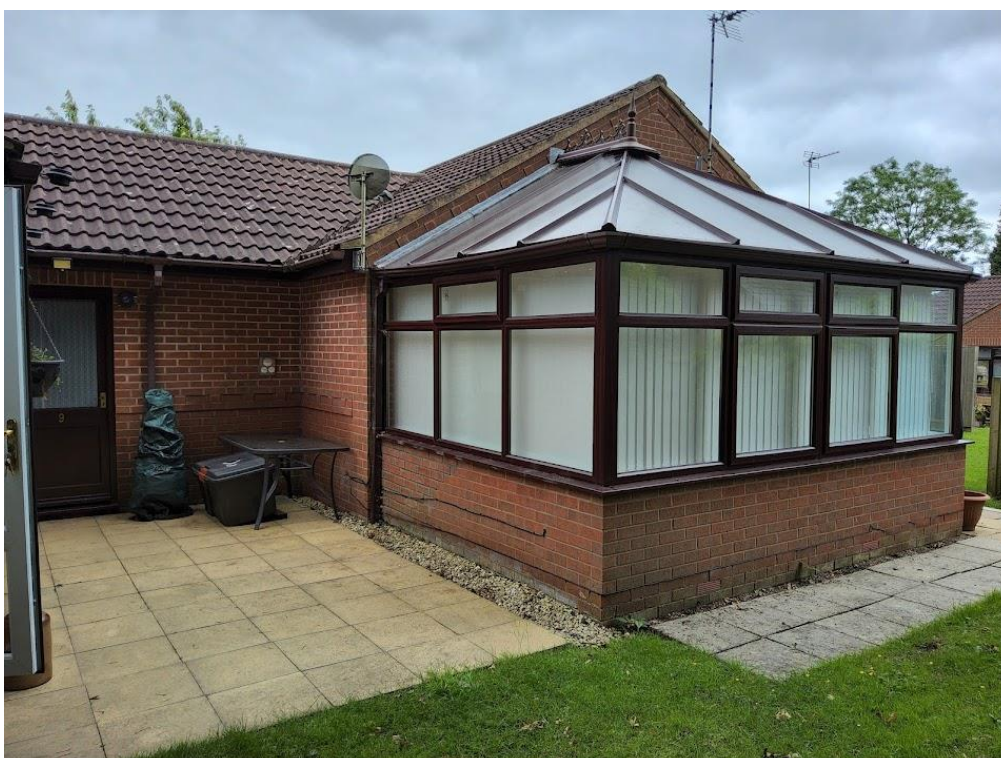
Photo 2 – Rear elevation of the property

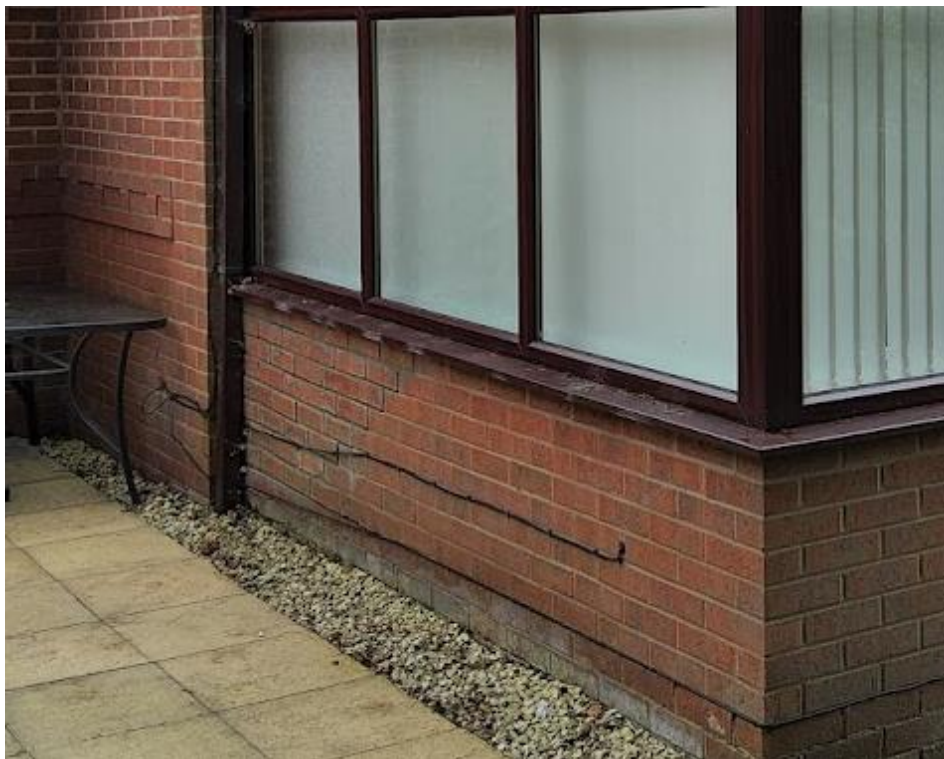
Photo 3 – Recently repaired brickwork due to subsidence movement

The external elevations appeared to be in acceptable condition, except the conservatory wall that indicates subsidence movement and requires further investigation. The movement appears to be due to shallow foundations and impact of tree roots of the adjacent trees and could also be related to defective drainage.

1. The neighbouring property documents related to subsidence movement should be obtained for review, if feasible, to determine the full extent of the investigations and findings.
2. An Arboriculturist should be engaged to prepare a tree survey and assess potential impact of trees on adjacent property foundations. Removal of trees should be considered to minimise impact of tree roots on foundations.
3. The rear conservatory should be monitored to establish full extent of movement.
4. A CCTV survey is required to confirm the condition of the underground drainage system.
5. At least 1 trial pit and ground testing is required to confirm depths of existing foundations and ground strength under foundations.
6. Once the testing is completed, a structural engineer should be engaged to develop adequate scope of repairs such as underpinning or ground improvement.

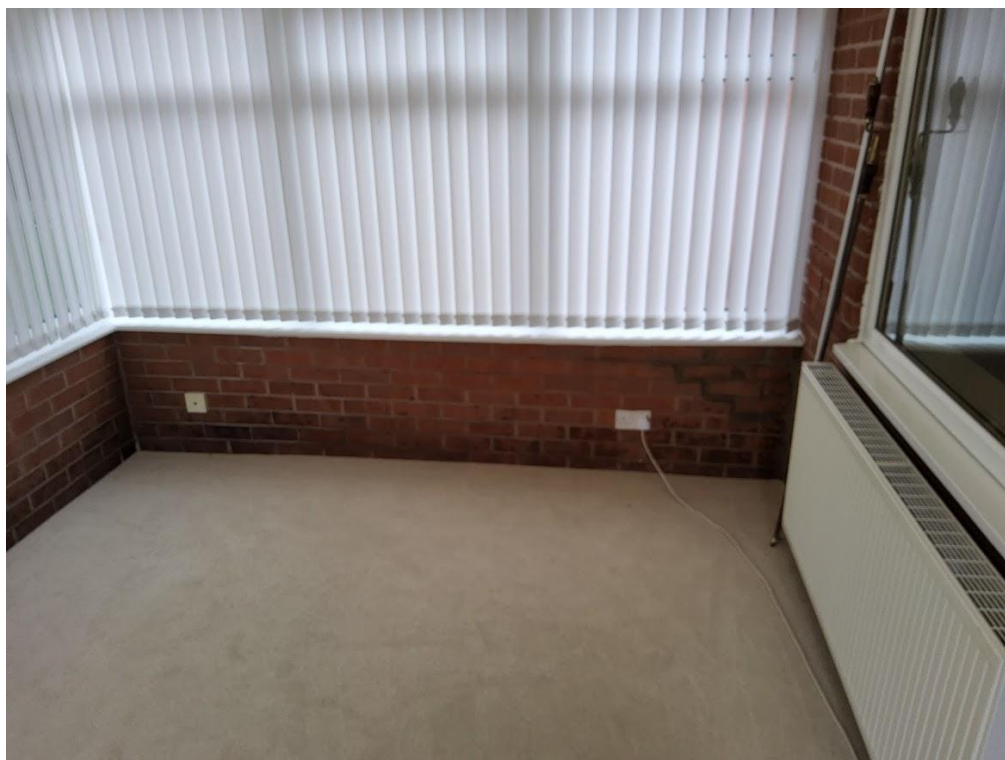
Photo 4 – Recently repaired brickwork due to subsidence movement

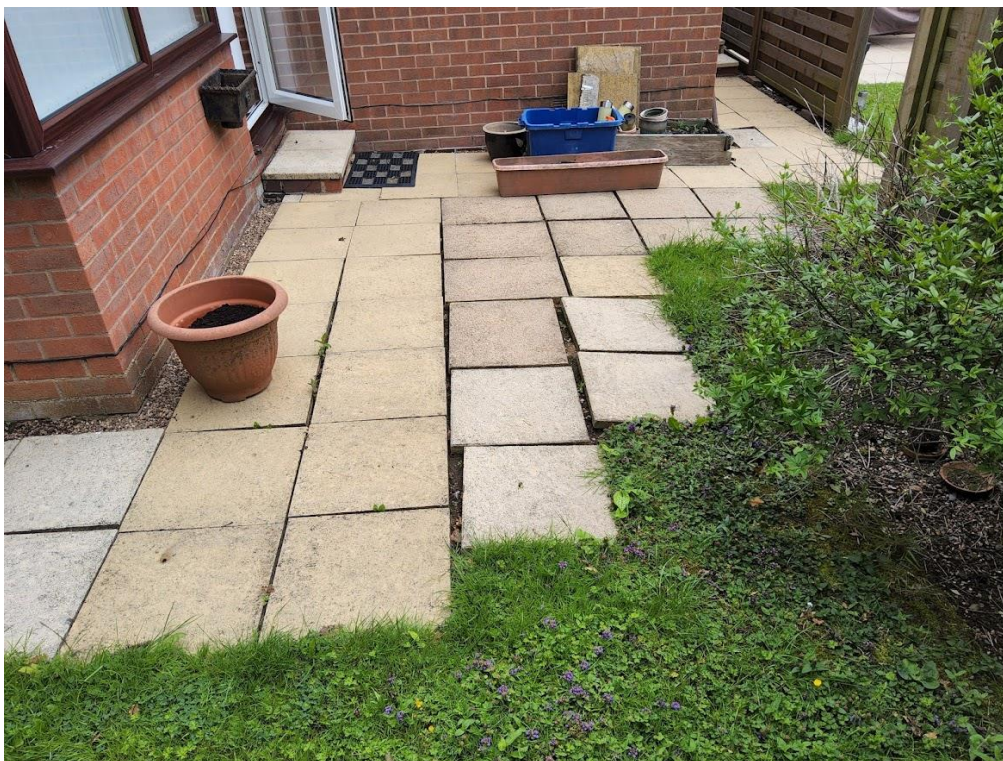
Photo 5 – Uneven garden paving

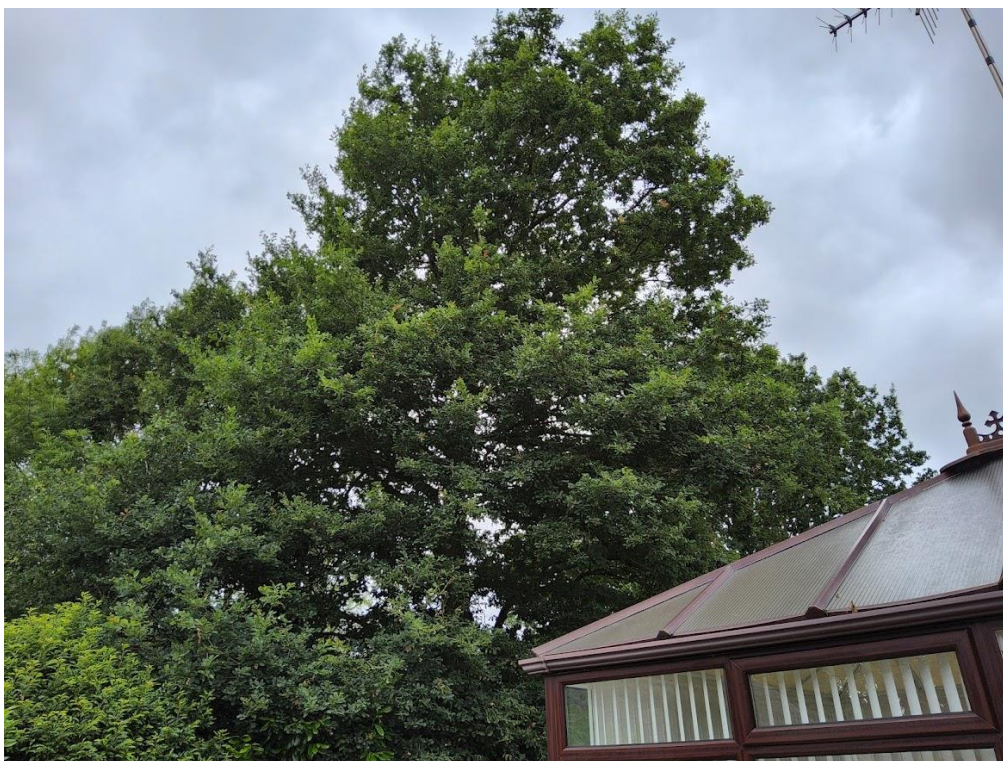
Photo 6 – Large tree in close proximity to rear conservatory

As reported by the next door neighbour, similar cracking was problematic along neighbouring conservatory which after investigation was found to be due to proximity of trees. As the result some trees were removed which reduced/eliminated cracking problems along the adjacent property. It would be advisable to follow the same approach for this property.
