# Arboricultural Appraisal Report

## Subsidence Damage Investigation at:

9 The Laurels  
Markfield Court Retirement Village  
Markfield  
Leicestershire  
LE67 9HA

| REPORT DATE: | 30-04-2018 |

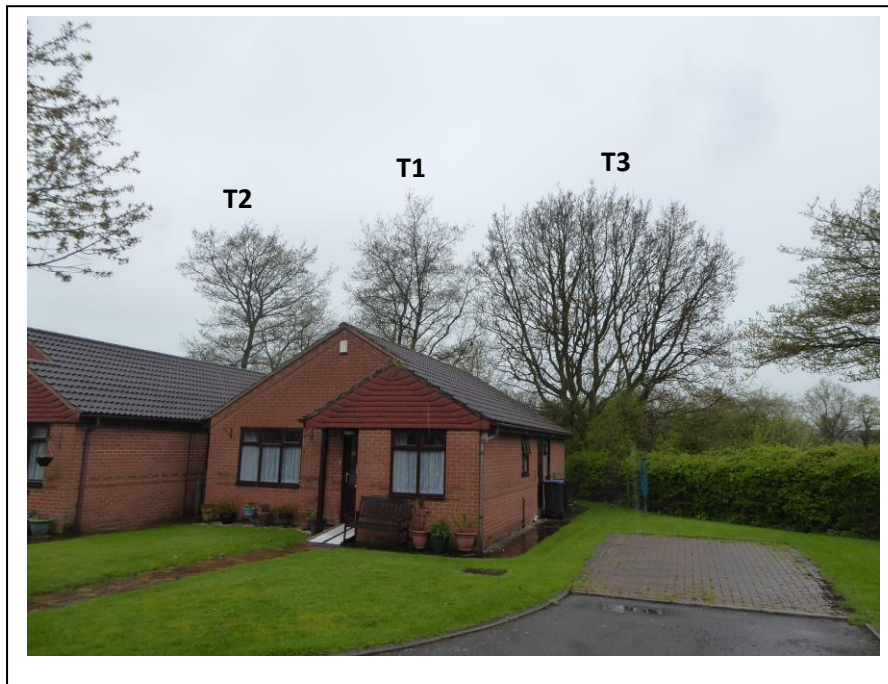
Roots were observed to a depth of 2.2m and 2.3m and recovered samples from both boreholes have been positively identified (using anatomical analysis) as oak, the origin of which will be T1 and T2 confirming their influence on the soils below the foundations.

Based on the technical reports currently available, engineering opinion and our own site assessment we conclude the damage is consistent with shrinkage of the clay subsoil related to moisture abstraction by vegetation. Having considered the information currently available, it is our opinion that both T1 and T2 are causal factors of the current subsidence damage.

The large oak T3 may also be contributory being within influencing distance of the property however the tree is significantly older than the properties and the removal of T1 & T2 offers the potential to restore stability. If movement persists the management of T3 may need to be reviewed.

View of oaks T1 – T3

If an arboricultural solution is to be implemented both trees will need to be removed.

| Tree No. | Species | Ht (m) | Dia (mm) | Crown Spread (m) | Dist. to building (m) | Age Classification | Ownership |
|---|---|---|---|---|---|---|---|
| Recommendation | | Remove (fell) to near ground level and treat stump to inhibit regrowth | | | | | |

| Tree No. | Species | Ht (m) | Dia (mm) | Crown Spread (m) | Dist. to building (m) | Age Classification | Ownership |
|---|---|---|---|---|---|---|---|
| Recommendation | | Do not allow to exceed current dimensions | | | | | |

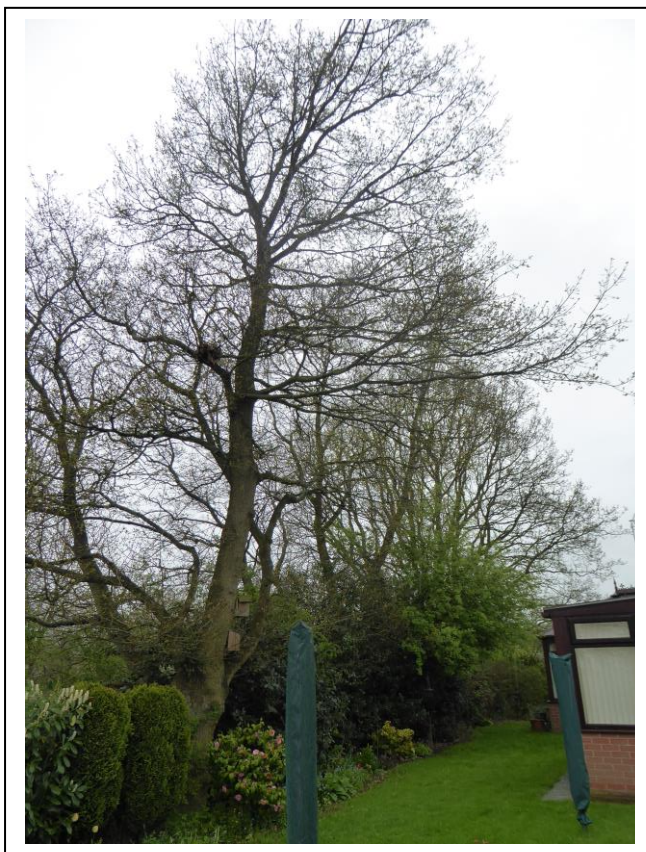
View of trees from rear with T2 in foreground

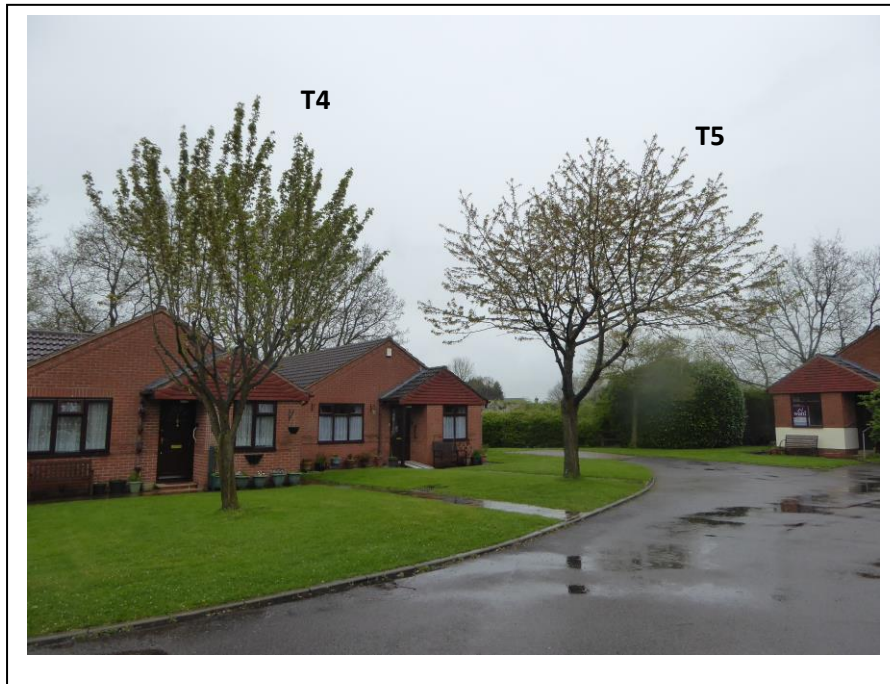
View of T4 & T5

| Tree No. | Species | Ht (m) | Dia (mm) | Crown Spread (m) | Dist. to building (m) | Age Classification | Ownership |
|---|---|---|---|---|---|---|---|
| Recommendation | | Do not allow to exceed current dimensions | | | | | |
