## ARBORICULTURAL APPRAISAL

### No.7 THE LAURELS

27<sup>th</sup> November 2024

No.7 The Laurels  
Markfield Court Retirement Village  
Markfield  
Leicestershire  
LE67 9HA

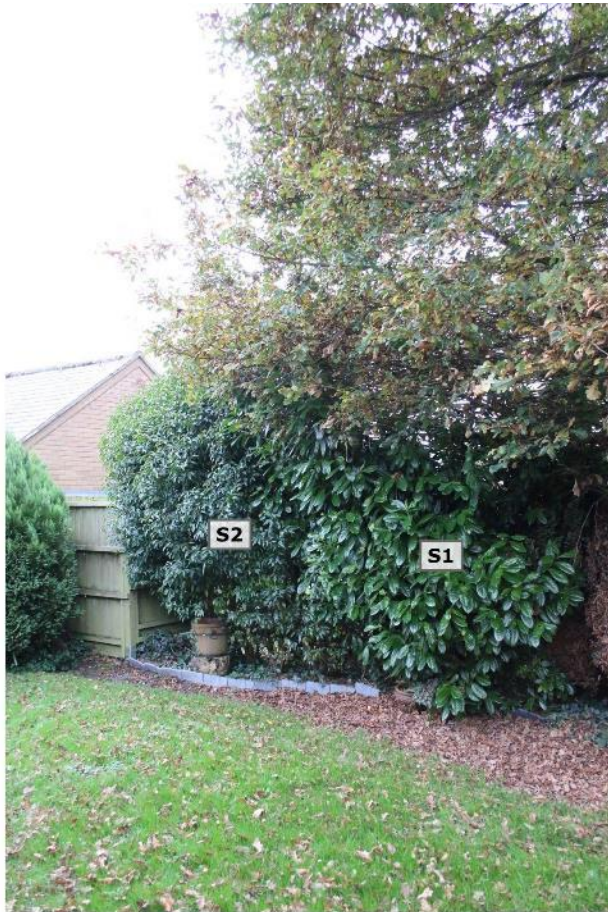
Shrubs - S1, S2

| Tree No. | Species | Age | Diameter (mm) | Est Height (m) | Crown Spread (m) | Distance To Main Building (m) | Ownership | Protection Status | Water Demand |
|---|---|---|---|---|---|---|---|---|---|
| | Management History | Routinely cut back and shaped | | | | Recommendations | Maintain at current height and spread | | |

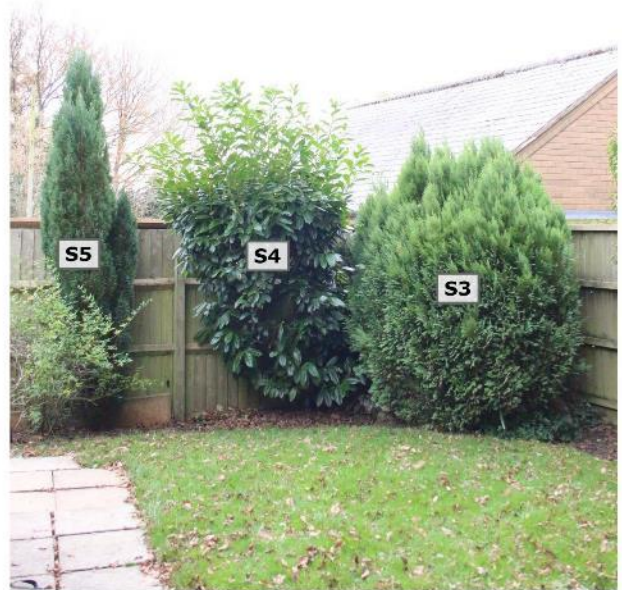
Shrubs - S3, S4, S5

| Tree No. | Species | Age | Diameter (mm) | Est Height (m) | Crown Spread (m) | Distance To Main Building (m) | Ownership | Protection Status | Water Demand |
|---|---|---|---|---|---|---|---|---|---|
| | Management History | Routinely cut back and shaped | | | | Recommendations | Maintain at current height and spread | | |

| Tree No. | Species | Age | Diameter (mm) | Est Height (m) | Crown Spread (m) | Distance To Main Building (m) | Ownership | Protection Status | Water Demand |
|---|---|---|---|---|---|---|---|---|---|
| | Management History | Routinely cut back and shaped | | | | Recommendations | Maintain at current height and spread | | |
| | Management History | No visible previous management | | | | Recommendations | Maintain height below 2m and lateral spread below 1.5m | | |

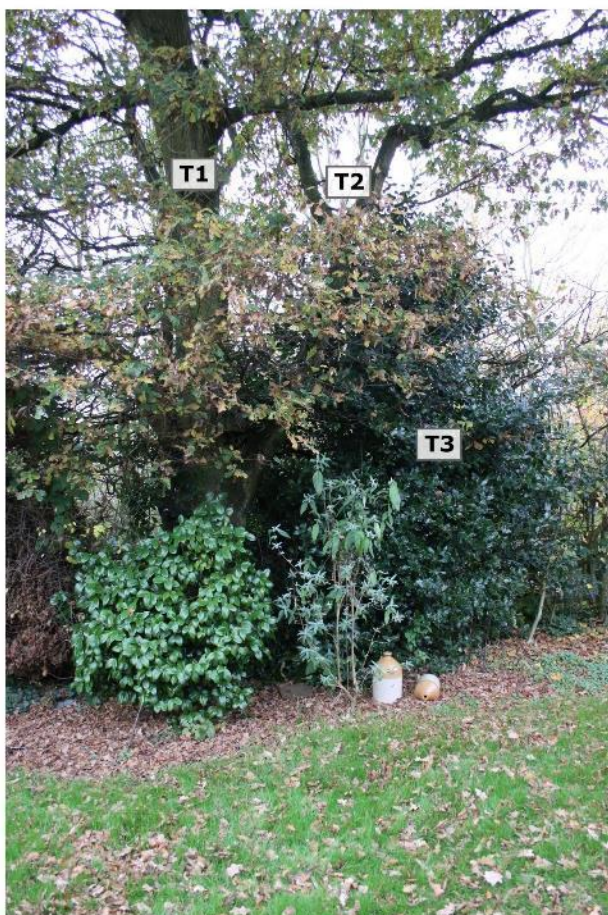
Trees - T1, T2, T3

| Tree No. | Species | Age | Diameter (mm) | Est Height (m) | Crown Spread (m) | Distance To Main Building (m) | Ownership | Protection Status | Water Demand |
|---|---|---|---|---|---|---|---|---|---|
| | Management History | No visible previous management | | | | Recommendations | Maintain height below 5m and lateral spread below 3m | | |

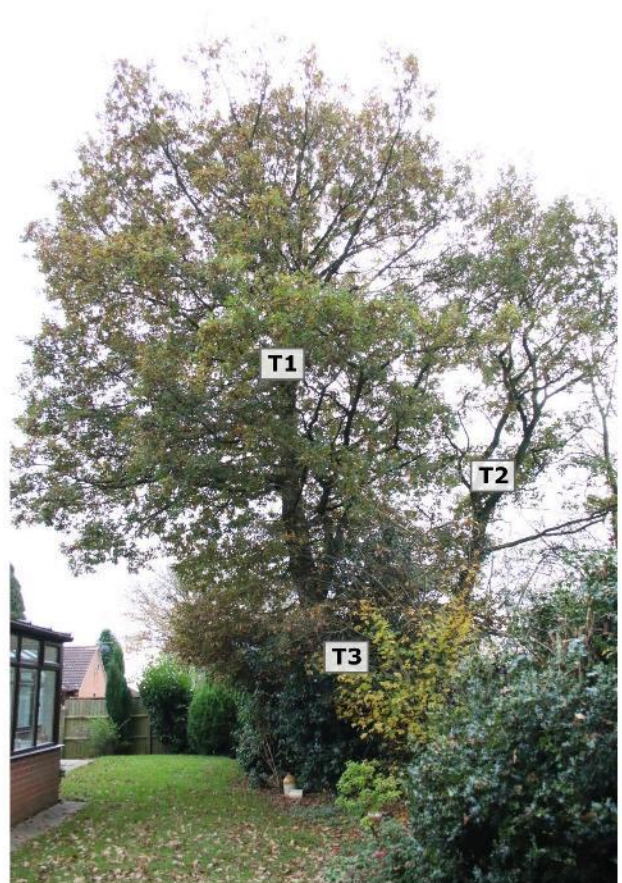
**10.3** - *Quercus spp* Roots were in abundance observed within the trial pit to a depth of 4.0. As the closest oak trees to the conservatory are T1 and T2, it is clear that these tree's roots are influencing the soil below the foundations. *Quercus robur* is categorised as a high-water demand species.

Trees - T1, T2

**13.1** - It is recommended that the Oaks T1 and T2 be removed and the stumps treated, with a suitable chemical herbicide, to prevent regrowth.

| Tree No. | Species | Age | Diameter (mm) | Est Height (m) | Crown Spread (m) | Distance To Main Building (m) | Ownership | Protection Status | Water Demand |
|---|---|---|---|---|---|---|---|---|---|
| | Management History | No visible previous management | | | | Recommendations | Take down to ground level, and treat stump to prevent regrowth | | |

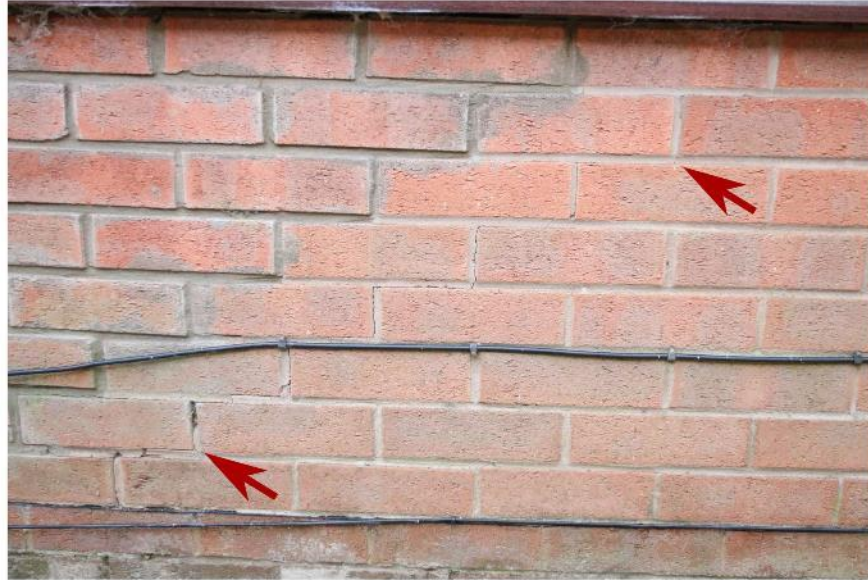
**7.1** - The damage at the property is located solely on the north-east corner of the conservatory located at the rear of the property. A stepped crack can be seen externally. This crack can be found underneath the sill of the conservatory window, at the centre of the northern wall. The crack then descends to the north-east corner, becoming wider as it travels.

**10.6** - Taking into account the expert reports, previous neighbouring subsidence and collected data, it is my opinion that both T1 and T2 are contributing factors to the subsidence damage. Another contributing factor however is the sub-standard foundations to the conservatory.

Damage - Current Damage

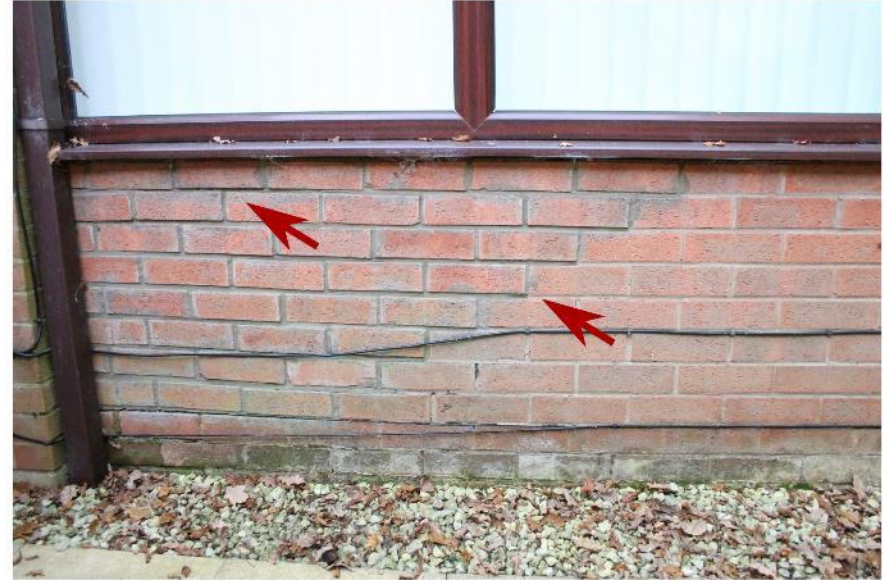
**7.2** - Previous re-pointing of the conservatory's northern brick wall is also present in the north-east corner and reveals evidence of another previous stepped crack.

Damage - Repaired Damage

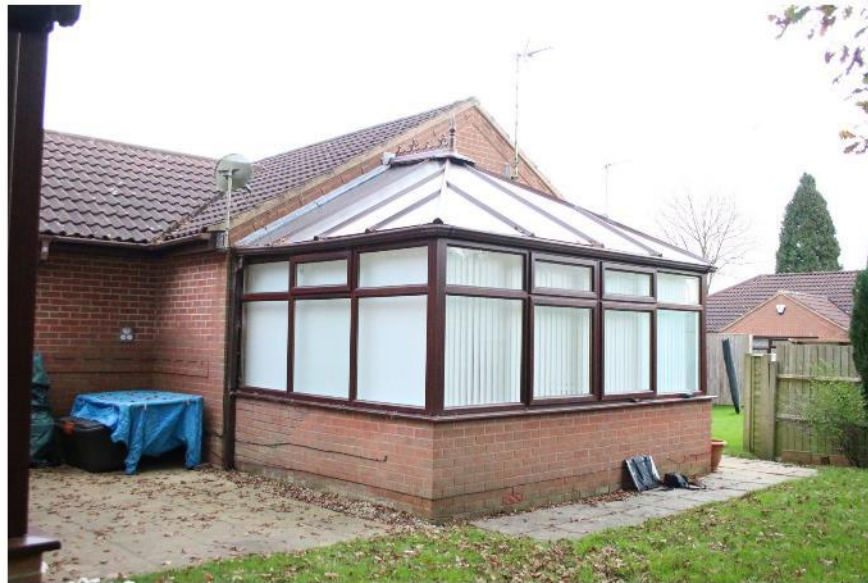
**10.5** - The foundation depth of the conservatory however is unacceptable and is a contributing factor to the damage.

Property - No7, Conservatory
