We have been asked to carry out a structural inspection of an agricultural building located at the back of 45 Bagworth Road in Newbold Verdon, Leicestershire.

The inspection of the agricultural building was undertaken on Wednesday 11<sup>th</sup> December 2024. During our inspection the weather was cold and dry with an air temperature of approximately 6°. The weather over the recent period had seen storms bringing high winds and rain.

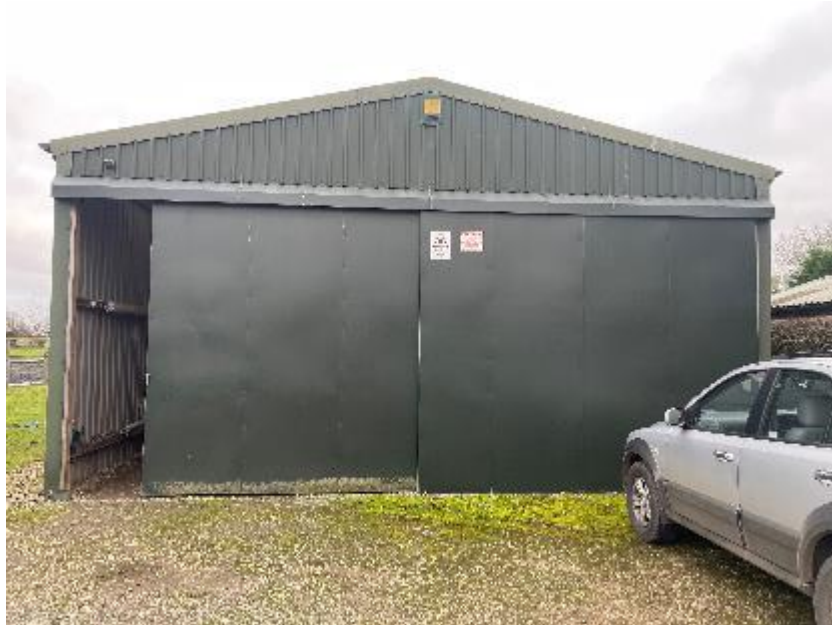
The building is single storey measuring approximately 18.2 m x 9.2 m, with a duo-pitch roof spanning the shorter distance. For the purposes of this report, the image below shows the front elevation.

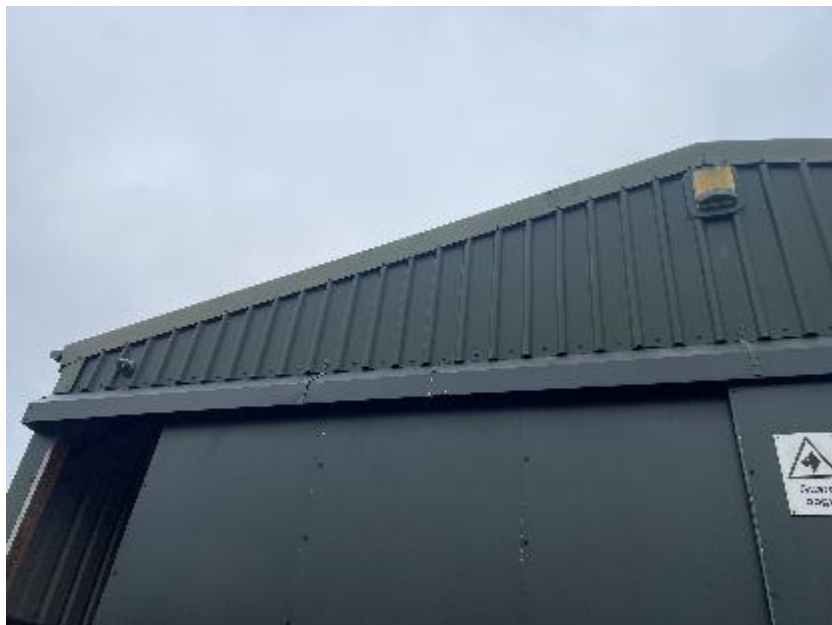
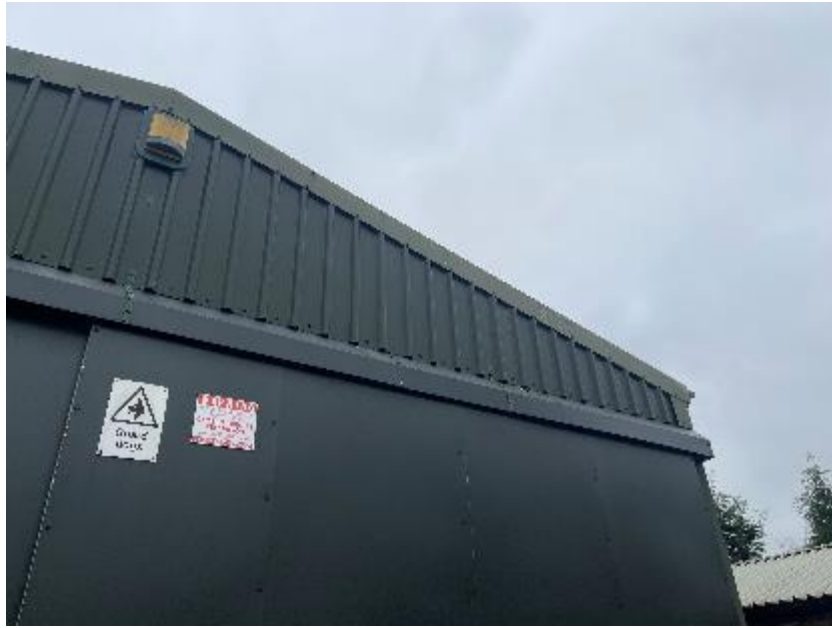
The front elevation contains a large sliding door made from steel. There are no defects to report on this. The doors and the cladding above are in a good condition.

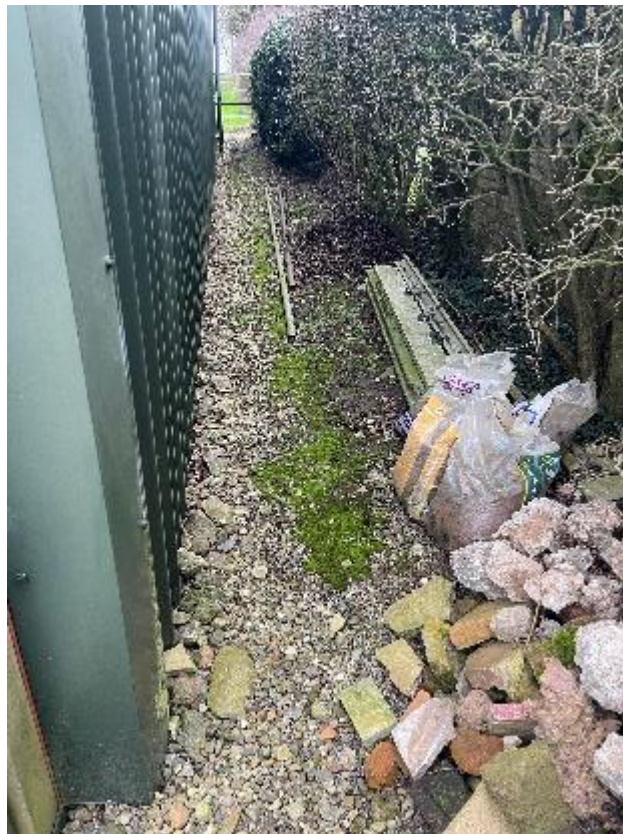
Access was available down the left-hand side via a narrow path between the building and hedgerow.

The cladding along this elevation was in a good condition with only one very minor defect.

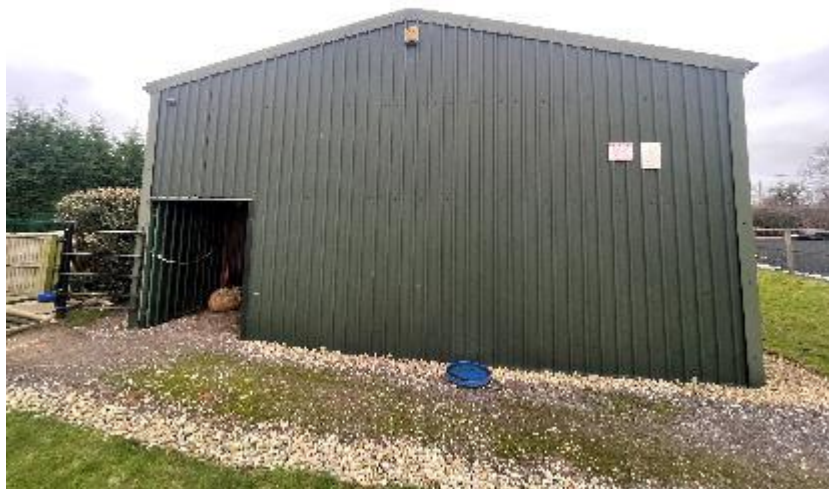
Most of the cladding is in a good condition with only a small dent to report.

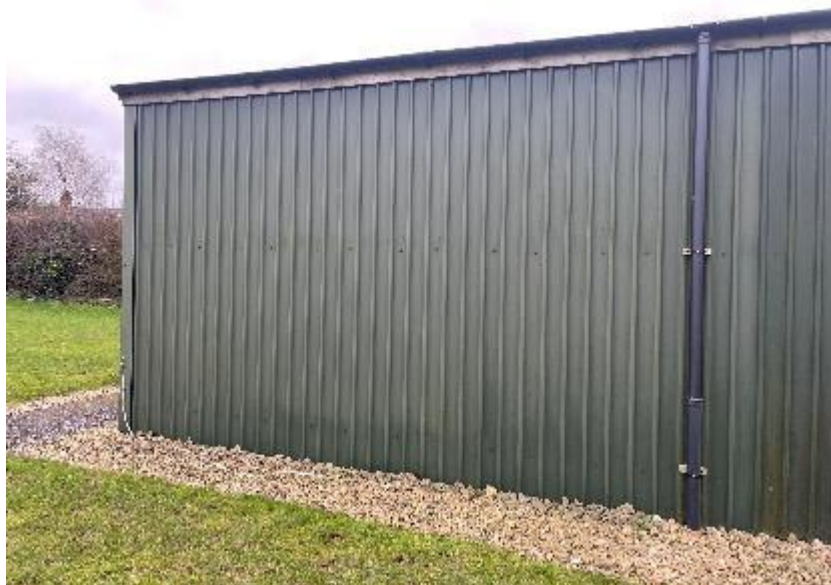
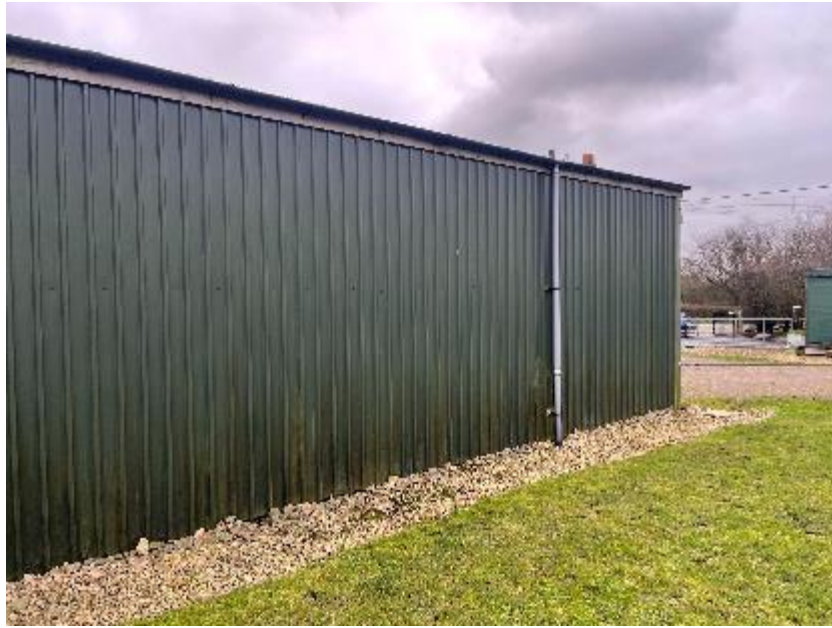
Much of the cladding is in a good condition, with just moss growing around the downpipe as with the opposite side.

Moss should be cleaned off the cladding if you plan to retain this.

The guttering and downpipes, particularly at their joints, would benefit from being cleaned to reduce any splashbacks and leakages which seems to have caused the moss growth.

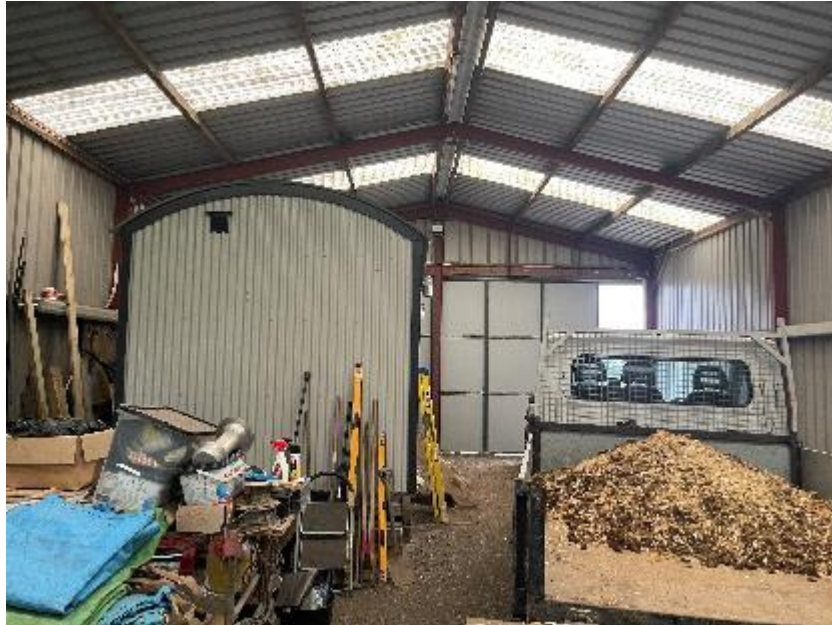
The cladding, timber purlins and steel frames are all in a good condition.

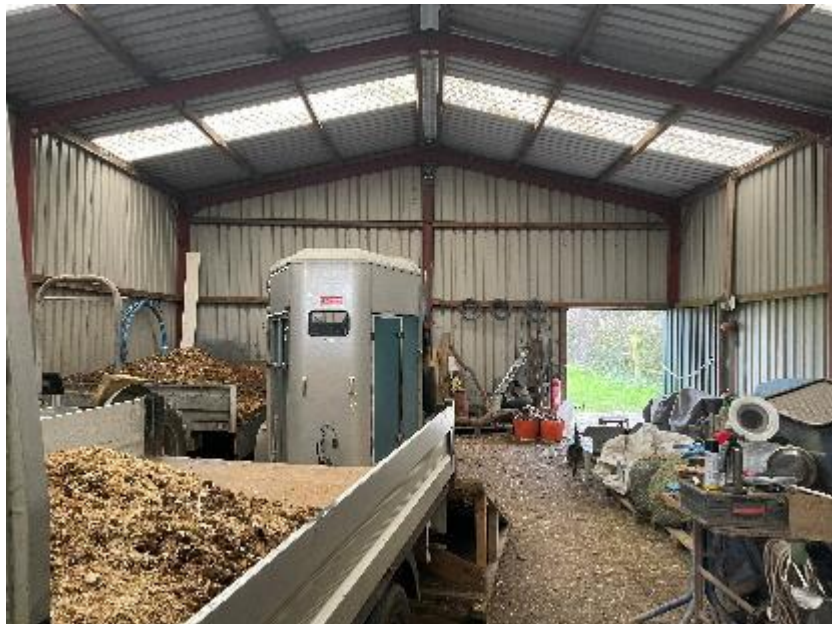
The timber purlins are 75x150s spaced at approximately 1.2m centres. These are in a good condition with no defects to report.

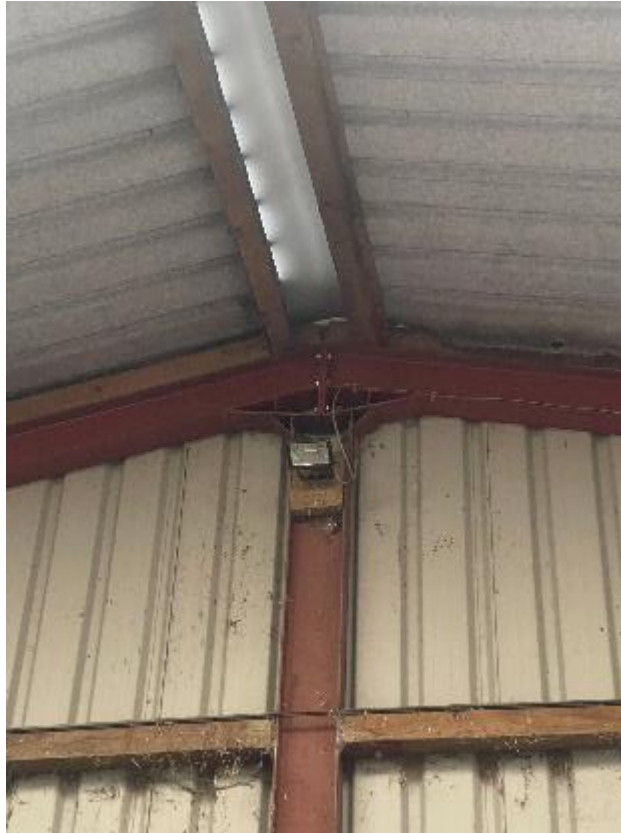
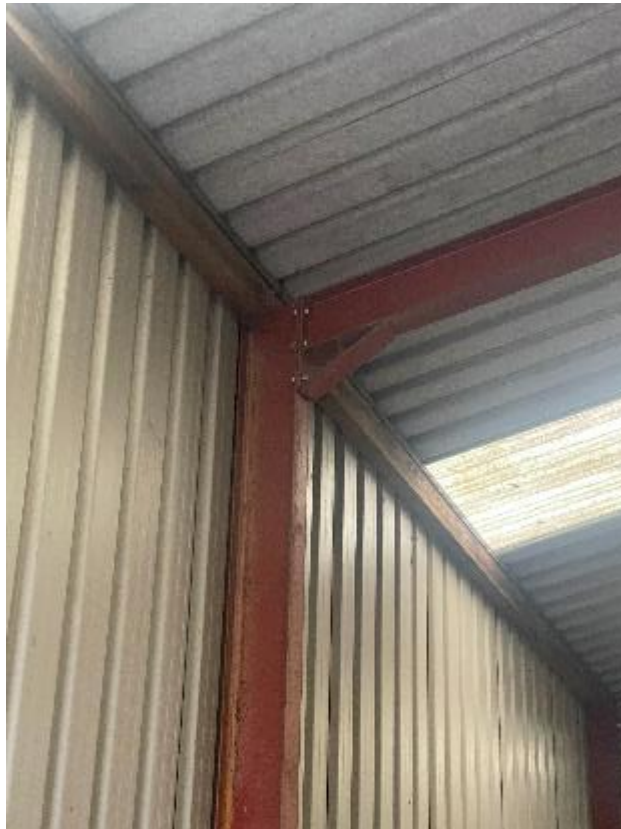
The steel portals are from 178x102x19UBs with haunched, bolted connections at both the apex and eaves. All connections are in a good condition.

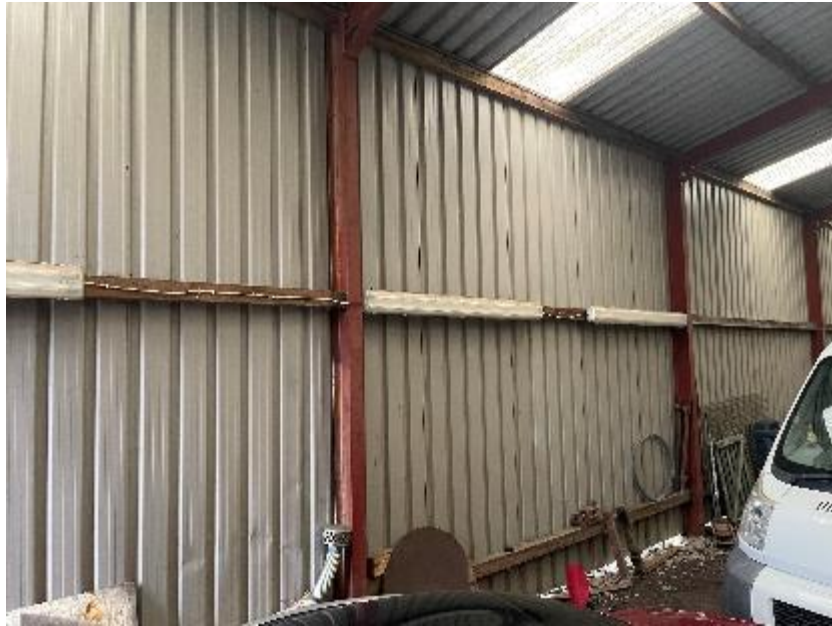
The wall cladding is fixed to timber cladding rails which are in a good condition.

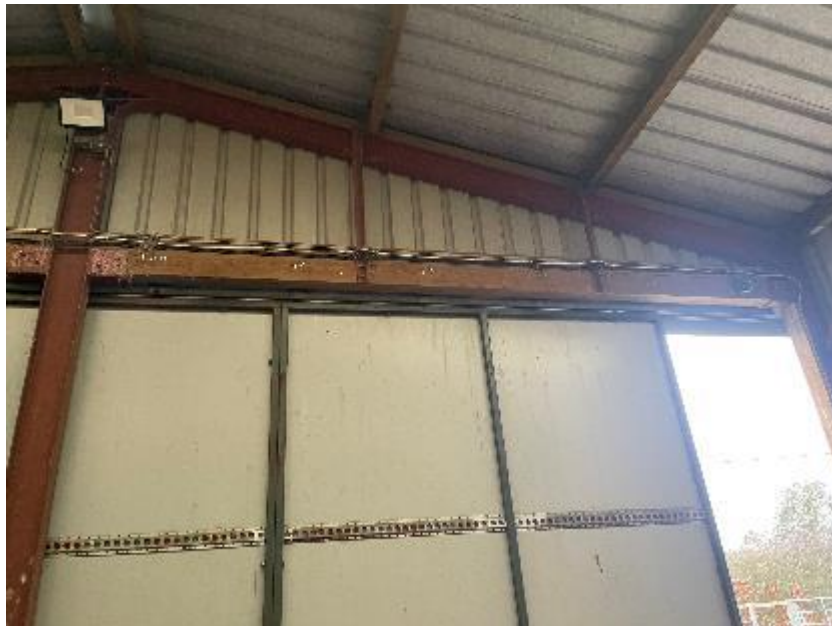
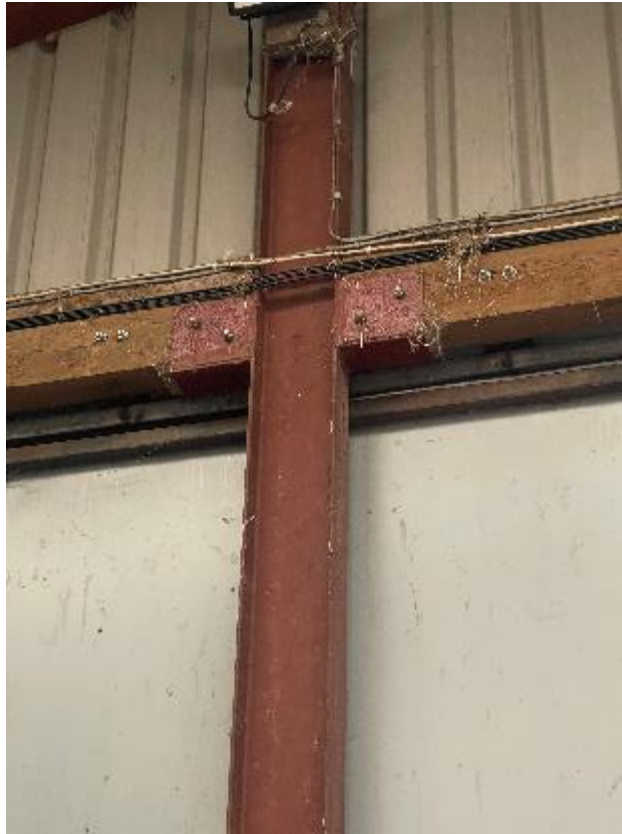
Openings within the building have been trimmed with timbers which are also in a good condition.

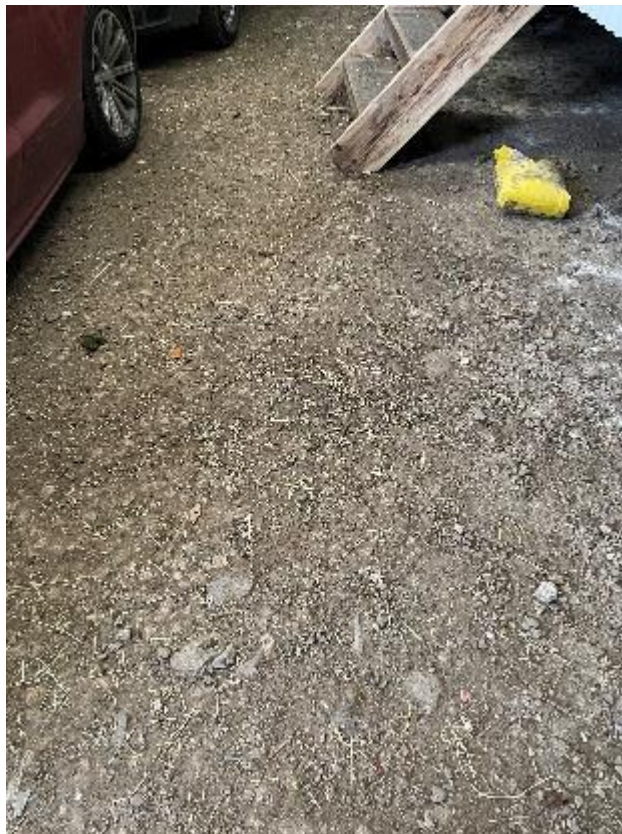
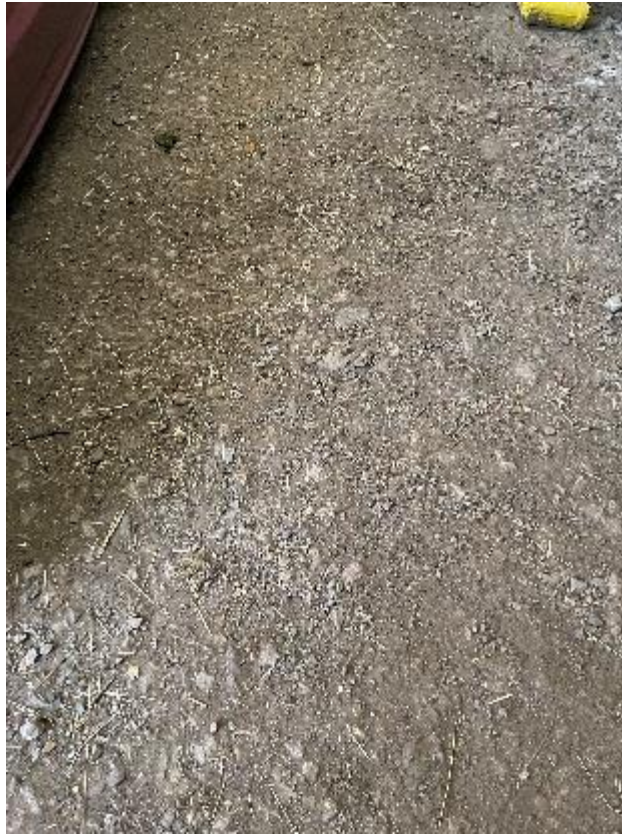
The floor is a well compacted hardcore base which is flat and level.
