**Subject:** 23/01048/FUL | Change of use of a building from agricultural to residential and associated works

# Building Condition Report and Schedule of Works

2.1. Red brick barn and courtyard off Hall Lane, Odstone, Nuneaton, CV13 0QS

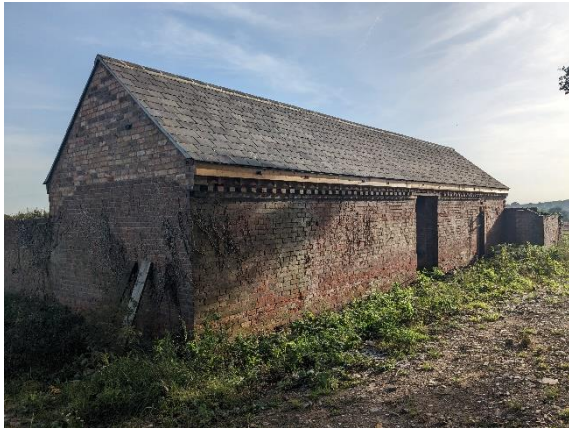
*Figure 1 - Main building*

3.1. CONSTRUCTION PRINCIPALS - The site comprises a barn constructed from red brick, with a pitched roof, that is supported off timber trusses and rafters. The building has an earthen floor also comprising hardcore and crushed stone. The building currently has no doors or window but is open to the elevation facing into the courtyard. The roof on the open elevation is supported by metal column's set on red brick plinths. A courtyard enclosed by a red brick wall is set off the open elevation with two existing openings. A red brick outbuilding no longer benefiting from a roof is also attached to the

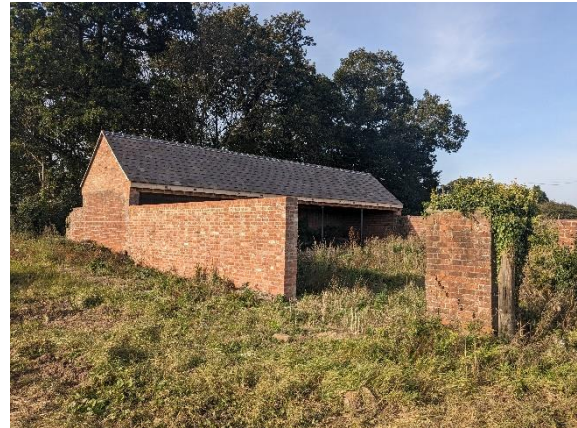
*Figure 2 - Courtyard*

2.3 The wider site includes a red brick courtyard.

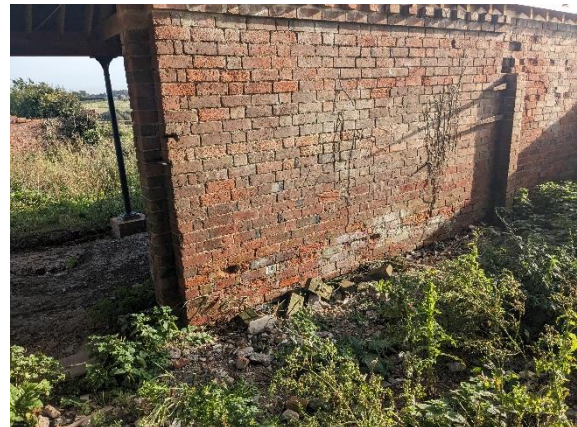
3.2. BUILDING WALLS - constructed from red brick and are 240mm thick, with the exception of the doorway and columns which the roof trusses sit on, which are circa 350mm x 350mm. Given the thickness of the walls and the original use of the building it is not anticipated there is a cavity, and no insulation is present. The walls of the building are in a satisfactory condition including at low level. There were no signs of structural movement, or deterioration to the structure, beyond a few isolated locations where spalling bricks on the north-east and north-west elevations would ideally need to be replaced. These can simply be cut out and replaced with matching red bricks and is considered peripheral damage only. There were no signs of any settlement or distortion to any of the walls.

*Figure 4 - Evidence of minor spalling*

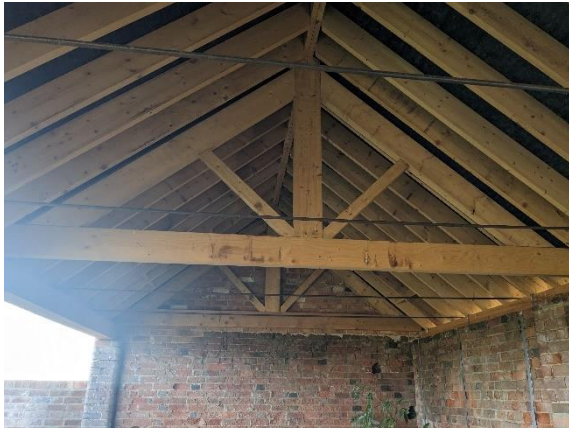
*Figure 5- Roof Truss*

3.3. ROOF STRUCTURE – The timber framed roof structure utilises king post trusses (210mm x 70mm) with timber rafters (230mm x 45mm). In between the trusses - two steel rafter ties are used per spacing. A fabric membrane is fitted between the roof structure and the main roof covering which the slate tiles are attached to. The roof structure is attached to the walls via timber wall plates and steel wall ties. No signs of movement to the roof were evident, with structural elements in good condition, weatherproof and suitable for conversion.

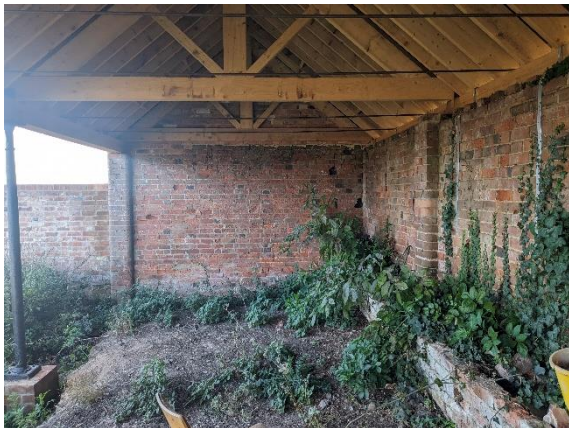
*Figure 7- Earthen Floor*

3.4. FLOOR – The building has an earth floor with a mix of hardcore and crushed stone, with the ground predominantly appearing to be clay based. A concrete floor will need to be installed for the conversion to take place. Please see earthen floor on image Figure 7.

3. Dig out and lay concrete floor and strip foundations in locations of proposed south-western wall of extension and south-western wall of existing building to be bricked up. All other existing walls to remain in situ.

6. Laying of damp-proof membrane. Celotex or similar insulation to be laid over with upstands to perimeter and with sand cement screed over.
7. Under draw ceiling and provide insulation in between purlins to Building Control Specification.

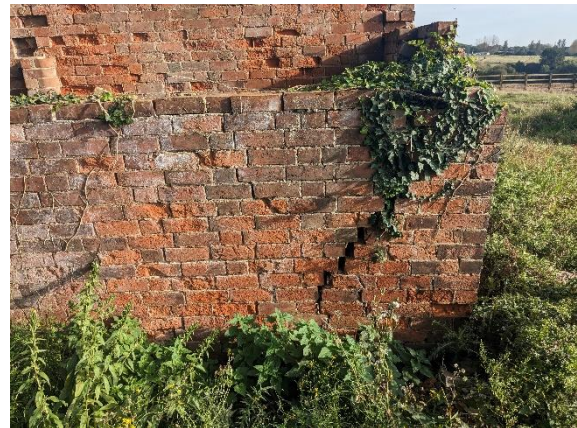
3.5 OUTBUILDING – The outbuilding attached to the main buildings north western elevation currently does not benefit from a roof. There are notable cracks to the north eastern elevation and will require localised rebuilding to that aspect. There is also minor cracking to the north-western elevation, but no significant movement is noted. See section to be repaired/localised rebuilding in Figure 8.

*Figure 8 - Section of outbuilding wall requiring repair/localised rebuilding.*

4. Localised repair work to be carried out to existing walls highlighted in section 3.
5. Erection of two above mentioned cavity walls, externally finished with matching red brick of same colour, size and weathering. Internal concrete block walls with rockwool insulation to current Building Control Specification.

5.2 The south-eastern courtyard wall and outbuilding will require some localised rebuilding and repair work, but the north-eastern and south-western courtyard walls are in good condition.

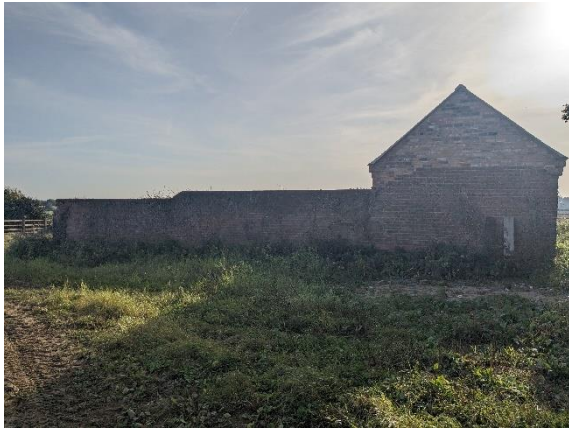
3.6 COURTYARD WALLS – The courtyard walls range in height but are circa 2.3m from the ground. The walls to the north-east and south-west elevations are in good condition and little or no evidence of spalling or movement. Elements of the south-eastern wall including the corner element require localised rebuilding due to being out of plumb, notable cracks and movement being evident.

Figure 9- Courtyard wall in good condition

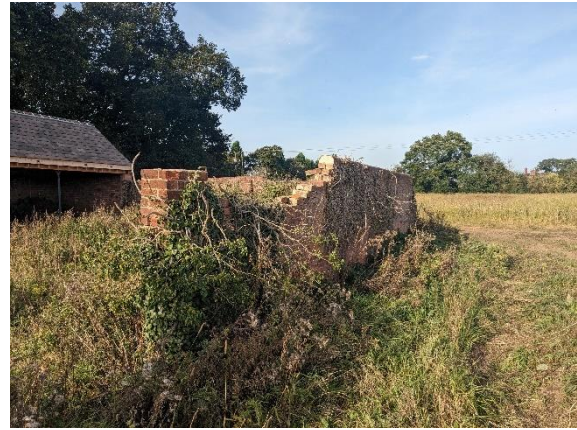
Figure 10- Are of courtyard wall that requires repair/localised rebuilding.
