**SOAKAWAY INVESTIGATION REPORT**  
**AT**  
**LAND OFF WATLING STREET,**  
**HINCKLEY**  
**FOR**  
**BEK LTD**

Report Reference: 3162-23 SA

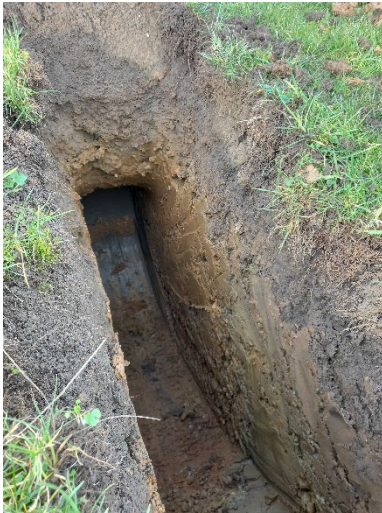
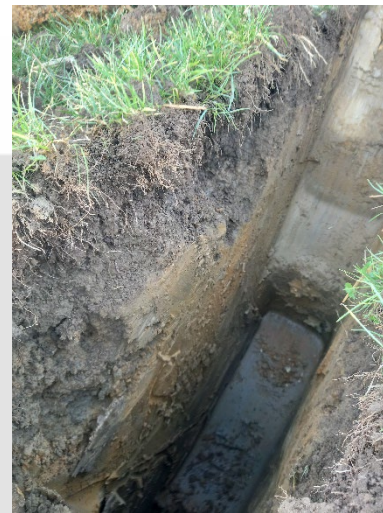
E. Photograph of TP01 side wall

F. Photograph of TP01 side wall

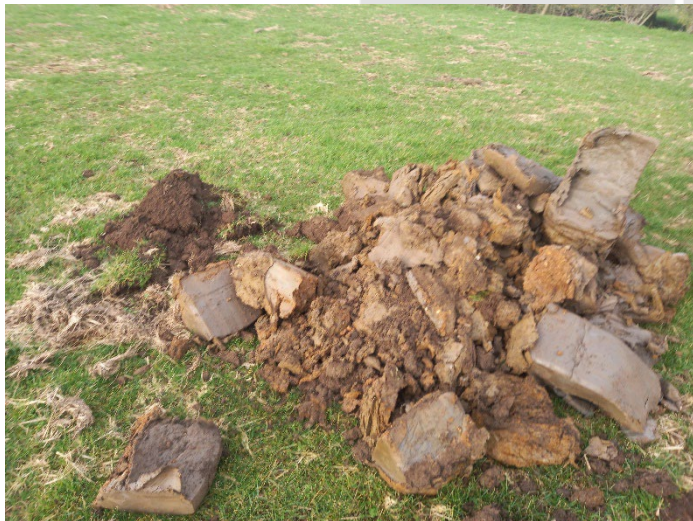
G. Photograph of TP01 arisings

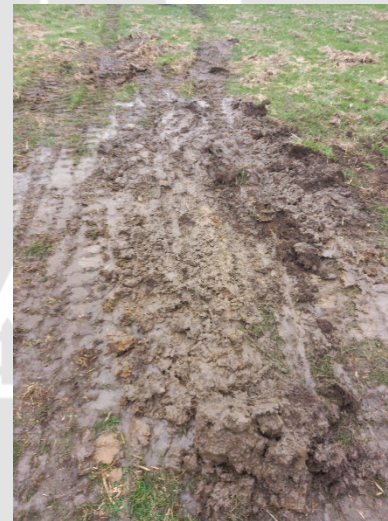
H. Photograph of TP01 reinstatement.

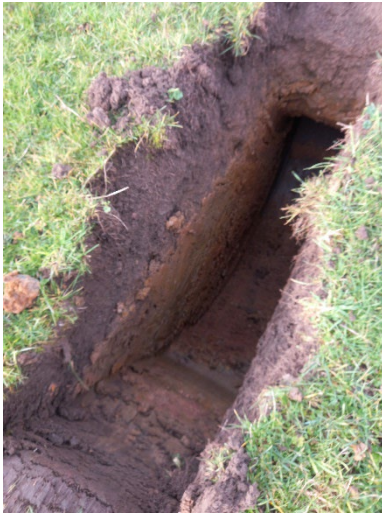
- I. Photograph of TP02 side wall
- J. Photograph of TP02 infiltration test.
- K. Photograph of TP02 airings
- L. Photograph of TP02 reinstatement.

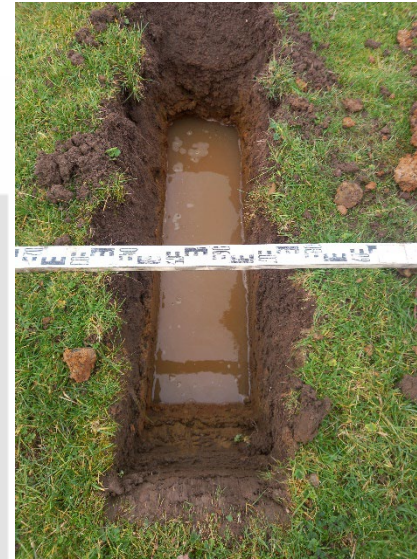
J.

N/A – an infiltration rate could not be calculated, as the water level did not drop beneath the 25% effective depth.

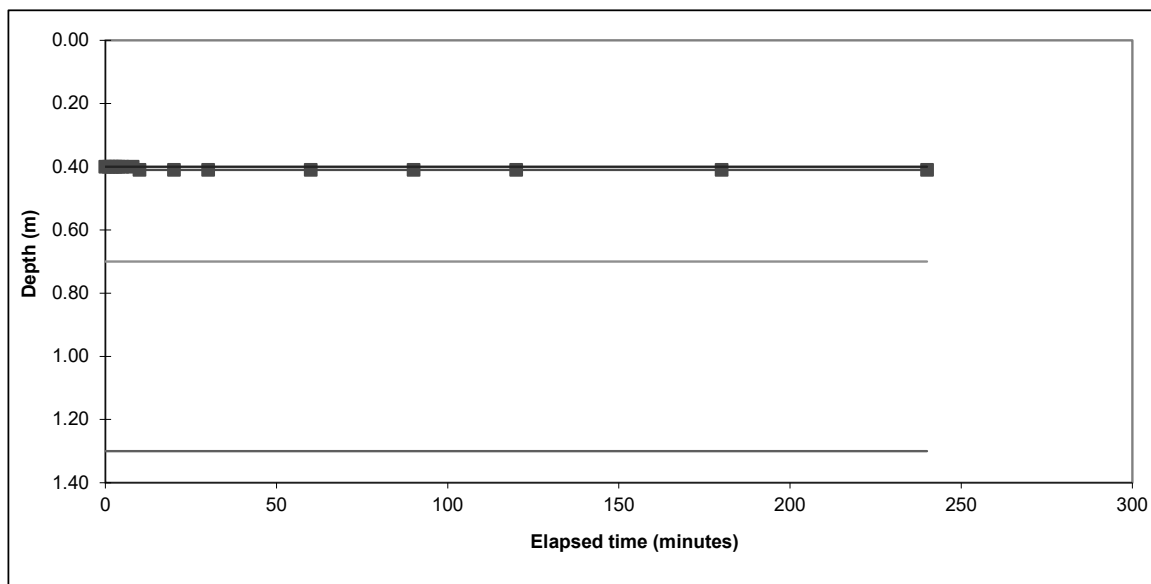
| Soil infiltration rate (m/s): | Test incomplete as 25% effective depth not achieved. Unable to reliably determine soil infiltration rate. |
| Remarks | Results processed following BRE 365 (2007).<br>Test extrapolated to 12 hours, test still not complete. |

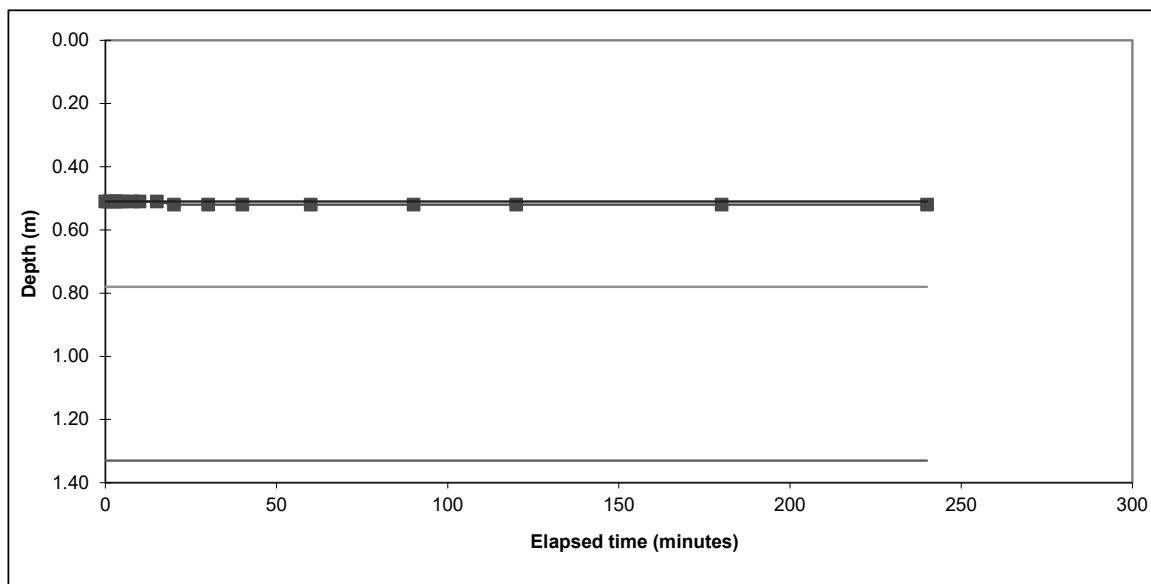
| <b>Soil infiltration rate (m/s):</b> | <b>Test incomplete as 25% effective depth not achieved. Unable to reliably determine soil infiltration rate.</b> |
| <b>Remarks</b><br>Results processed following BRE 365 (2007).<br>Test extrapolated to 12 hours, test still not complete. | |
