Reference: **024-23-446.2872**

**Keytec Geomembranes Ltd**

**VALIDATION OF GAS PROTECTION MEASURES  
PLOTS 125 TO 137  
MARKFIELD ROAD, RATBY**

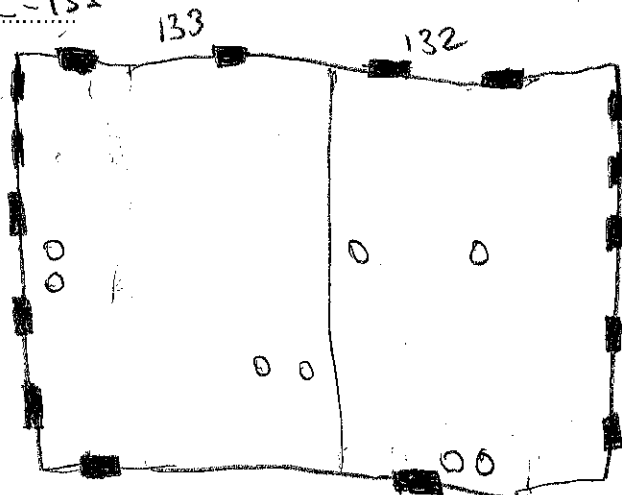
| <b>Inspection Findings:</b><br>(note repairs, defects, vent locations, and any other issues identified)<br>Plot No(s). <u>132-133</u><br> | <b>Key:</b><br>X Repairs<br>■ Vents<br>○ Penetrations<br>□ Columns |

| Number of Defects/Repairs Identified: <u>0</u> | All Defects/Repairs Completed: <u>Yes</u> No |
| General Comments/Further Action Required:<br><u>Passed, good quality</u> | |
