# STRUCTURAL ENGINEER'S REPORT

**Site Address:** Ratcliffe House Farm, Ratcliffe House Lane, Ratcliffe Culey, Atherstone,  
CV9 3LZ

**Project No:** 231008

**Date of Inspection:** 7<sup>th</sup> November 2023

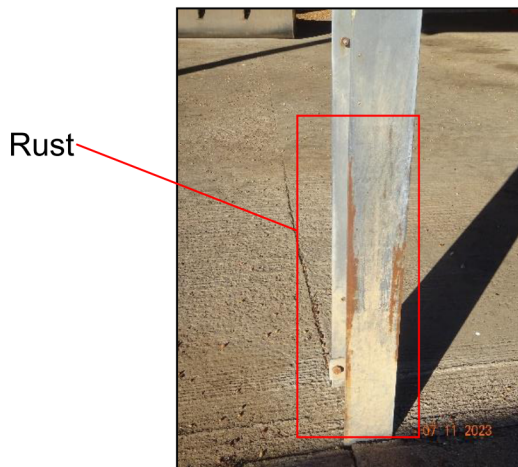
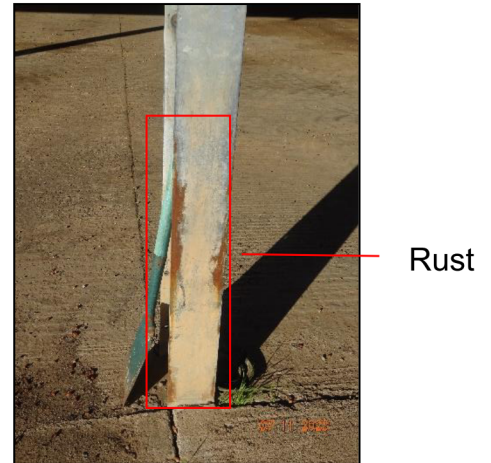
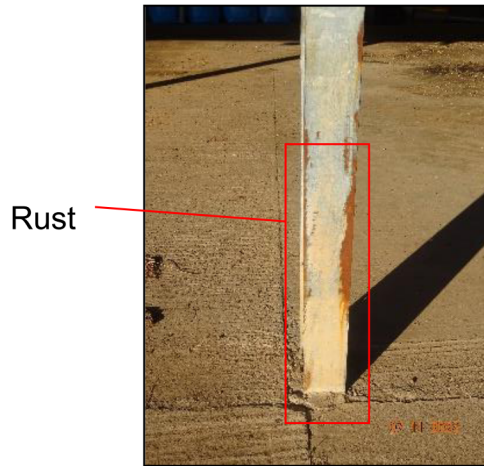
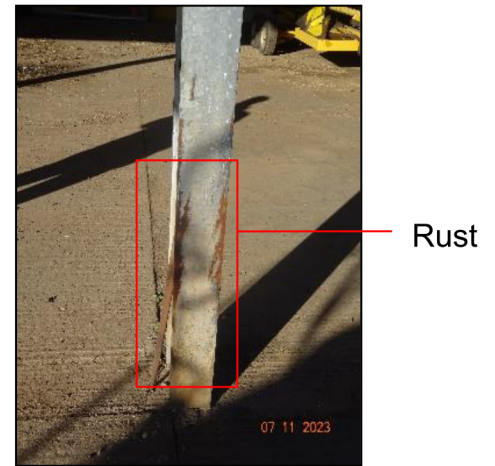
47. Fig FE3 to Fig FE6 show the rust at the base of the columns.

81. The structural steelwork portal frames are in a good condition. However, there is rust on the steel, the steel is to be cleaned off and repainted.

93. To be cleaned of all rusted areas and repainted.
94. All corroded areas to be sandblasted and cleaned off to a Sa 2½ - very thorough blast cleaning (See Appendix B: P.4). All loose material is to be removed and steel is to be sandblasted, primed and painted (See Appendix C: Table 1).

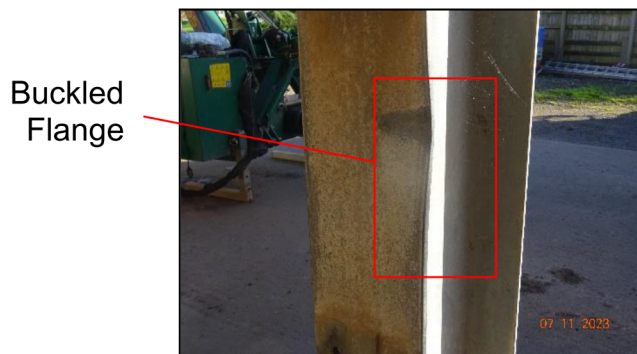
48. Fig FE7 shows the buckled flange on the column by side elevation S2 (East Elevation).
49. Fig FE8 shows the solar panels on the roof.

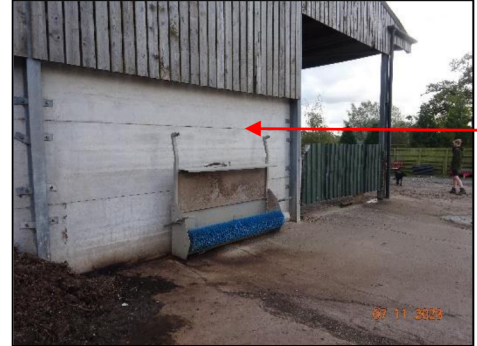
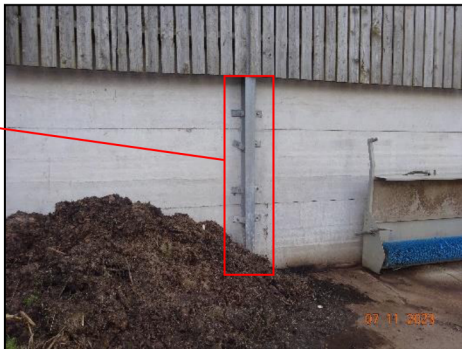
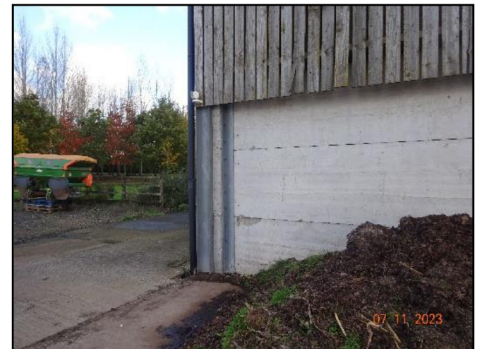
51. Fig SE1.1 is a general view of side elevation S1 (West).
52. Fig SE1.2 to Fig SE1.4 show the precast concrete 3m high panels on the side elevation. They are bolted to the structural steelwork columns.

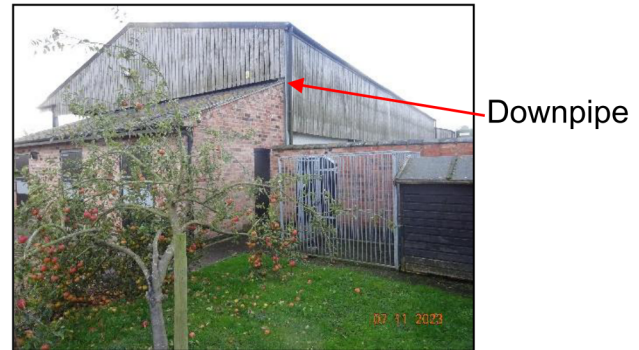
56. Fig SE2.1 is a general view of side elevation 2 (S2).
57. Fig SE2.2 shows the gutter downpipe at the rear corner.
58. Fig SE2.3 and Fig SE2.4 show the boundary wall.

90. The drainage points around the building are to be exposed and checked to trace their drainage runs. It would be prudent to carry out a CCTV of the drainage system.
91. All broken, cracked or leaking drains are to be replaced.
