**A Historic Building Photographic Survey at**

**102 Main Street,**

**Nailstone,**

**Leicestershire**

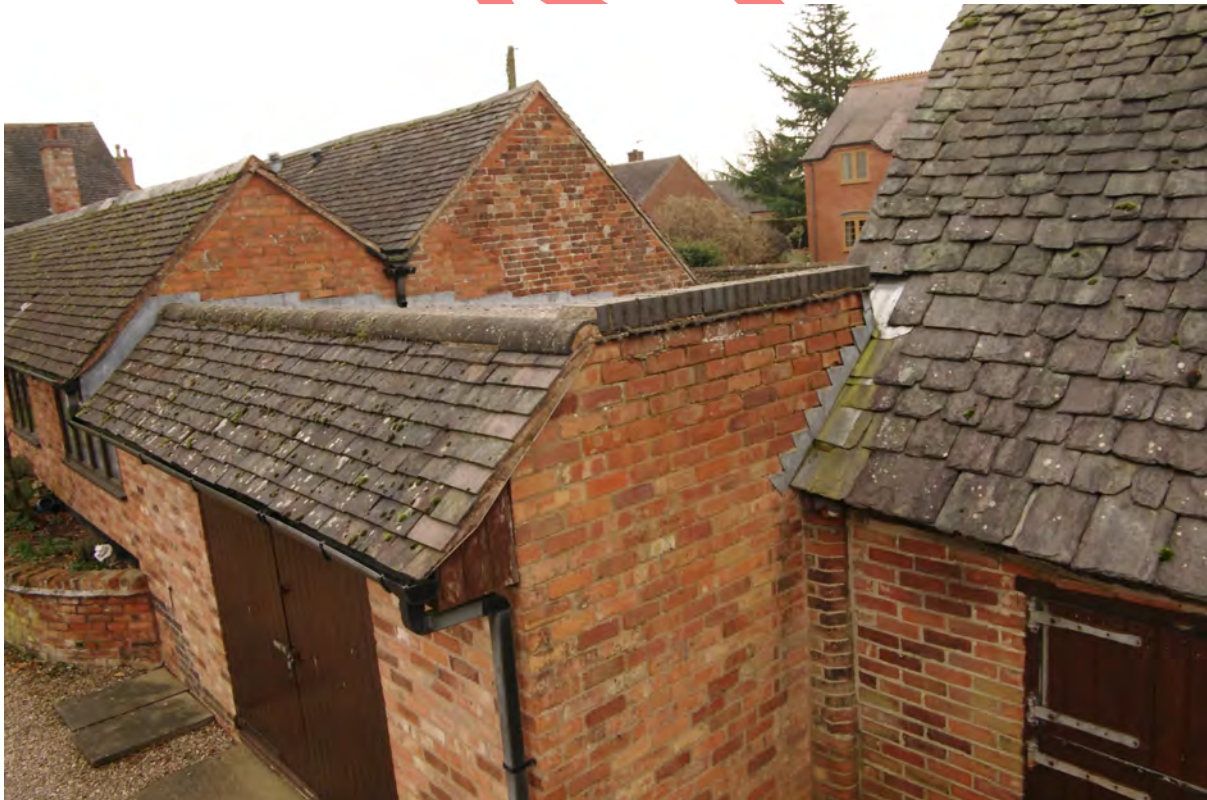
Figure 24: Flat-roofed section on the southern range

*Looking south-east towards Main Street. The brickwork on the infilled area is late 20th century. Note the different brickwork on the range behind which suggests that it has been extended. Most site buildings use roof tiles although the north-facing roof of the right hand barn has graded Swithland slates*

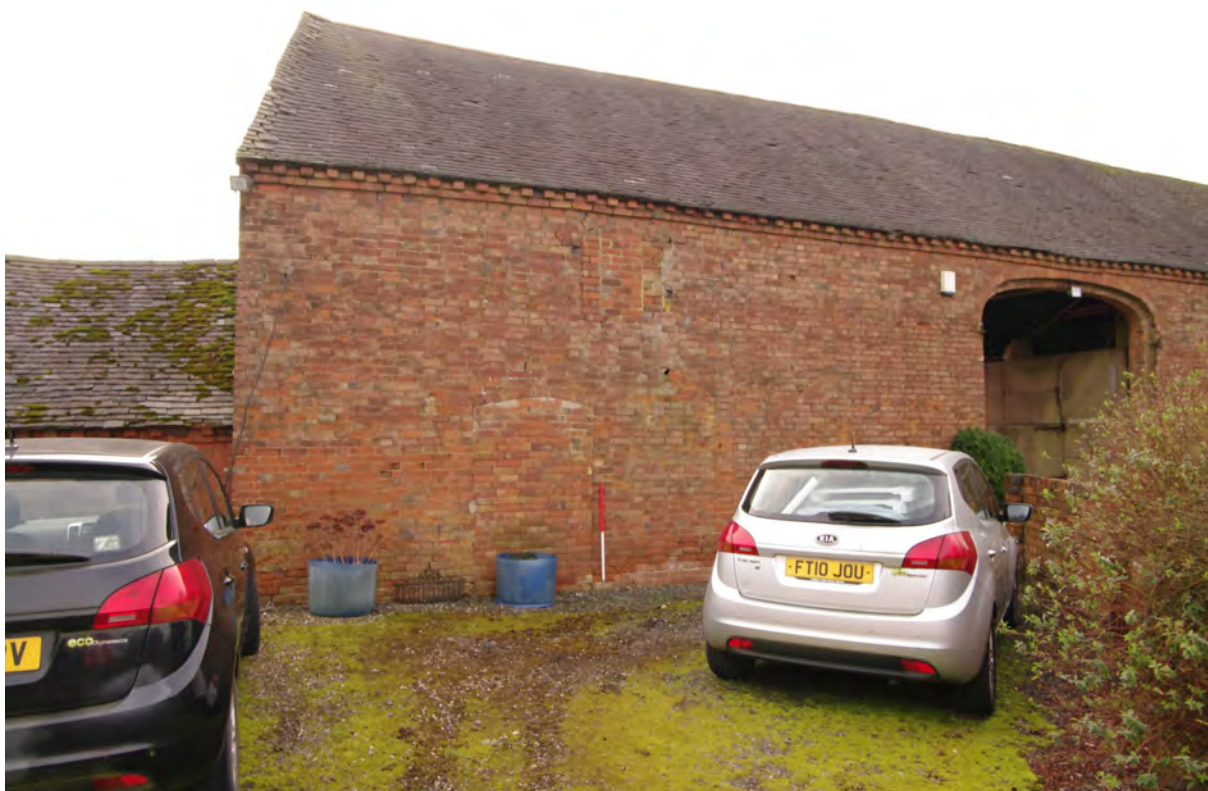
Figure 26: Threshing barn. Eastern end of the north-west facing elevation  
*Note the blocked doorway to the left of the 1m scale. Another first floor window above the scale has been blocked*

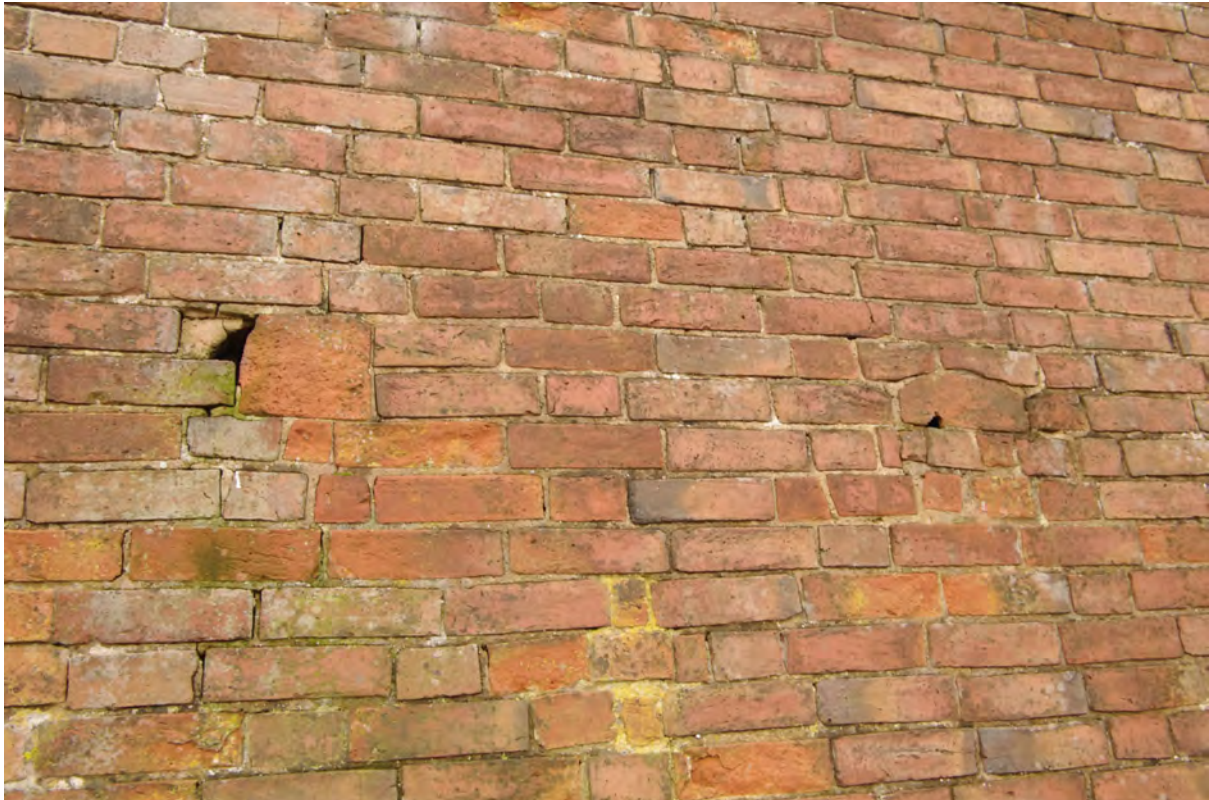
Figure 27: Threshing barn vents. Eastern end of the north-west facing elevation  
*Note the two blocked vents which are located below the blocked window shown in Figure 26*

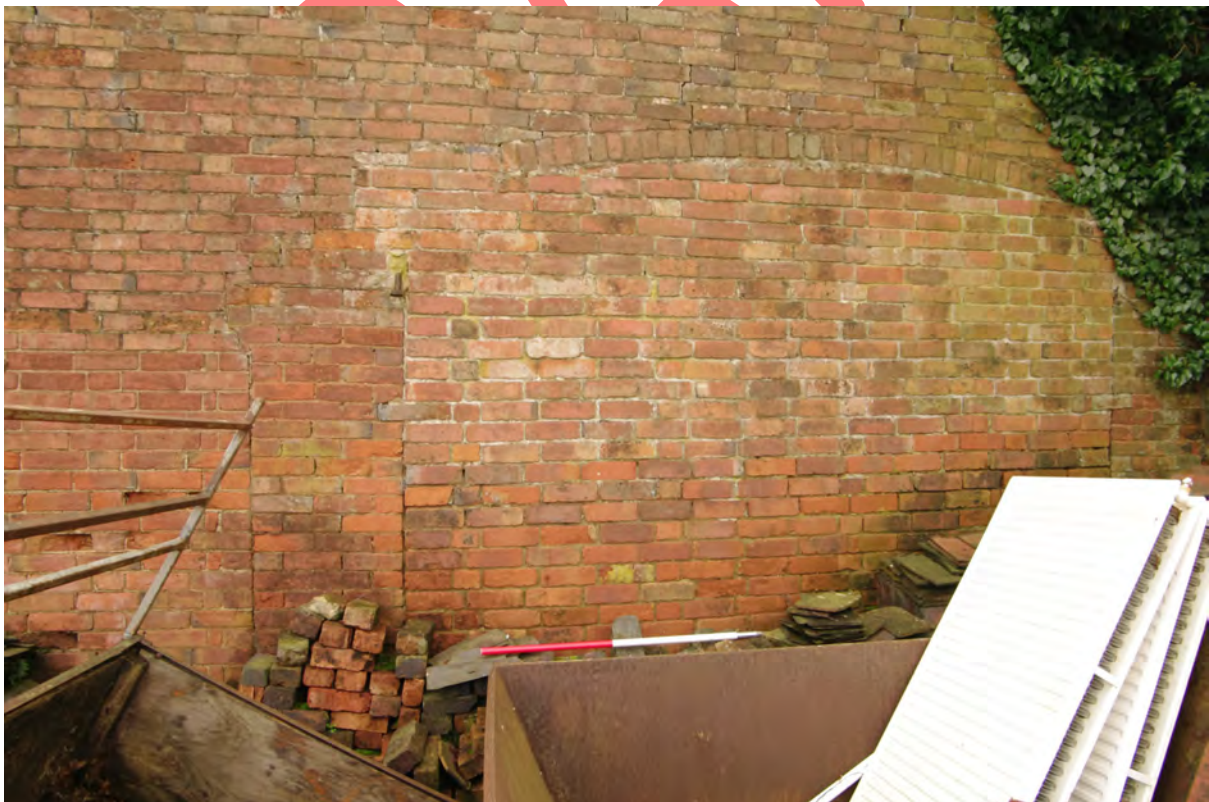
Figure 28: Threshing barn. Western end of the north-west facing elevation  
*Note the wide opening above the 1m scale. There is evidence of another blocking to the left of this*

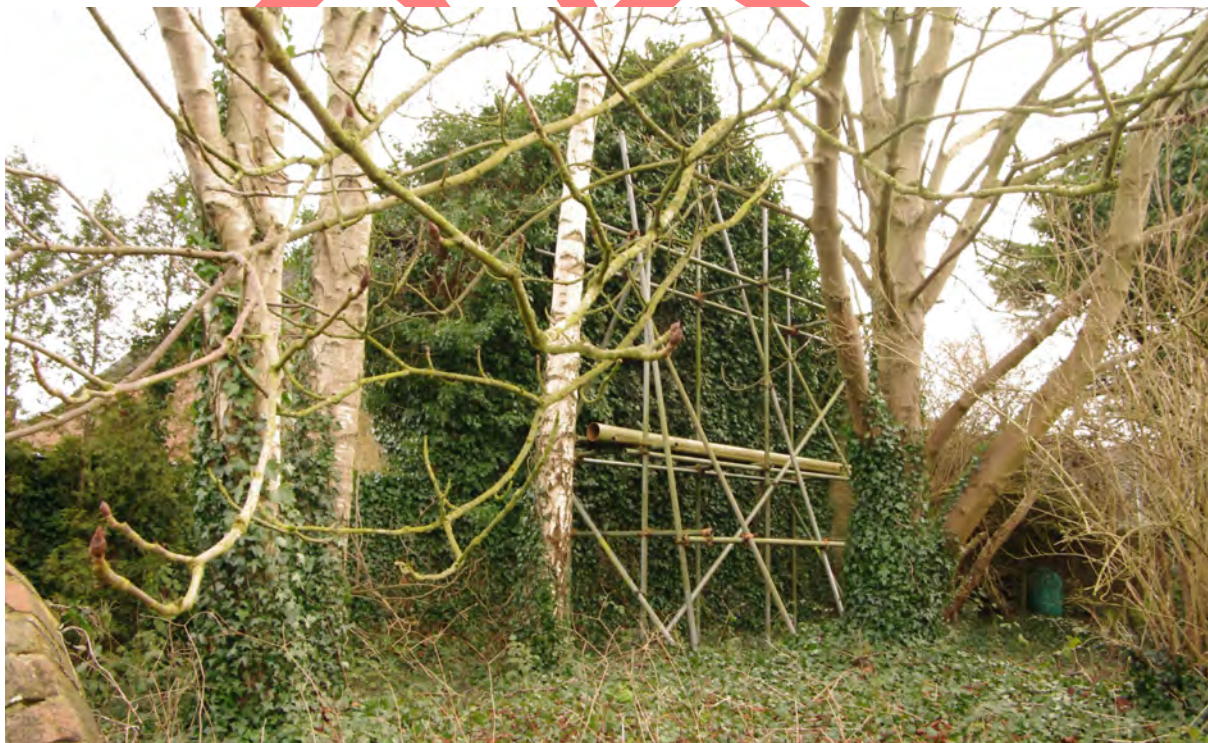
Figure 30: Threshing barn. South-west facing gable end  
*Looking east. Hardly any brickwork was visible during the survey. The scaffolding suggests a poor and unstable condition so no attempt was made to remove the vegetation*

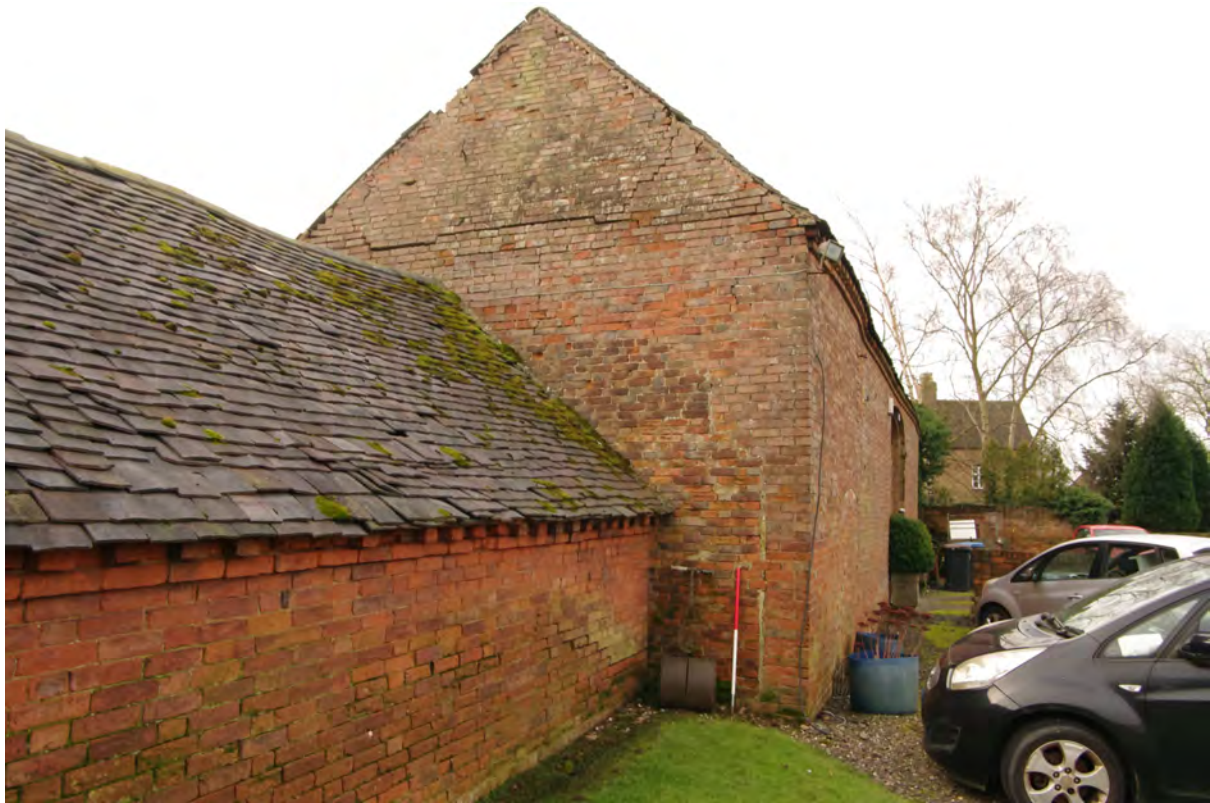
Figure 31: Threshing barn. North-east facing elevation

*Note the blocked window close to the ridgeline of the single-storey stable on the left. Also note the earlier brickwork rising up behind the 1m scale*

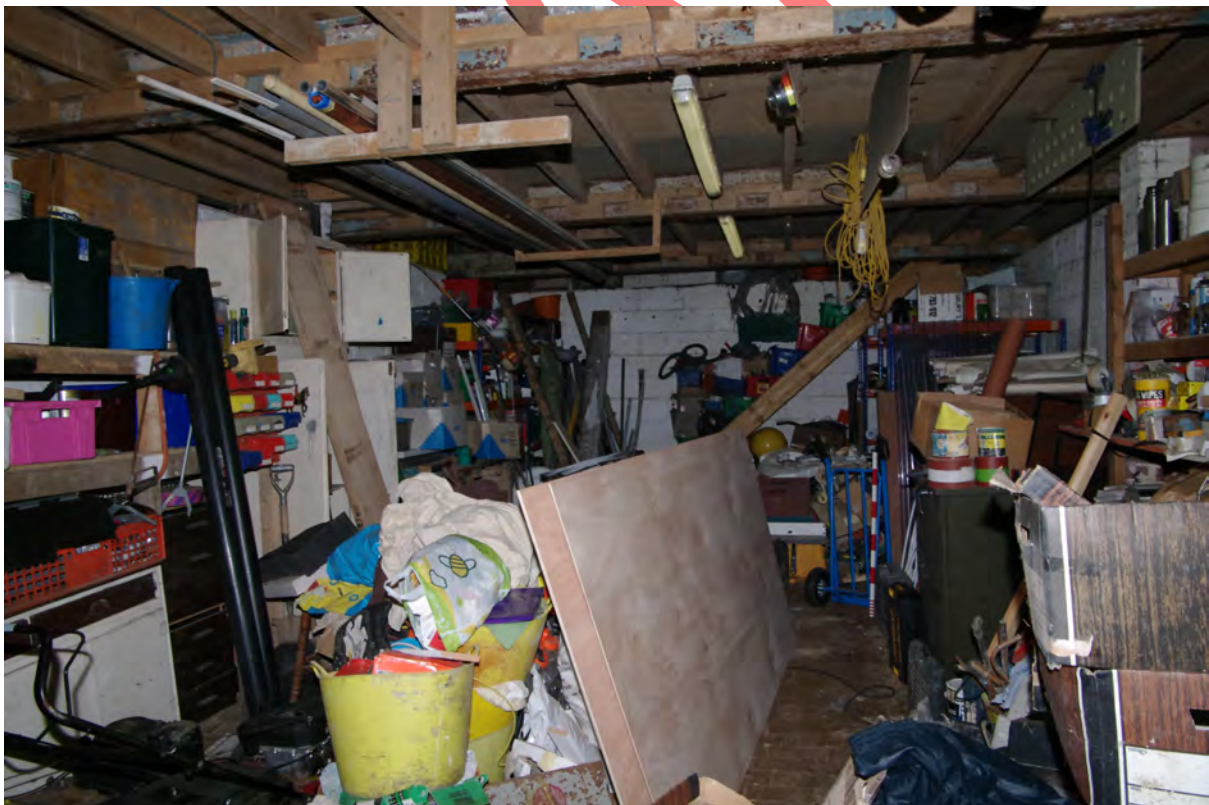
Inside the threshing barn the walls have been lined with 20th century concrete breeze blocks, probably added to support failing brickwork. This masks the earlier fabric of the building. To the west of the central doorway the ground floor room is an open single room with a low ceiling supported by modern RSJ girders (Figure 34). Modern steps lead up to the first floor to reveal the roof structure (Figure 35). The roof trusses appear to be of early to mid-19th century in date and consist of pegged (rather than bolted) king posts with cleated purlins resting on the backs of the principal rafters.

Figure 34: Threshing barn ground floor  
Looking south-west in the western room. Note the breeze block-lined wall at the end and sides of the room and the modern RSJ girders forming the ceiling

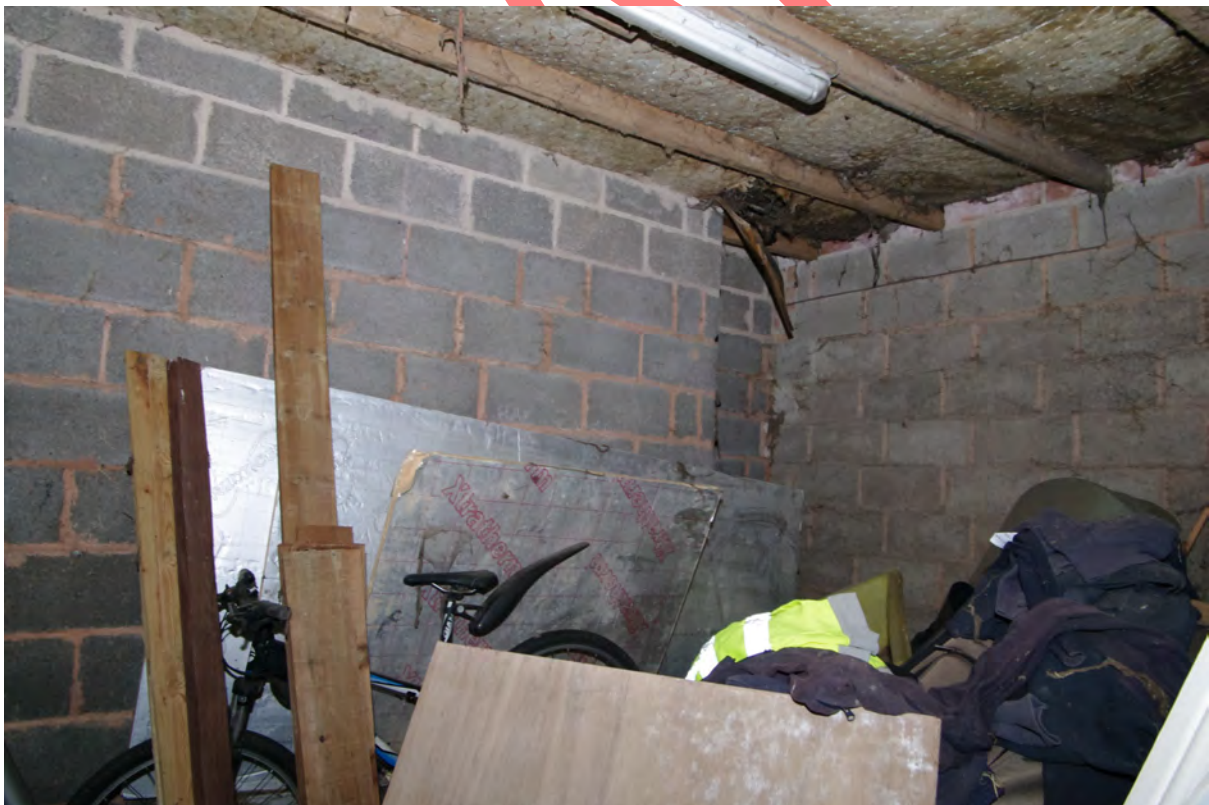
Figure 36: Threshing barn ground floor store to the east of the central doorway  
*Looking east. The internal dividing walls are concrete blocks as are the lined external walls (to the right of this picture)*

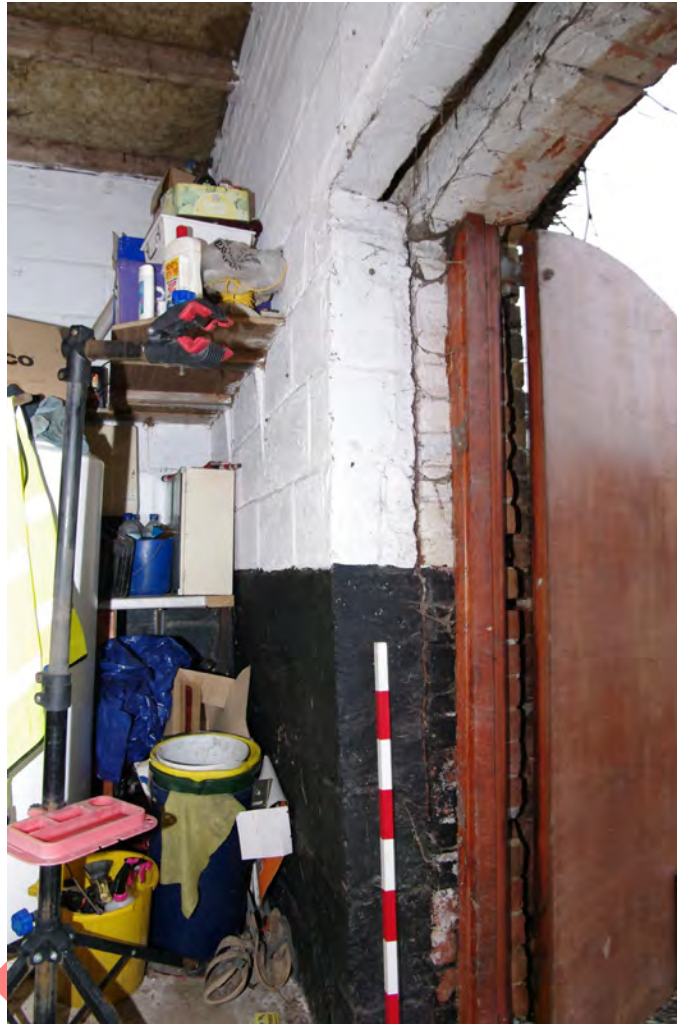
Figure 37: Threshing barn ground floor east end room

*Looking north-east at the concrete block lined wall (behind the 1m scale) and the outside doorway*

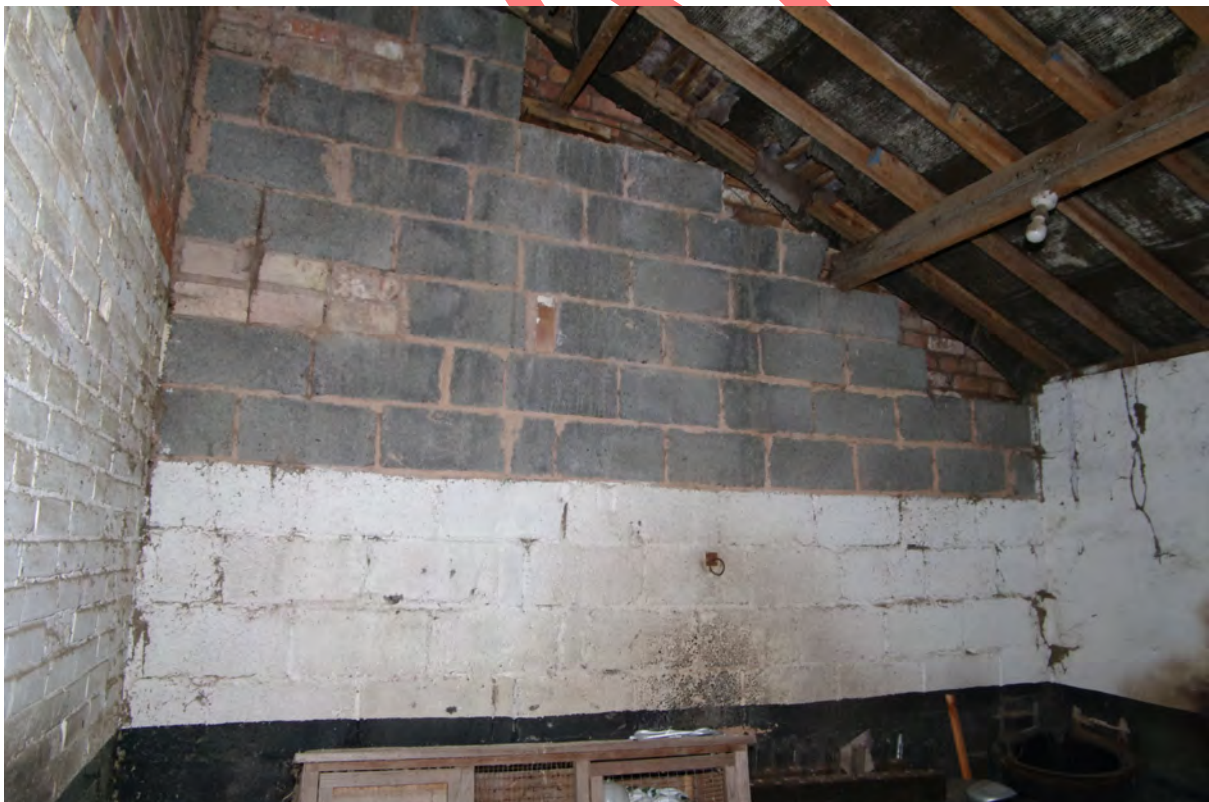
Figure 44: South-western stable, reinforced eastern end wall  
Looking north-east at the inserted skin of modern blockwork

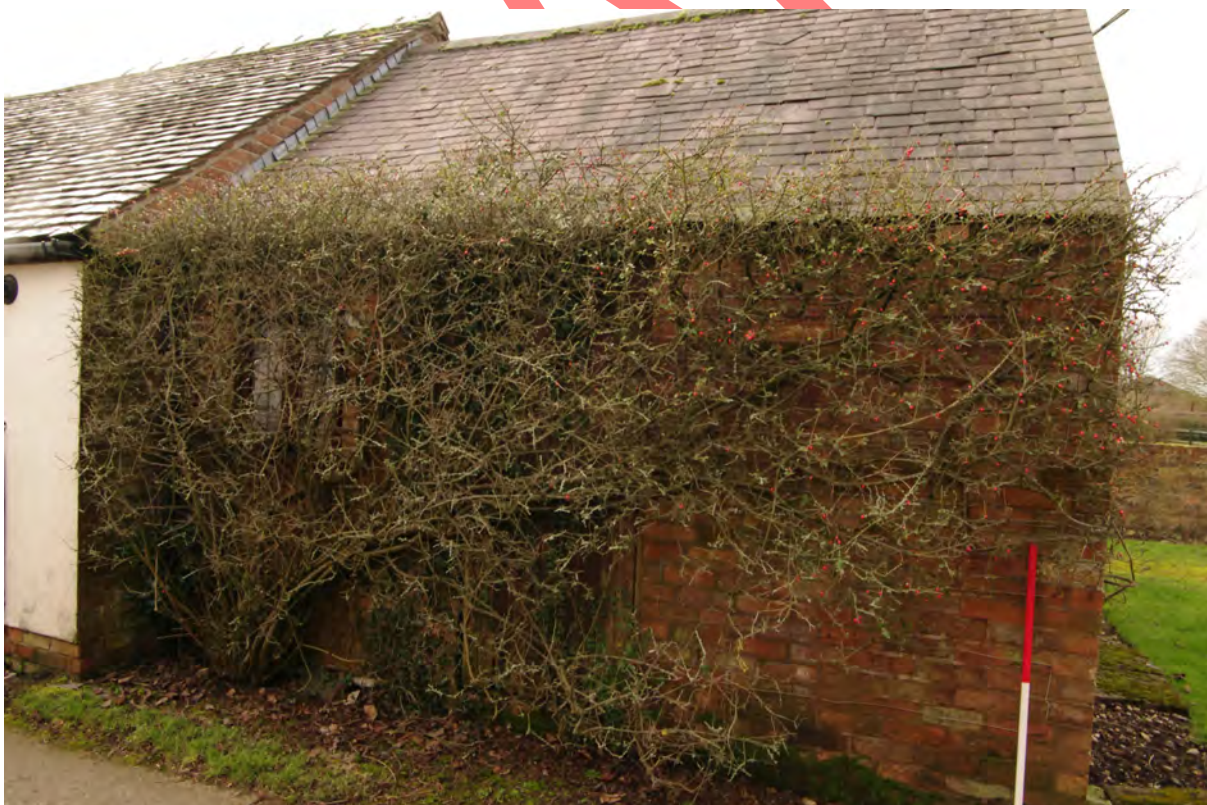
The north-east facing elevation is covered with thick vegetation but it is possible to see a single-width doorway and window (Figure 51). The window lights a small toilet and shower room. The north-west facing elevation has a small window and doorway (Figure 52). Another window and door are located on the south-west facing elevation (Figure 53). Attached to the south-west corner of the office annex is a modern timber and glass porch which will be removed during the proposed works (Figure 54).

Figure 51: North-east facing elevation of the office annex  
*Looking south-west. 1m scale. Note the obscured window and doorway behind the vegetation*
