BS5837:2012 Tree Survey
Land at Shilton Road
Barwell
Leicestershire
NGR SP45371 97076

Survey by
Christopher Barker CEnv dipHort ACIEEM

Report prepared by: C Barker	Date Issued: 28 October 2024
		Report Version: V1
	Reviewed by: KLB	C B E Consulting Highbank, 5 Grantham Road, Navenby Lincoln. LN5 0JJ. Telephone (01522) 810086. www.cbeconsulting.co.uk
	Report ref: P2914 /1024 /02

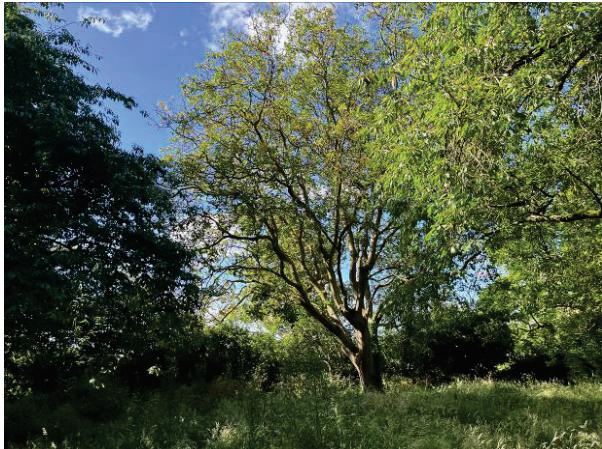
Tree No	Species	Ht (m)	Stem Diam mm@ 1.5m	Canopy Spread (m)	Height of Crown Clearance	Age Class	Est yrs	Overall Condition	Structural condition	Recommendations	BS 5837 Category	RPA Radius (m)
T29	Walnut <i>Juglans nigra</i>	12	650	N-8 S-7 E-6 W-7	5	M	20+	G	Open and sparse with internal regeneration. No structural faults visible from ground level but appears in decline.		C2	7.8
T30	Apple <i>Malus sp</i>	6	10 x 50	N-1 S-2 E-2 W-2	1	OM	<10	P	In severe decline. No structural faults visible from ground level	Removal recommended	U	1.8
T31	Sycamore Acer <i>pseudoplatanus</i>	9	210	N-2 S-3 E-3 W-3	1	Y	10	F	Upright extending south. No structural faults visible from ground level		C2	2.5
T32	Indian Bean <i>Catalpa bignoides</i>	12	980 570	N-6 S-8 E-6 W-8	1	M	20+	G	Irregular with large branch at base extending south west. No structural faults visible from ground level		B2	13.6
T33	Ornamental Cypress <i>Cupressus sp</i>	10	530	N-2 S-2 E-2 W-2	1	M	20+	G	Conical. No structural faults visible from ground level		B2	6.3

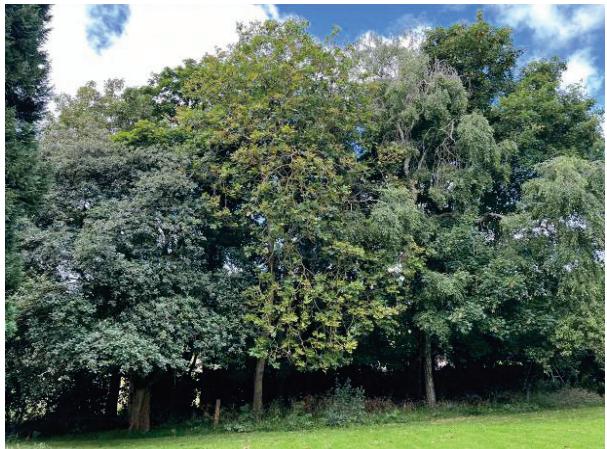
T44 – T49

T44	Walnut <i>Juglans nigra</i>	18	370	N-4 S-2 E-6 W-0	5	SM	10	P	Irregular and unbalanced. Leaning and extending east. No structural faults visible from ground level	Monitor lean if retained.	C2	4.4
T45	Sycamore <i>Acer pseudoplatanus</i>	20	365	N-2 S-4 E-2 W-6	5	SM		F	Higg crown. Limited space. Choked with dense ivy. No structural faults visible from ground level	Remove ivy if retained	C2	4.3
T46	Sycamore <i>Acer pseudoplatanus</i>	20	555	N-6 S-6 E-5 W-8	4	M		G	Dominant with minor ivy. No structural faults visible from ground level	Remove ivy if retained	B2	6.6
T47	Sycamore <i>Acer pseudoplatanus</i>	20	640	N-8 S-5 E-8 W-6	4	M		G	Dominant with minor ivy. No structural faults visible from ground level	Remove ivy if retained	B2	7.6
T48	Birch <i>Betula pendula</i>	19	385	N-5 S-3 E-8 W-0	5	SM		F	Irregular, Lacks space. Suppressed on west and extending east. No structural faults visible from ground level		B2	4.6
