## Barn Survey Document

**Folly Farm**

**Kirkby Mallory, LE9 7QL**

**Date:** 24<sup>th</sup> November 2025

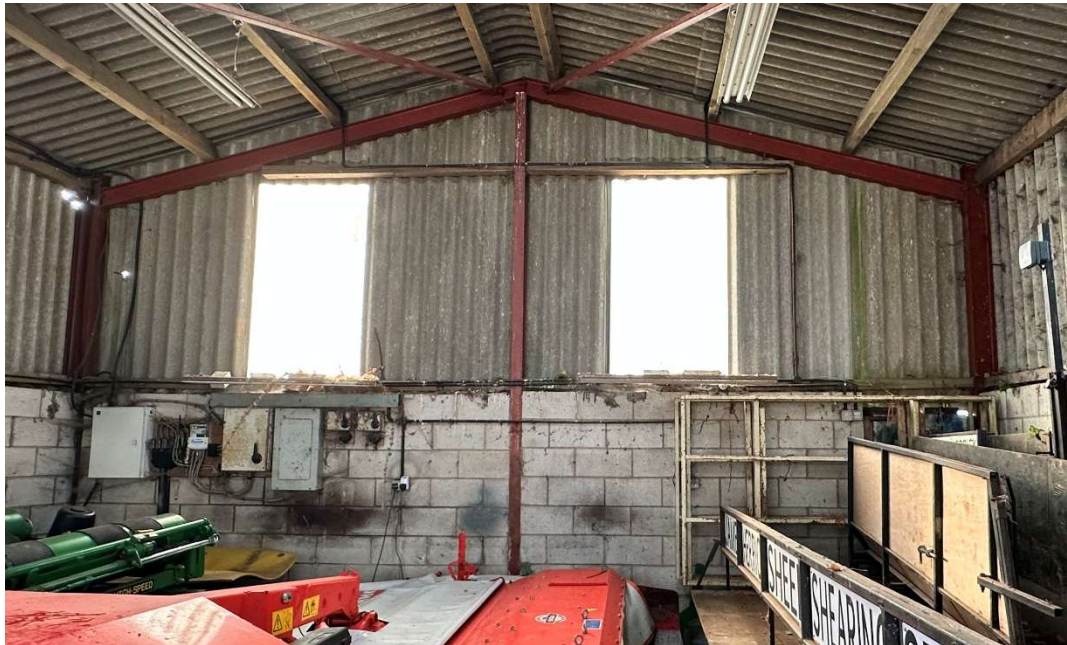
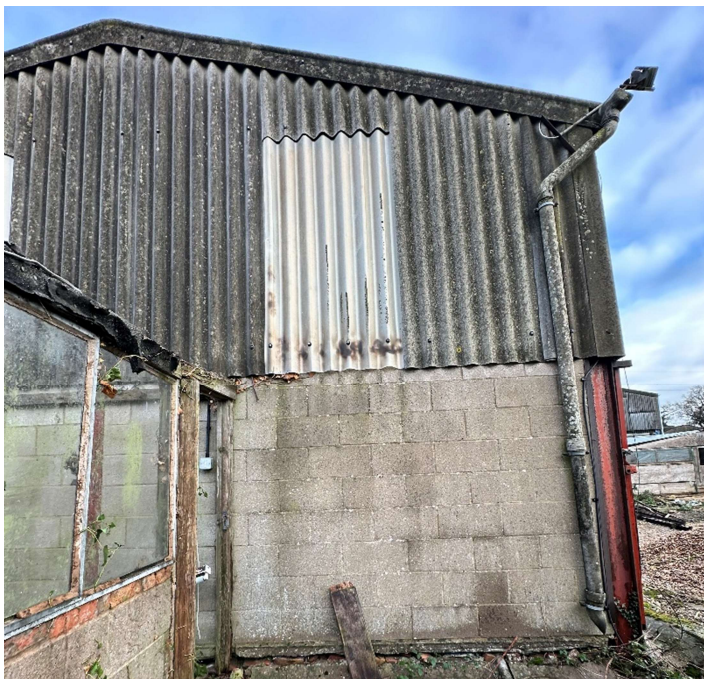
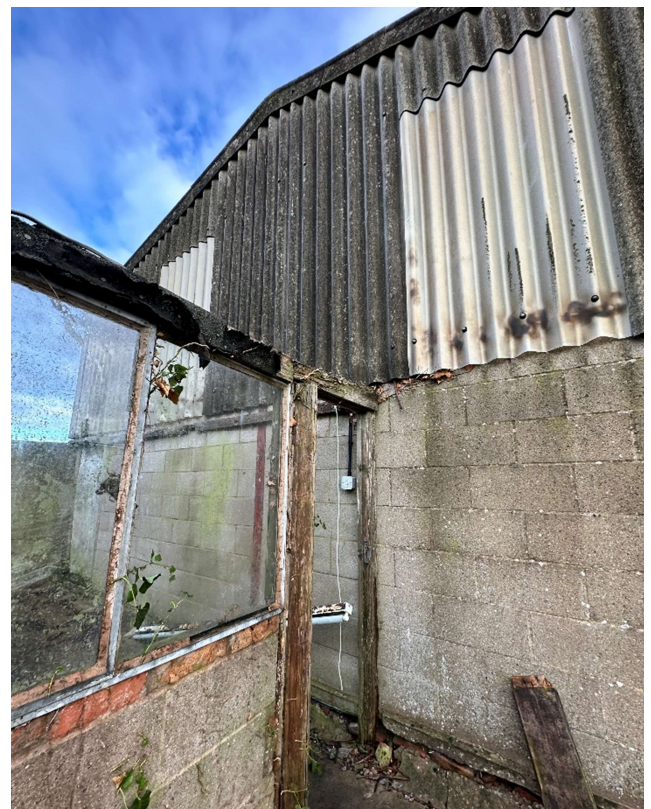
### 6.0 South elevation

- 6.1 The south elevation has 2 corrugated lights. There are no signs of any structural cracking. The walls appear vertical in alignment with no structural defects noted.
- 6.2 The steelwork is in relatively good condition.

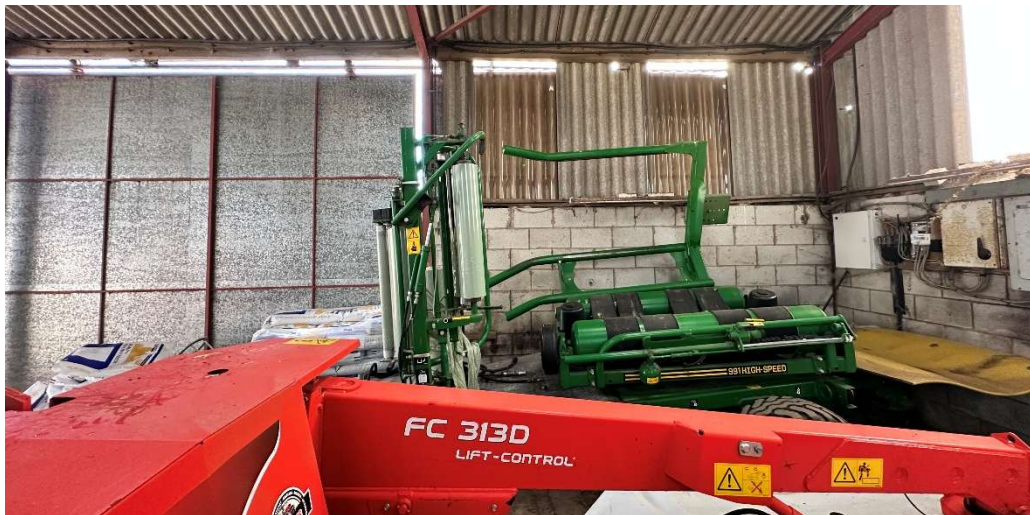
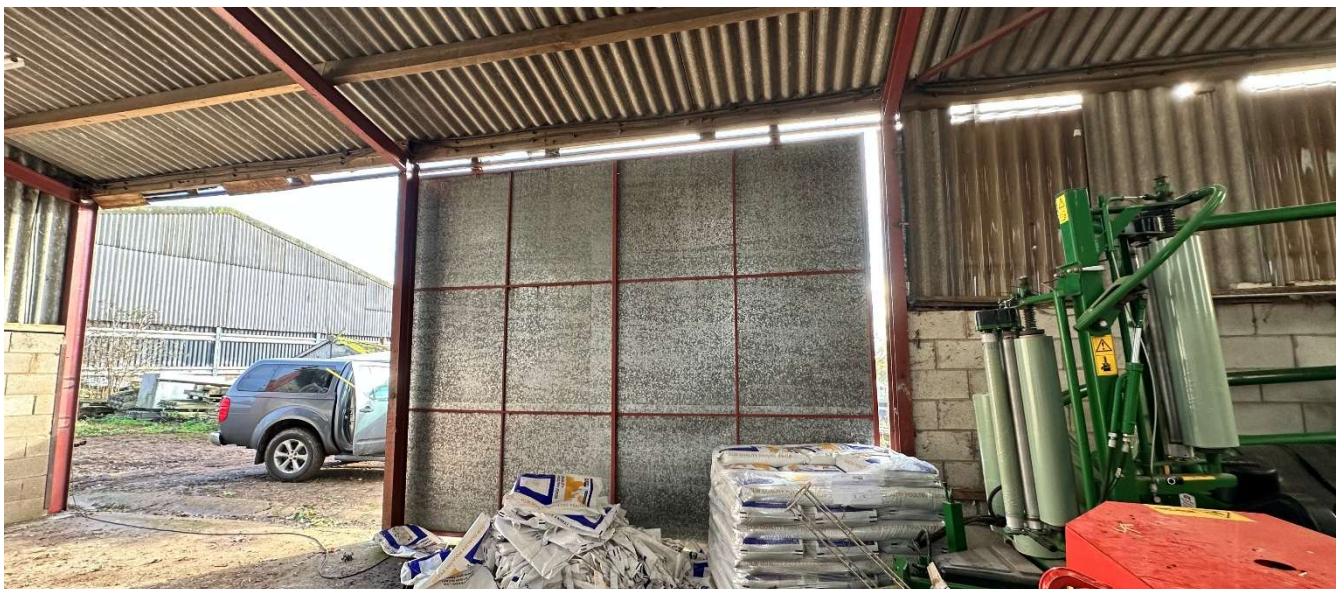
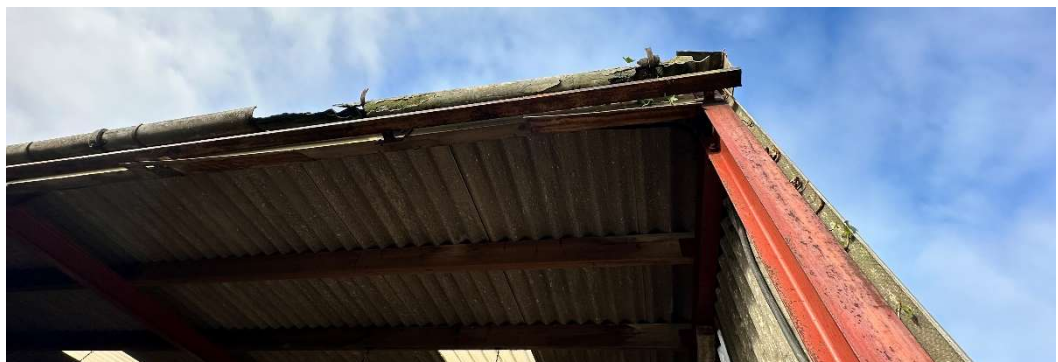
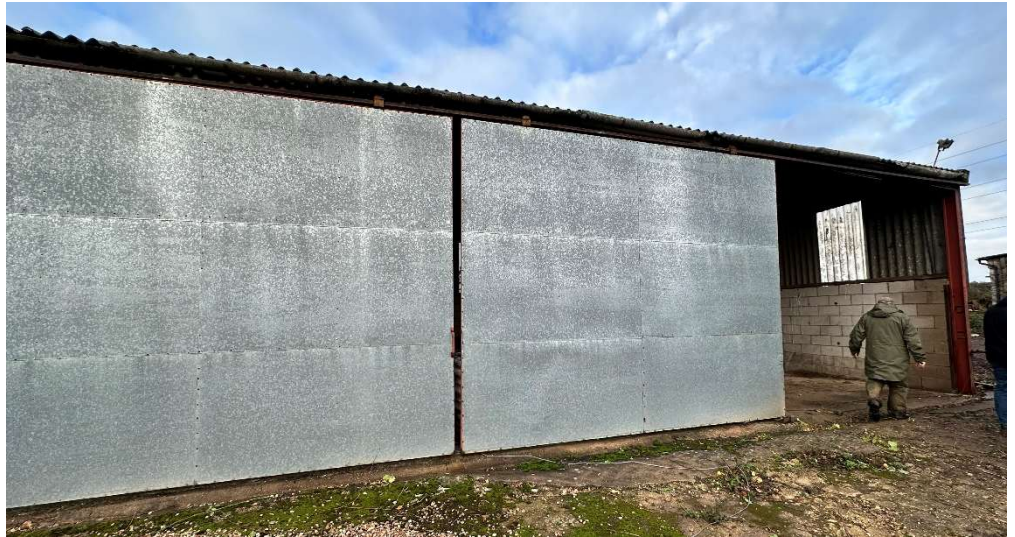
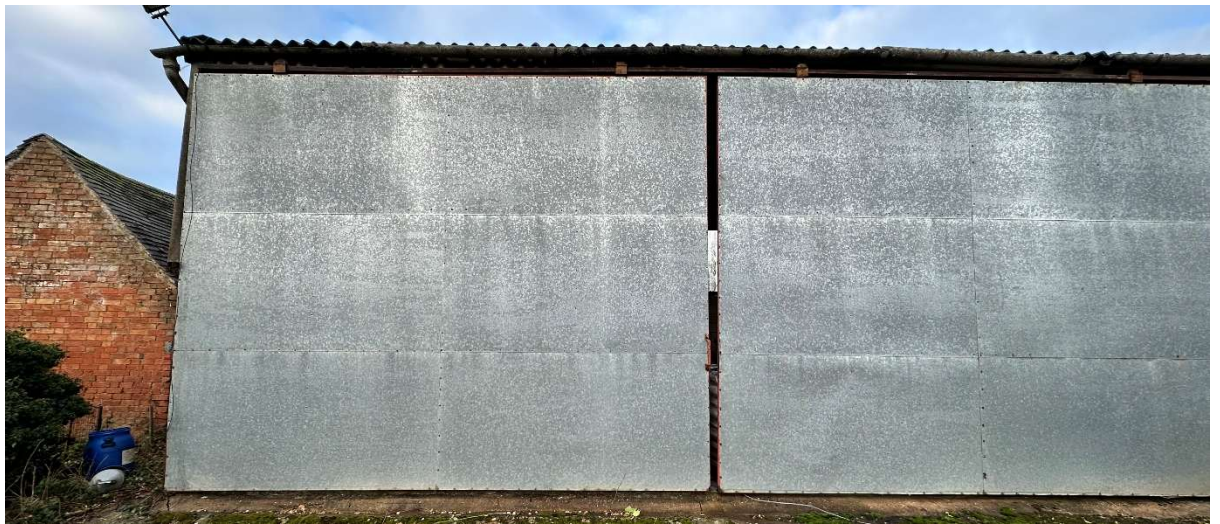
## 7.0 East Elevation

- 7.1 The east elevation comprises of 2 door large opening between 2 portal frames with the bay to the south east of similar construction to the rest of the barn.
- 7.2 No significant defects were noted to the wall construction. The walls appear vertical in alignment and the steel is in reasonable condition.
- 7.3 The door are top hung from 75mm channel section which appears to be performing adequately.

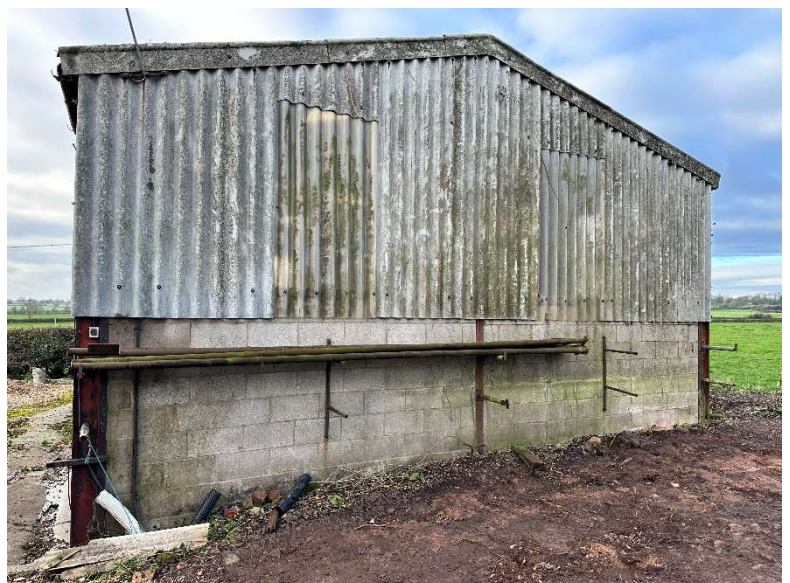
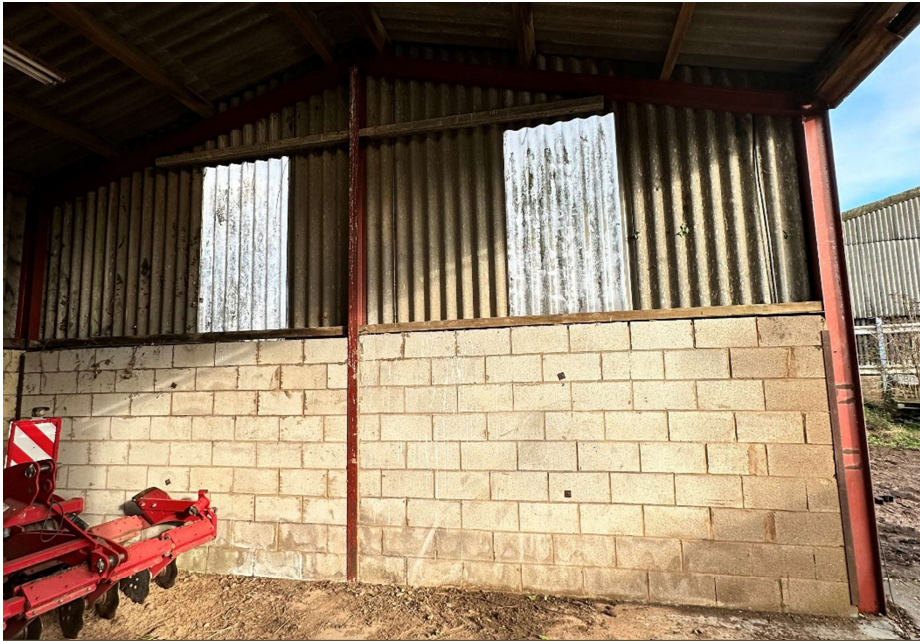
## 8.0 North Elevation

- 8.1 The north elevation has no significant defects noted to the construction. No cracking to the walls and they appear vertical in alignment. The steels are in reasonable condition.
- 8.2 The walls retains the earth behind to a height of approximately 450mm.
- 8.3 No cracking is evident and the walls are capable of retaining the earth but damp may be an issue.

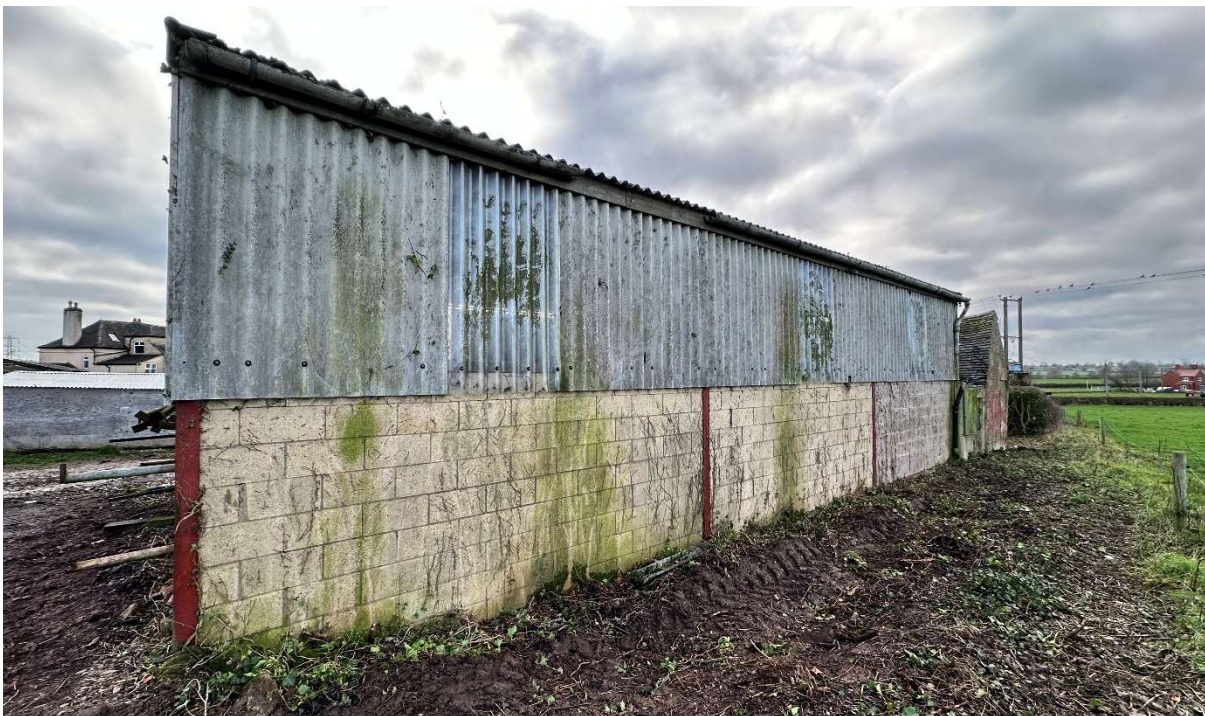
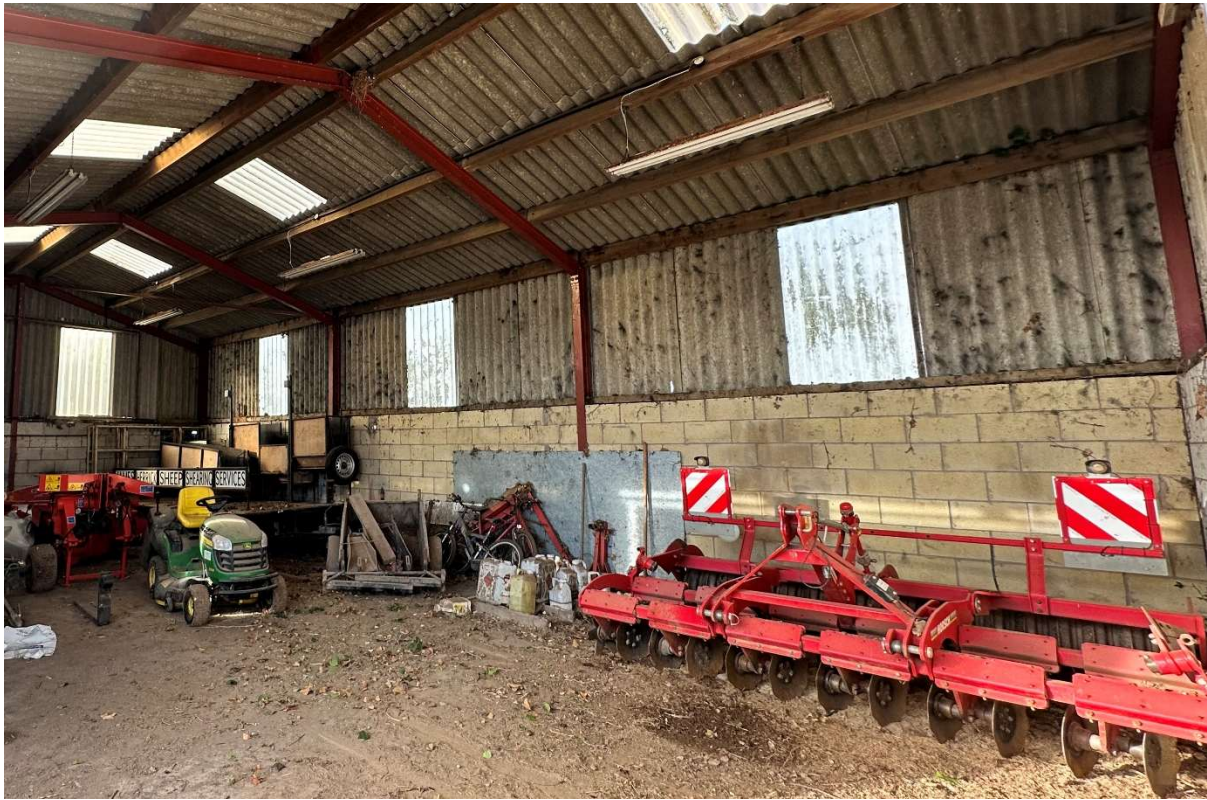
## 9.0 West Elevation

- 9.1 The west elevation walls are vertical in alignment with no significant defects noted. The steel members are in reasonably good condition.
- 9.2 The ground level drops to the rear to the same as the internal floor level.
