## **BUILDING CONDITION SURVEY**

**FORMER PUBLIC HOUSE**

**HIGHAM ON THE HILL**

**AUGUST 2019**

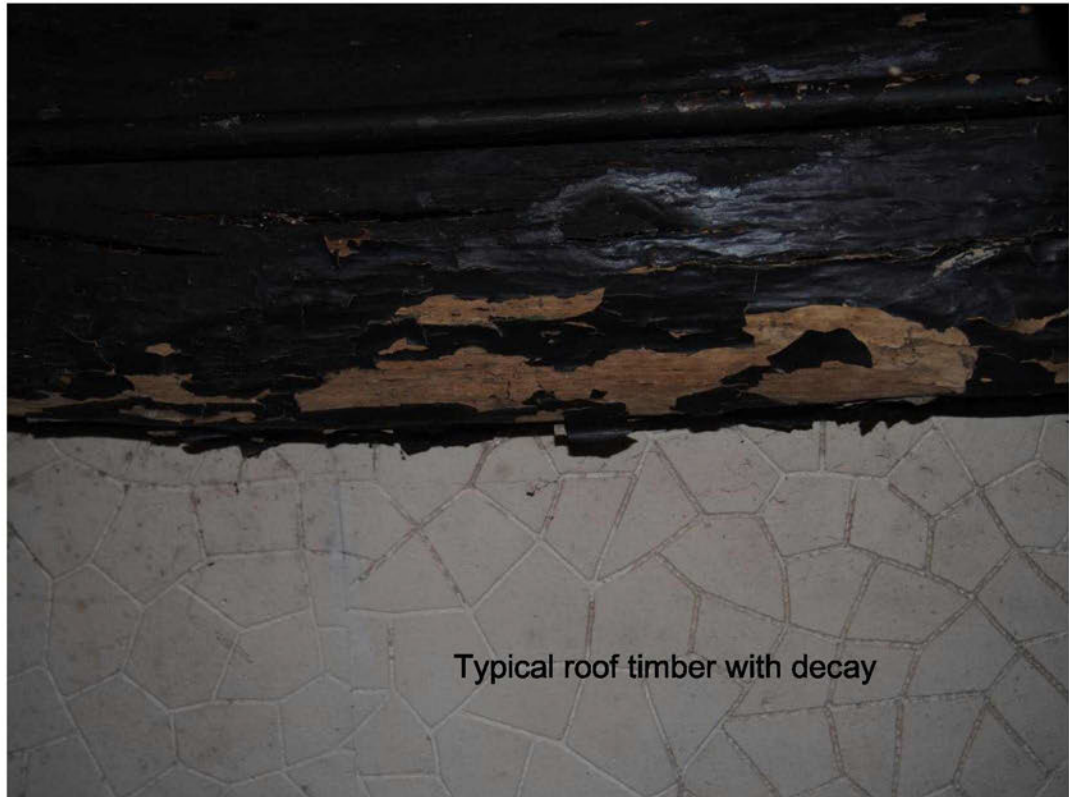
Much of the roof structure is enclosed within the accommodation to the second floor. A number of the original purlins and ties to the roof were visible. These are of

random rough sawn timber and have a black painted finish. The timbers showed signs of past wood boring insect activity and also some rot due to dampness. It is considered that these timbers would require significant treatment and repair to stabilise the roof structure. The addition of steel roof ties at eaves level would also aid the structural integrity of the building.

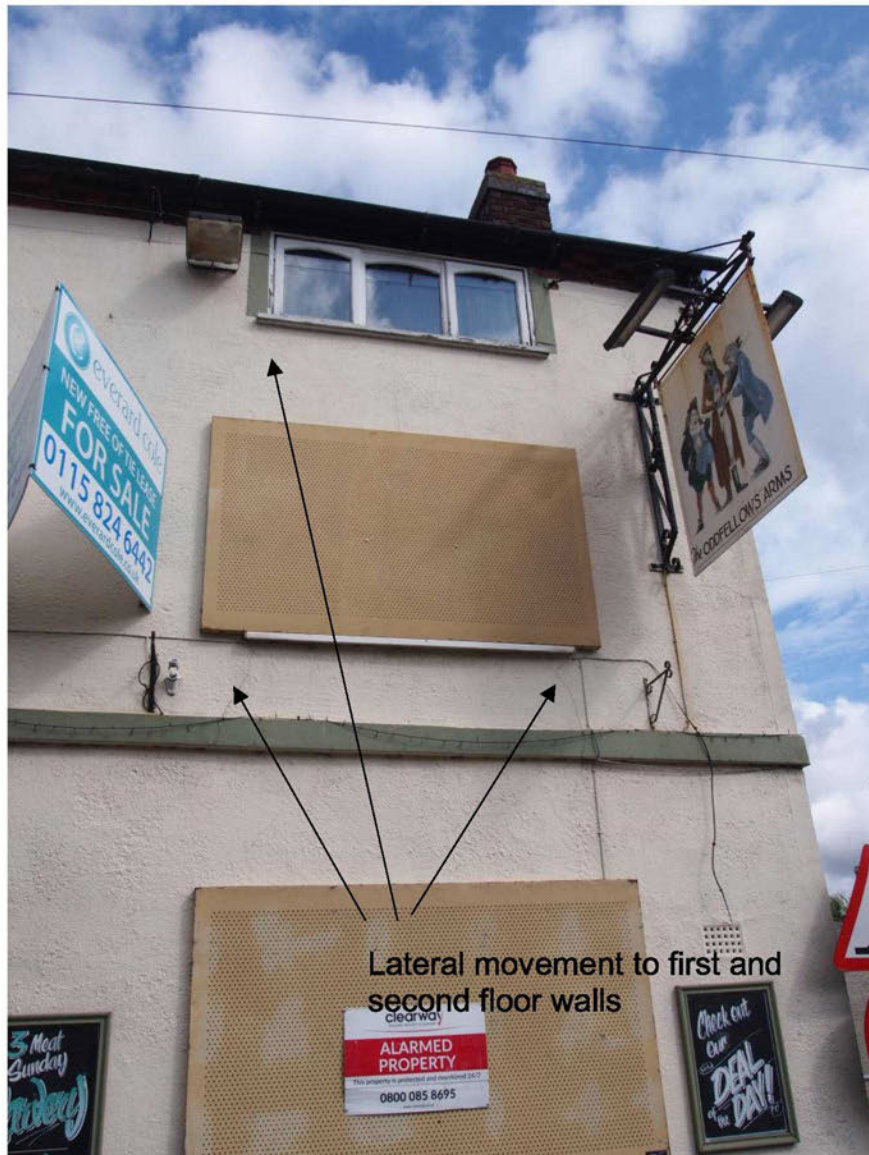
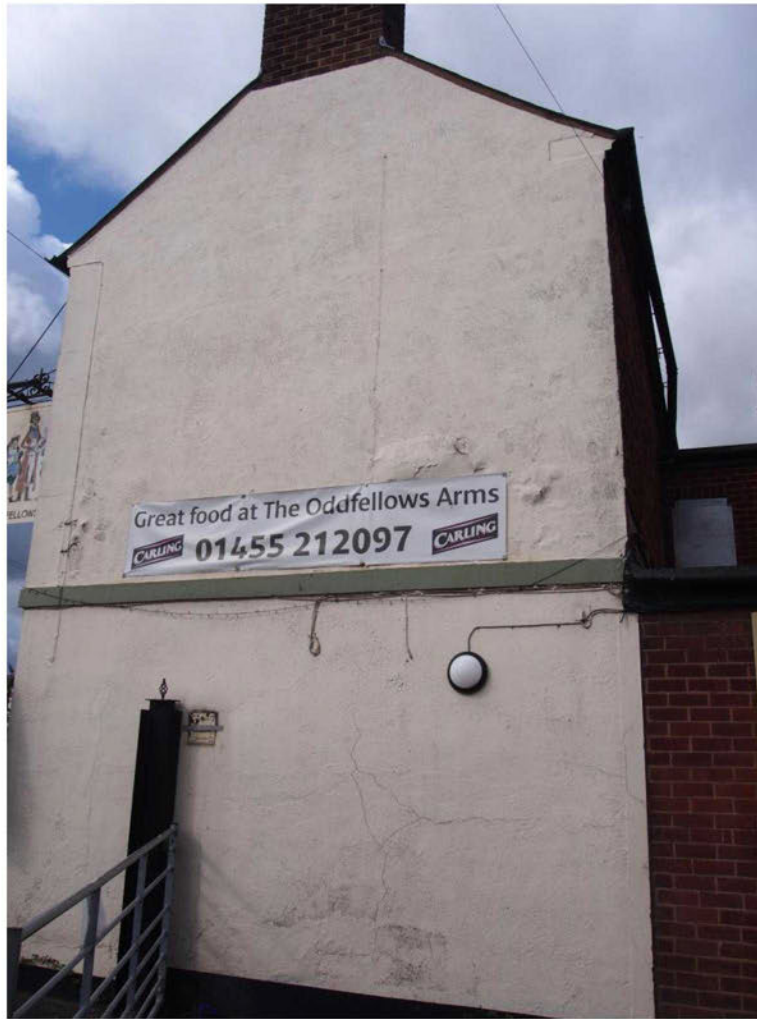
The render itself is in poor condition being badly cracked to all areas and is also suffering from deterioration due to dampness as the render extends to ground level. All the render now requires removal and make good the brickwork to the face before applying a replacement render.

Typical poor condition of render to front and sides

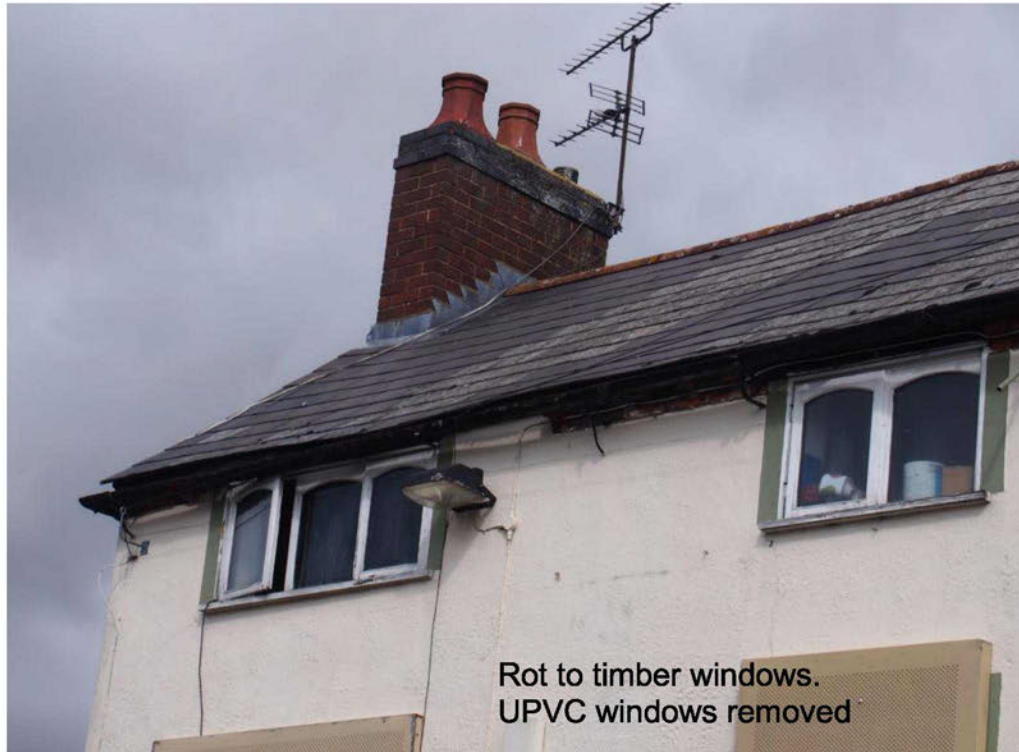
The windows to the rear property are a mixture of replacement UPVC sealed units some of which have been removed to facilitate the blocking up of windows and to the second floor the windows are of timber construction. The windows to the second floor all showed signs of deterioration and damage and now require complete replacement. To the first and ground floor it was difficult to assess the condition of the windows as majority of the glazed units have been removed so therefore it is assumed that complete replacement of the windows is now required.

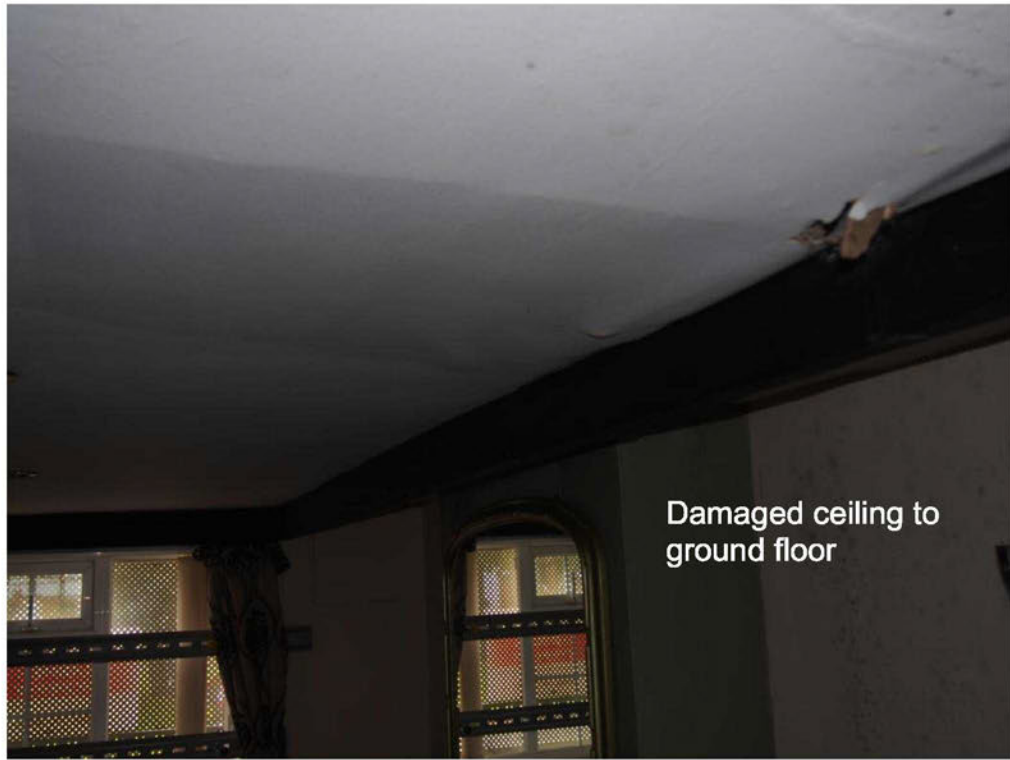
The ceilings to the property are of a mixture of lath and plaster and plasterboard construction. The majority of the ceilings to the more recent parts of the building are of plasterboard construction and although showing signs of cracks, are generally satisfactory. The ceilings to the original part are part beamed and have undergone significant alteration in the past. There are signs of damage to all of the ceilings to the ground floor and part of these are underdrawn. It is considered that these ceilings will require removal and replacement. To the first and second floor

again the ceilings are a mixture of plasterboard and lath and plaster construction. All showed signs of significant deterioration, dampness and distortion and all required removal and replacement.

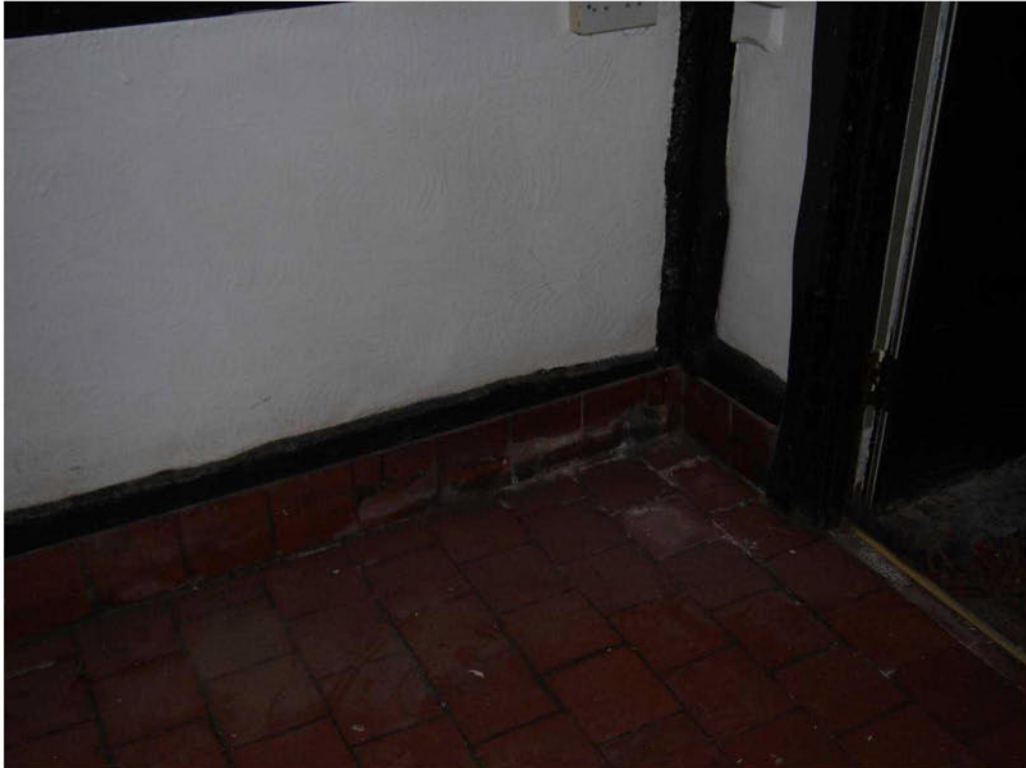
To the ground floor the floors are of solid construction with predominantly a quarry tile finish. There is some distortion to the levels of the floor indicating a poor sub-base and it is unlikely that the floors are insulated. Random damp meter tests on the floor revealed high levels of dampness indicating that there is no damp-proof membrane. It would therefore be recommended that the floors are removed and replaced with a dampproof membrane, insulation and a level screed finish.

Dampness to floors. Note also rising damp to walls in original section of the building.

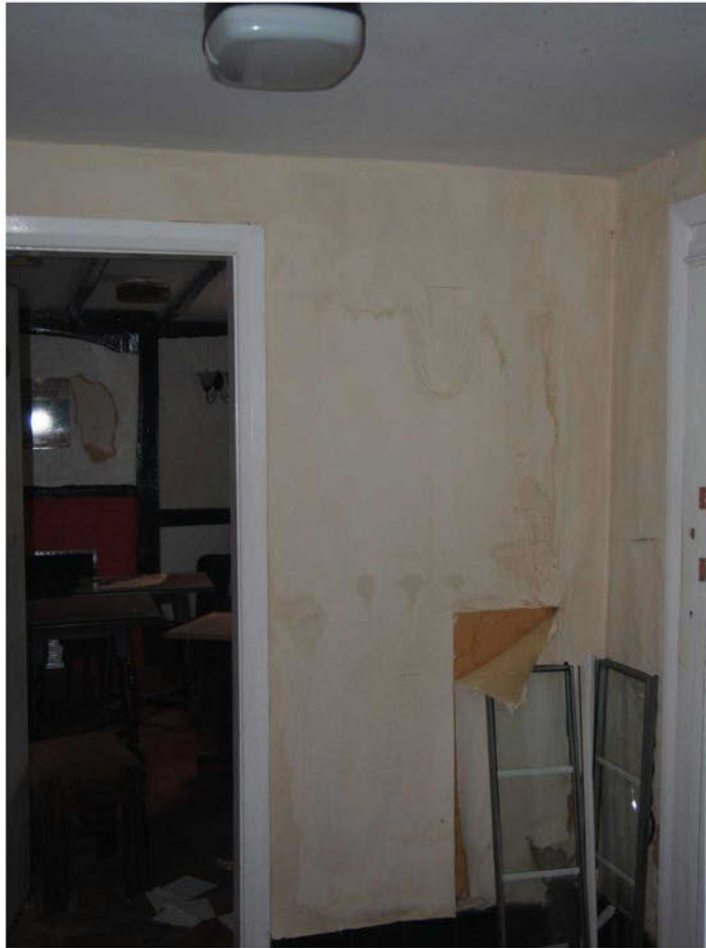
The internal walls are of solid brick construction with a wet plaster finish to the majority. To the ground floor the walls had a rustic plaster finish with some inserted timberwork and much of this plaster has deteriorated at lower levels due to rising damp. The plasterwork is also loose to the upper sections. Much of the timber work has deteriorated. Complete replacement of the plasterwork is now required.

To the first floor the plasterwork has again deteriorated in a number of places and appears to have been damaged caused by water penetration to the bedroom areas and plasterwork has come away from the walls in these areas. There is also significant cracking around the window openings. To the stud partition between the bedroom and kitchen area the plasterwork is satisfactory.

Damage to internal walls caused by dampness
