# Building Condition Report and Schedule of Works

2.1. Red brick barn and courtyard off Hall Lane, Odstone, Nuneaton, CV13 0QS

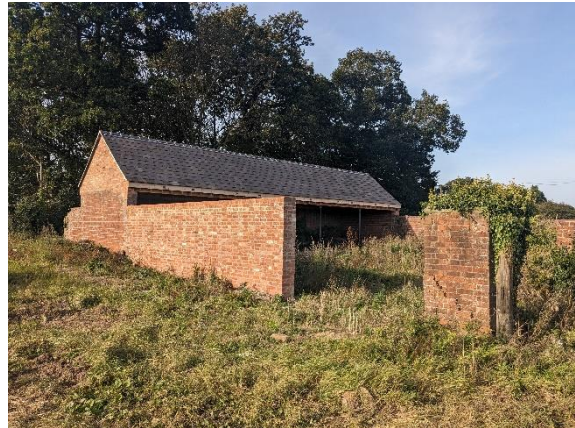
*Figure 2 - Courtyard*

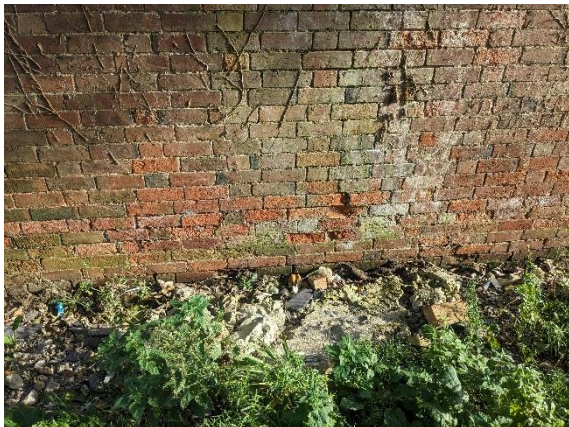
3.2. BUILDING WALLS - constructed from red brick and are 240mm thick, with the exception of the doorway and columns which the roof trusses sit on, which are circa 350mm x 350mm. Given the thickness of the walls and the original use of the building it is not anticipated there is a cavity, and no insulation is present. The walls of the building are in a satisfactory condition including at low level. There were no signs of structural movement, or deterioration to the structure, beyond a few isolated locations where spalling bricks on the north-east and north-west elevations would ideally need to be replaced. These can simply be cut out and replaced with matching red bricks and is considered peripheral damage only. There were no signs of any settlement or distortion to any of the walls.

*Figure 3 - Evidence of minor spalling*

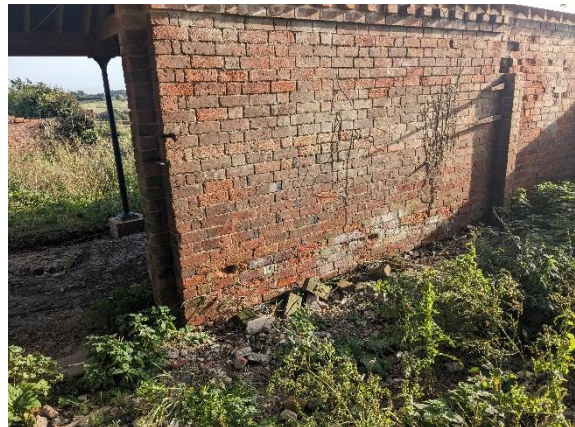
*Figure 4 - Evidence of minor spalling*

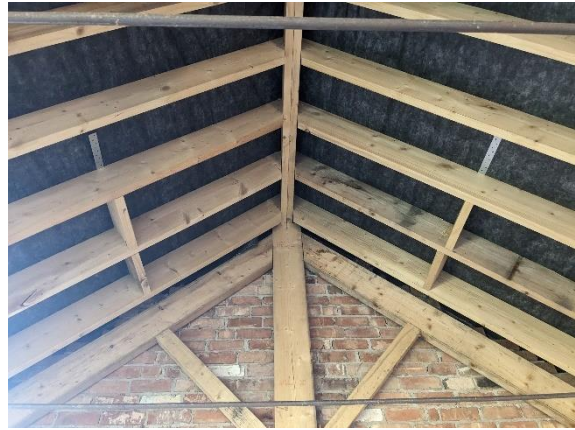
3.3. ROOF STRUCTURE – The timber framed roof structure utilises king post trusses (210mm x 70mm) with timber rafters (230mm x 45mm). In between the trusses - two steel rafter ties are used per spacing. A fabric membrane is fitted between the roof structure and the main roof covering which the slate tiles are attached to. The roof structure is attached to the walls via timber wall plates and steel wall ties. No signs of movement to the roof were evident, with structural elements in good condition, weatherproof and suitable for conversion.

*Figure 6- Rafters and membrane*

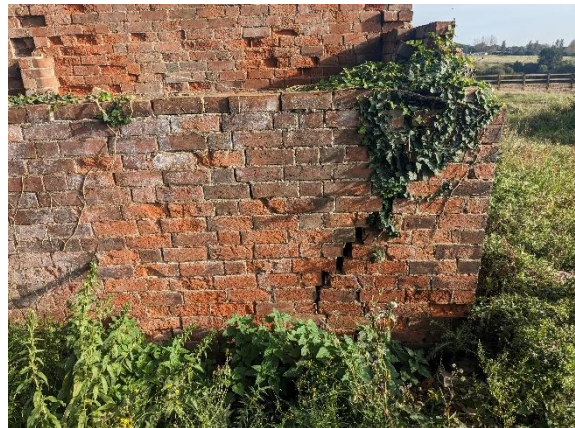
3.5 OUTBUILDING – The outbuilding attached to the main buildings north western elevation currently does not benefit from a roof. There are notable cracks to the north eastern elevation and will require localised rebuilding to that aspect. There is also minor cracking to the north-western elevation, but no significant movement is noted. See section to be repaired/localised rebuilding in Figure 8.

*Figure 8 - Section of outbuilding wall requiring repair/localised rebuilding.*

4. Localised repair work to be carried out to existing walls highlighted in section 3.
5. Erection of two above mentioned cavity walls, externally finished with matching red brick of same colour, size and weathering. Internal concrete block walls with rockwool insulation to current Building Control Specification.

5.2 The south-eastern courtyard wall and outbuilding will require some localised rebuilding and repair work, but the north-eastern and south-western courtyard walls are in good condition.
