*The Fulford  
Bosworth Road  
Barlestone*

# *Structural Inspection*

*Project:* **The Fulford  
Bosworth Road  
Barlestone**

*Project No:* **23-20536**

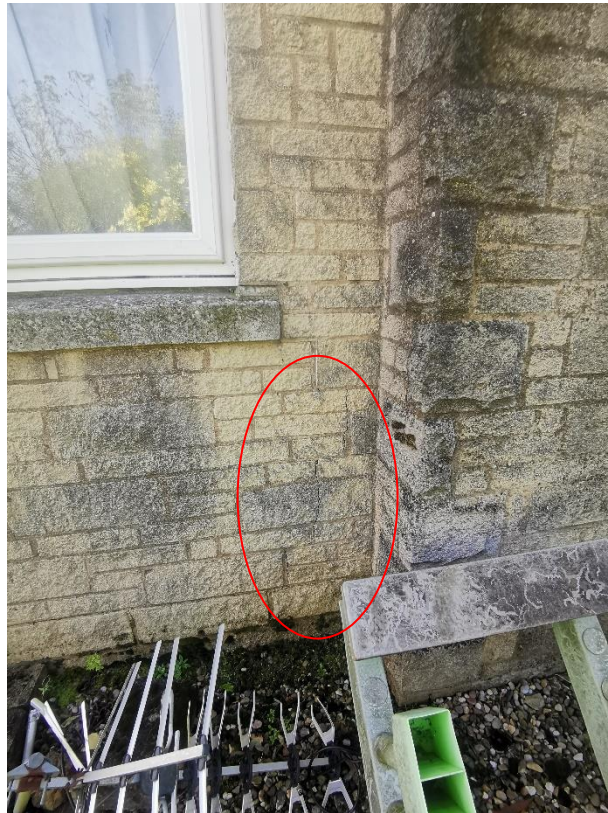
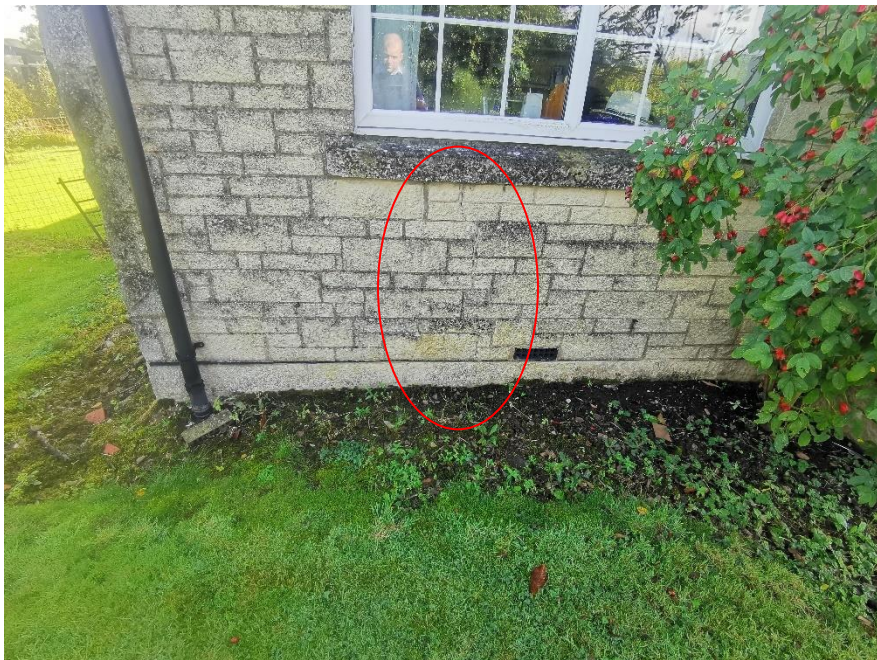
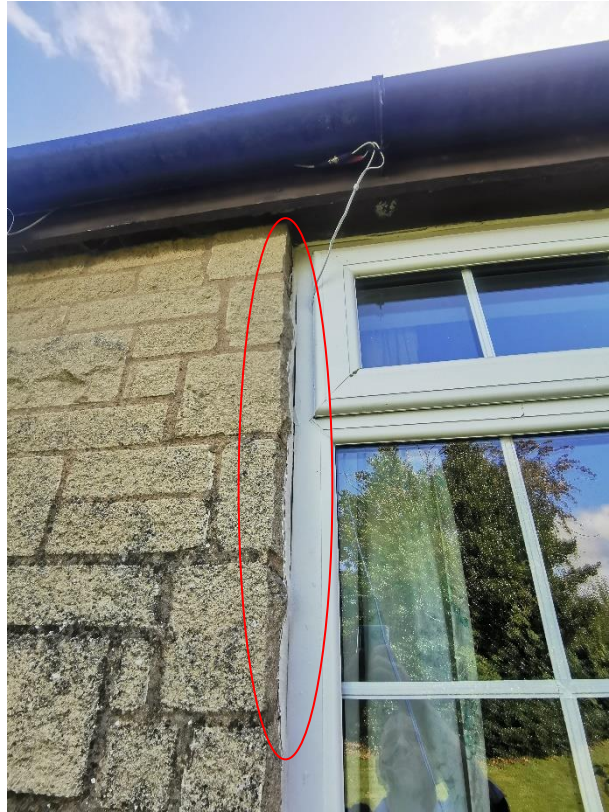
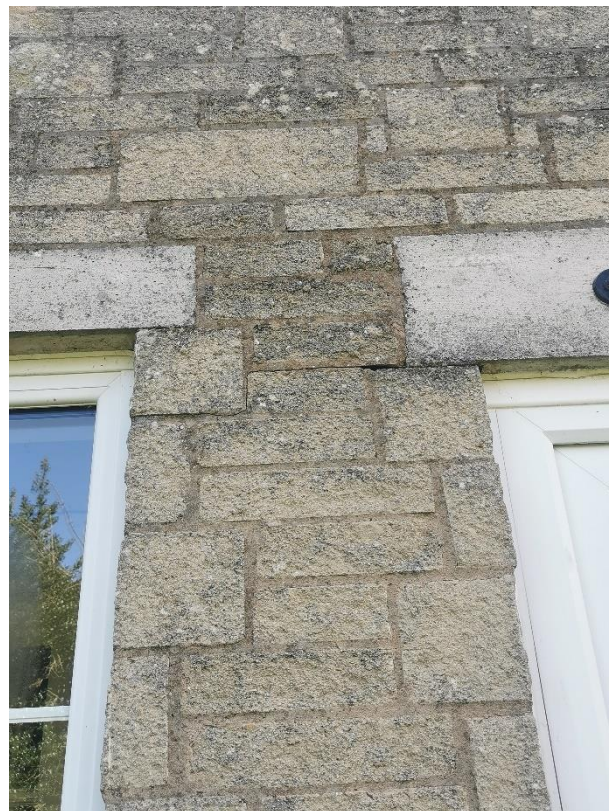
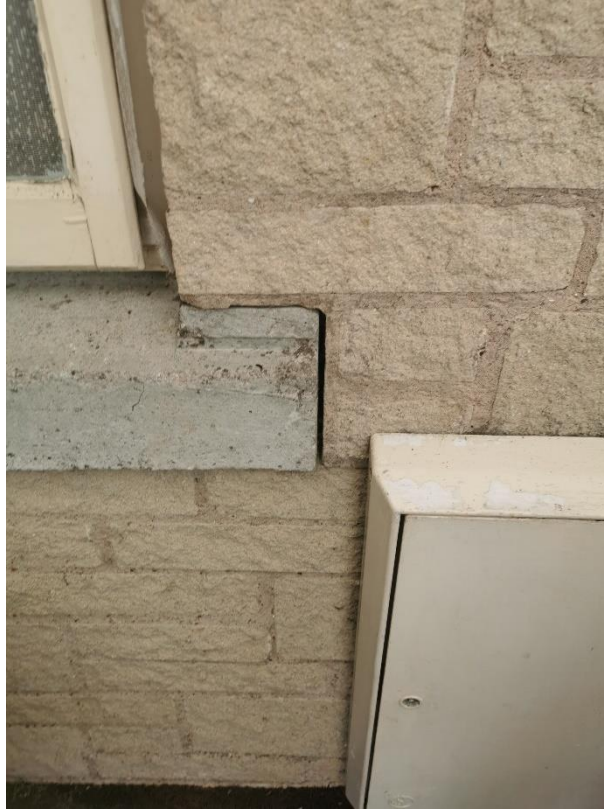
## Appendix A – External Crack Photos

- 2.6 Internal walls are of thin timber stud construction and exhibit signs of flex when pressure is applied.
- 2.7 There are a number of settlement cracks to the external stone façade as can be seen in Appendix A. This façade has been built off a small concrete foundation at a founding depth of 350mm below ground level. The cracking coincides with down-pipe locations suggesting that the below ground drainage is in a poor state of repair. A trial hole was dug and various roots and rootlets are visible around the founding depth which would contribute to the foundation movement visible in the cracked façade.

- The sealant to the windows has pulled away on one side of each window on the front façade suggesting that movement has occurred in the past.

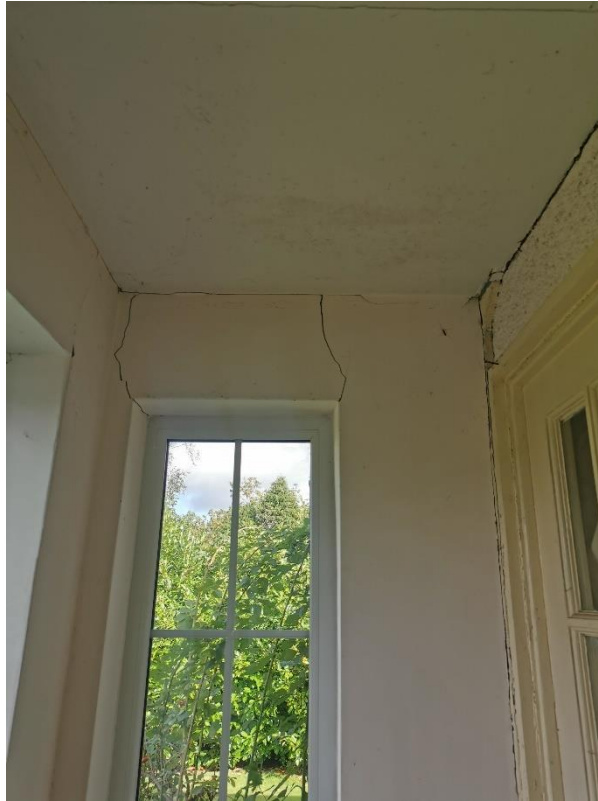
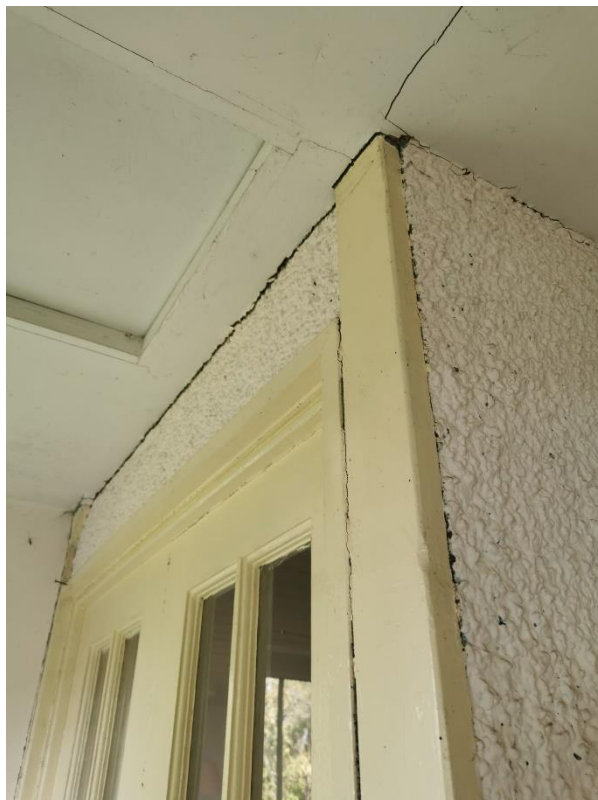
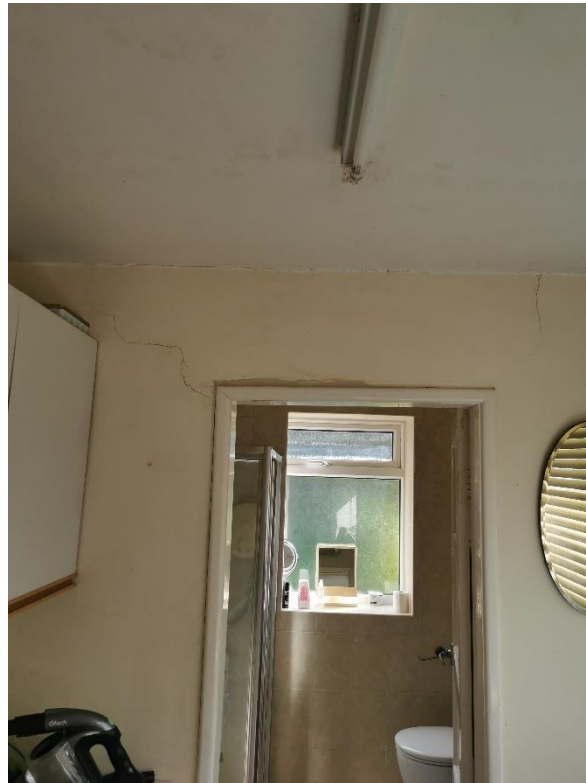
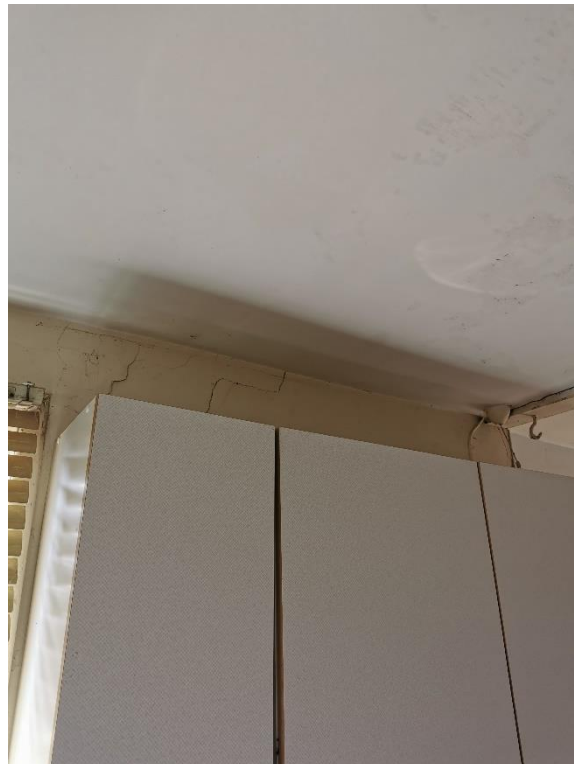
## Appendix B – Internal Crack Photos

- 2.8      There are a number of internal cracks visible in the porch and the kitchen where different forms of construction are exhibiting differential movement and differential settlements.
- 2.9      The foul drains currently run to a septic tank which is beyond its usable age and would need to be replaced.
