## *Structural Inspection Building 3*

Project: ***Red House Farm  
39 Main Road  
Ratcliffe Culey  
Atherstone  
CV9 3NY***

Project No: ***24-21204***

Document No: ***0-031***

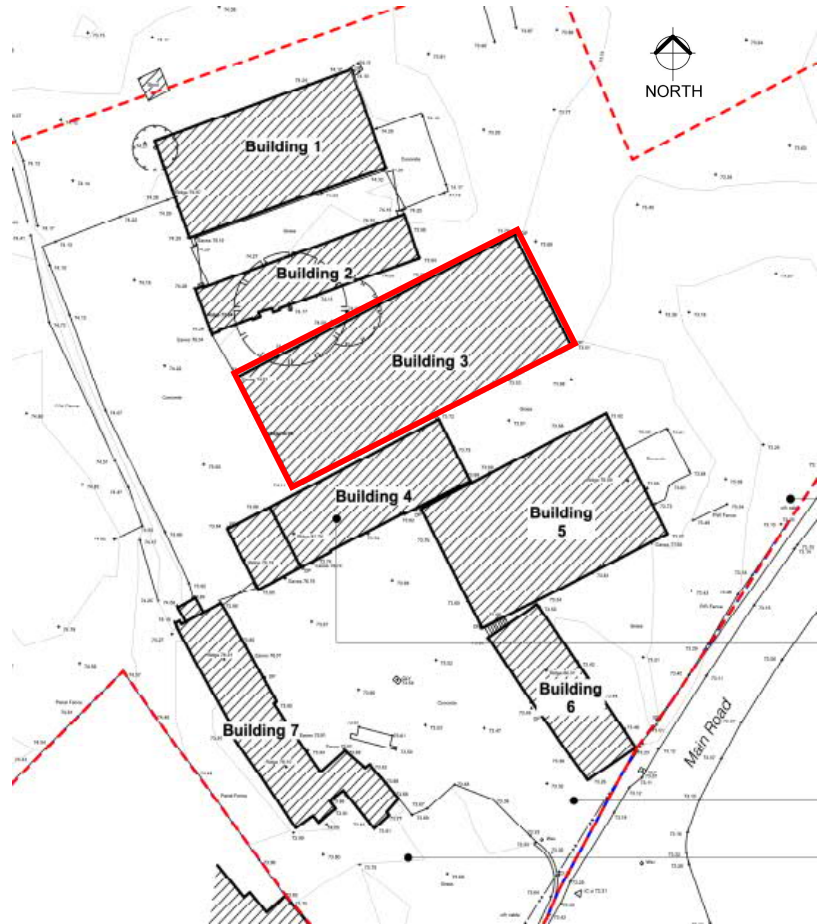
Figure 1

2.1 Building 3 is located to the centre of the farm complex. [Figure 1]
