## *Structural Inspection Building 4*

Project: ***Red House Farm  
39 Main Road  
Ratcliffe Culey  
Atherstone  
CV9 3NY***

Project No: ***24-21204***

Document No: ***0-032***

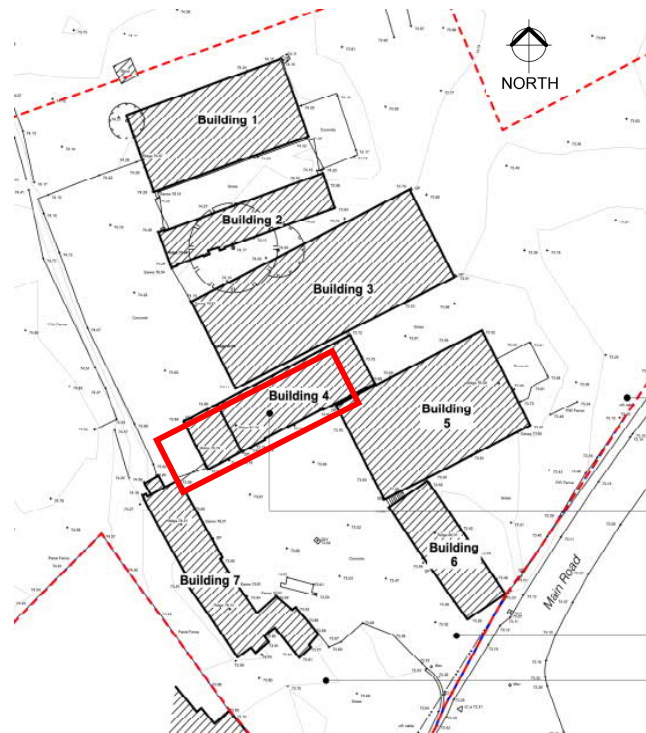
Figure 1

- 2.1 Building 4 is located towards the centre of the farm complex between two further, newer buildings and a temporary accommodation unit. [Figure 1]
