## Land at Junction 22 of the M1,

### Cliffe Hill Farm

## Response to Additional LLFA Comments

**Document No:** 30206-BGL-XX-XX-TN-D-00002

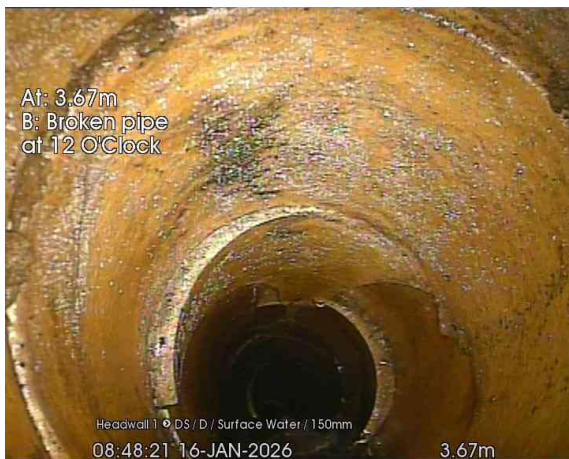
| Section Inspection - 16/01/2026 - Headwall 1X | | | | | | | | | | |
|---|---|---|---|---|---|---|---|---|---|---|
| 3.67 | | B | Broken pipe at 12 o'clock | | | 00:00:34 | 3 | 4 | | |

3, 00:00:34, 3.67 m  
Broken pipe at 12 o'clock

After completing the inspection, we found that that the header wall downstream requires 3 x 150mm epoxy patch repairs at 3.67m, 8.25m and 10.89m to seal broken sections of pipeline.

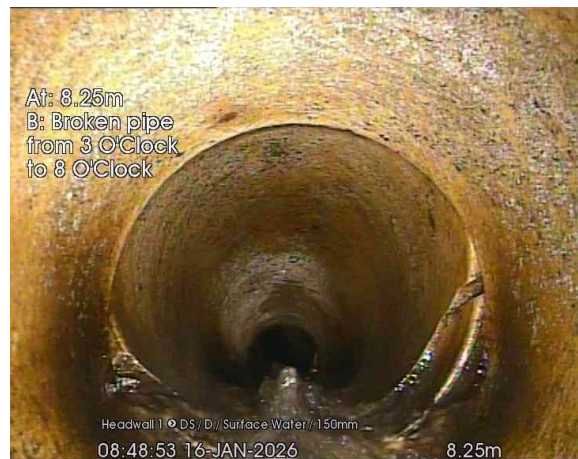
| Section Inspection - 16/01/2026 - Headwall 1X | | | | | | | | | | |
|---|---|---|---|---|---|---|---|---|---|---|
| 8.25 | | B | Broken pipe from 3 o'clock to 8 o'clock | | | 00:00:57 | 4 | 4 | | |

4, 00:00:57, 8.25 m  
Broken pipe from 3 o'clock to 8 o'clock

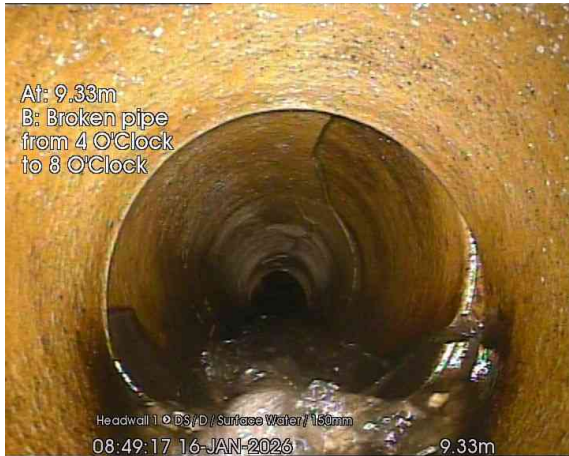
| Section Inspection - 16/01/2026 - Headwall 1X | | | | | | | | | | |
|---|---|---|---|---|---|---|---|---|---|---|
| 9.33 | | B | Broken pipe from 4 o'clock to 8 o'clock | | | 00:01:04 | 5 | 4 | | |

5, 00:01:04, 9.33 m  
Broken pipe from 4 o'clock to 8 o'clock

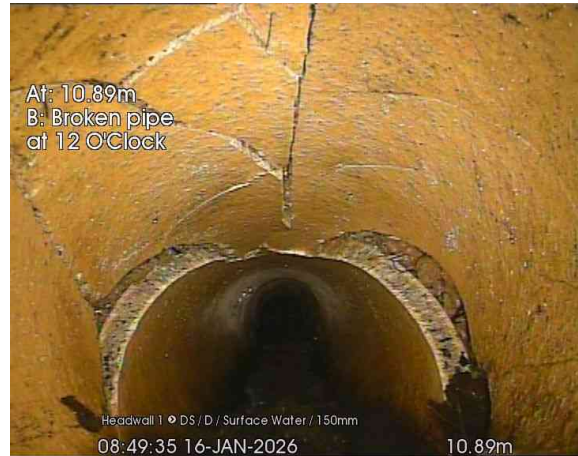
| Section Inspection - 16/01/2026 - Headwall 1X | | | | | | | | | | |
|---|---|---|---|---|---|---|---|---|---|---|
| 10.89 | | B | Broken pipe at 12 o'clock | | | 00:01:17 | 6 | 4 | | |

6, 00:01:17, 10.89 m  
Broken pipe at 12 o'clock

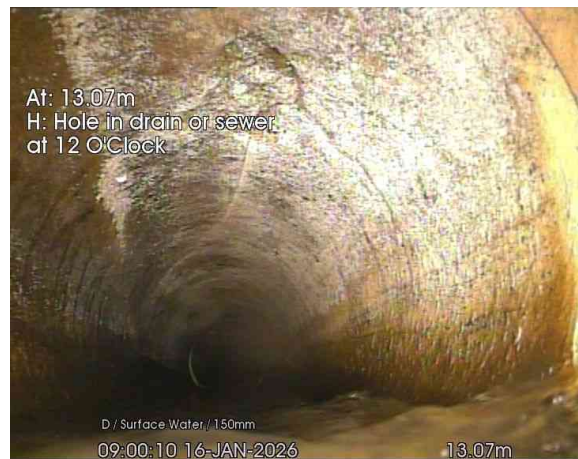
| 4 | 13.07 | H | Hole in drain or sewer at 12 o'clock |

4, 00:01:33, 13.07 m  
Hole in drain or sewer at 12 o'clock

Main line downstream has a hole in the line at 13.07m and a fracture at 17.17m. These should ideally be sealed using 2 x 150mm epoxy patch repairs. Line also holds water at 22.05m, the camera was under water. |Survey abandoned at this point.

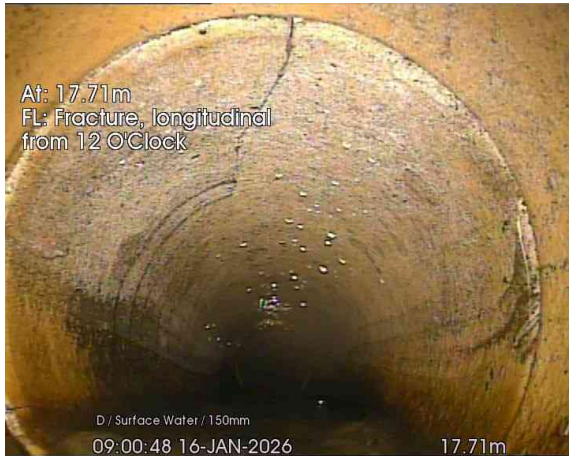
<table><tr> <th>Position [m]</th> <th>Code</th> <th>Observation</th> <th>MPEG</th> <th>Photo</th> <th>Grade</th> </tr><tr> <td>17.71</td> <td>FL</td> <td>Fracture, longitudinal at 12 o'clock</td> <td>00:02:05</td> <td>5</td> <td>3 / 2</td> </tr></table>

5, 00:02:05, 17.71 m  
Fracture, longitudinal at 12 o'clock

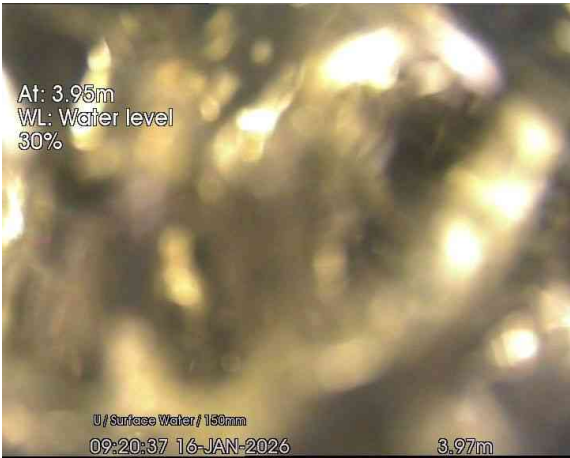
2, 00:00:28, 3.97 m  
Water level, 30% of the vertical dimension
