## 1.0 Introduction

- 1.1 This Technical Note provides a response to the comments made by Leicestershire County Council as Lead Local Flood Authority (LLFA) in their consultation response dated 21<sup>st</sup> November 2024 to planning application reference 24/00484/OUT. A copy of the response is enclosed in **Appendix A**.

# CCTV DRAINAGE SURVEY

**Project Name:** GR6825 - 15 Spring Gardens - Earl Shilton LE9 7EE

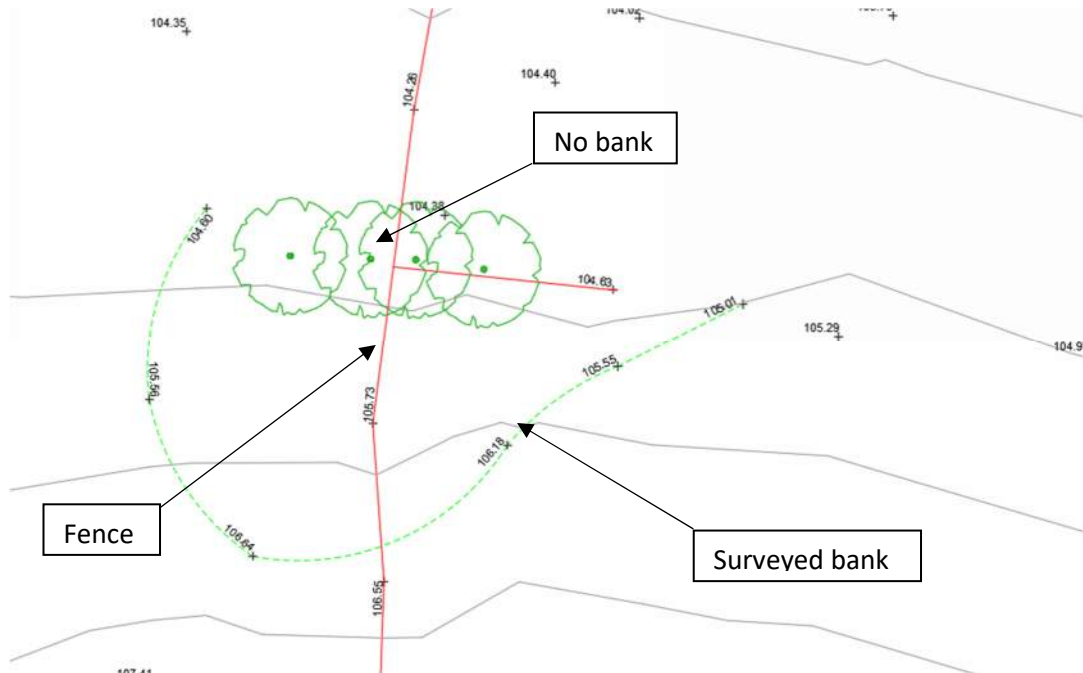
Figure 2.1: Extract from Topographical Survey

- 2.1 The references to pond on the OS map are incorrect, there is no pond in this location.
- 2.2 The area marked “pond” on the OS map can be seen on the topographical survey extract at **Figure 2.1** below with the full survey in **Appendix B**. There is a surveyed ridge (green dashed line) to three sides but nothing to the north. The surveyed levels do not indicate any depression here either.

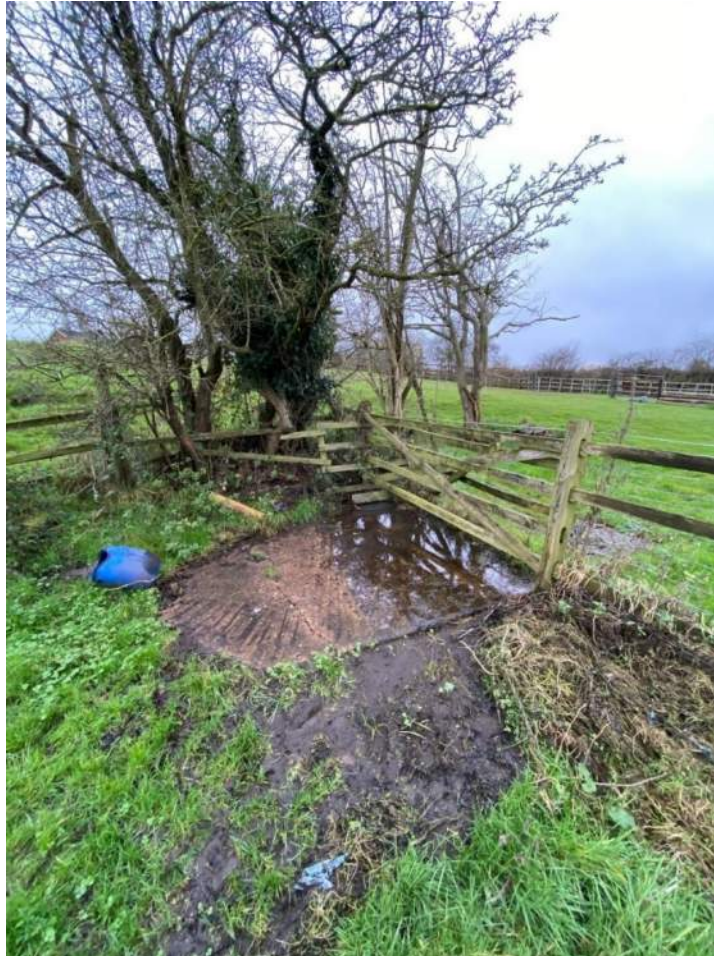
Figure 2.2: OS Marked “Pond” Area with standing water – 6<sup>th</sup> December 2024

- 2.3 A site visit has confirmed that there is no pond in this location as shown in the photograph of the area at **Figure 2.2**. Therefore, whilst there might be a slight localised depression here, if there is it is minimal and as the topographical survey of the “pond” shows this area is unable to store any water.

- 2.4 The landowners have advised that there is a water flow from the ground (spring) in this area and the area is often wet, as shown in **Figure 2.2**. It should be noted that the standing water is on an area of hardstanding which is impermeable.

- 2.5 The flow from the ground is not thought to be large and the volume of water is relatively small as demonstrated on the photograph below taken on 6th December 2024 after the previously wet period comprising named storms in late September and late November 2024. A further, more recent, photo of this area from 24 January 2025 is shown at **Figure 2.2**.

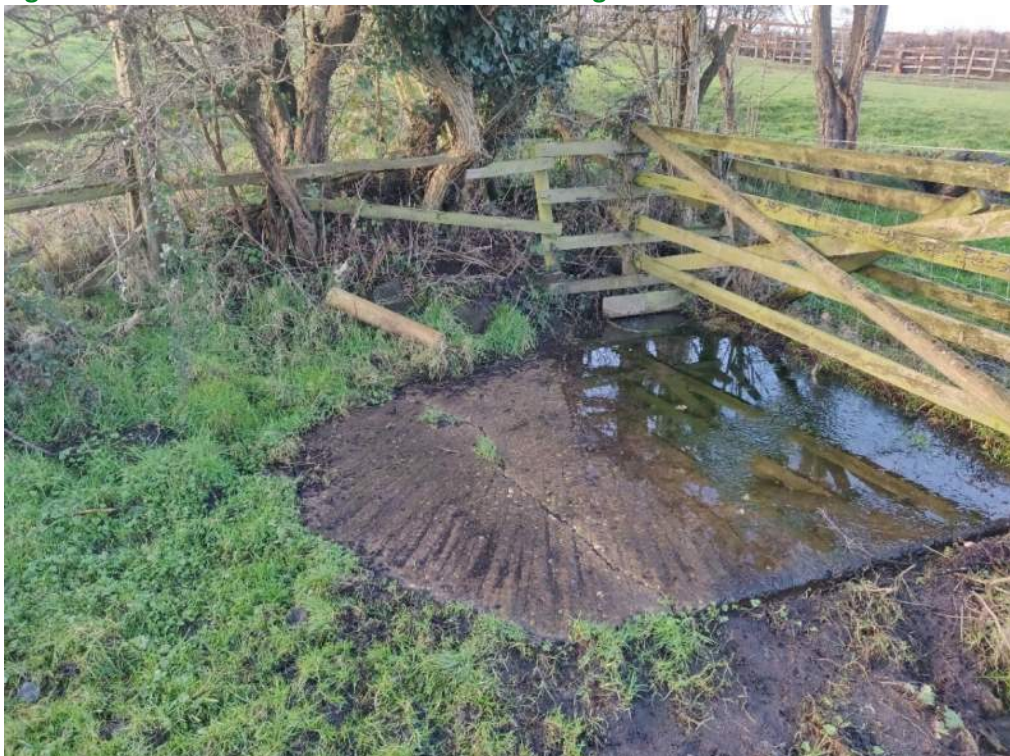
**Figure 2.3: OS Marked "Pond" Area with standing water – 6<sup>th</sup> December 2024**

- 2.6 From further conversations with the landowner we understand that the spring water is collected in a trough and used for animal water. There is an overflow from this which is currently piped down to the ditch adjacent to the site's northern boundary. **Figure 2.4** shows the outfall of this overflow into the ditch.
- 2.7 To ensure that the water does not cause a nuisance for future residents the water will be collected in a feature within an area of open space or a private garden and collected such that the flow can be piped or accommodated within a swale / ditch within the development down to the existing ditch located adjacent to the unnamed road to the north. Thus, post development the spring water will be collected and managed in a manner similar to the existing situation.

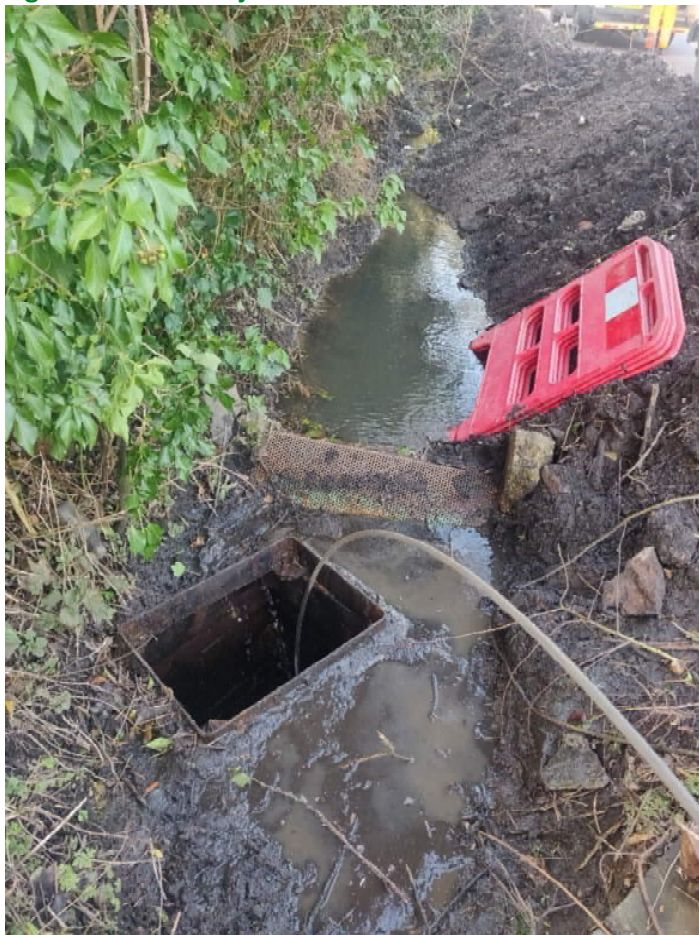
**Figure 4.1: Ditch adjacent to site**

- 4.1 The proposed development will discharge surface water to a ditch located adjacent to the site's northern boundary. The ditch is adjacent to the site boundary and is therefore riparian owned by the landowner and does not form part of the highway. Therefore, the application site has the required permissions to discharge into the ditch.
- 4.2 The ditch has a manhole located at its eastern extent adjacent to Spring Gardens. The ditch which was recently cleaned can be seen in the **Figure 4.1** below.

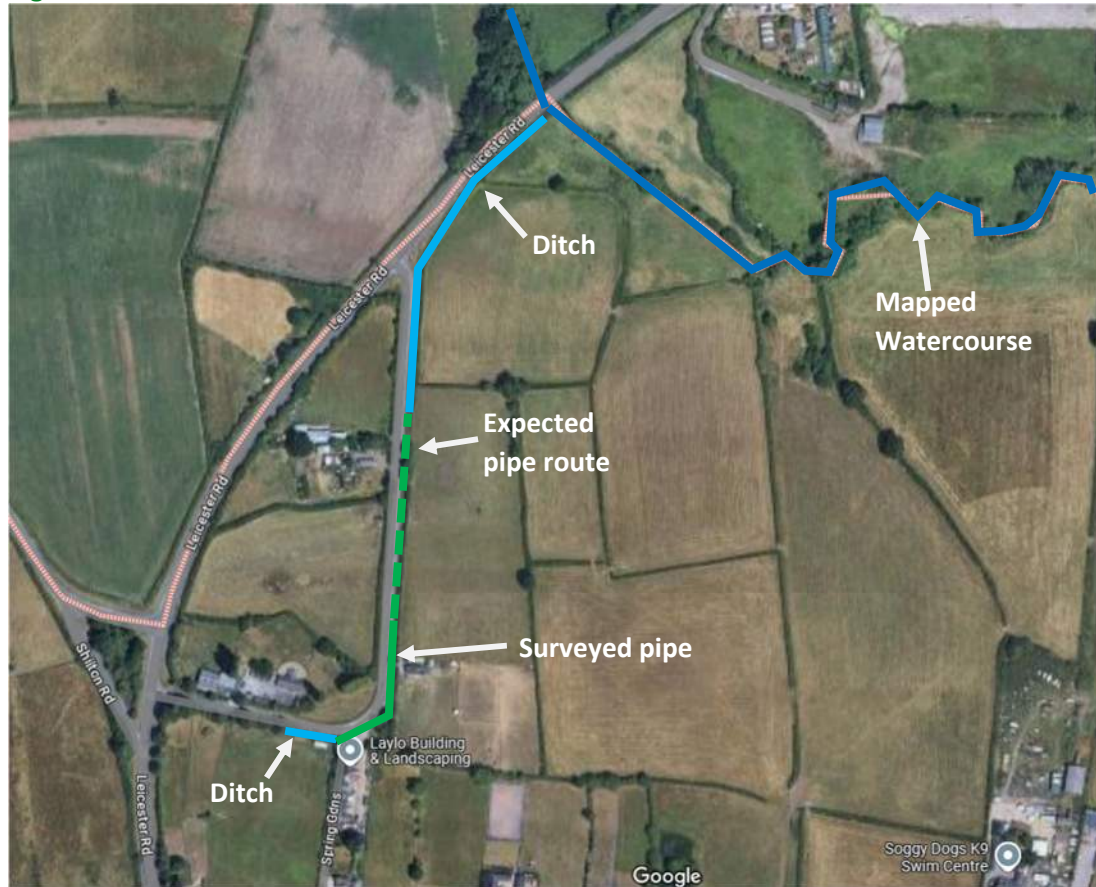
Figure 4.2: Route of outfall to watercourse

- 4.5 The indicative route of the outfall is shown in **Figure 4.2** below. As this shows, the pipe travels for approximately 38m towards the hedge line located on the eastern side of the unnamed road, at which point the pipe turns northwards and travels along the route of what is presumably a now piped ditch with an approximate depth of 1.4m.

- 4.6 The pipe was clear with some minor root ingress but otherwise in good condition and at all times was running clear with no standing water which indicates that this is the case all the way to the outfall. If it was not and the outfall was blocked the pipe would be full in no time with the incoming flow.

- 4.7 The survey of the drainage outfall was able to cover some 90m from the manhole, which was the limit of the survey due to technical constraints comprising upstream access only, a small diameter pipe, the turn to follow the ditch line and no other access points being provided.

- 4.9 It is unclear if the pipe drains into the ditch or if it continues piped all the way to the watercourse. However, as noted above due to a lack of standing water or other blockages in the pipe we are confident that this provides a good outfall for the proposed development and will not cause flooding to down stream neighbours.

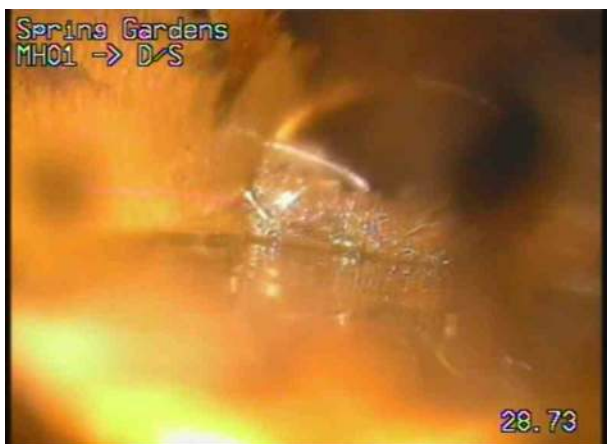
1\_MH01\_Downstream\_DS.jpg, 00:04:11, 28.73 m

Survey abandoned, Unable to pass mass roots and silt, further cleaning required

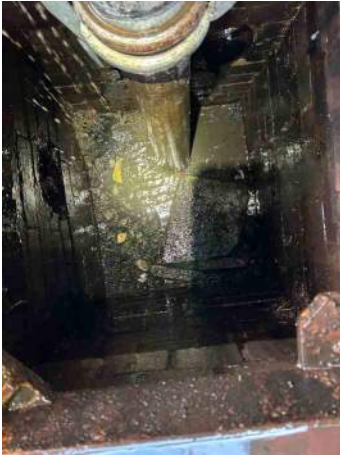
2\_MH01\_Downstream\_DS.jpg, 00:00:00, 0.00 m  
Start node, catchpit, reference: MH01

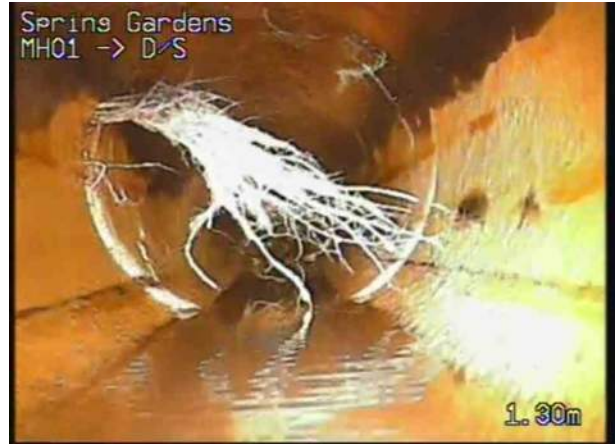
3\_MH01\_Downstream\_DS.jpg, 00:00:41, 1.30 m  
Roots, mass at joint, 10% cross-sectional area loss

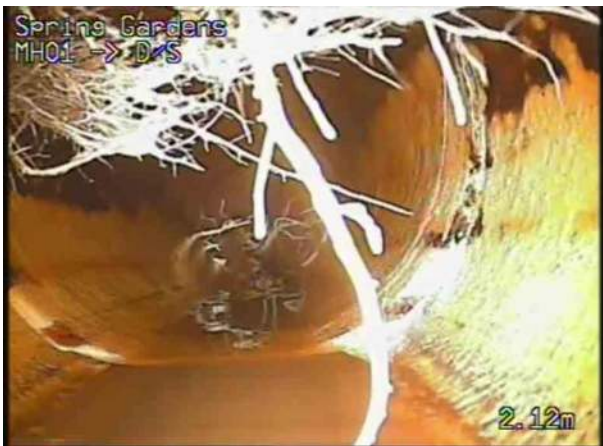
| Scale: 1:272 | Position [m] | Code | Observation | MPEG | Photo | Grade |
|---|---|---|---|---|---|---|
| | 2.21 | CCJ | Crack, circumferential at joint from 1 o'clock to 5 o'clock | 00:00:49 | 4_MH01_Downstream_DS.jpg | 2 / 2 |

4\_MH01\_Downstream\_DS.jpg, 00:00:49, 2.21 m  
Crack, circumferential at joint from 1 o'clock to 5 o'clock

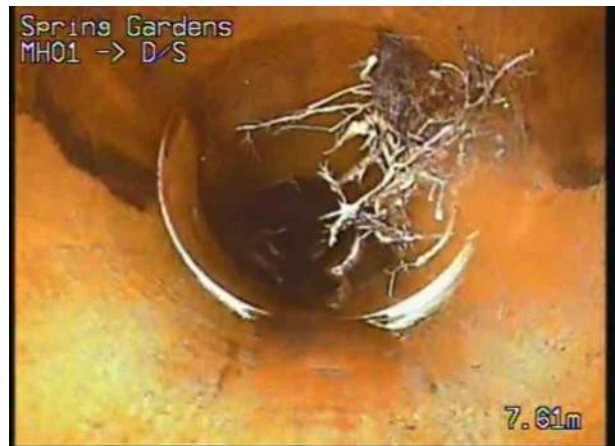
5\_MH01\_Downstream\_DS.jpg, 00:01:41, 7.61 m  
Roots, mass at joint, 10% cross-sectional area loss

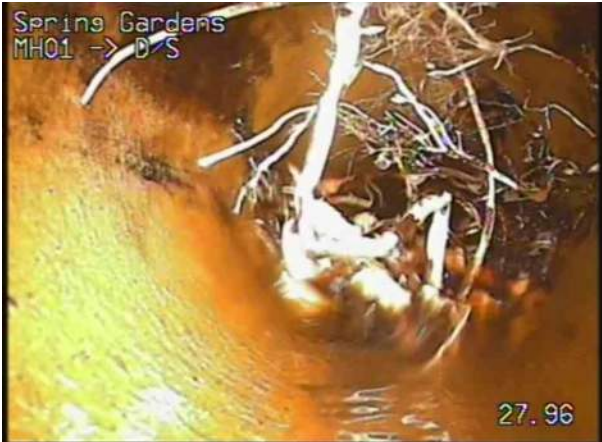
6\_MH01\_Downstream\_DS.jpg, 00:04:37, 27.93 m  
Roots, tap at joint

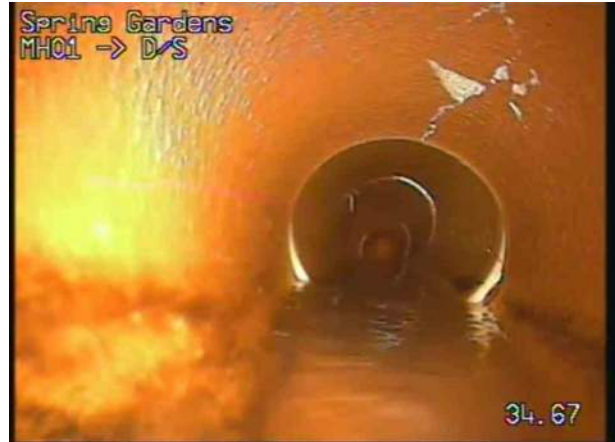
| | <u>34.67</u> | | CL | Crack, longitudinal at 12 o'clock | 00:06:20 | 7_MH01_Downstream_DS.jpg | 2 / 2 |

7\_MH01\_Downstream\_DS.jpg, 00:06:20, 34.67 m  
Crack, longitudinal at 12 o'clock

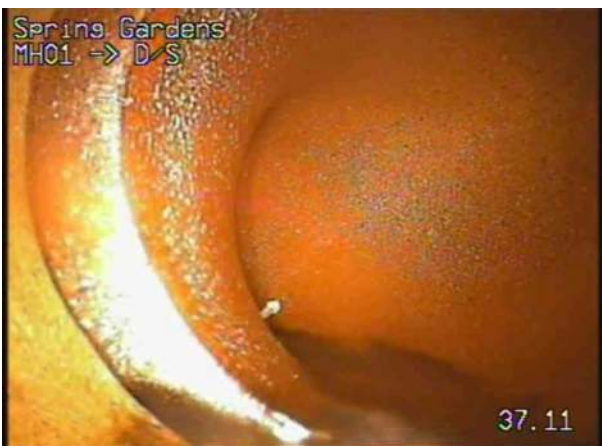
8\_MH01\_Downstream\_DS.jpg, 00:06:41, 37.11 m  
Line deviates left, Sharp

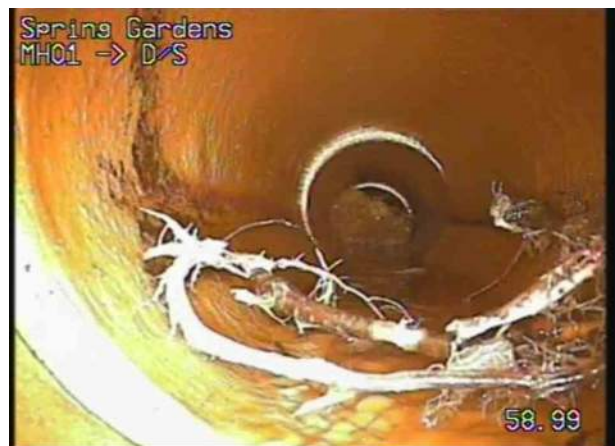
9\_MH01\_Downstream\_DS.jpg, 00:10:29, 58.99 m  
Survey abandoned, Unable to pass tap roots

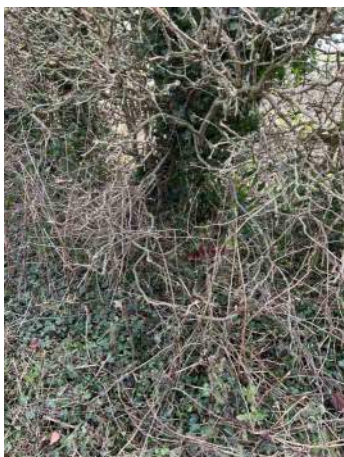
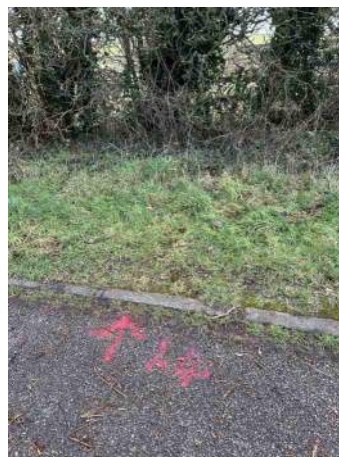
10\_MH01\_Downstream\_DS.jpg, 00:10:30, 58.99 m  
General photograph taken at this point, Position traced & marked 1.4m deep

11\_MH01\_Downstream\_DS.jpg, 00:10:30, 58.99 m  
General photograph taken at this point, Position traced & marked 1.4m deep

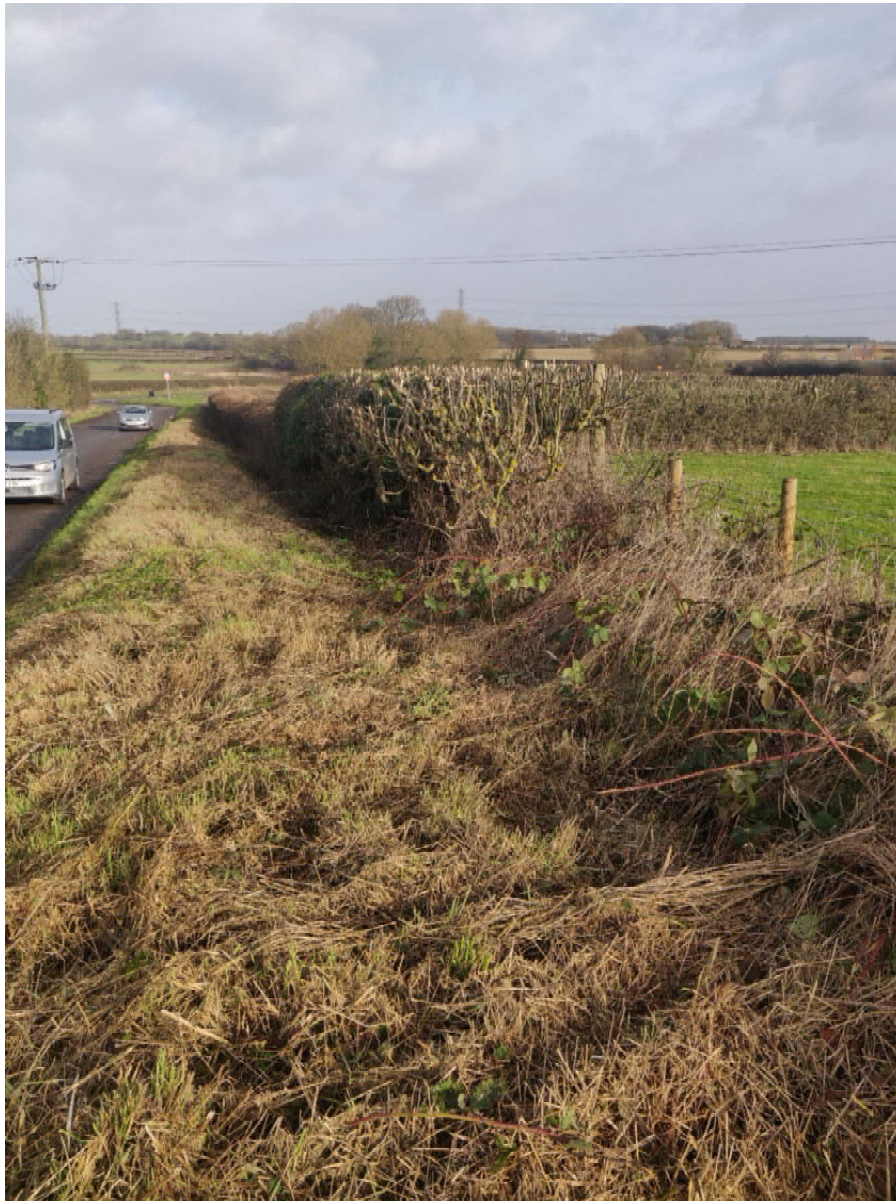
**Upstream end of ditch adjacent to unnamed road looking north**

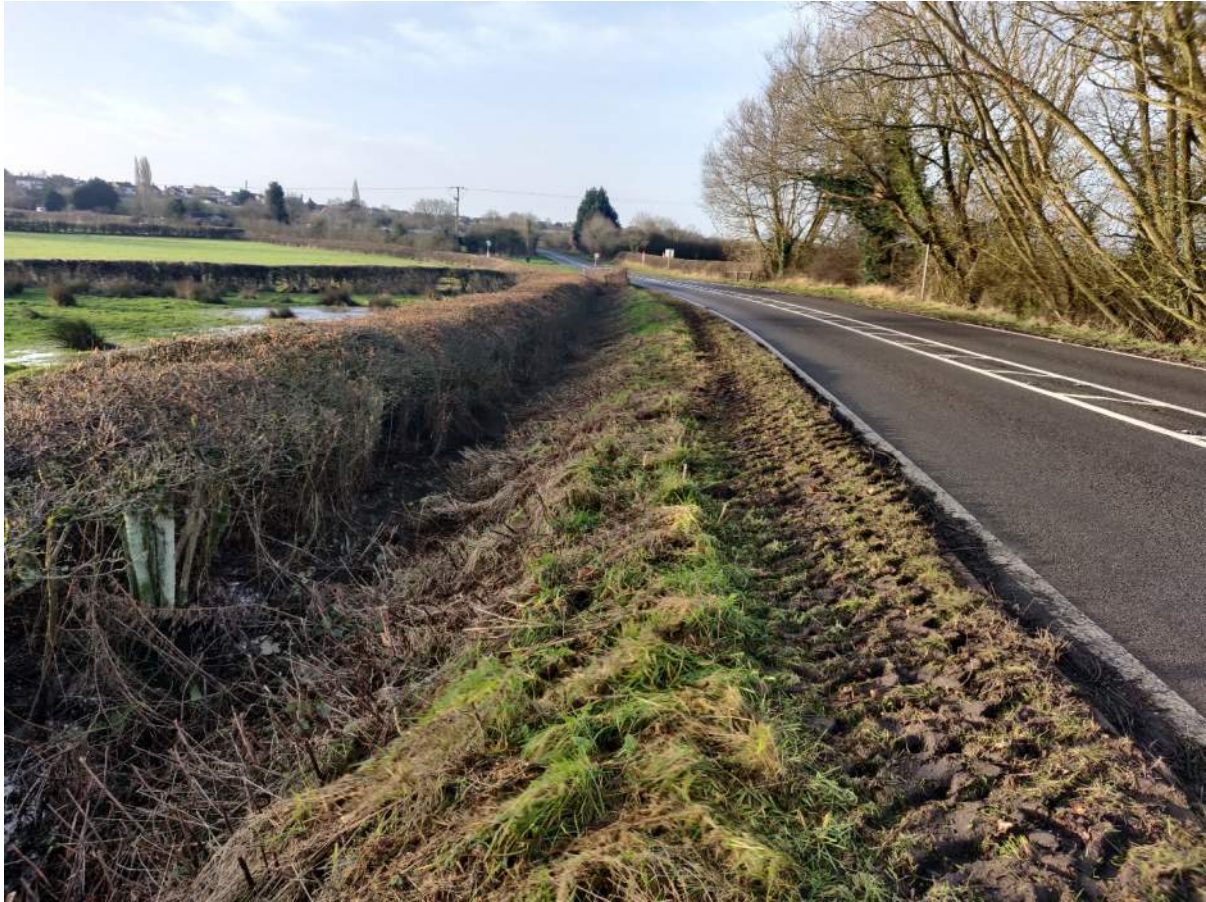
**Ditch adjacent to Leicester Road road looking west towards unnamed road**
