**Arboricultural Report:**  
**Pine trees at School Court, 99–101 Main Street, Stanton under Bardon**

Document reference: 1048/26, Revision 0

## 1. Introduction and background

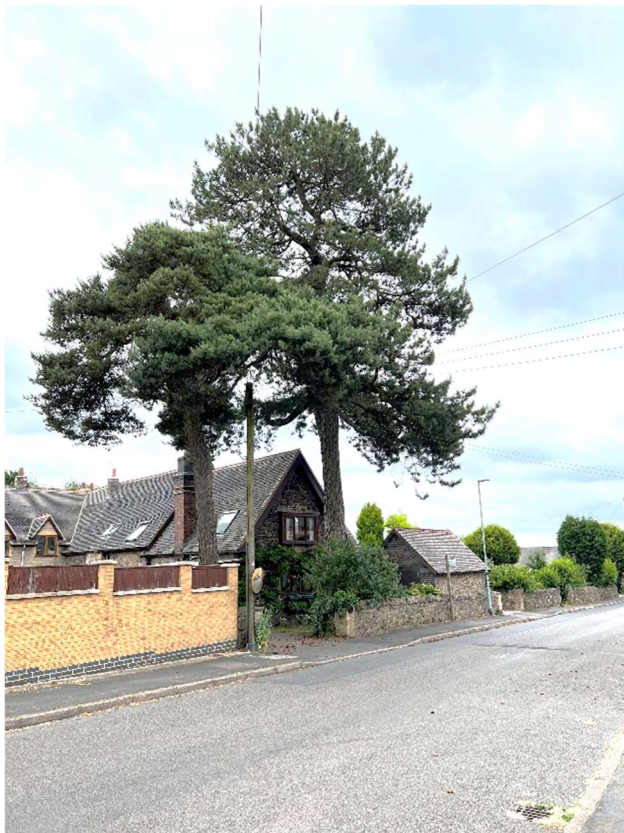
Photograph 1: The report trees as viewed from the uphill side to the north with the smaller tree in the foreground being the Scots pine and the taller tree the Corsican pine (taken in 2023).

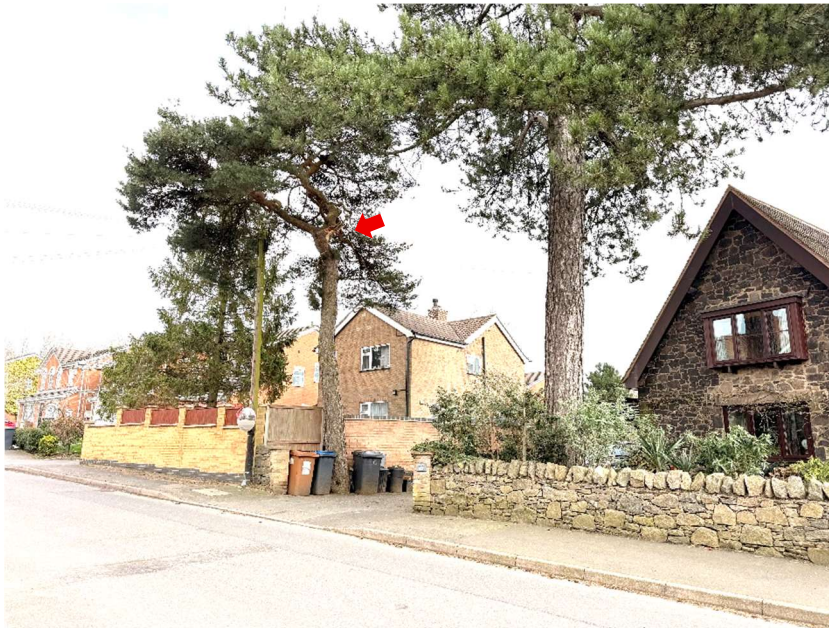
Photograph 2: Showing the two report pine trees in 2026. Red arrow points to recent area of damage.

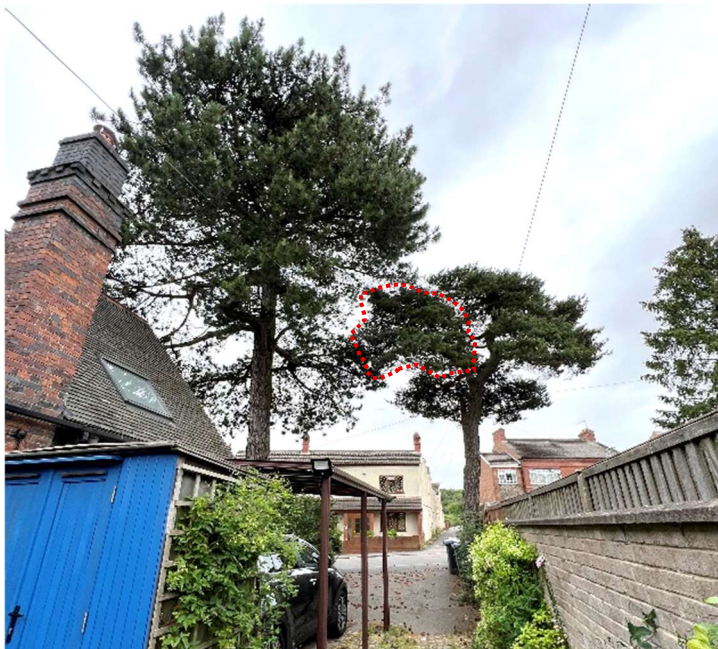
Photograph 3: Looking towards the two trees from within the report property (taken in 2023), before the storm damage. The section of crown outlined with a dashed red line has failed.

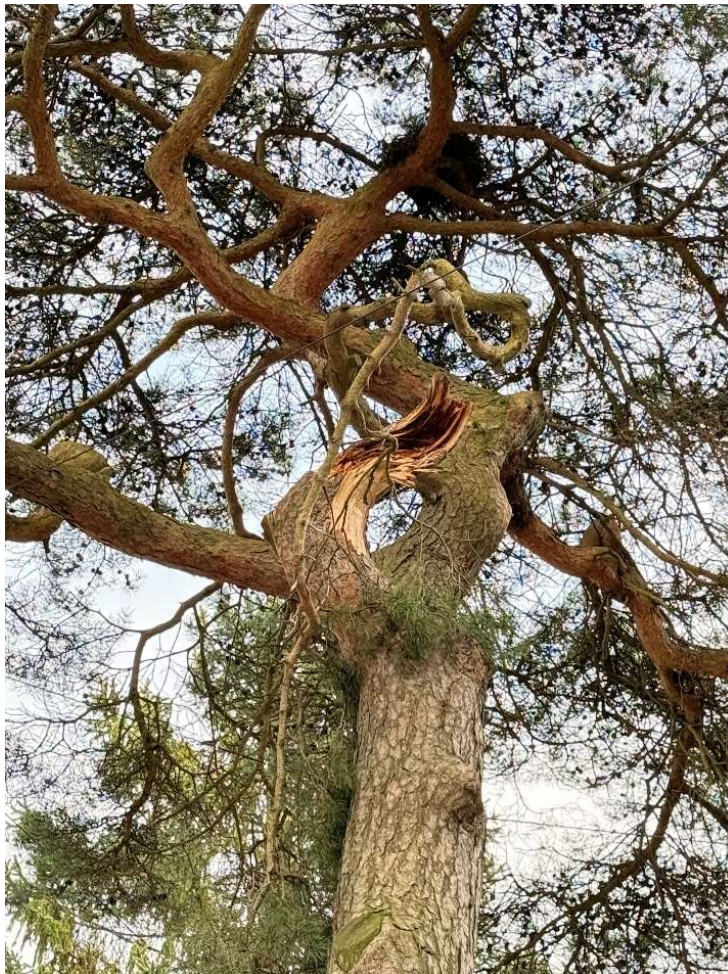
- 2.10 Historically, the tree has been heavily crown lifted, removing all side branches to a height of 7–8m, at which point, the crown is borne from two stems. That to the driveway side measures around 25cm in diameter and it is at this point that the main branch has failed, leaving a truncated stub of around 0.6m radiating out from the trunk. This torn stub exhibits brown cubical decay occupying around 70% of the cross-section of the stem.

Photograph 4: Recent limb failure in tree 1. Note the sparse needle density and brown cubical decay.

- 4.1 Tree 1, the Scots pine has been substantially damaged during a recent winter storm. A leading stem supporting a significant proportion of its crown has failed at the point of some historic decay. This has left a heavily asymmetric remaining crown, which entirely overhangs the neighbouring property, pavement and road.

- 4.2 Due to the age, reduced vigour and species characteristics, there is no prospect of significant new growth forming around the point of damage. The part-compromised crown itself remains at heightened risk of future wind damage, and this hazard cannot be appropriately addressed by way of crown pruning in this instance.

- 4.4 It is recommended that an application be made to the Council for the proposed removal of Scots pine tree 1 of this report. A low stump should remain and will not rejuvenate.

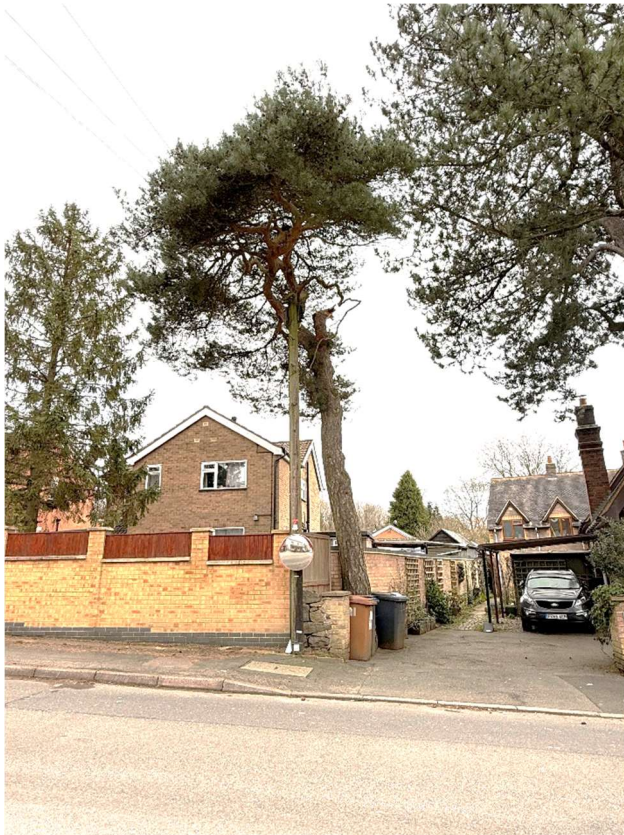
- 2.11 The entirety of the remaining crown is now supported by a sole stem on the northern side which has a diameter of around 35cm and entirely overhangs the neighbouring property 95 Pine View.
- 2.12 At a height of around 1.2m above the main fork, there is a further old, longstanding bark wound upon the remaining stem and it is entirely plausible that there is underlying localised aerial decay similar to that exhibited within the failed main branch on the drive side.

Photograph 5: Showing the heavily offset crown of tree 1 over the neighbouring property, post storm damage.

- 3.1 Tree 1 has been significantly negatively impacted by recent substantial branch loss. Taking into account its age, reduced vigour and suppression on the downhill side by the adjacent tree, there is no realistic prospect of any significant new growth rejuvenation. This means that in addition to its general growth list on the uphill side, the entirety of the crown is borne on this side with at least 80% of it overhanging the neighbouring property and/or the public pavement and road.

- 3.2 Notwithstanding that the tree inherently has some shelter from oncoming winds from a south westerly direction (from the downhill side), taking into account the urban environment with the road corridor and roofs at different alignments and orientations, there is now increased pathways for oncoming winds to load individual branches within the crown and an increased likelihood of future storm damage to remaining branches that would almost certainly occur on either the highway side or where overhanging the neighbouring property.

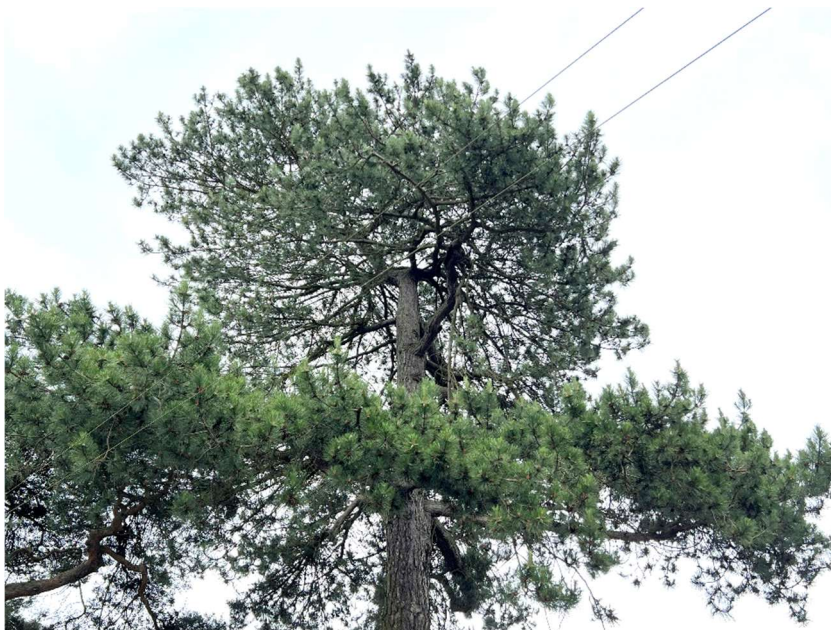
- 2.17 The trunk extends around 7m before the main fork occurs. The road side of the crown features a more central stem continuing upward but, on the side of the report property, there is a primary branch supporting a lower section of the crown that also has a bias over the roof, having been cut back in the past and currently providing around 1.5–2m clearance off the roof/eaves.
- 2.18 The upper crown is developing a slightly flattened, double bellowing form with two distinct strata becoming evident. Although the upper vigour is still reduced, it has not significantly changed since my previous assessment.

Photograph 6: Showing the upper crown formation (taken in 2023). Note the reduced growth density in the upper crown region.

- 2.19 The upper crown has previously suffered some wind damage with some partially folded, part broken branches. However, these remain relatively well attached with no obvious pathway to freefall through the crown should they become detached.
- 2.20 Physiologically, the tree is considered in fair overall condition. However, it is evident that growth in the upper crown has thinned out with a less than optimum current needle density. This species of pine is commonly impacted by a number of fungal needle blight pathogens. However, there is no peripheral branch dieback at present in the report tree and a review of recently cast needles from the floor did not reveal any obvious needle band blight. Overall, only very small diameter deadwood was noted.

- 4.5 The vigour of the upper crown of tree 2 should continue to be considered during ongoing monitoring.
- 4.6 Where applicable, tree works should comply with BS3998:2010 *Tree work – Recommendations* and be carried out by suitably experienced and qualified specialist arboricultural contractors, ensuring any necessary consent is in hand prior to commencement. If bird nesting activity is noted within tree 1, it would be appropriate to wait until this has ceased, before undertaking the removal of the tree.

- 4.7 It is recommended that the remaining pine, tree 2, should be reviewed in summer 2028.

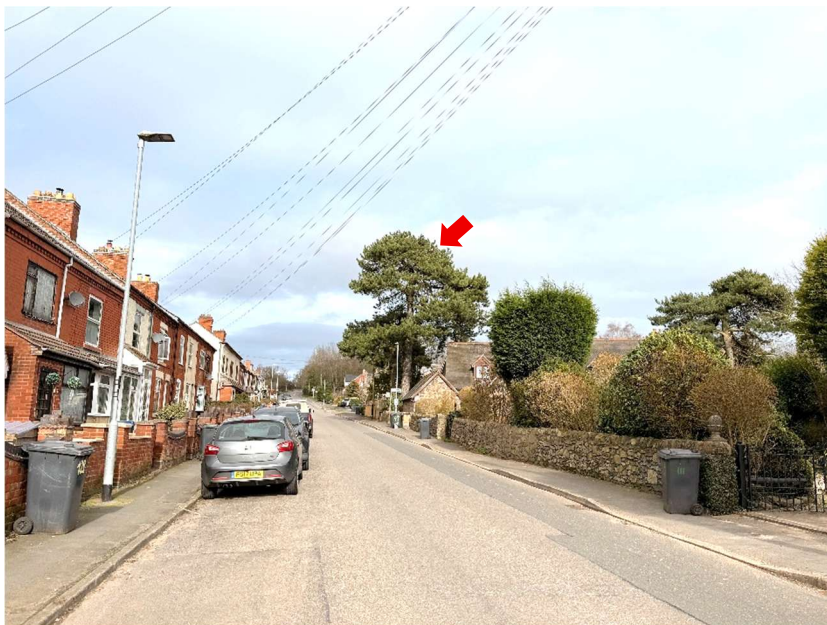
- 3.3 The trees are protected primarily by virtue of their visual amenity contribution. When approaching from the centre of the village to the downhill side of the report property (level with the school and church), it is only the upper crown of tree 2 that is visible and, indeed, this is a prominent feature above the roof lines.

Photograph 7: Distant view towards the upper crown of tree 2 (red arrow) from the village centre to the south.

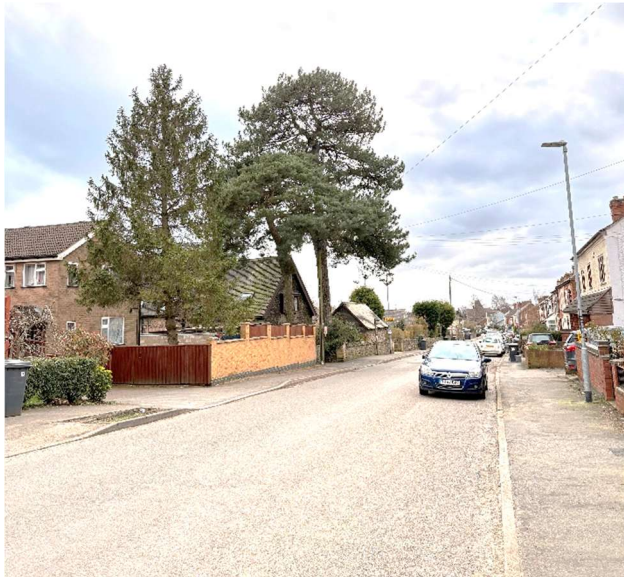
- 3.5 When viewed from the north to the uphill side, the compact crown of tree 1 is less defined against the backdrop of the taller pine's crown.

Photograph 8: Looking towards the two report trees from the uphill side, noting the dominance of the larger pine tree 2.

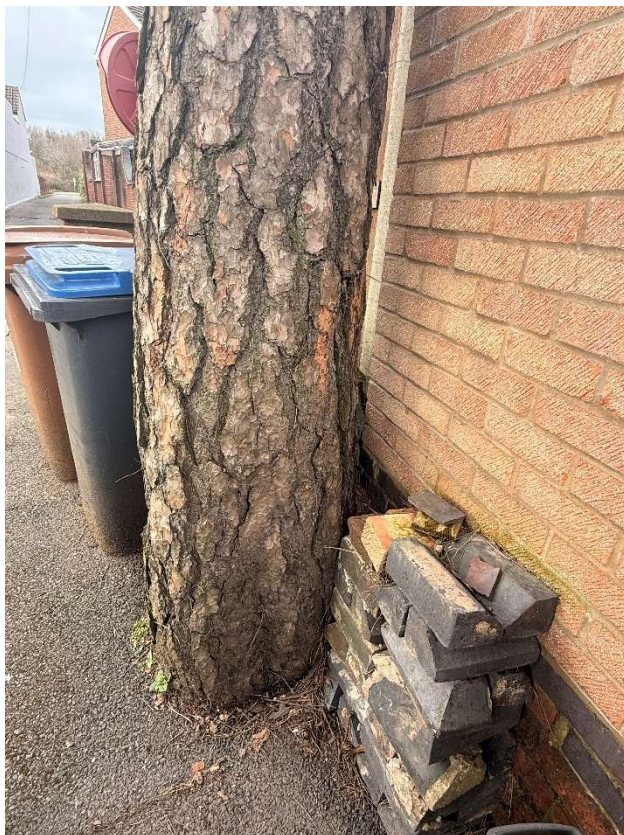
- 3.12 Unfortunately, it is not plausible to replant a replacement tree in situ as it would either be too close to the wall (table A1 of BS 5837:2012 - *Minimum distance between young trees or new planting and structure to avoid direct damage to a structure from future tree growth*) or would impede the use of the drive.

Photograph 9: Tree 1 is too close to the boundary wall to plant a replacement tree in-situ.
