**Project Name:** Forts Estates LTD Hinckley Road PJ479983  
**Project Date:** 12/05/2023

On site to survey lines as directed by site contact. All lines surveyed and found defects in all, including debris and roots.

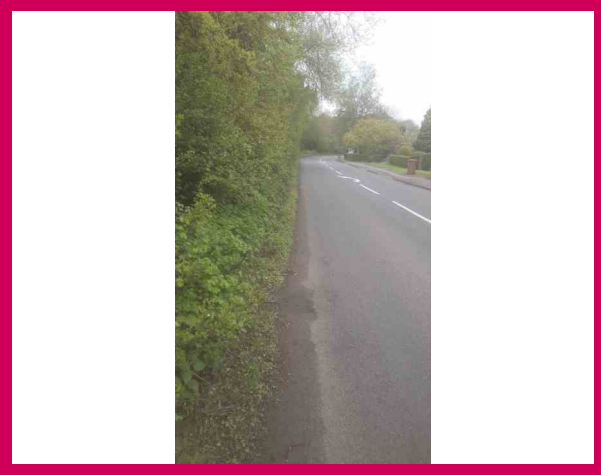
Further works will need TM (1)

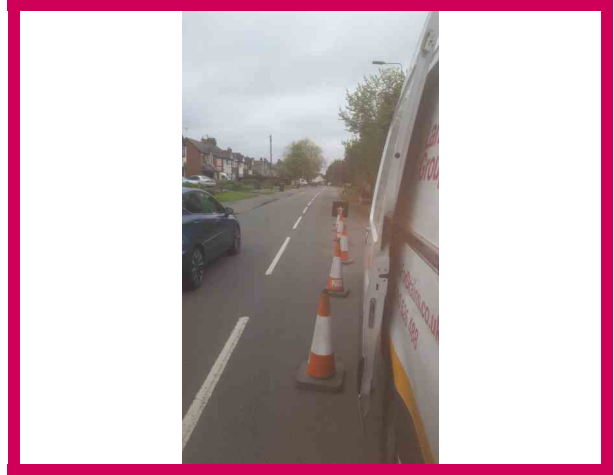
Further works will need TM (2)

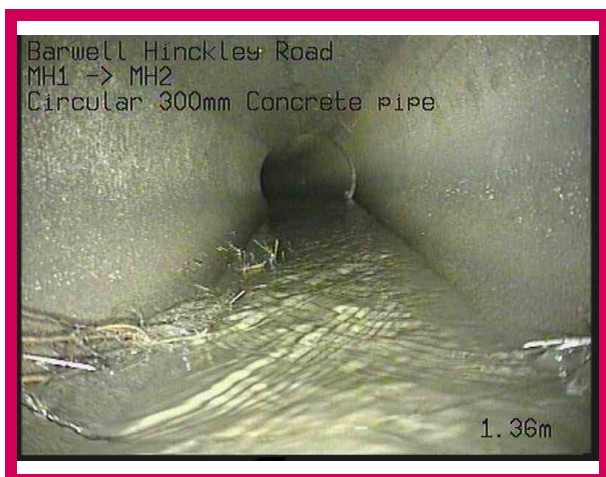
<table><tr><td>0.00</td><td>MH</td><td>Start node, manhole, reference: MH1</td><td>00:00:01</td><td></td><td></td></tr><tr><td>1.36</td><td>S02</td><td>RFJ</td><td>Roots, fine at joint, start</td><td>00:00:14</td><td>MH1X_be<br/>1794be-35<br/>72-4021-a</td></tr><tr><td>58.01</td><td>F02</td><td>RFJ</td><td>Roots, fine at joint, finish</td><td>00:08:07</td><td></td><td>2</td></tr></table>

MH1X\_be1794be-3572-4021-a4f4-c6ea53cc6a12\_20230512\_092320\_558.jpg, 00:00:14, 1.36 m  
Roots, fine at joint, start

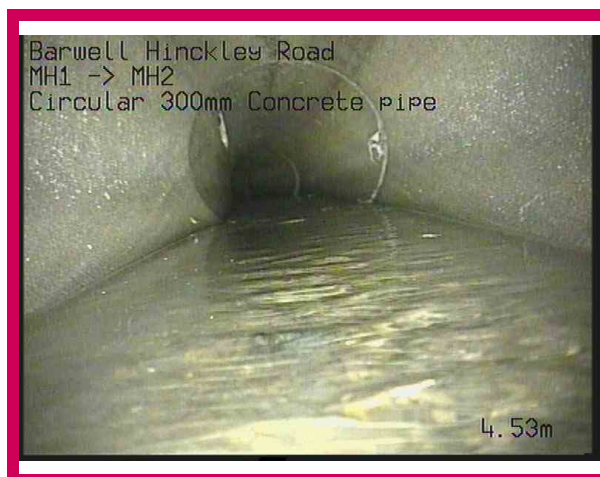
<table><tr><td>0.00</td><td>MH</td><td>Start node, manhole, reference: MH1</td><td>00:00:01</td><td></td><td></td></tr><tr><td>4.53</td><td>S01</td><td>DEC</td><td>Settled deposits, hard or compacted, 5% cross-sectional area loss, start</td><td>00:00:38</td><td>MH1X_93<br/>58778a-26<br/>84-4085-9</td></tr><tr><td>58.01</td><td>F01</td><td>DEC</td><td>Settled deposits, hard or compacted, 5% cross-sectional area loss, finish</td><td>00:08:11</td><td></td><td>2</td></tr></table>

MH1X\_9358778a-2684-4085-95bd-070cae35a578\_20230512\_092347\_170.jpg, 00:00:38, 4.53 m  
Settled deposits, hard or compacted, 5% cross-sectional area loss, start

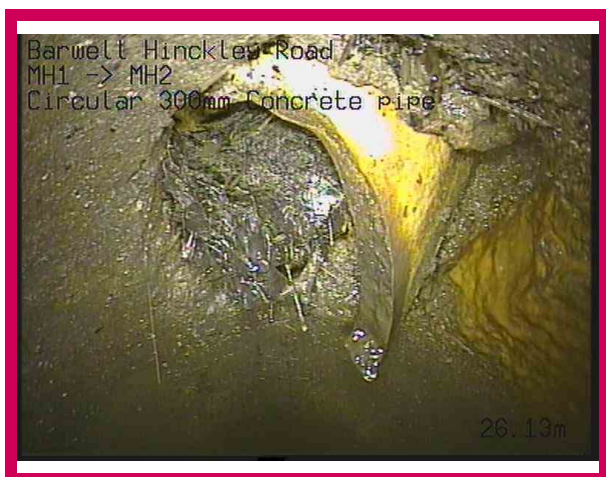
<table><tr><td>0.00</td><td>MH</td><td>Start node, manhole, reference: MH1</td><td>00:00:01</td><td></td><td></td></tr><tr><td>26.13</td><td>CXB</td><td>Connection defective, connecting pipe is blocked at 01 o'clock, diameter: 150mm</td><td>00:03:46</td><td>MH1X_9d<br/>364977-05<br/>eb-40c5-8</td><td></td></tr></table>

MH1X\_9d364977-05eb-40c5-8a1d-4b2cbe5c1326\_20230512\_092742\_945.jpg, 00:03:46, 26.13 m  
Connection defective, connecting pipe is blocked at 01 o'clock, diameter: 150mm

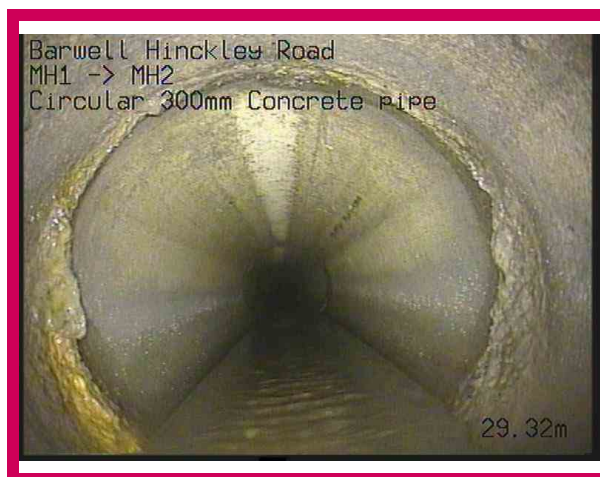
<table><tr><td>0.00</td><td>MH</td><td>Start node, manhole, reference: MH1</td><td>00:00:01</td><td></td><td></td></tr><tr><td>29.31</td><td>S03</td><td>DEEJ</td><td>Attached deposits, encrustation at joint from 12 o'clock to 12 o'clock, 5% cross-sectional area loss, start</td><td>00:04:27</td><td>MH1X_caa<br/>4ccd6-a17<br/>5-469f-944</td></tr><tr><td>58.01</td><td>F03</td><td>DEEJ</td><td>Attached deposits, encrustation at joint from 12 o'clock to 12 o'clock, 5% cross-sectional area loss, finish</td><td>00:08:13</td><td></td><td>2</td></tr></table>

MH1X\_caa4ccd6-a175-469f-9445-378d2495e79a\_20230512\_092838\_343.jpg, 00:04:27, 29.31 m  
Attached deposits, encrustation at joint from 12 o'clock to 12 o'clock, 5% cross-sectional area loss, start

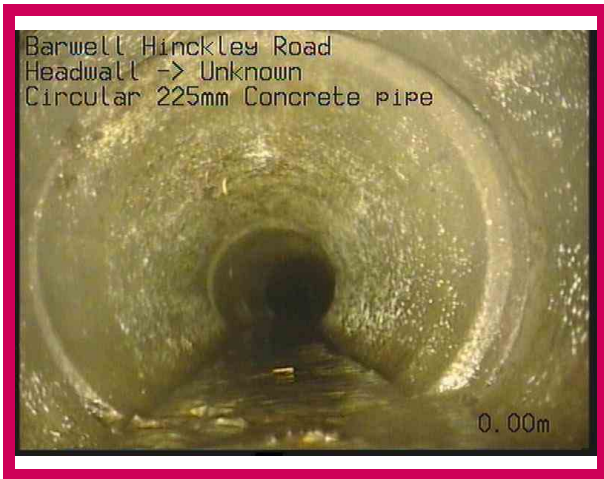
| Scale: | 1:50 | Position [m] | Code | Observation | MPEG | Photo | Grade |
|---|---|---|---|---|---|---|---|
| | 0.00 | S01 | DEC | Settled deposits, hard or compacted, 5% cross-sectional area loss, start | 00:00:04 | HeadwallX_dbc4058-8-2428-42 | |
| | 5.73 | F01 | DEC | Settled deposits, hard or compacted, 5% cross-sectional area loss, finish | 00:00:59 | | 2 |
| | 5.73 | SA | | Survey abandoned: Needs cleanse | 00:01:01 | | |

HeadwallX\_dbe40588-2428-429a-a180-0996b50be15e\_20230512\_100737\_938.jpg, 00:00:04, 0.00 m  
Settled deposits, hard or compacted, 5% cross-sectional area loss, start

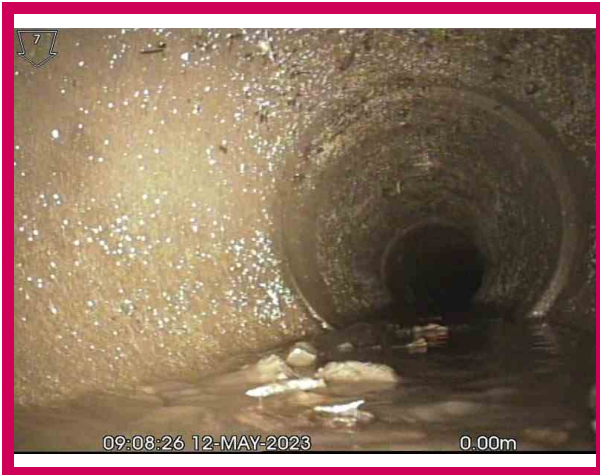
| Scale: | 1:199 | Position [m] | Code | Observation | MPEG | Photo | Grade |
|---|---|---|---|---|---|---|---|
| | 0.00 | S01 DEC | Settled deposits, hard or compacted, 5% cross-sectional area loss, start | 00:00:00 | | HeadwallY_ef8fb813-651a-4342 | |
| | 23.08 | F01 DEC | Settled deposits, hard or compacted, 5% cross-sectional area loss, finish | 00:01:39 | | | 2 |

Headwally\_ef8fb813-651a-4342-958d-f61b861e3aef\_20230512\_105325\_342.jpg, 00:00:00, 0.00 m  
Settled deposits, hard or compacted, 5% cross-sectional area loss, start

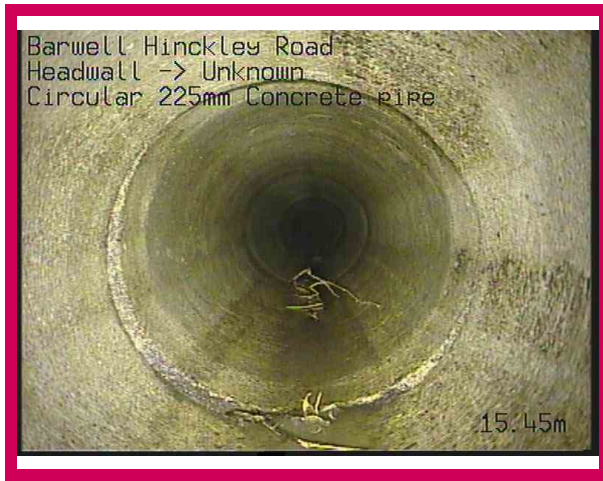
| Scale: | 1:245 | Position [m] | Code | Observation | MPEG | Photo | Grade |
|---|---|---|---|---|---|---|---|
| | 15.45 | S01 | RFJ | Roots, fine at joint, start | 00:02:30 | HeadwallZ<br>ed0df475<br>-4ebc-498f | |
| | 28.33 | F01 | RFJ | Roots, fine at joint, finish | 00:04:31 | | 2 |
| | 28.33 | SA | Survey abandoned: mass root | 00:04:37 | | | |

HeadwallZ\_ed0df475-4ebc-498f-b62e-c4c11c447984\_20230608\_101406\_030.jpg, 00:02:30, 15.45 m  
Roots, fine at joint, start

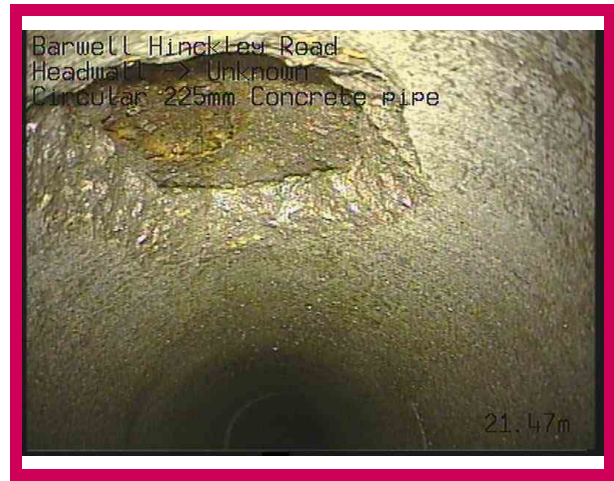
| Scale: | 1:245 | Position [m] | Code | Observation | MPEG | Photo | Grade |
|---|---|---|---|---|---|---|---|
| | 21.47 | H | Hole in drain or sewer from 11 o'clock to 12 o'clock | 00:03:34 | HeadwallZ<br>7866e84<br>1-7100-4af | | 4 |

HeadwallZ\_7866e841-7100-4af3-8475-b18f6978f9f6\_20230608\_101520\_678.jpg, 00:03:34, 21.47 m  
Hole in drain or sewer from 11 o'clock to 12 o'clock

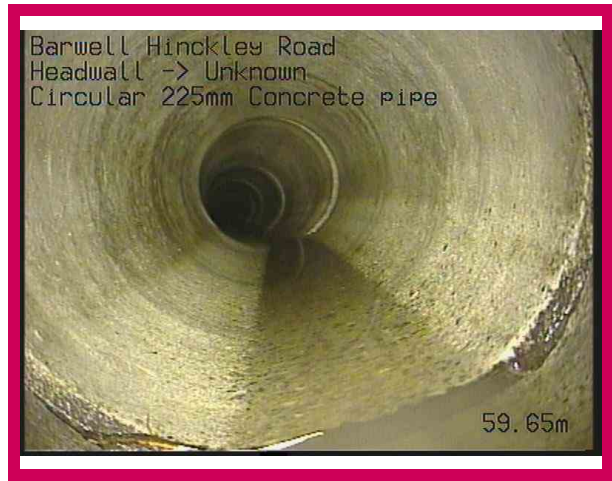
| Scale: 1:636 | Position [m] | Code | Observation | MPEG | Photo | Grade |
|---|---|---|---|---|---|---|
| | 59.65 | RFJ | Roots, fine at joint | 00:06:17 | HeadwallA_247d0fcd-3474-4e0 | 2 |

HeadwallA\_247d0fcd-3474-4e02-8490-c9ee06e1604d\_20230608\_134839\_398.jpg, 00:06:17, 59.65 m  
Roots, fine at joint

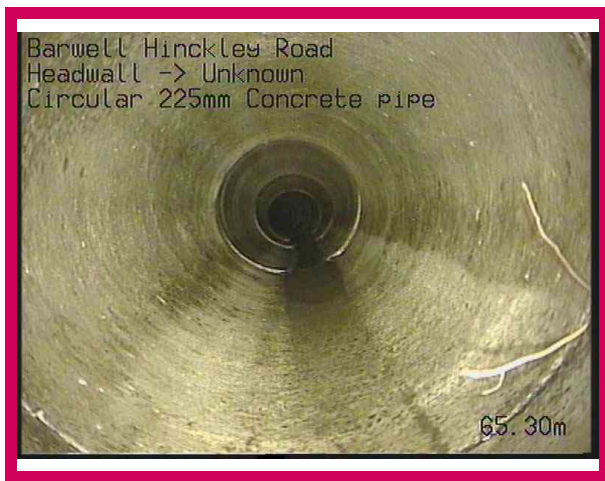
| Scale: 1:636 | Position [m] | Code | Observation | MPEG | Photo | Grade |
|---|---|---|---|---|---|---|
| | 65.30 | RFJ | Roots, fine at joint | 00:00:00 | HeadwallA_b0145eaf-9605-414f | 2 |

HeadwallA\_b0145eaf-9605-414f-9f97-1fa380cf1c8b\_20230608\_134932\_957.jpg, 00:00:00, 65.30 m  
Roots, fine at joint
