01 March 2024

**Trees at Land off Hangman's Lane, Hinckley Leicestershire**

I am pleased to submit my observations in respect to the condition and future management of a group of crack willow (*Salix fragilis*) identified below as group G1, an ash (*Fraxinus excelsior*) identified as tree T2, and a weeping willow (*Salix babylonica*) identified as tree T3 at land off Hangman's Lane in Hinckley. The trees are cross referenced to the accompanying Tree Survey Plan 01.

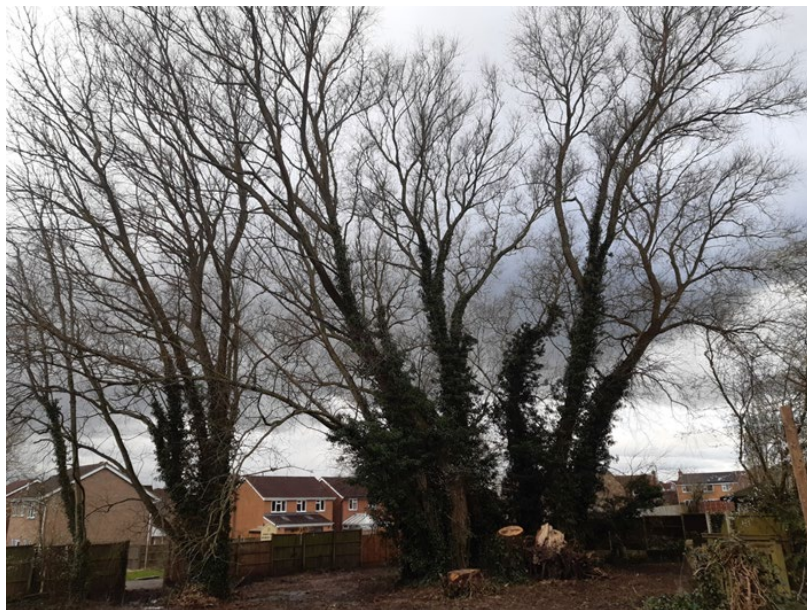
Photograph 1

**Group G1:** The Crack willow trees in the group G1 are over-mature. They are roughly 18-20m in height with an average stem diameter of 700mm. Roughly six main stems in two clumps come together to form one canopy, hence why I have dealt with them on a collective basis and that the 2002 TPO describes them as a group.

The crack willow trees have an over-extended structural makeup (photograph 1) with heavy end branch weight that leaves them vulnerable to failing on a frequent basis. Two main stems failed from the central group in recent stormy weather. They were made safe, I understand, with the approval of the local planning authority under an exemption from the need to submit an application.

A number of the stems are attached to one another by potentially fragile included bark unions, which occur in the forks of acutely angled stems. The strength of these unions is compromised by wood fibres not fusing at the point of bark to bark contact. There is an increased likelihood of failure here as a result.

Wind moves branches around in different directions in an uncoordinated way. This movement acts to lessen the shock on the overall canopy; it is sometimes called mass damping. The recent loss of two complete stems has resulted in a change to the makeup of the canopy which will open it up to wind gusts it was previously sheltered from increasing wind loading on branches and escalating considerably the risk of boughs failing.

Crown reduction pruning would not be feasible in terms of managing the trees in the long-term. It would result in decay and vigorous re-growth at the points of pruning which would be difficult and potentially hazardous to manage by re-pruning. Further, crack willow trees do not lend themselves well to pruning in that they do not efficiently defend themselves from decay. The wounds expected to occur because of pruning would most likely lead to rot in the stems with extensive shoot growth arising at and around the points of injury. Shigo A (1989) is clear in his research that pruning stimulates sprouts which are unsightly, weakly attached and potentially hazardous. He recognises also that reduction pruning leads to cavities shortening further the safe life expectancy of these trees. The degree of pruning needed would be extensive leaving the trees unsightly.

- Remove to ground level the crack willow trees in the group G1 and plant replacements.
- Remove to ground level the ash tree T2 and plant a replacement.
- Remove to ground level the weeping willow tree T3 and plant a replacement.

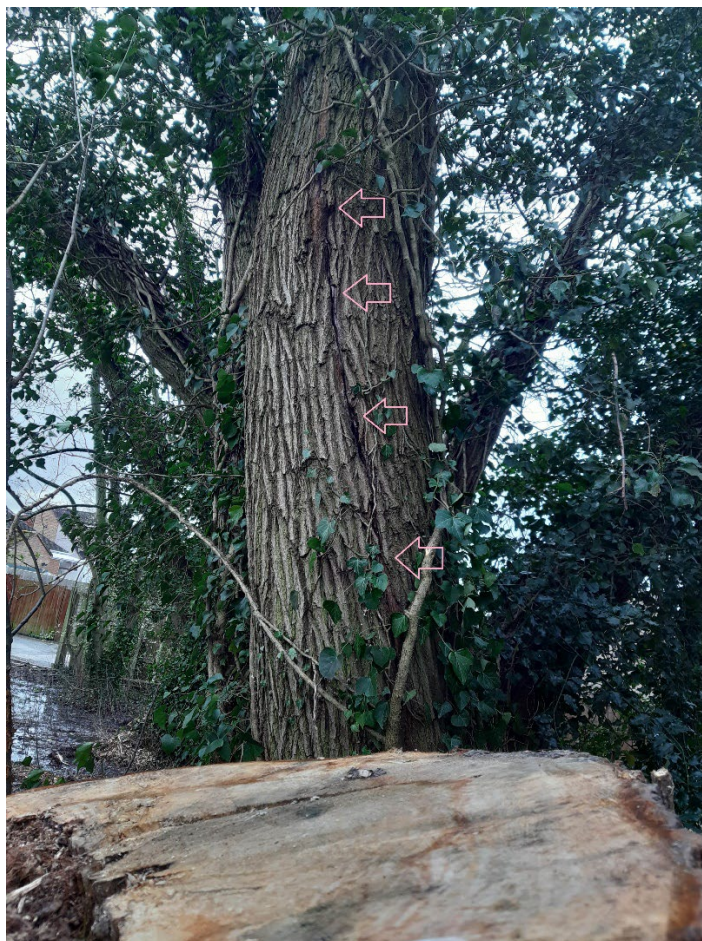
Photograph 2

There is a vertical stress fracture (photograph 2-highlighted by pink arrows) identified through a central stem of the main group. There are significant tension and torsional stresses on all the remaining stems as they blow about in the wind.

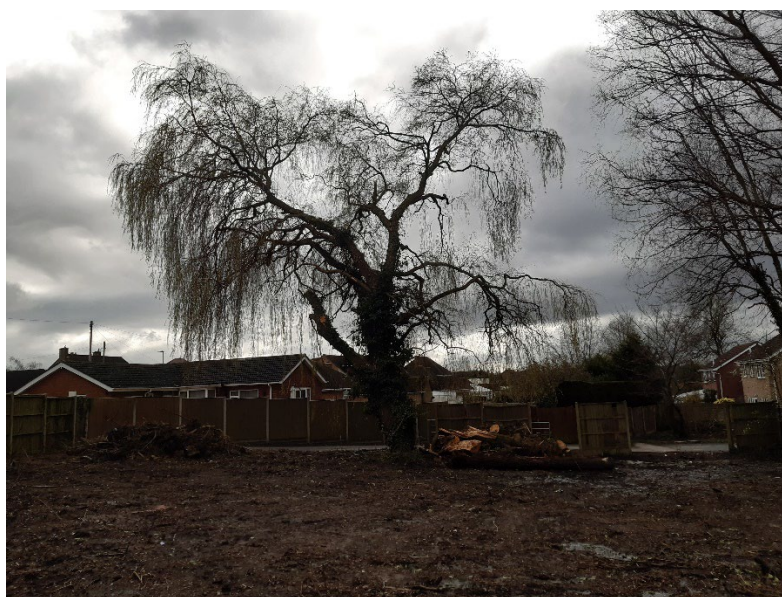
Photograph 3

**Tree T3:** The over-mature weeping willow tree T3 has a very unbalanced exposed form (photograph 3) because of its proximity to another willow tree that was recently removed because of storm damage. It has a moderate degree of public visibility.

Stress fractures are evident throughout the branch framework. Several substantial boughs have broken in the recent storms and been made safe by pruning with the approval of the local planning authority. Very dense ivy restricted a view of its stem. Like crack willow trees, weeping willows have an inherently fragile structure that is prone to shedding boughs. There is a foreseeable risk of the tree T3 breaking up further because of its exposed form and collapsing completely onto the adjacent accessway.

The willow tree T3 could possibly be maintained in the short term by pruning, the degree of which would leave it unsightly and vulnerable to pathogen ingress and decay.
