## 8613 – Internal Photo Record

New Apartments and  
Demolition of the Laban  
Tansey Building at the  
Former Factory Works site  
Between Upper Bond St.  
/ Druid St. Hinckley

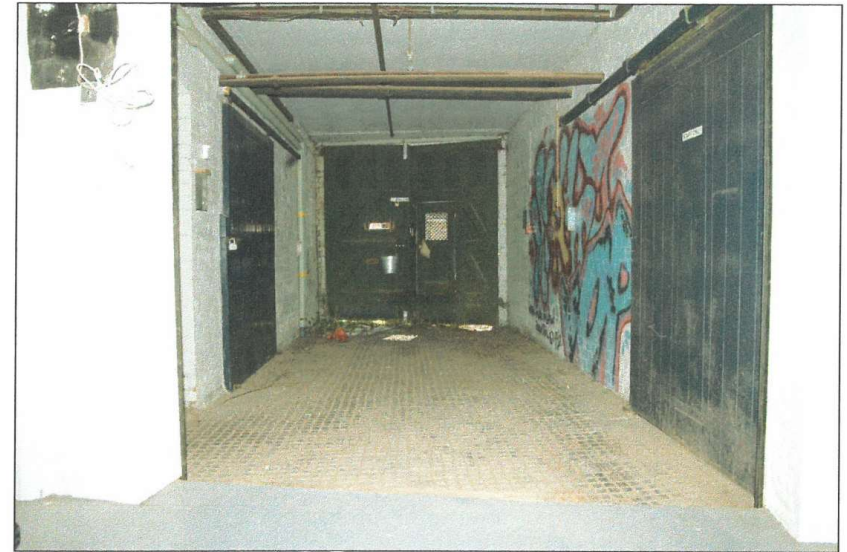
Inside of goods entrance.  
Looking east.

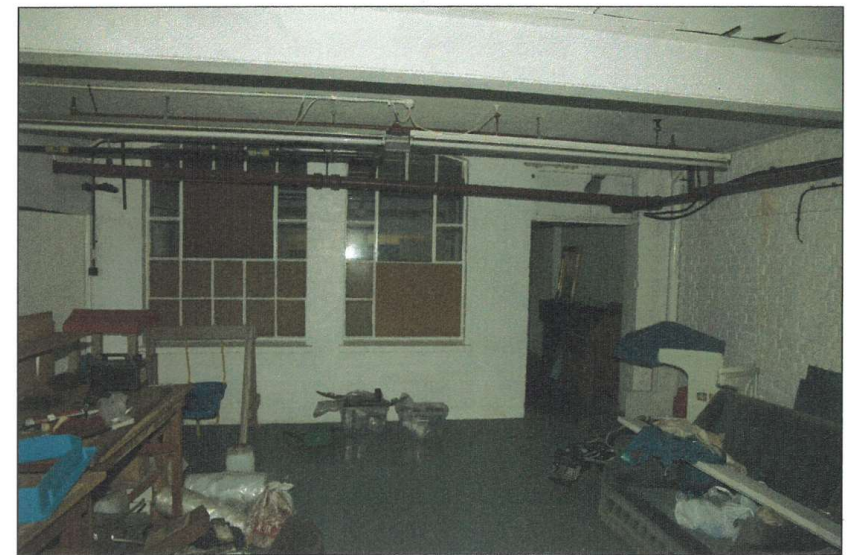
Gable-ended building, ground floor. Original back wall and windows.  
Looking east.
