## **ARBORICULTURAL SURVEY**

**ARGUILE PLACE  
HINCKLEY  
LEICESTERSHIRE  
LE10 0GH**

**Prepared for  
Midland Property Management Ltd  
Whitehouse Court  
New Road  
Featherstone  
Nr Wolverhampton  
Staffordshire  
WV10 7NW**

**7<sup>th</sup> October 2024**

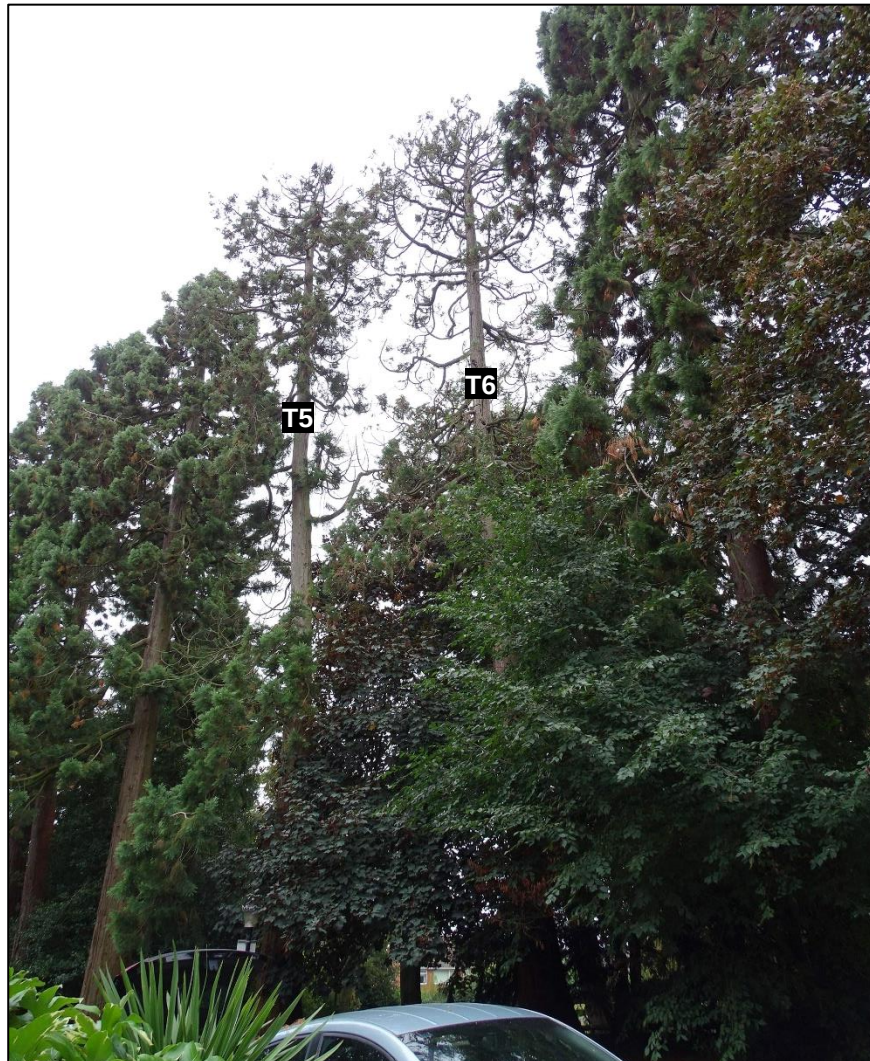
**Photograph 1: T5 & T6 viewed from the north-east**

- 5.1.1** The crown dieback affecting this tree and the neighbouring T6 was the issue of greatest concern arising from my 2022 inspection. T5 is situated close to the western edge of drive. It is a tall specimen with a relatively slender and high crown that had died back significantly prior to my inspection in 2022.
- 5.1.2** Whilst the change in the tree's condition has not been dramatic, its decline has continued and it is supporting less needle cover than in 2022. In view of this, there appears to be little prospect of wellingtonia recovering and my recommendation is that it now be removed along with the stump.

**5.2.1** Situated to the north of T5, this is a similar sized tree set slightly further back from the western edge of the drive. Of the pair, this tree had died back more extensively prior to my inspection in 2022. As with T5, its condition has deteriorated and it now has insufficient needle cover to sustain it in the long-term, and there is no realistic prospect of it recovering. Accordingly, I recommend that this tree is also removed along with the stump. A single replacement wellingtonia should be planted between the current positions of T5 & T6

**5.2.2** Following the issuing of my previous report, the Borough Council's Tree Officer inspected this tree and concluded that it should be felled. With regards to T5, he suggested that it *'may last a bit longer with dead wood removal'* but given its further decline this is no longer a realistic option. There was still no readily apparent reason for the trees' decline.

| Tree ID | Species | Recommended Works | Priority |
|---|---|---|---|
| T5 | Wellingtonia | Fell to ground level and grind the stump | 1 |
| T6 | Wellingtonia | Fell to ground level and grind the stump<br>Plant a single replacement wellingtonia between current positions of T5 & T6 | 1 |

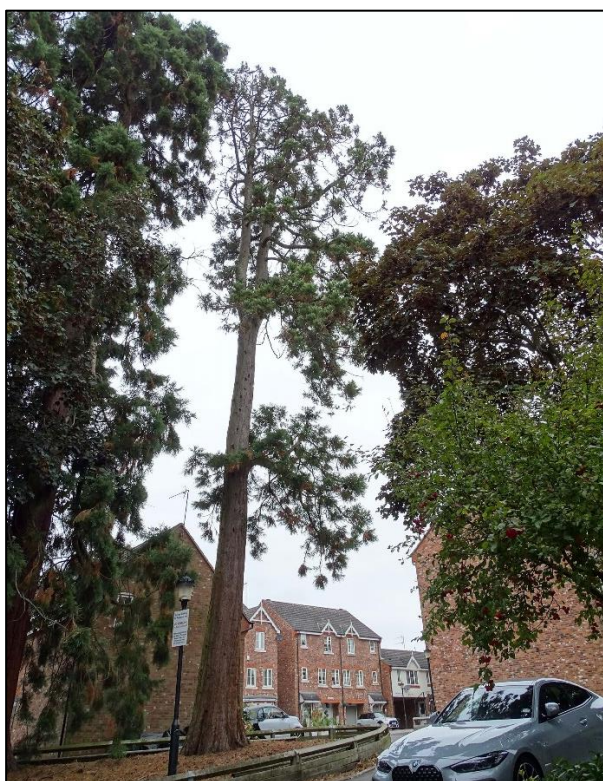
**Photograph 3: T10 viewed from the south-east**

**5.5.1** Growing close to the northern end of the bed, this tree is inclined slightly to the north, with a paucity of branching on the southern side due to the competing influence of T9. The trunk bifurcates at around 12 metres but the fork appeared to be reasonably optimised and not especially predisposed to failure. In my previous report, I observed that although less densely foliated than the adjacent T9, this was likely to have been a consequence of its greater exposure rather than indicative of ill-health or decline and did not recommend any remedial pruning.

**5.5.2** In the intervening period, there has been a further decrease in needle density in the southern section of the upper crown, but this is relatively localised rather than an overall decline. Given the extent of the dieback, consideration could now be given to the removal of the significant dead branches from the upper section of the crown. However, as the majority of these are in the southern side, over the bed rather than the drive, this is not currently critical.

| Tree ID | Species | Recommended Works | Priority |
|---|---|---|---|
| T10 | Wellingtonia | Remove the dead wood of 25mm dia. and above from the upper crown | 2 |

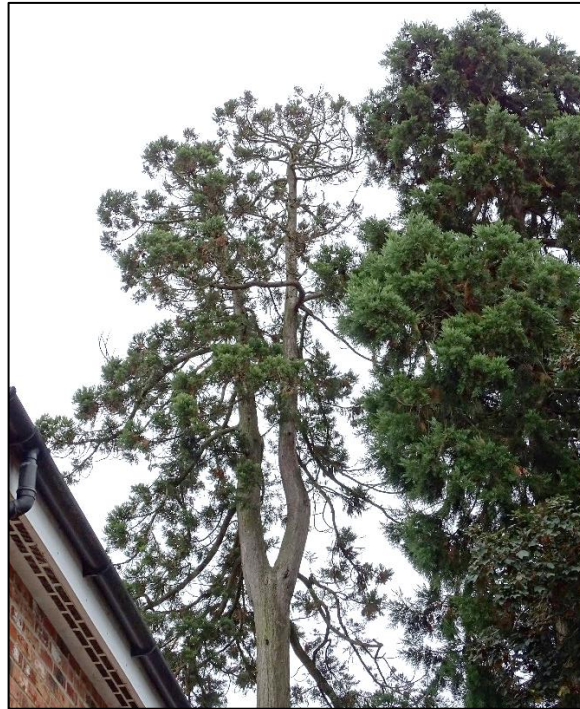
**Photograph 4: Upper crown of T10 viewed from the west, showing the reduced needle density in the southern (right) side**

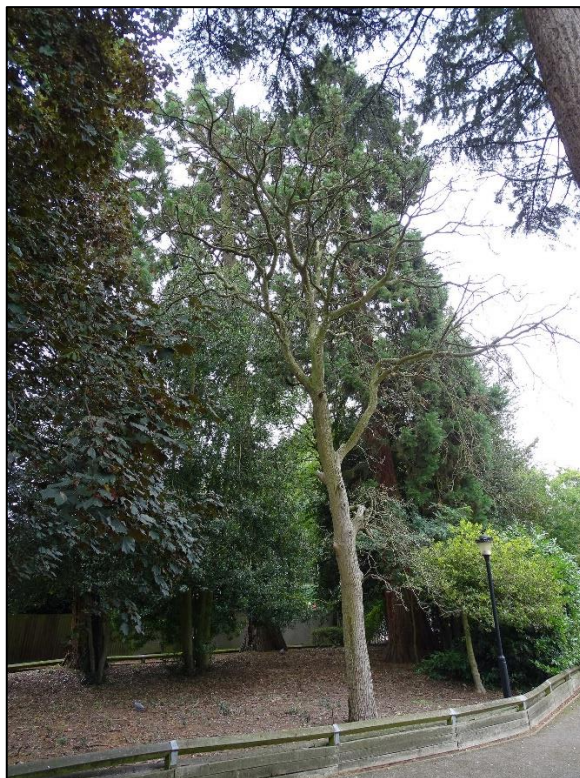
**Photograph 5: Dead walnut viewed from the north-west**

- 5.6.1** This is an immature specimen situated on the western edge of the bed containing the wellingtonias, which has died since my previous inspection and requires removal prior to its crown beginning to break up.

| Tree ID | Species | Recommended Works | Priority |
|---|---|---|---|
| A | Walnut | Fell to ground level and grind the stump | 1 |

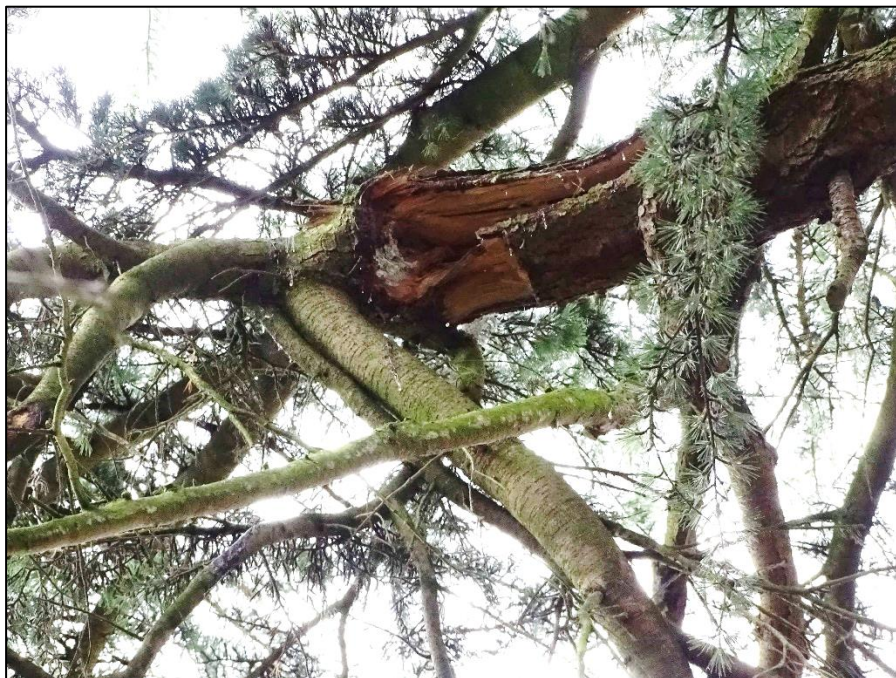
- 5.7.1** The cedar is in the early stages of maturity and situated to the front of number 5 Arguile Place. There is a fractured branch in the southern side of the mid-crown. Although this is supported by a branch below and appeared to be relatively stable, given the proximity of the tree to the adjacent house and path, the damaged section of the branch would be better removed.

**Photograph 6: fractured branch in the crown of Deodar cedar B**

| Tree ID | Species | Recommended Works | Priority |
|---|---|---|---|
| B | Deodar cedar | Remove the damaged section of the fractured branch from the southern side of the mid-crown | 1 |

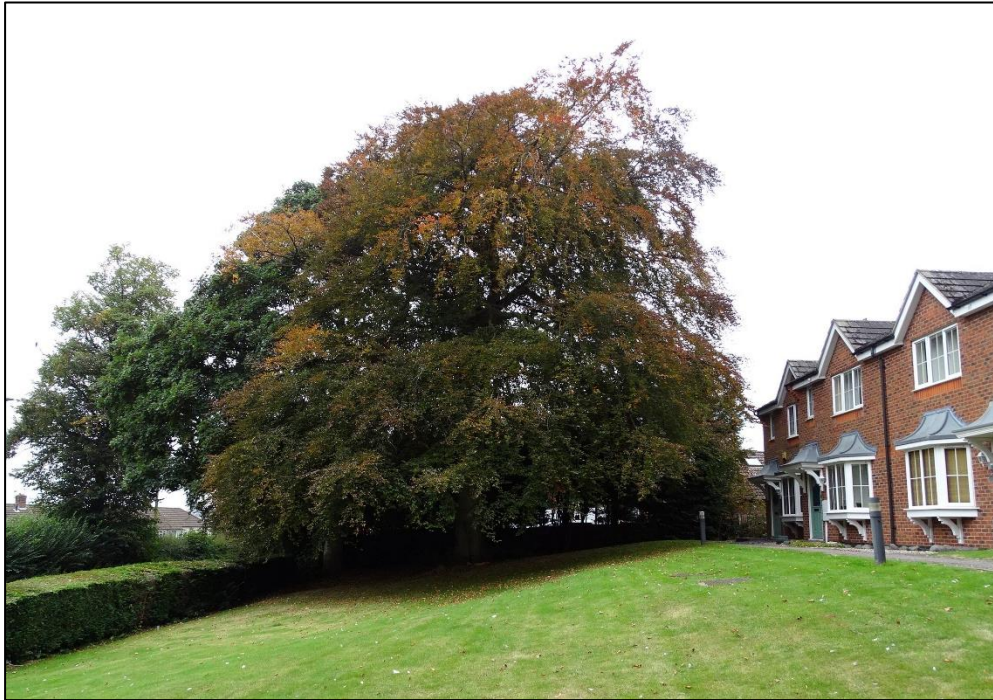
**Photograph 7: Copper beech C viewed from the east**

- 5.7.1** This is a substantial and prominent mature trees situated to the front of number 1 Arguile Place. Its crown is supported on two principal upright stems arising from a tight fork at 2.5m. A braided polypropylene hollow rope ('Cobra') brace has been installed between the two stems at a high level to support the weak fork.

**5.7.3** Given its proximity to both the adjacent house and the road, I recommend that further investigations be undertaken utilising an air spade operated by a specialist contractor to expose the underside of the buttress roots to assess the extent of decay associated with the fungal colonisation and its likely impact on the immediate and longer term stability of the tree. This information can then be used to inform the future management of the tree.

| Tree ID | Species | Recommended Works | Priority |
|---|---|---|---|
| C | Copper beech | Undertaken an air spade investigation to determine the extent of the decay associated with the fungal colonisation of the roots | 1 |

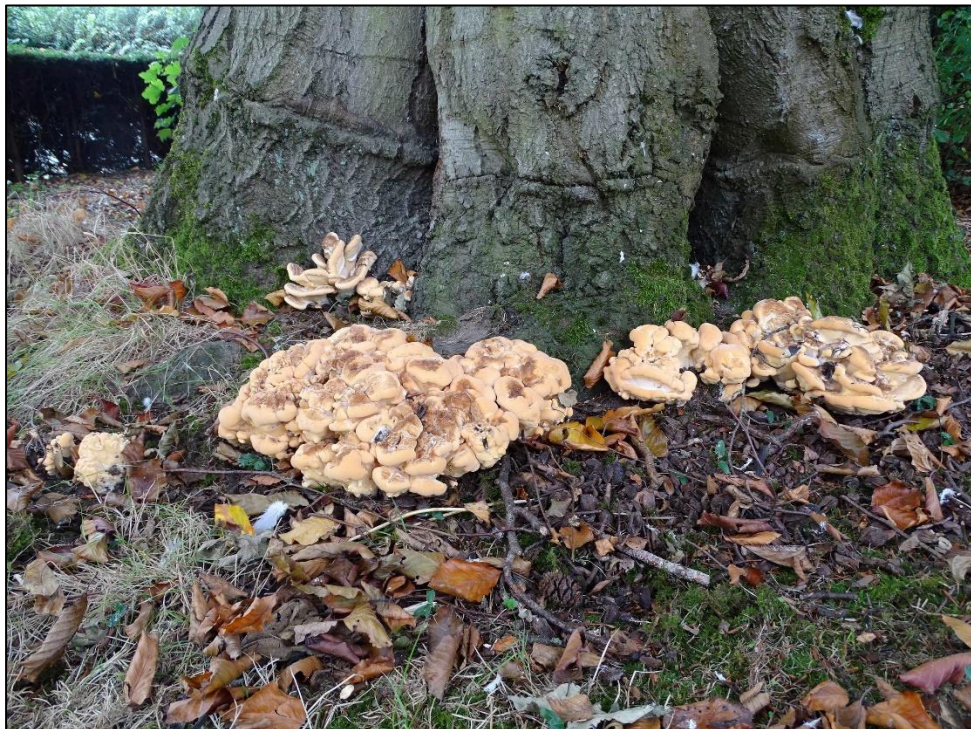
- 5.7.2** Whilst the copper beech was not included in the instruction, I noticed a cluster of fungal fruiting bodies at the base of its trunk that warranted further investigation. The fruiting bodies, which were around the north-eastern side of the base of the tree, were of the Giant polypore fungus (*Meripilus giganteus*). This fungus, which is most commonly found on beech, decays the main structural roots of affected trees, particularly on the underside. It is one of the most serious root rotting fungi on beech and can render colonised trees susceptible to windthrow, sometimes before there are any signs of decline evident in the crown. Other than when the colonisation is at an advanced stage, it is typically difficult to accurately assess the development of the decay associated with the fungus as the deeper roots may be extensively degraded and susceptible to brittle fracture, whilst the upper, younger roots remain unaffected.

**Photograph 8: Giant polypore fruiting bodies at the base of copper beech C**

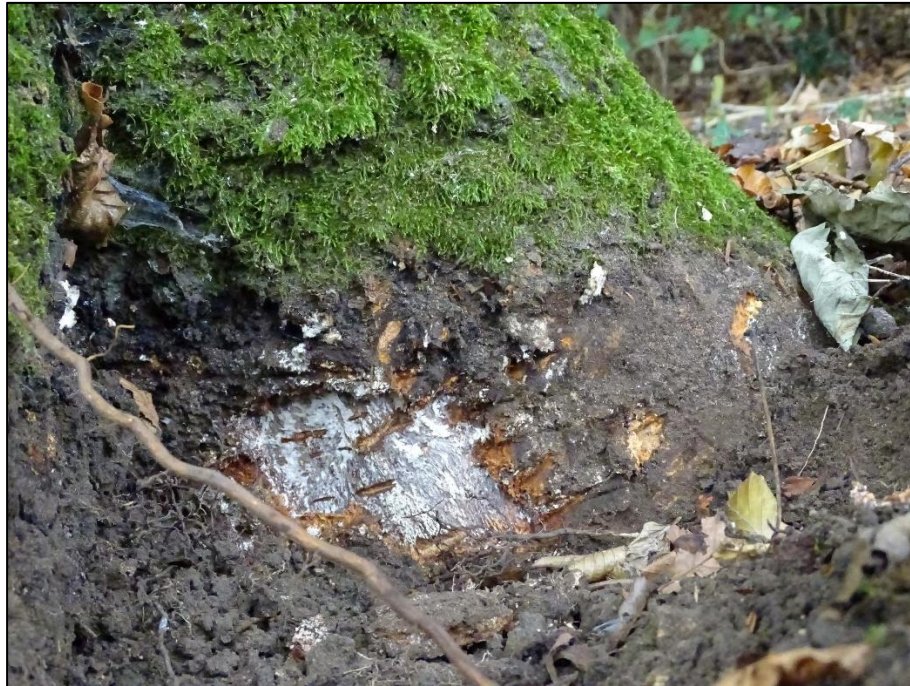
**Photograph 9: Dead bark removed from a colonised buttress exposing the fungal mycelium beneath**
