## Arboricultural Report BS5837:2012

Travelodge Old Markfield Services, Markfield LE67 9PP

Project ref: AEL-19394

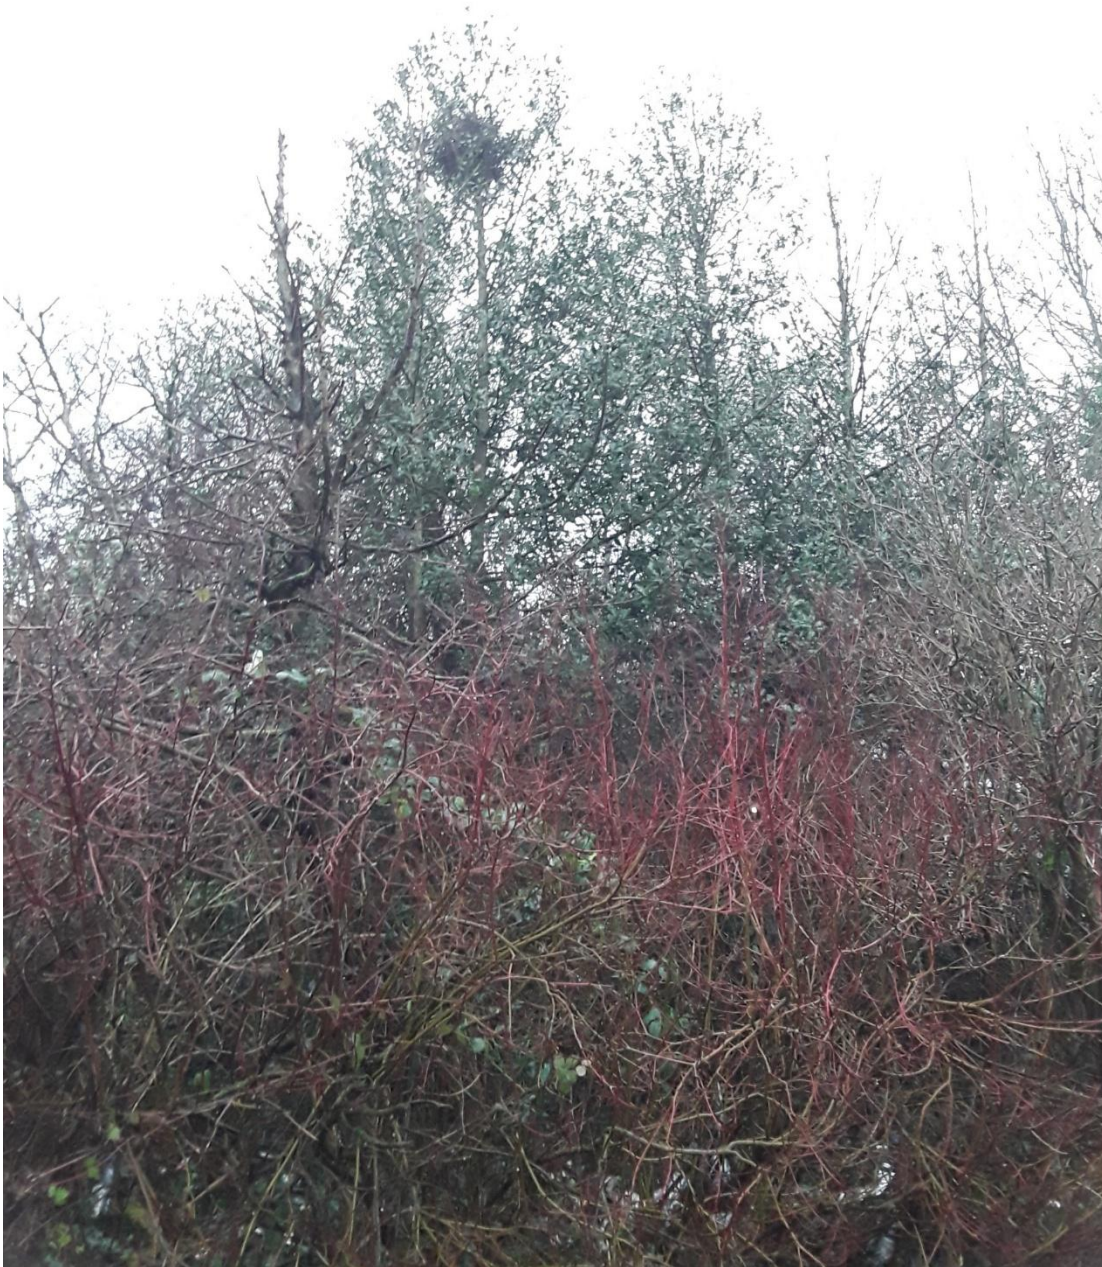
| Ref. | Species | Measurements | Survey Notes | Retention Category | RPA | Condition |
|---|---|---|---|---|---|---|
| G01 | Mixed species<br>(Mixed species) | Stem Diam(mm): 150<br>Spread (m): 1.5N, 1.5E, 1.5S, 1.5W<br>Crown Clearance (m): 0<br>Lowest Branch (m): 0<br>Rem. Contrib.: 10+ Years | Unable to fully inspect due to access, mainly holly trees and several dead stems. | C2 | Area: 64 sq m. | Other Reference:<br>Physiological Condition: Fair<br>Structural Condition: Poor<br>Distance1:<br>Distance2:<br>You customise:<br>Public Amenity Value: Low<br>Inspection Limitations: None<br>Bat Habitat: None |

Image 1 – Showing G01 with undergrowth restricting access and dead trees within the group

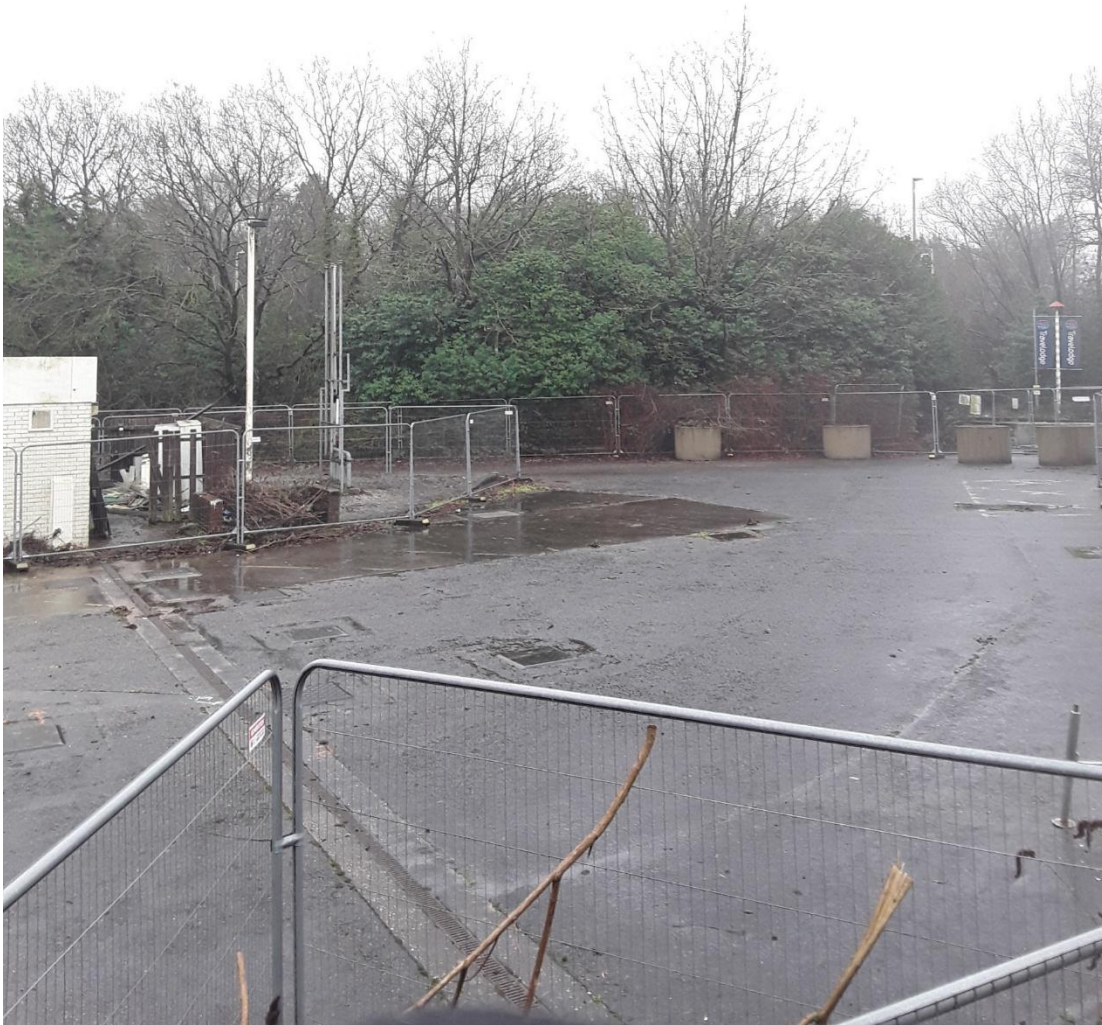
| T02 | Common ash<br>( <i>Fraxinus<br/>excelsior</i> ) | Height (m): 13<br>Stem Diam(mm): 460<br>Spread (m): 5.5N, 4E, 7S, 4.5W<br>Crown Clearance (m): 2.5<br>Lowest Branch (m): 4(N)<br>Life Stage: Mature<br>Rem. Contrib.: 10+ Years | Deadwood in canopy and<br>evidence of previous branch<br>failures. Tree has been reduced<br>in the past and new growth has<br>failed.<br><br>Pests and Diseases:<br>Ash Health Class 1 - 100%-75%<br>remaining canopy | C1 | Radius: 5.5m.<br>Area: 95 sq m. | Other Reference:<br>Physiological Condition: Fair<br>Structural Condition: Fair<br>Distance1:<br>Distance2:<br>You customise:<br>Public Amenity Value: Low<br>Inspection Limitations: None<br>Bat Habitat: None |

Image 2 – Showing T02 and the petrol station area

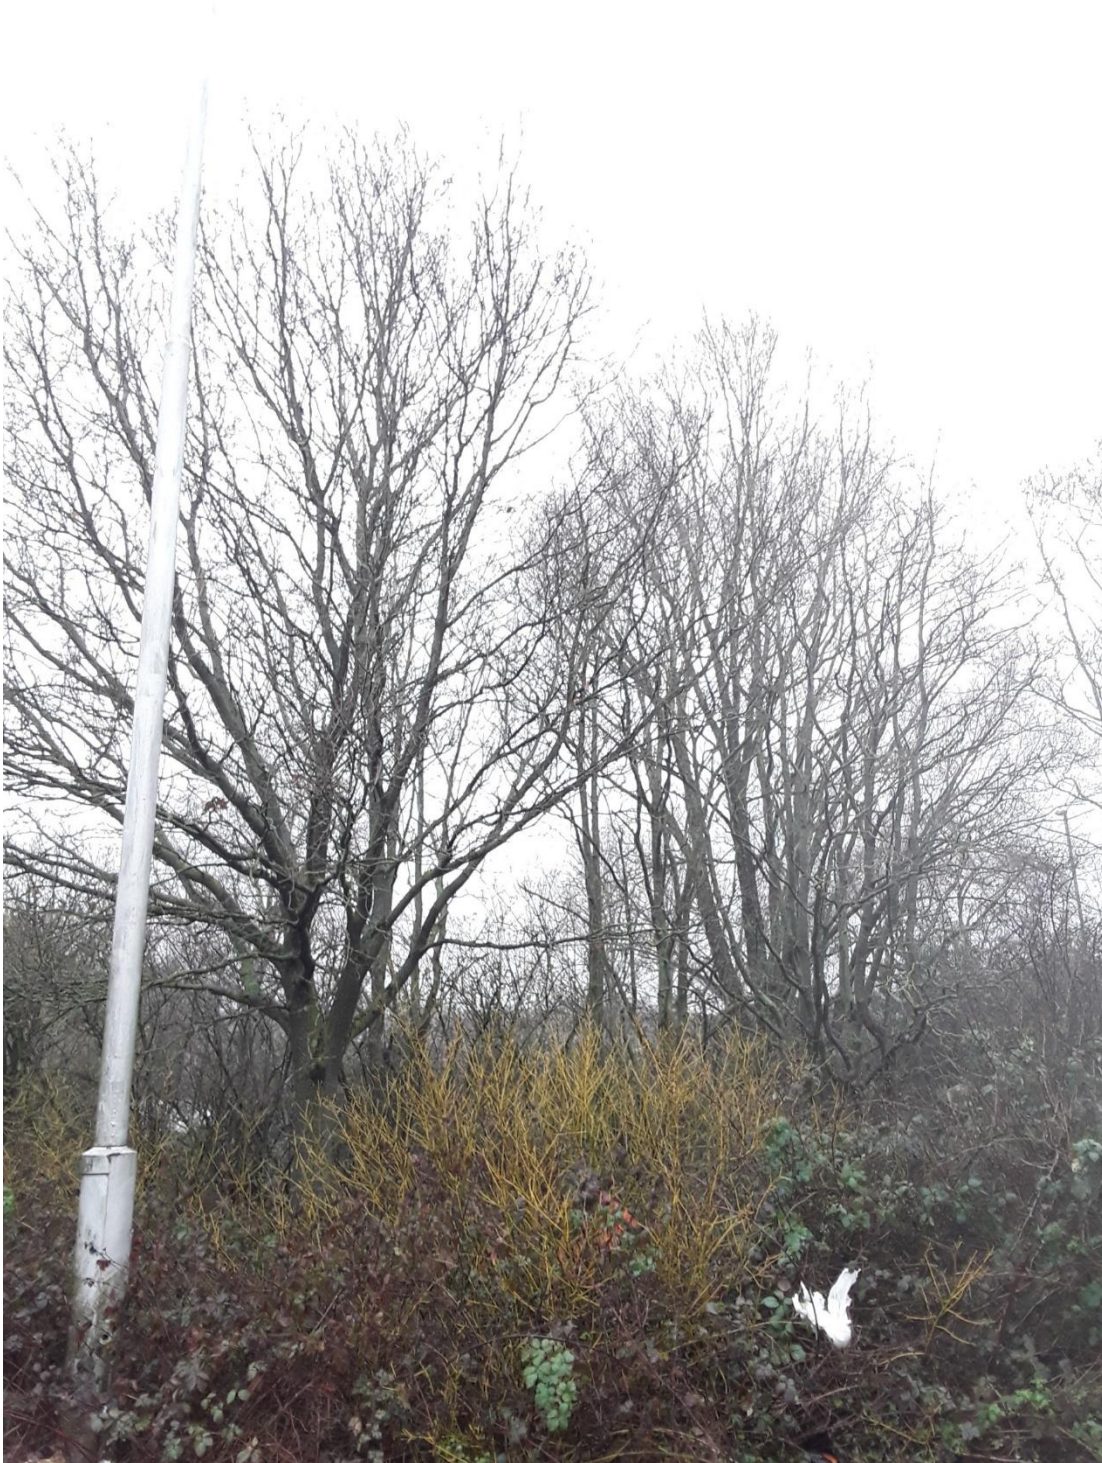
Image 3 – Showing T03 and the Willow trees within the group which can be retained

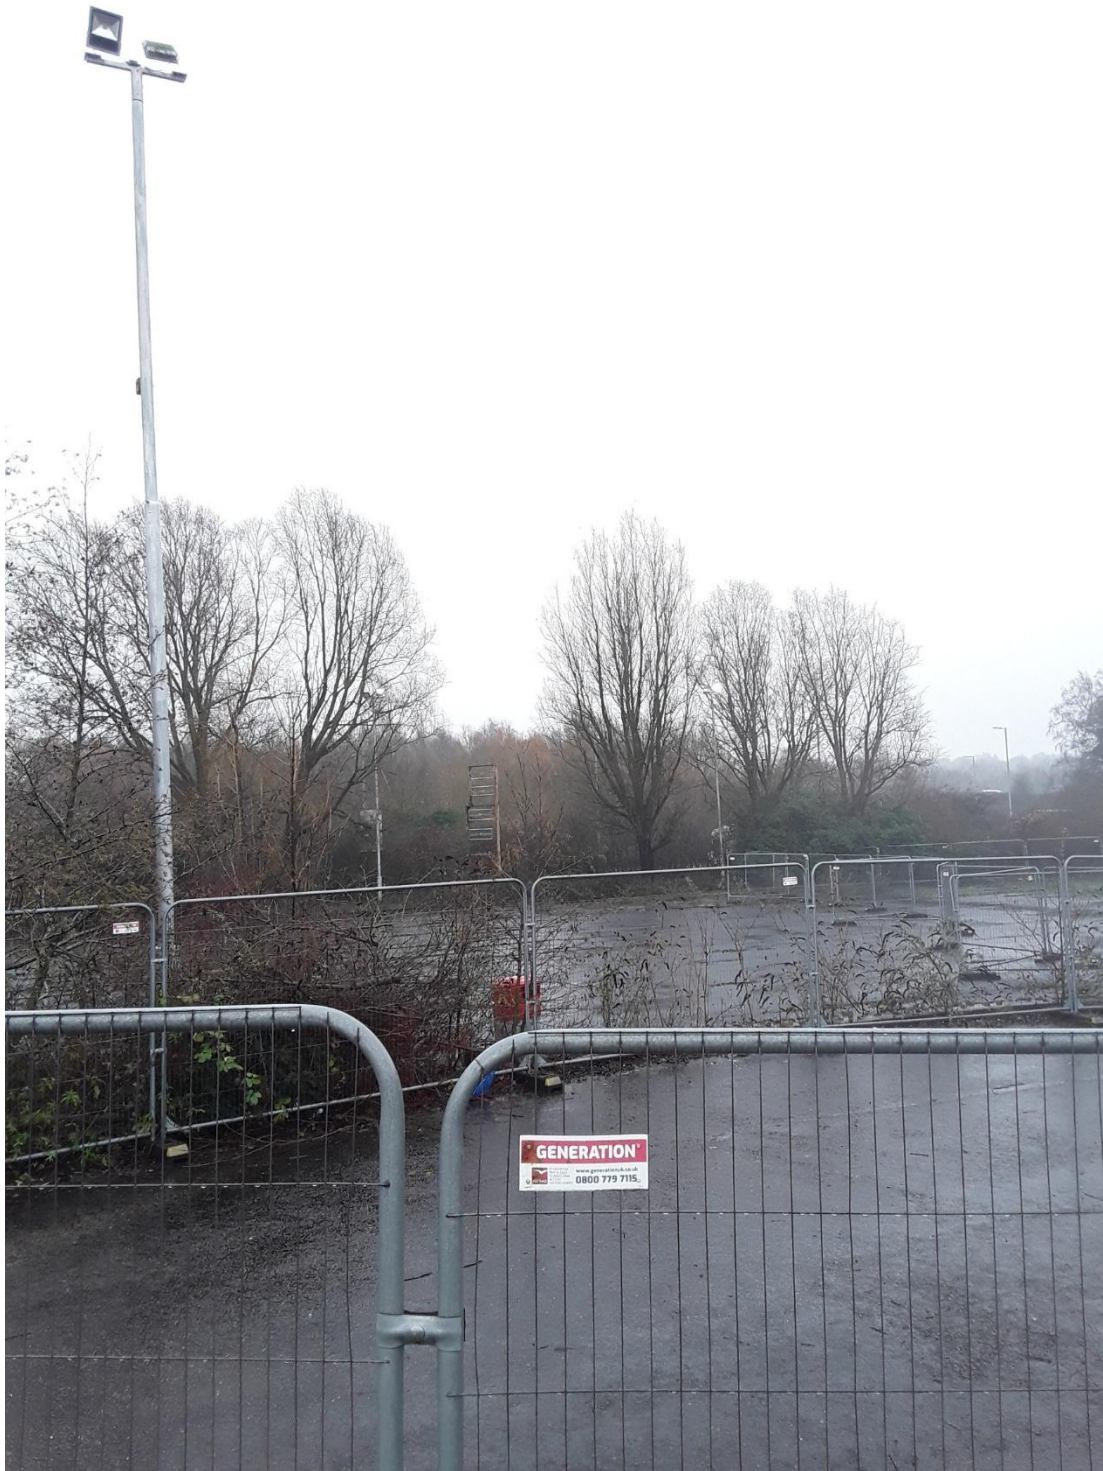
Image 4 – Showing T03 with Willow trees

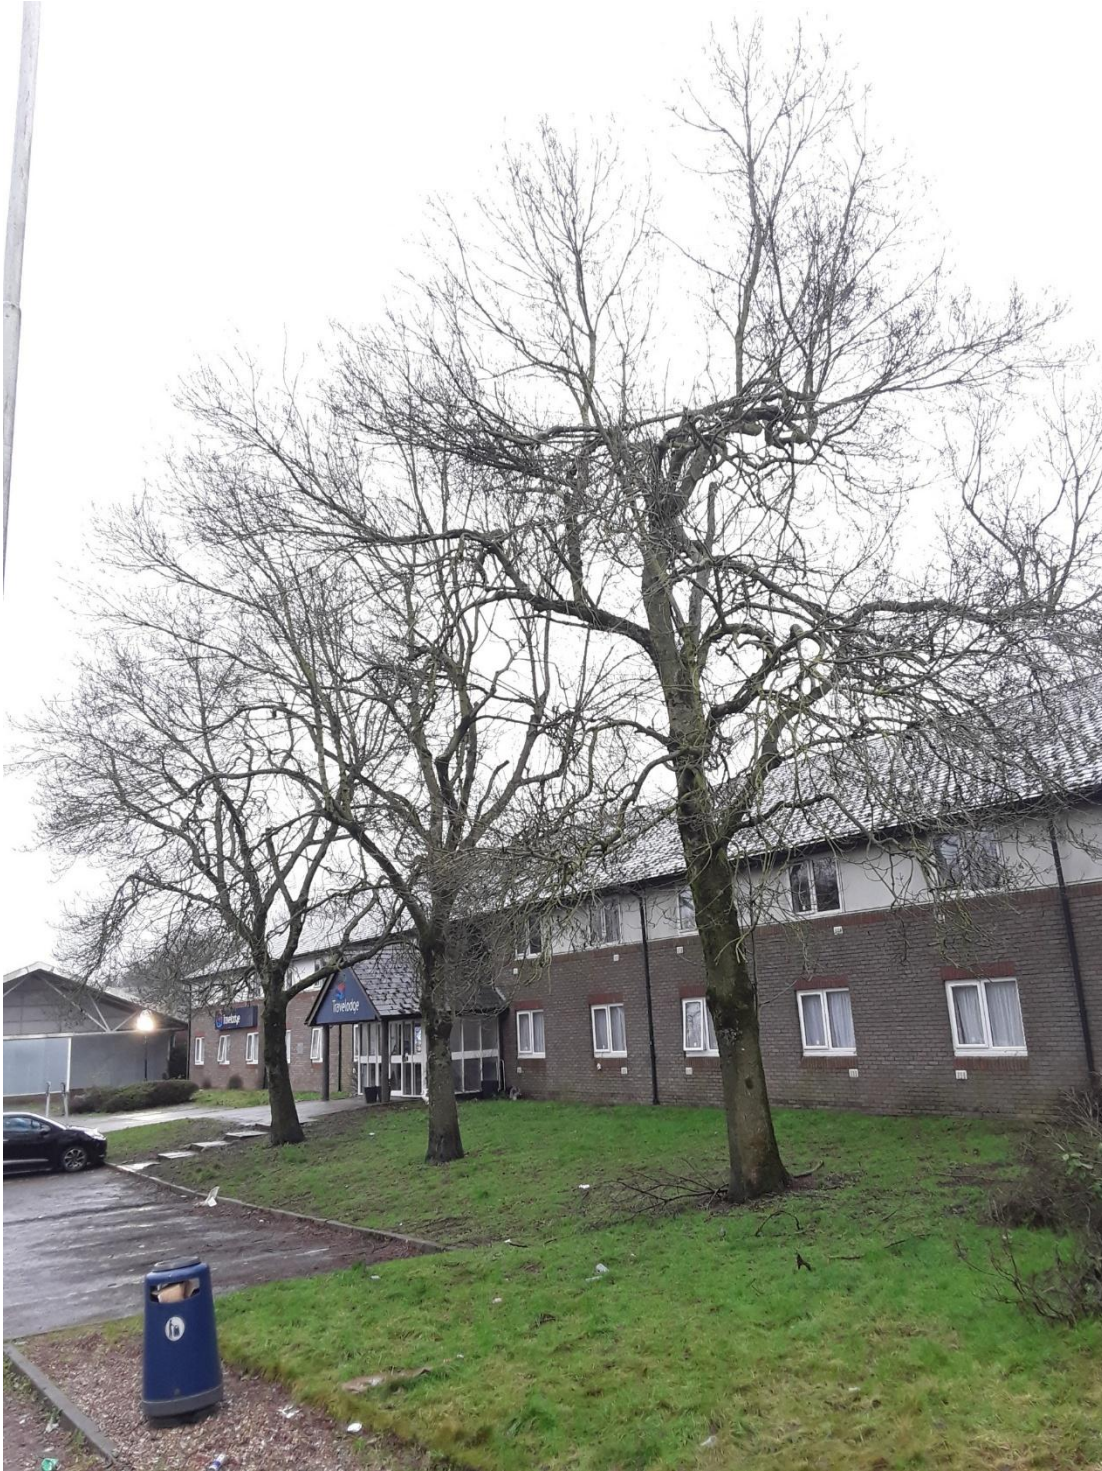
Image 5 – Showing T01-T03 to the front of the hotel area

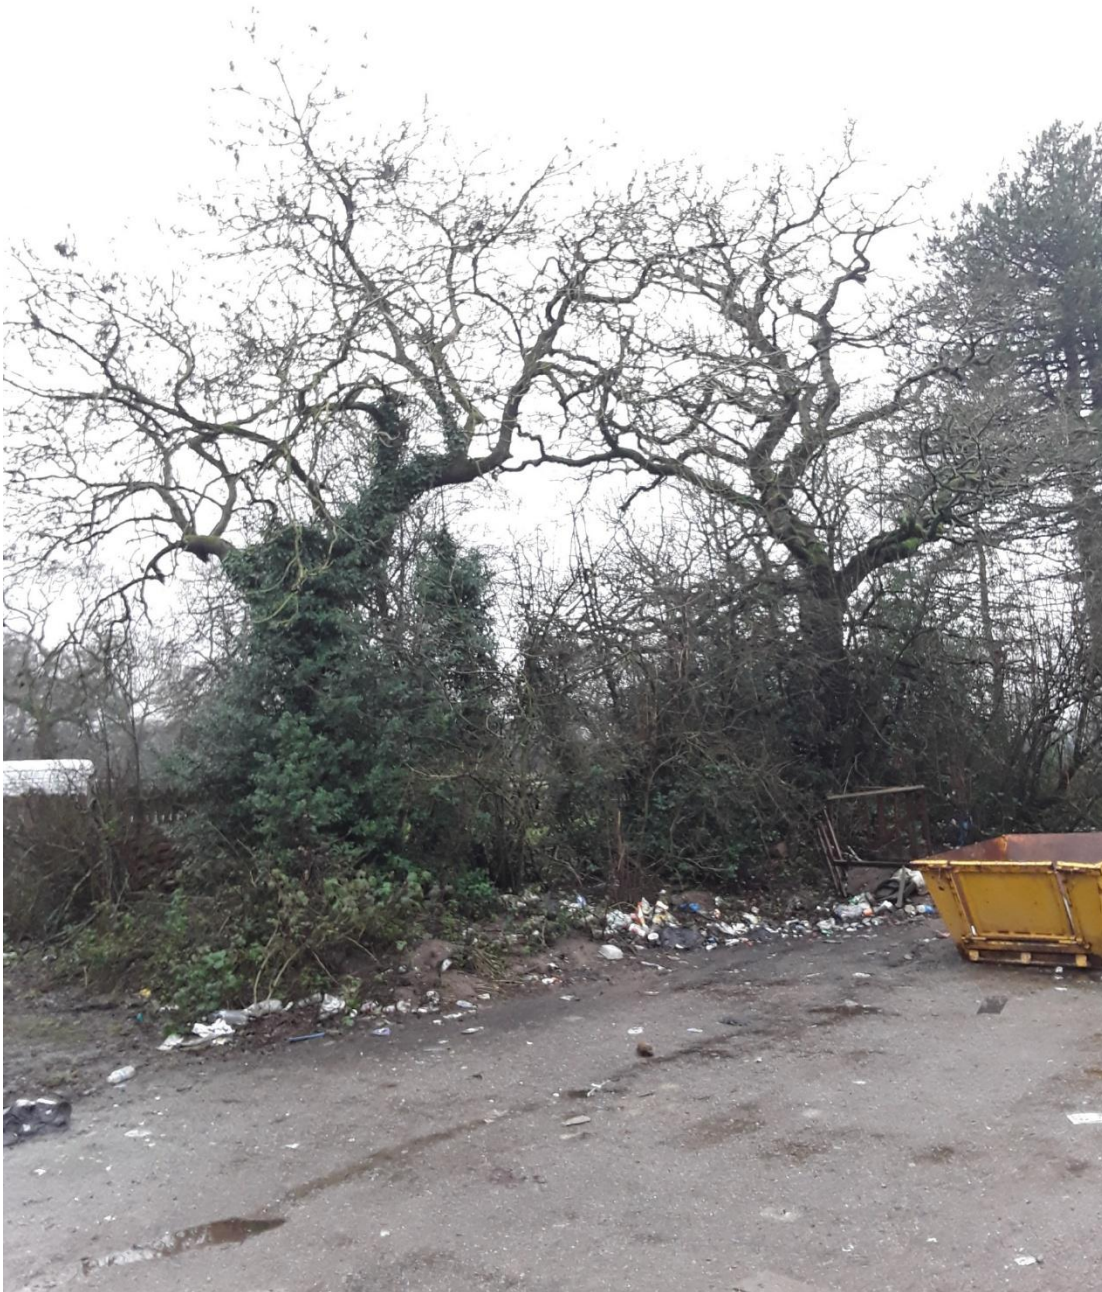
| T05 | Common ash<br>( <i>Fraxinus excelsior</i> ) | Height (m): 12<br>Stem Diam(mm): 490<br>Spread (m): 4N, 4E, 4S, 4W<br>Crown Clearance (m): 1<br>Lowest Branch (m): 3(S)<br>Life Stage: Mature<br>Rem. Contrib.: 10+ Years | Unable to fully inspect due to location. Deadwood throughout the canopy<br><br>Pests and Diseases:<br>Ash Health Class 1 - 100%-75% remaining canopy | C1 | Radius: 5.9m.<br>Area: 109 sq m. | Other Reference:<br>Physiological Condition: Fair<br>Structural Condition: Fair<br>Distance1:<br>Distance2:<br>You customise:<br>Public Amenity Value: Low<br>Inspection Limitations:<br>Access<br>Bat Habitat: Low |

Image 6 – Showing T05 and area of new drive thru driveway

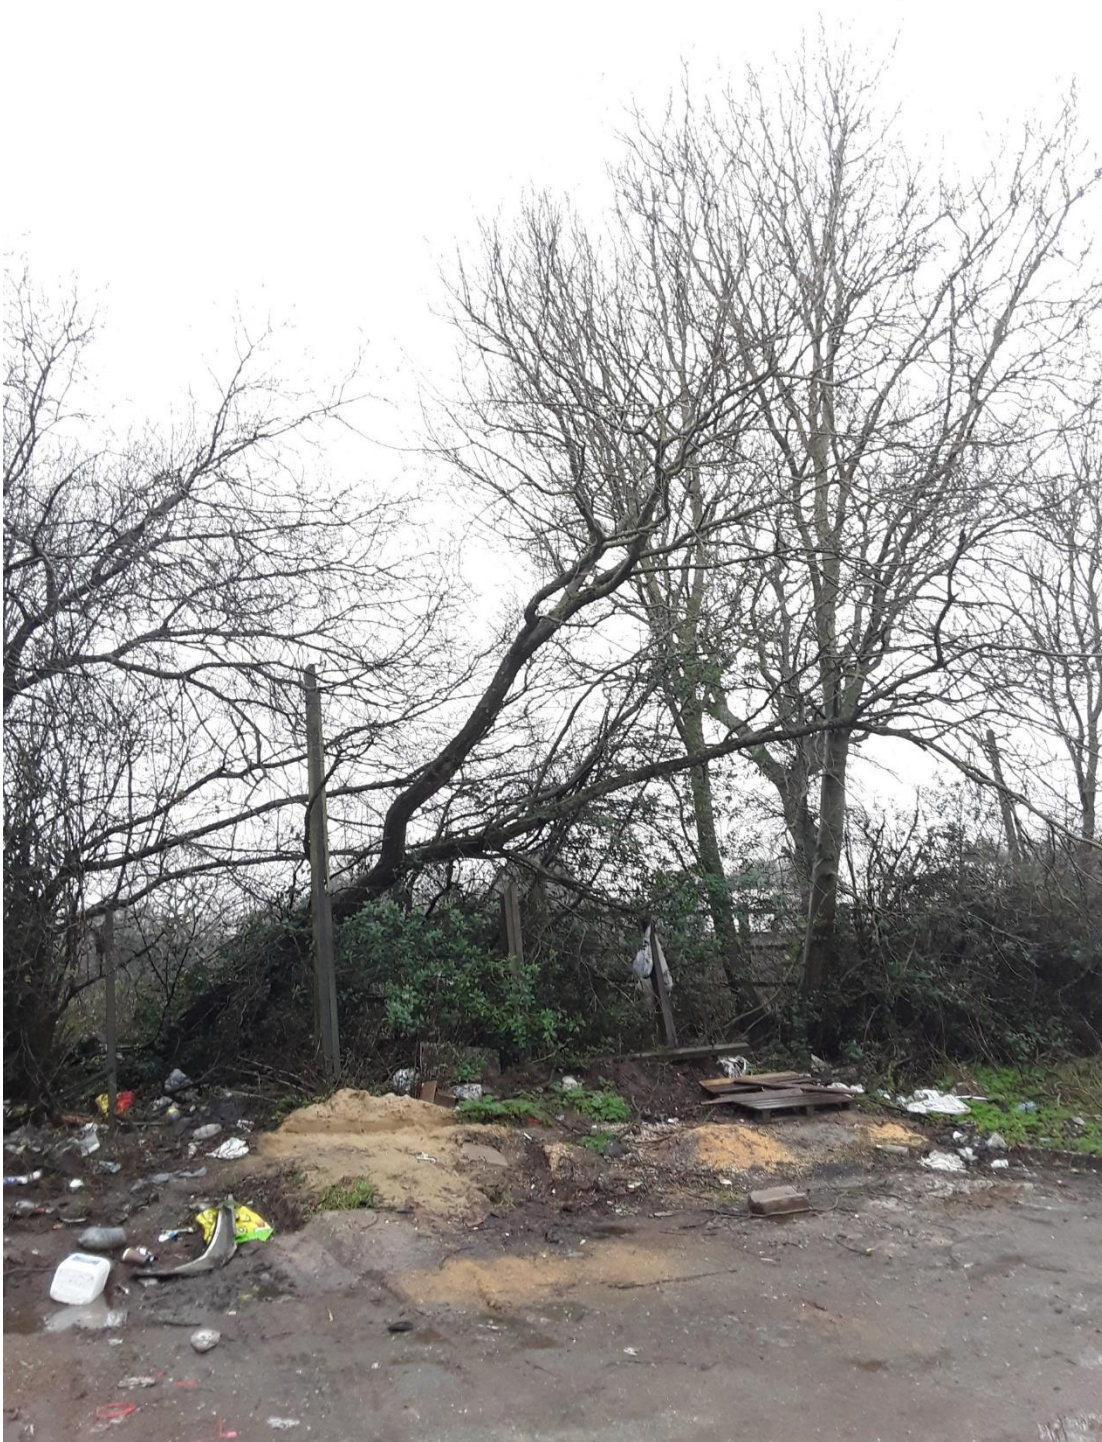
| T08 | Willow<br>( <i>Salix sp.</i> ) | Height (m): 7<br>Stem Diam(mm): 330<br>Spread (m): 10N, 8E, 1S, 1W<br>Crown Clearance (m): 1<br>Lowest Branch (m): 2(N)<br>Life Stage: Early Mature<br>Rem. Contrib.: <10 years | Tree is collapsing and needs to be removed. | U | Radius: 4.0m.<br>Area: 50 sq m. | Other Reference:<br>Physiological Condition: Fair<br>Structural Condition:<br>Collapsing<br>Distance1:<br>Distance2:<br>You customise:<br>Public Amenity Value: Low<br>Inspection Limitations: None<br>Bat Habitat: None |

Image 7 – Showing Category U tree T08 with will require removal

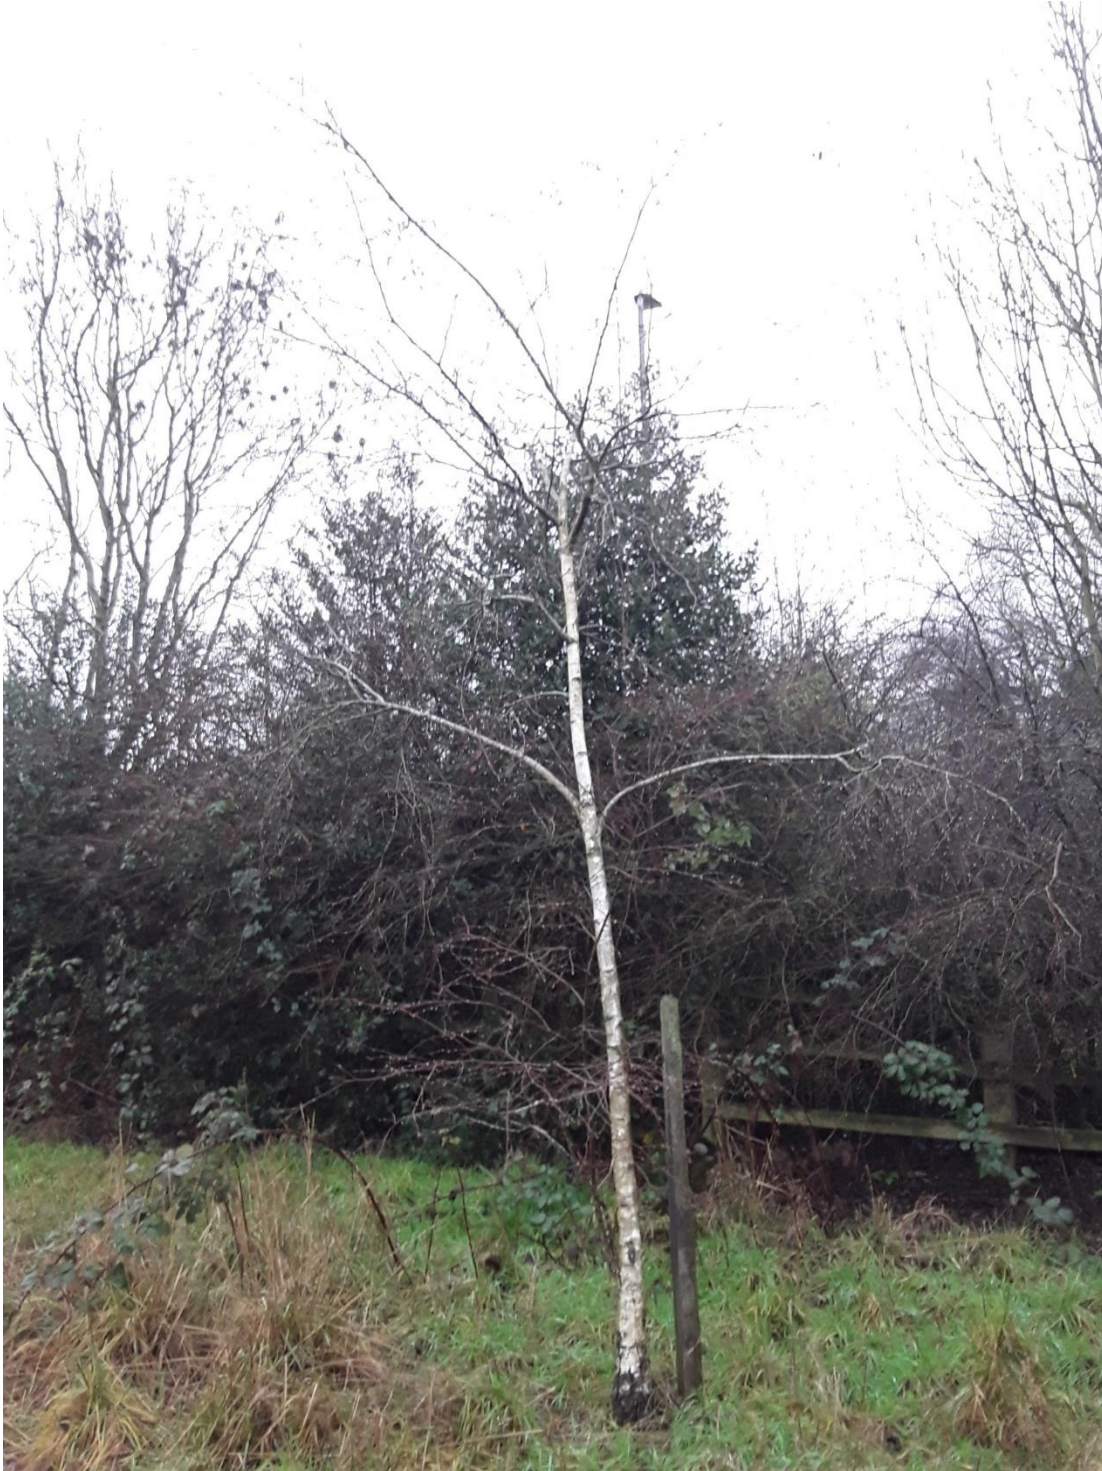
| T12 | Silver birch<br>( <i>Betula pendula</i> ) | Height (m): 3<br>Stem Diam(mm): 60<br>Spread (m): 1N, 1E, 1S, 1W<br>Crown Clearance (m): 1<br>Lowest Branch (m): 1(S)<br>Life Stage: Newly planted<br>Rem. Contrib.: 20+ Years | Newly planted tree but left. | C1 | Radius: 0.7m.<br>Area: 2 sq m. | Other Reference:<br>Physiological Condition: Good<br>Structural Condition: Good<br>Distance1:<br>Distance2:<br>You customise:<br>Public Amenity Value: Low<br>Inspection Limitations: None<br>Bat Habitat: None |

Image 8 – Showing T12 newly planted tree

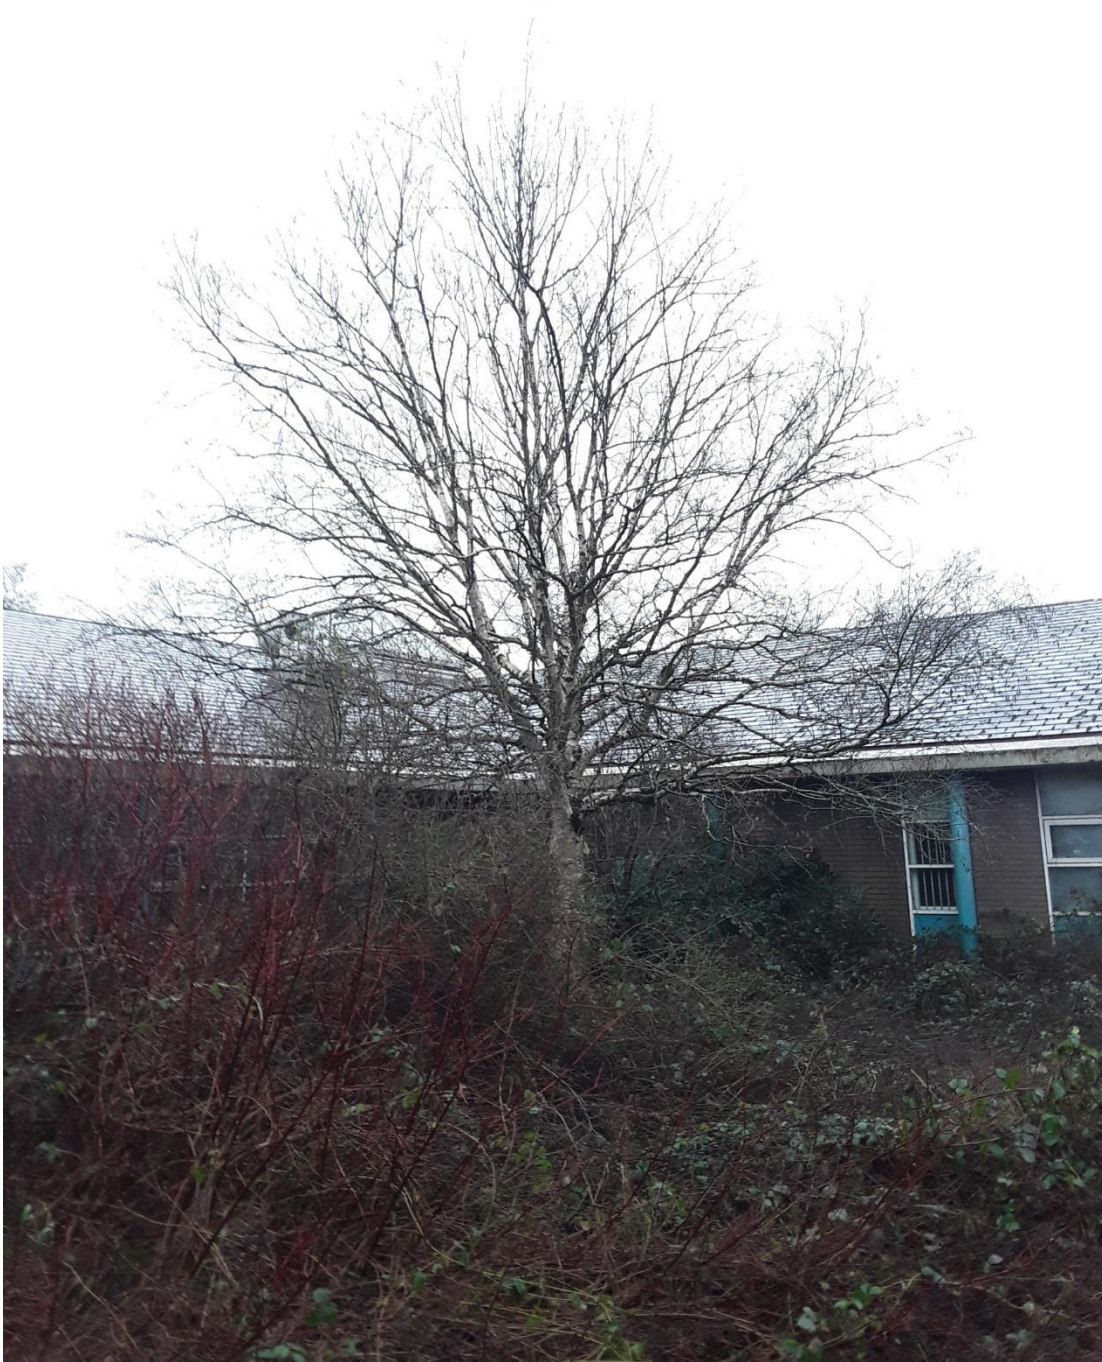
| T17 | Silver birch<br>( <i>Betula pendula</i> ) | Height (m): 10<br>Stem Diam(mm): 400<br>Spread (m): 4N, 4E, 4S, 4W<br>Crown Clearance (m): 2<br>Lowest Branch (m): 2(S)<br>Life Stage: Early Mature<br>Rem. Contrib.: 40+ Years | Growing at the rear of the building and has a canopy close to the building | B1 | Radius: 4.8m.<br>Area: 72 sq m. | Other Reference:<br>Physiological Condition: Good<br>Structural Condition: Good<br>Distance1:<br>Distance2:<br>You customise:<br>Public Amenity Value: Low<br>Inspection Limitations:<br>Access<br>Bat Habitat: None |

Image 9 – Showing T17 at the back of the shopping area

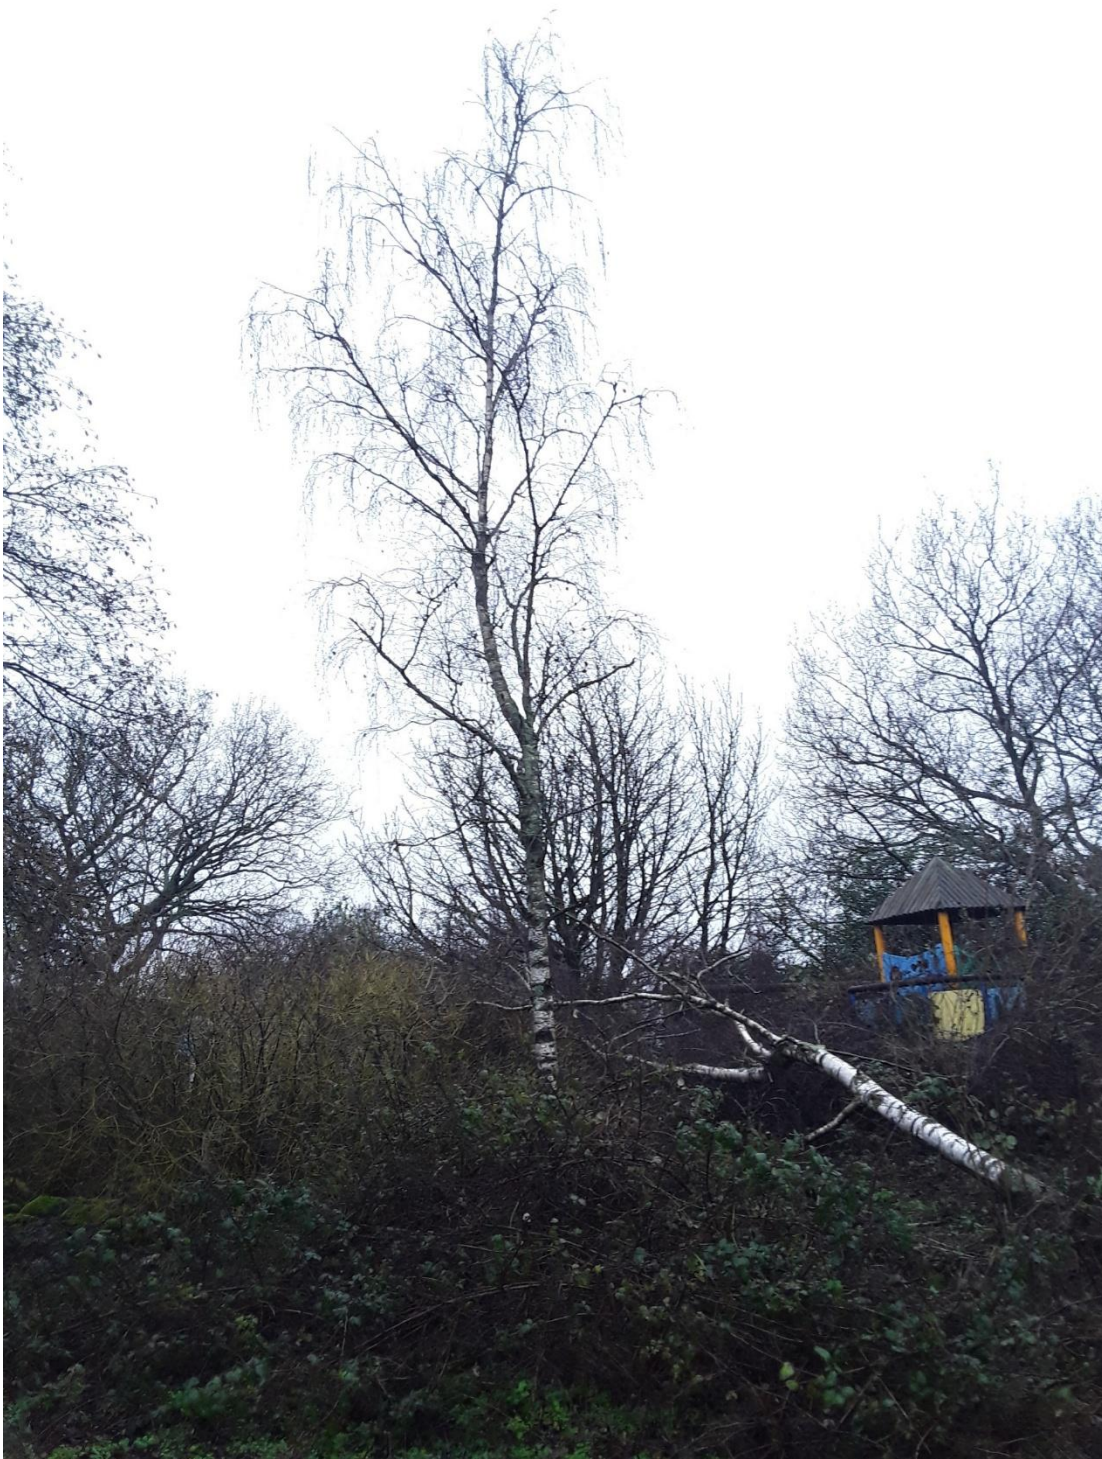
Image 10 – Showing T23 and G02 to the rear
