## **Phase I & II Geo-Environmental Assessment**

### **Markfield Services**

Little Shaw Lane  
Markfield  
Leicestershire  
LE67 9PP

**EPS Project Reference:** UK26.7708

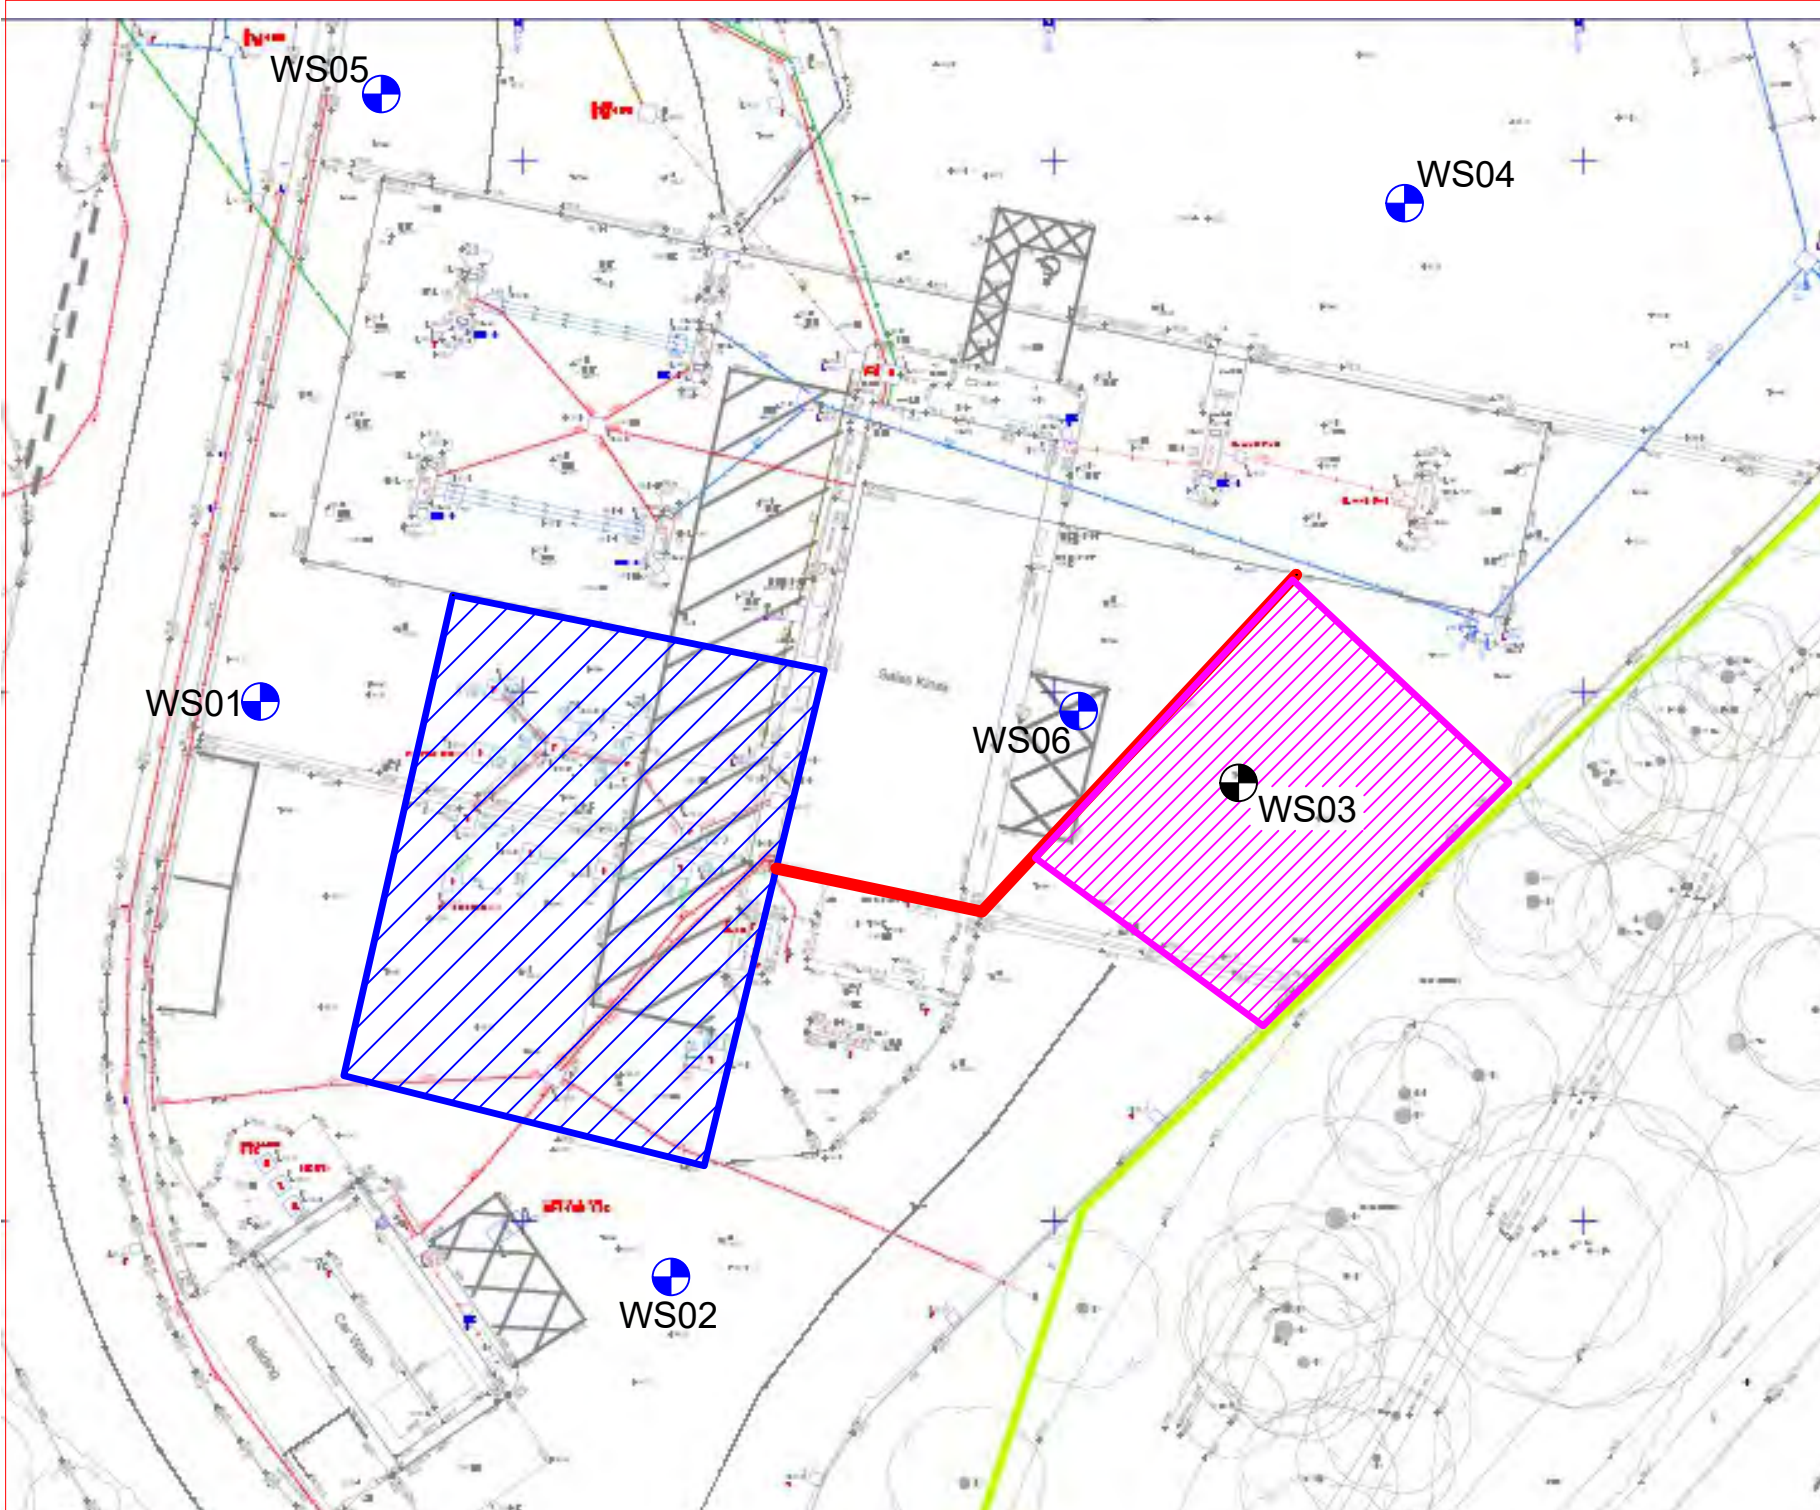
It should be noted that visible evidence of fuel contamination has been observed on-site in the soils at WS03, with the soil sample from this location recording elevated concentrations of TPH (WS03 ES1 0.90-1.00m). Therefore, the impacted made ground subbase material in the area of WS03 should be classified as **Hazardous**. Based on the information available, the wider subbase material from across the site has been classified as **Non-Hazardous**, however, it would be prudent to complete further waste testing to confirm the Waste Acceptance Criteria.

- It is recommended that a Remedial Strategy & Implementation Plan (RS & IP) is developed for site, which will initially include the removal of existing fuel storage and distribution infrastructure (old tanks and lines), as well as any grossly impacted soils.
- Upon removal of the fuel infrastructure, further soil, vapour and groundwater sampling/monitoring is to take place as part of the verification works, the results of this work will establish if any further in-situ treatment of groundwater is necessary (unlikely) and also determine on whether vapour resistant membranes are required for new buildings.

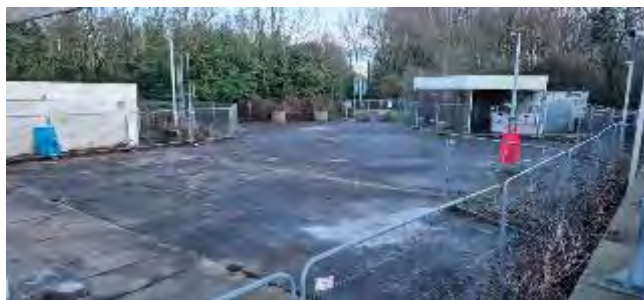
***Photo 1: Kiosk and car wash of the PFS, looking southeast.***

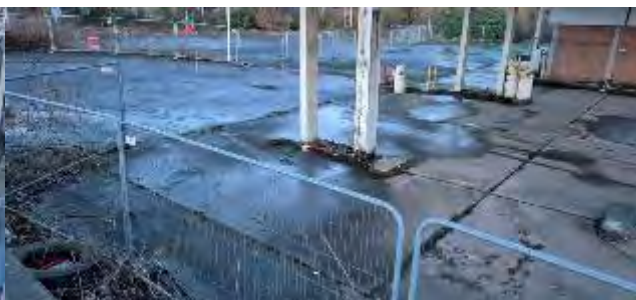
***Photo 2: PFS on the east of site, facing northeast.***

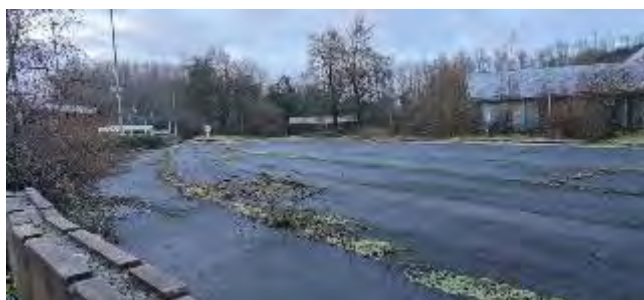
***Photo 3: Car parking in the centre of the site, facing southwest.***

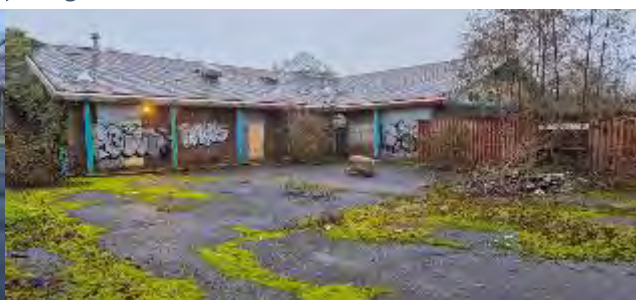
***Photo 4: Southeast corner of the services building, facing northwest.***

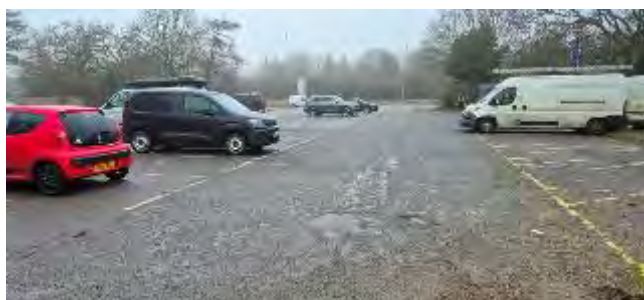
***Photo 5: Car parking on the west of the site, facing north.***

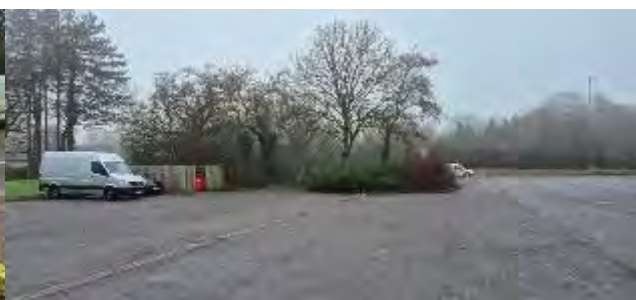
***Photo 6: Enclosed bins in car park, facing north.***

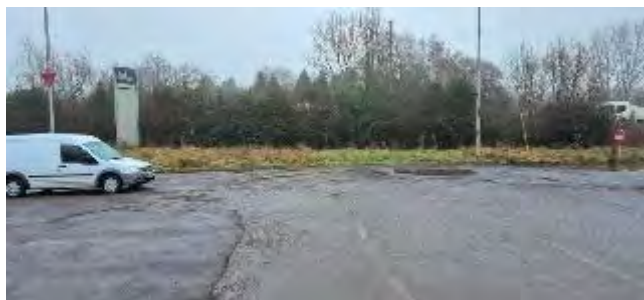
*Photo 7: Edge of car park, facing north.*

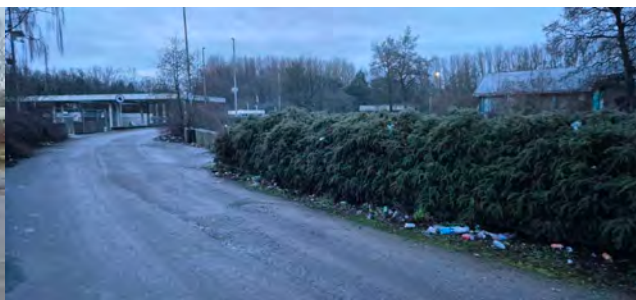
*Photo 8: Service road, facing southeast.*
