**Report of the structural condition of the Barn at Lea Grange Farm,**  
**Orton on the Hill, Twycross, CV9 3NP**

# **Report of the structural condition of the Barn at Lea Grange Farm, Orton on the Hill, Twycross, CV9 3NP**

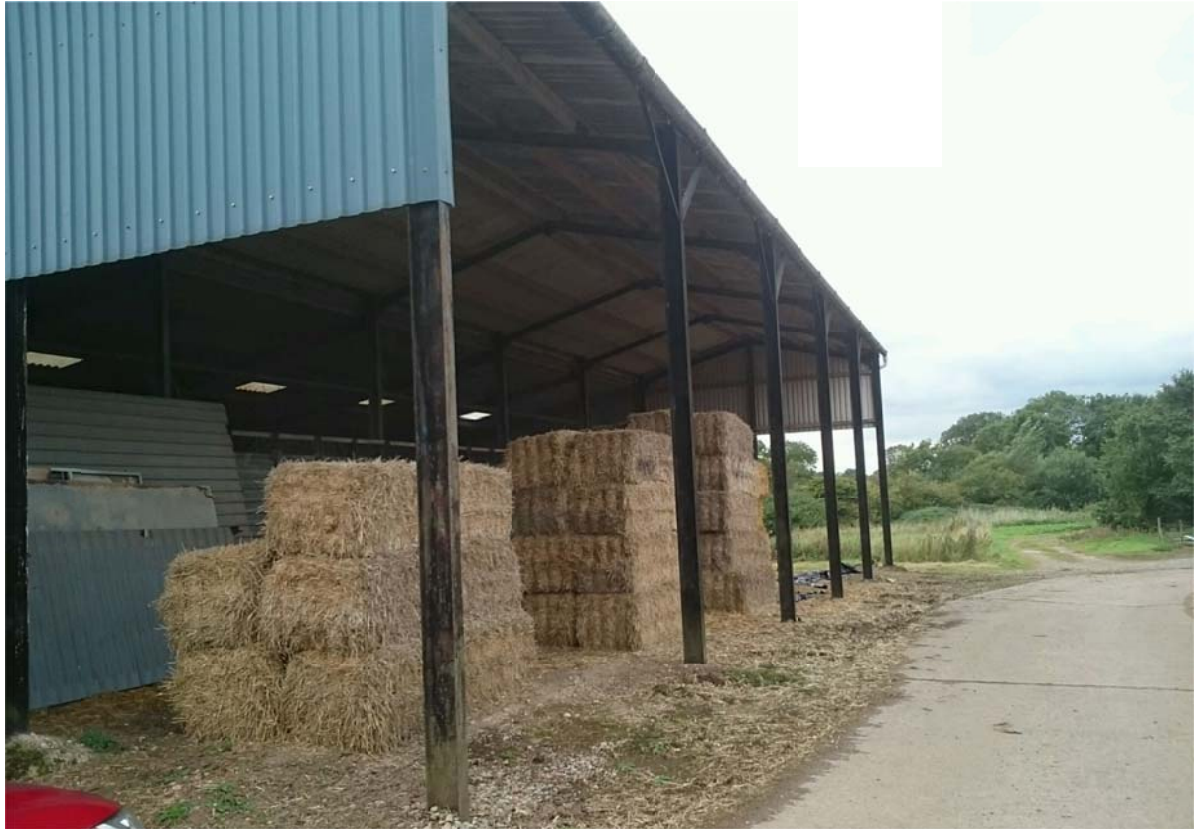
North Elevation

- 4.4. The Portal frame section of barn will require a new floor, which it is recommended is continued to surround the column bases of the portal to provide further resistance to corrosion which was noted to the north western gable column. The surface rust should be removed prior to the pouring of concrete.

5.1. The structure is in quite good condition requiring minor repairs where there has been minimal corrosion at the base of columns to the exposed northern elevation.

5.4. The minor corrosion at the foot of columns can be simply de-scaled and protected by casting concrete around the base as this provides a highly alkaline protection.

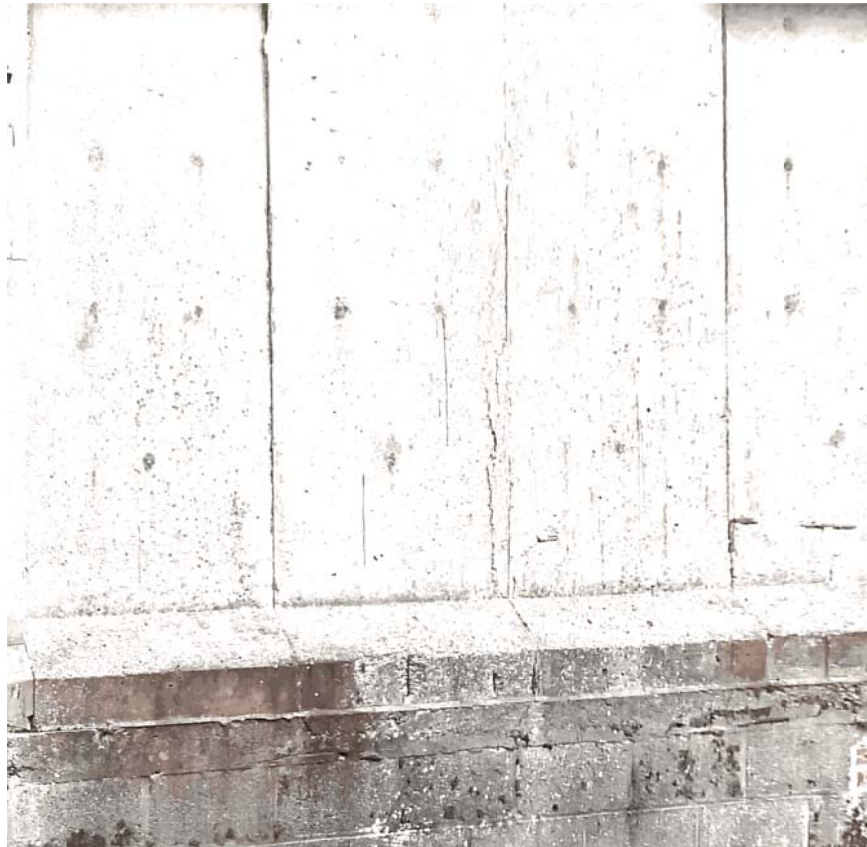
Retaining Wall units/push wall on raised blockwork and slab
