# **Pre-development Tree Survey BS5837:2012**

## **Convent Drive**

## **Stoke Golding**

April 2023, rev Nov 2023

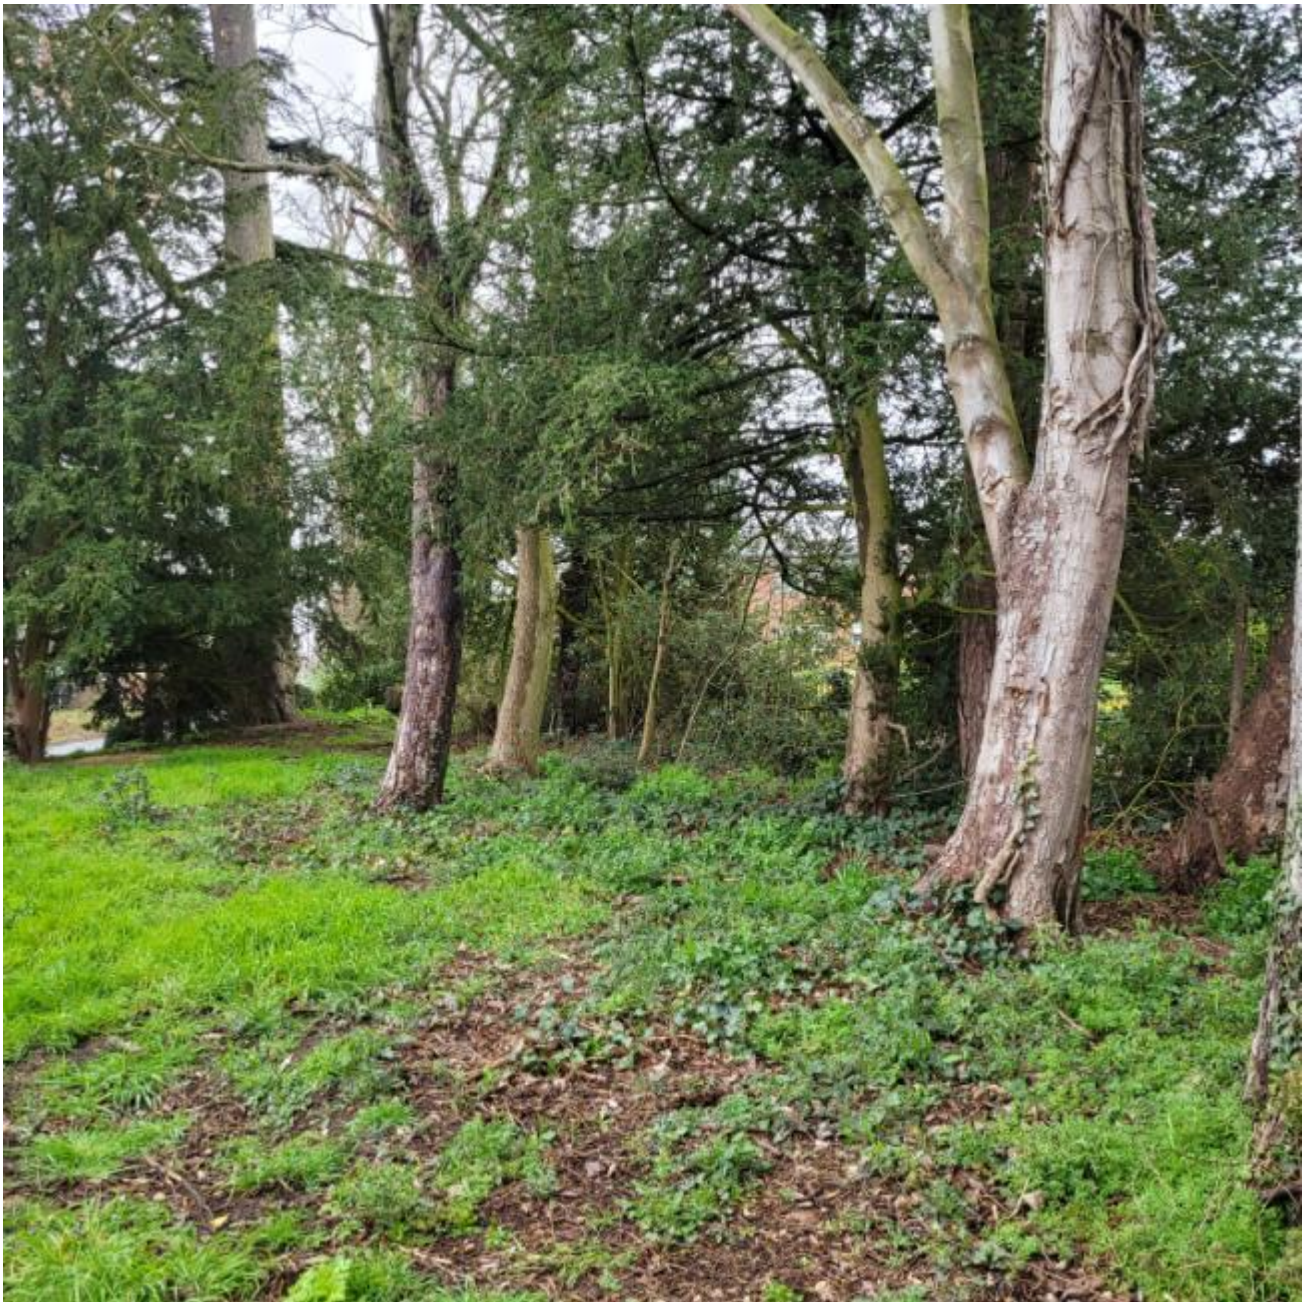
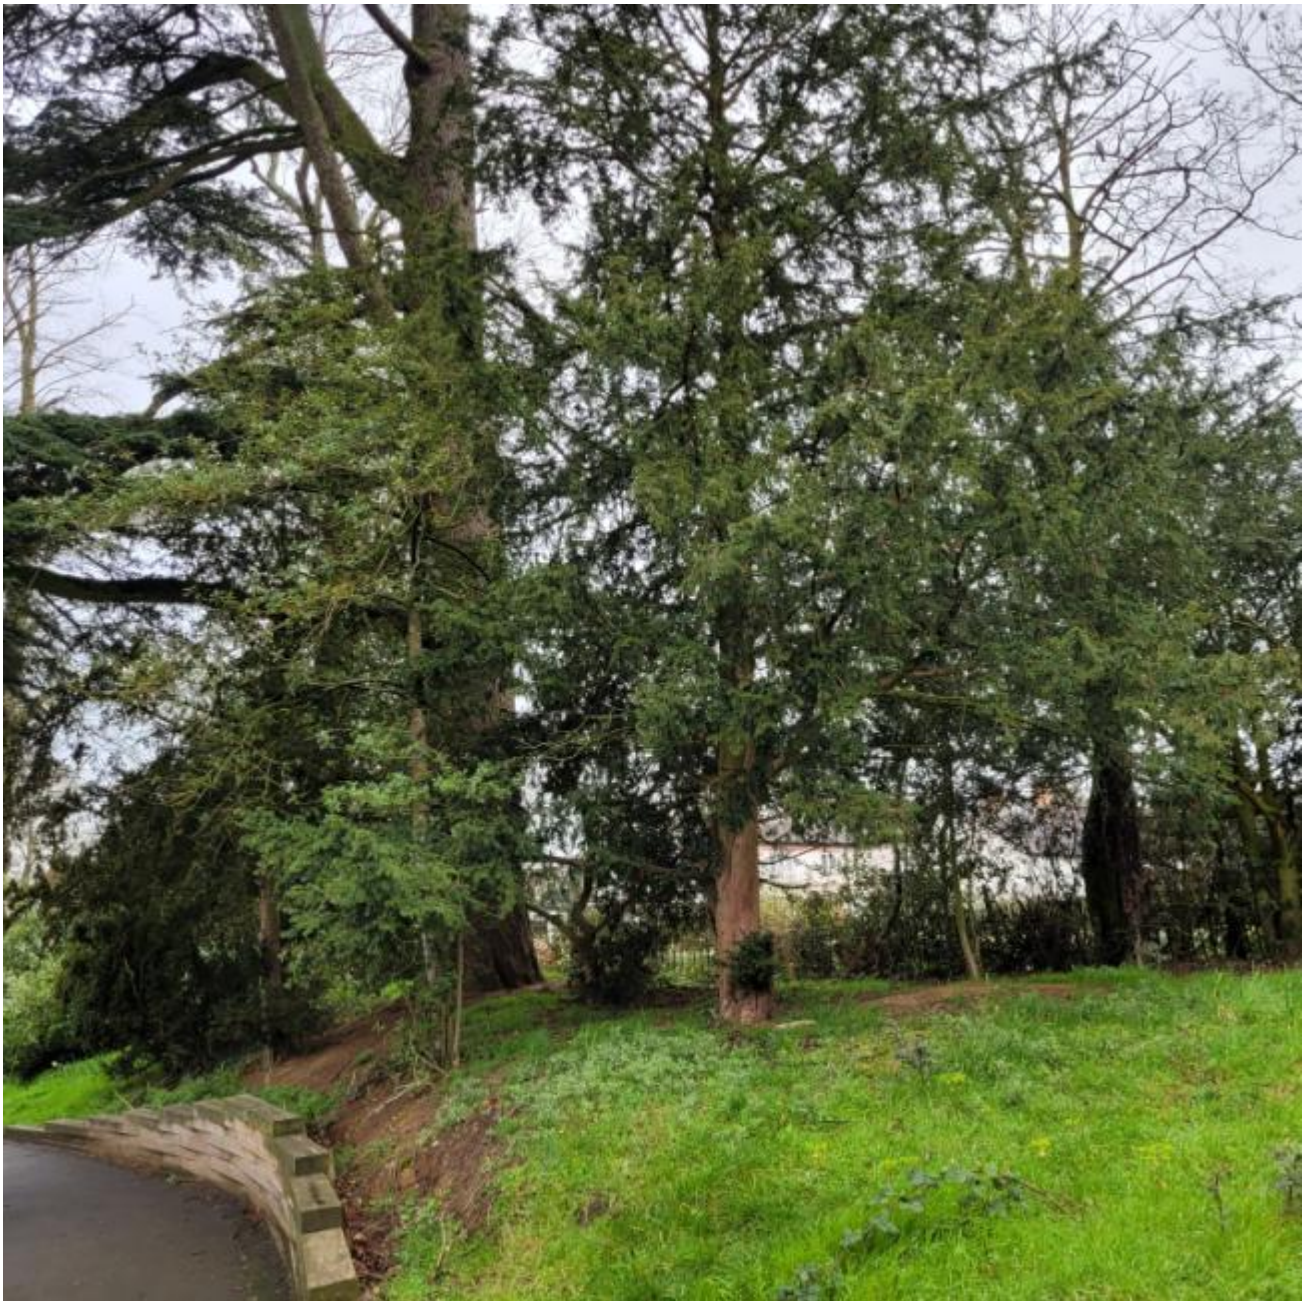
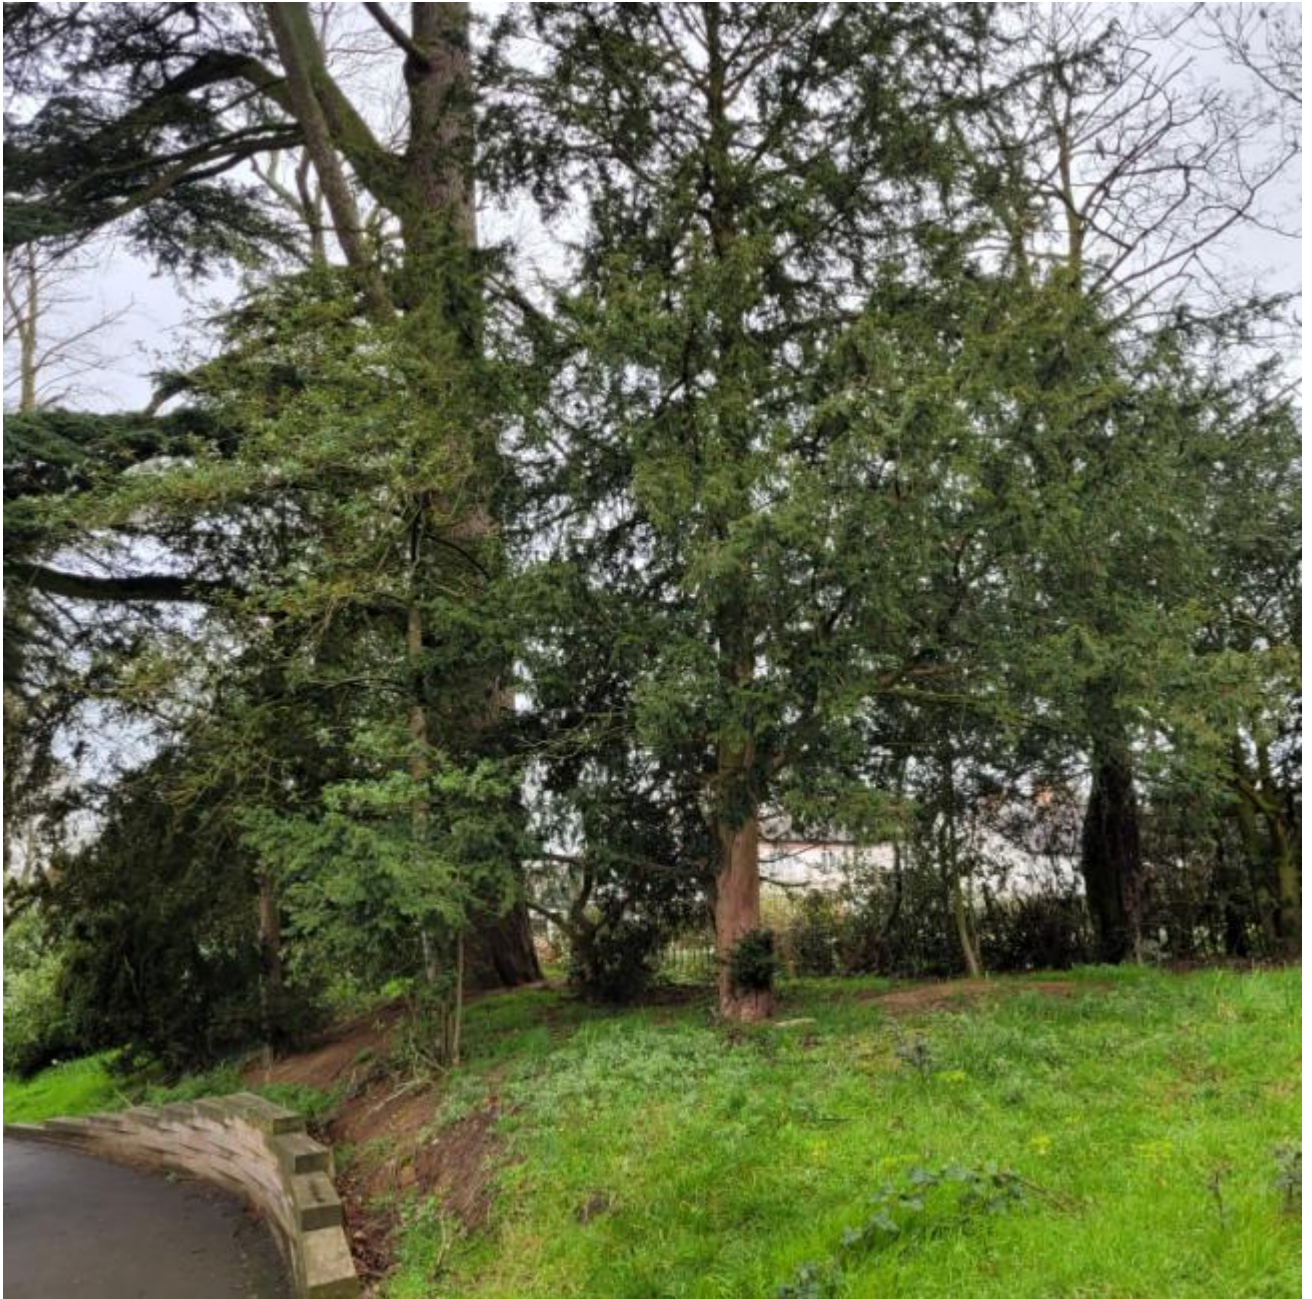
## Appendix 1: Images of trees and shrub vegetation

There are a total of eleven trees on site. The trees are mainly mature and semi-mature, native and non-native trees located along the northern site boundary, with two significant landscape trees at either end of the site. A proportion of the trees such as sycamore, holly and the younger yew trees are self set. Two of the on-site trees have been classified as A category trees, one tree and two groups are B category, with the rest C category trees and six U category trees.

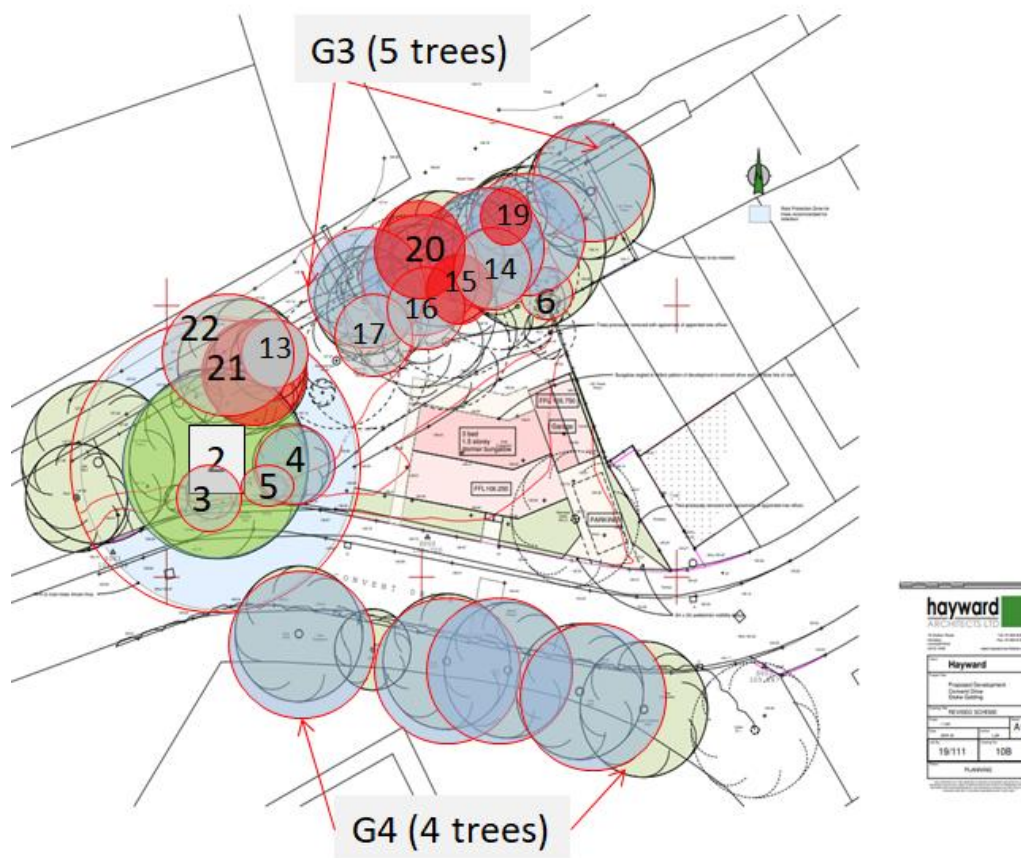
## Appendix 2: Tree Location Plan

**On the northern boundary are 5 Corsican pine, and south of the road 4 Common lime. Tree 2 is the Cedar, with a large nominal RPA.**

Any development within the area will need to take account of the tree roots. It is considered that a development could be situated within the site provided the nominal RPZs of Trees 2, and group 3 are entirely avoided. Group 4 RPAs do not extend onto the site and lie within the highway.

In addition, it is recommended that all retained trees, are protected during development by tree protection fencing as detailed below in section 4.1.4.
