# *Structural Inspection*

*Project:* **Manor House Farm  
45 Main Street  
Carlton  
CV13 0BZ**

*Project No:* **23-20021**

*Document No:* **0-030**

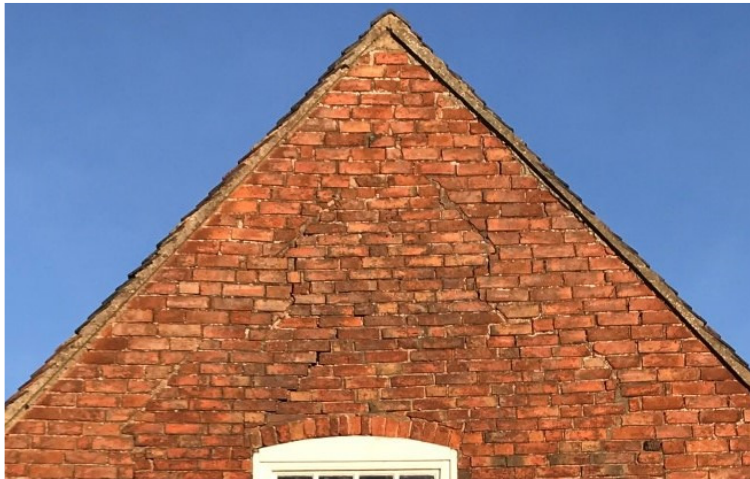
Photograph 1

- 3.2 The south-facing gable wall appears to have been increased in height, and there is some cracking and a discontinuity of coursing at the interface. There is also stepped diagonal cracking extending from the top, left-hand corner of the first floor arched lintel. [Photograph 1]

- 4.3 Consequently, for the damage identified in Photographs 1 -5 it is recommended that the cracks are repaired using a crack stitching technique, involving raking out the mortar joints and inserting resin-bonded helical reinforcing bars into every third bed-joint before re-pointing. The small area of brickwork and brick arch to the eastern-facing side wall of the rear brickwork extension, [Photograph 4], will probably benefit from being taken down and re-built, especially since this section is likely to collapse when the window is replaced.

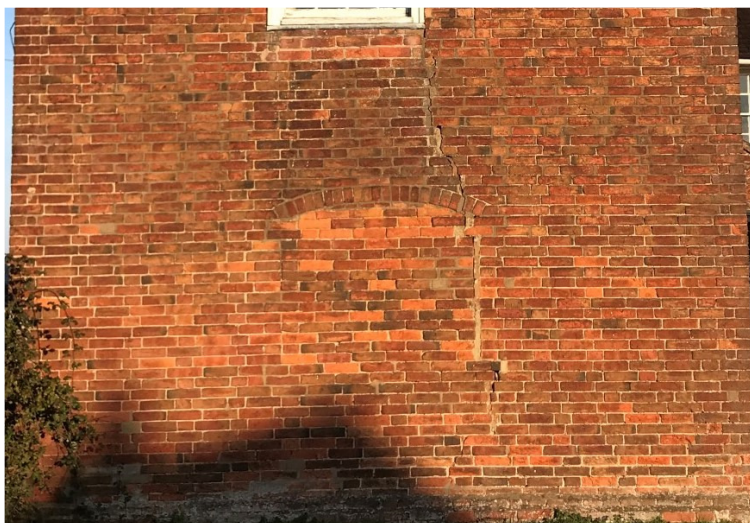
Photograph 2

- 3.3 There is a further vertical crack in this gable wall extending from the bottom, right-hand corner of the first floor window to the top right-hand corner of an infilled former ground floor window. [Photograph 2]

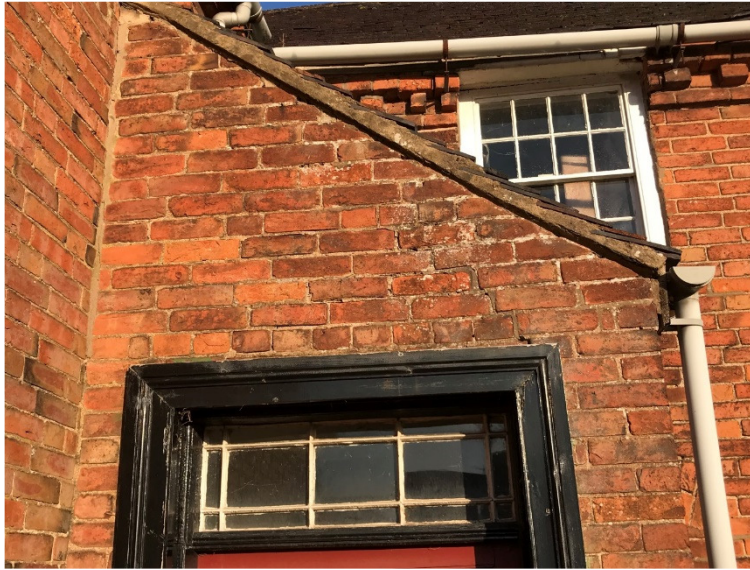
Photograph 3

- 3.5 There is a stepped diagonal crack above the front door in the single-storey lean-to entrance.

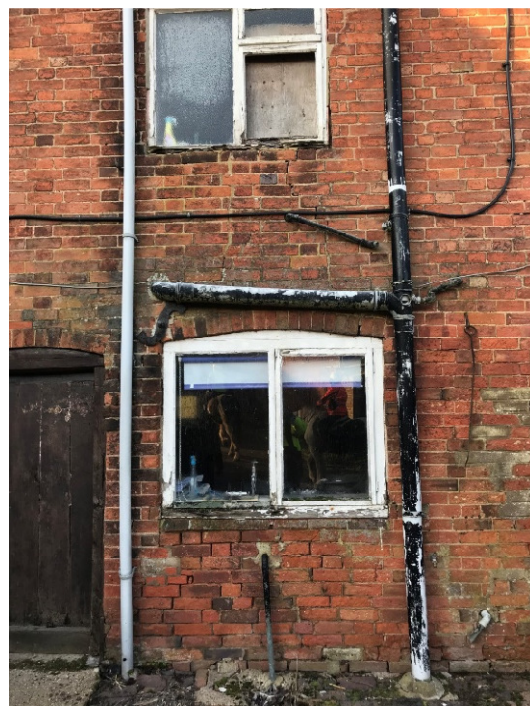
Photograph 4

- 3.7 The eastern-facing side wall of the rear brickwork extension is suffering from low level erosion of mortar joints, and cracking above the ground floor window due to failure of the brick arch lintel. [Photograph 4]

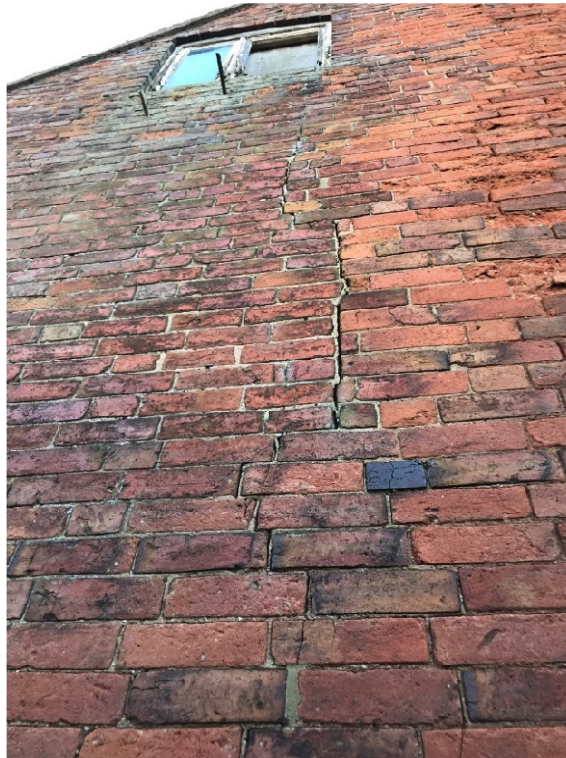
Photograph 5

- 3.8 There is a nearly full-height crack in the north-facing gable wall due to inadequate brick bonding and discontinuity of coursing. [Photograph 5]

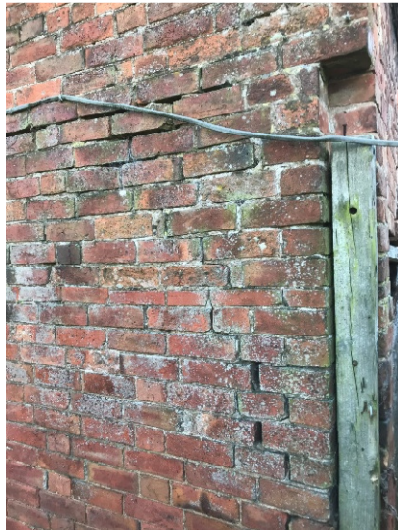
Photograph 6

- Separation cracking of brickwork at the north-west corner [Photograph 6]
- Multiple cracking and distortion over the door in the western-facing wall [Photograph 7]
- Stepped diagonal cracking in the south-facing wall. [Photograph 8]
- Separation of the south-facing gable wall adjoining the main house. [Photograph 9]

This damage is believed to be associated with foundation subsidence resulting in rotation away from the main house.

- 4.5 The single-storey lean-to structure attached to the north-western corner is potentially in a dangerous condition and should be taken down and re-built if required, on a new foundation although this only currently forms an external store and is not part of the habitable accommodation.

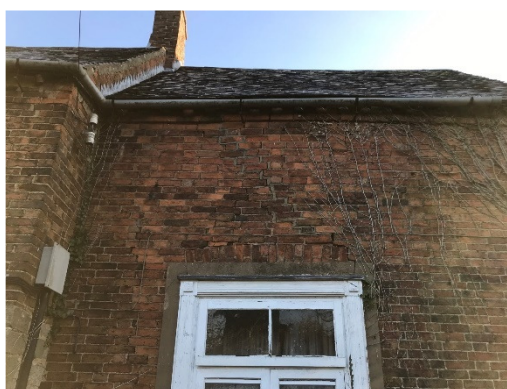
Photograph 10

3.10 There is significant cracking and distortion of the brickwork above the ground floor door to the western-facing wall of the front extension due to failure of the brick arch lintel.

- 4.4 Due to the severity and extensive damage to the section of wall above the ground floor door to the western-facing wall of the front extension, [Photograph 10], this section should be taken down and re-built.

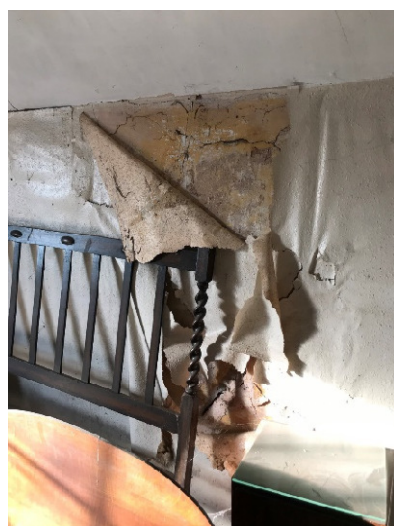
Photograph 11

This damage is also visible internally. [Photograph 11]
