## Tree Risk Assessment Survey Report

Market Bosworth PCC

Ambion Rise Spinney

Ref: NAC-5316.102

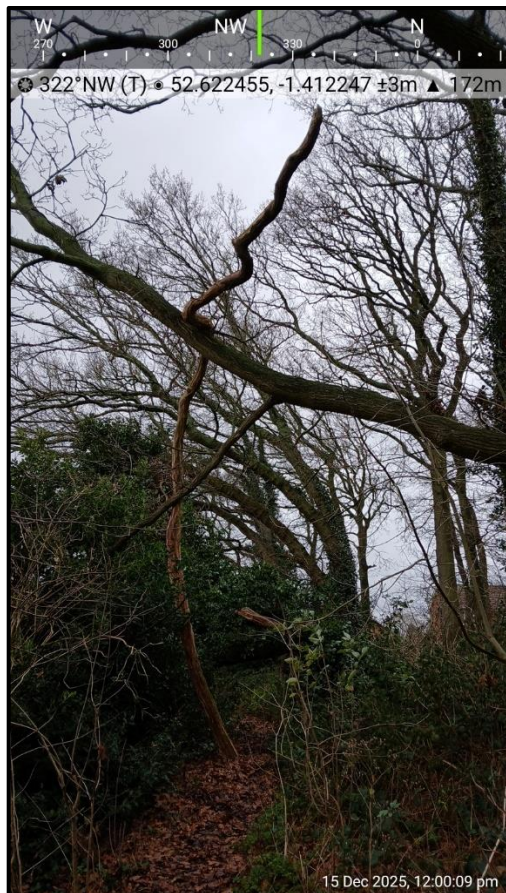
- 4.4 A selection of key findings of this survey are detailed below. Full details of all recorded trees can be found in the attached SCH.
- 4.5 A total of 13 trees have been identified as a result of this tree risk assessment survey, 1 of which have been assessed as posing an unacceptable risk, 4 as posing an unacceptable risk (where imposed on others) or tolerable (by agreement), 4 as posing a tolerable risk (if ALARP) and 4 as posing a broadly acceptable risk.
- 4.6 A high number of trees in the woodland had ivy obscuring their stems and unions. Ivy has the potential to conceal pests, diseases and other abnormalities, potentially limiting the accuracy of visual assessment.
- 4.7 A large piece of unattached deadwood was identified hanging over the footpath, northwest. It is recommended this is removed as soon as possible.
