# GeoShield Verification Report

PROJECT REFERENCE: GEO103990

PROJECT: Aldi Bardon

PROJECT ADDRESS: Aldi Distribution Centre

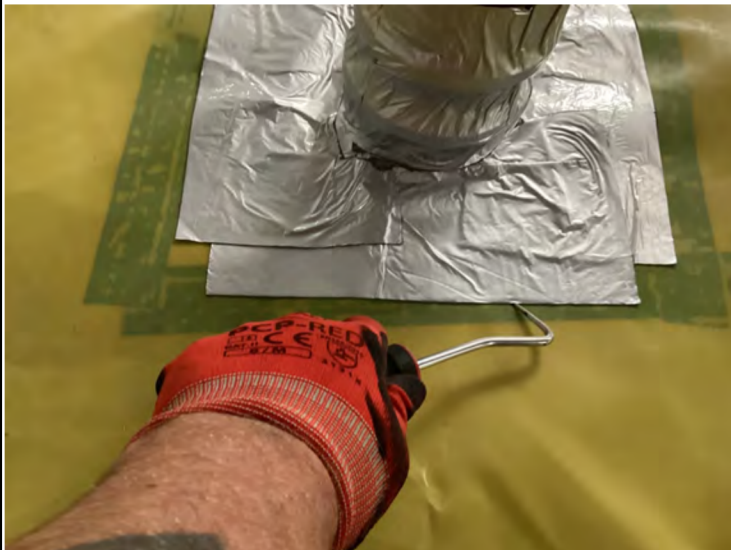
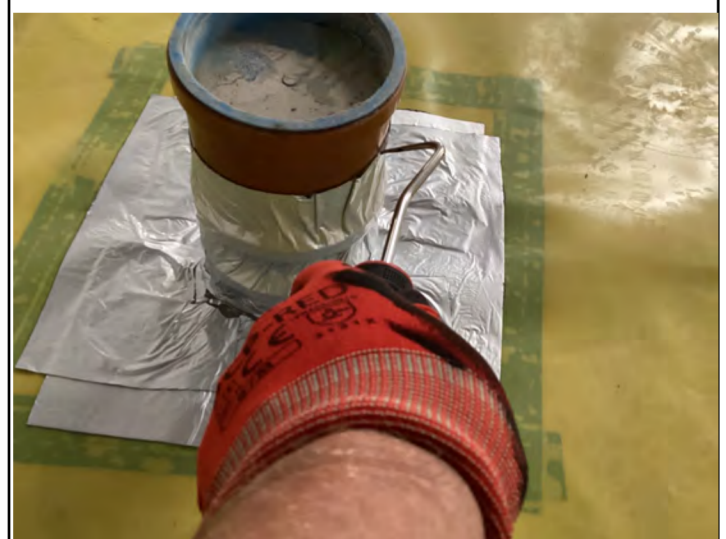
NOTES: Pipe Penetration Detailing

The various pipe penetrations had all been detailed using strips of Visqueen ProDetailing

Tape providing a full seal with both the pipe and the Visqueen Low Permeability

Membrane. The initial inspection noted that there were minimal creasing along the width

of the detailing and therefore no potential capillary leak risks throughout. The Mechanical

Point Stress Test was undertaken along the edges proving a full bond.

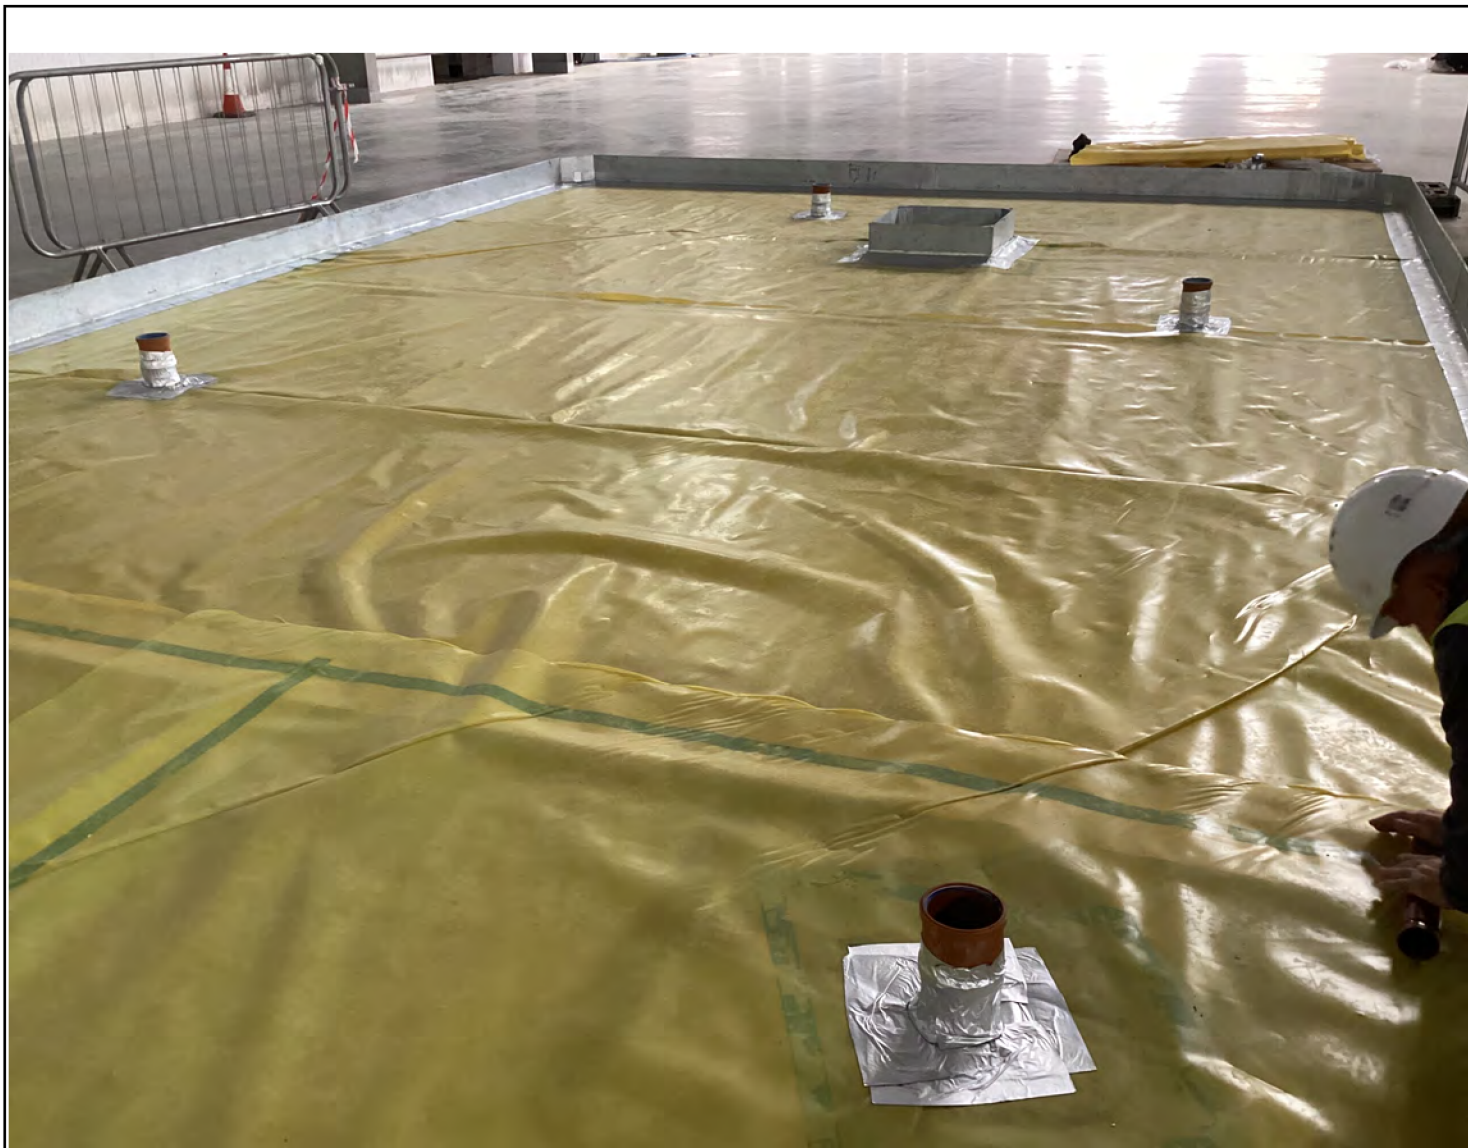
The overview image shows typical pipe penetrations sealed with the Visqueen Low Permeability Membrane and subjected to both a visual inspection along with the Mechanical Point Stress Test. The application of both heat and sufficient pressure ensured the Visqueen ProDetailing Tape had been fully bonded and sealed.

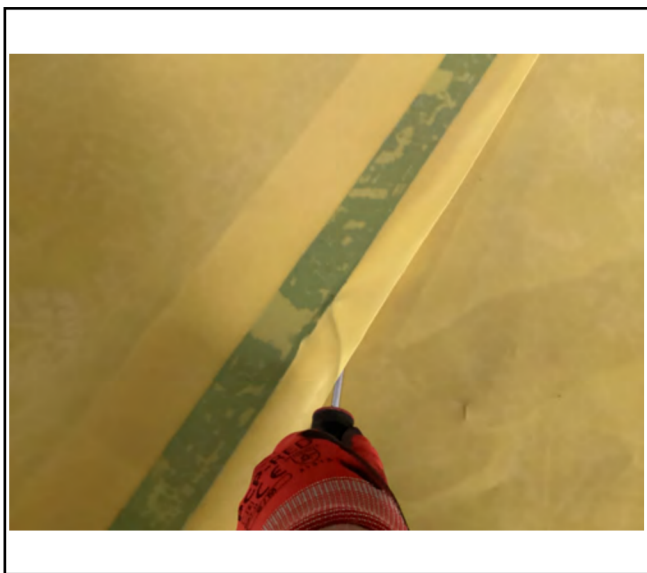
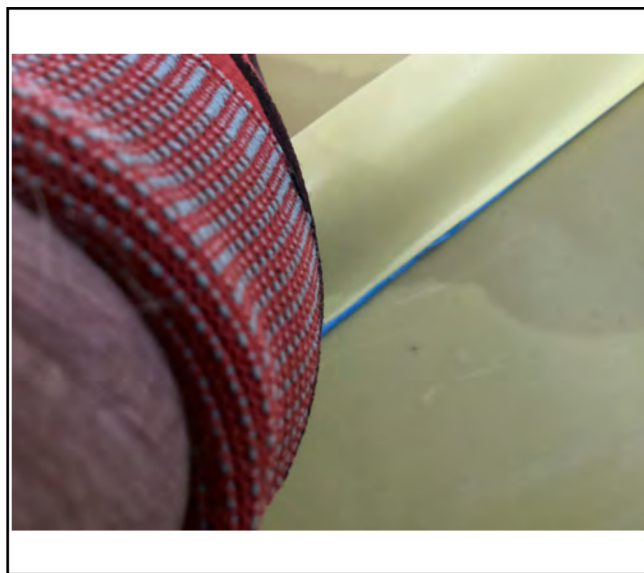
NOTES: Visqueen Low Permeability Membrane - Lap Joints

The Visqueen Low Permeability Membrane had been dual taped combining both the Visqueen Double Sided Butyl Tape (the initial seal) and a second seal using the Visqueen ProDetailing Tape. The left image shows the Mechanical Point Stress Test

being undertaken along the edge of the Visqueen Double Sided Butyl Tape so as to ensure a complete seal. There were some areas of the inspected lap joints which can be seen in 'Verification Item Three' this report. The right image shows the Visqueen Double Sided Butyl Tape in position within the lap joint.

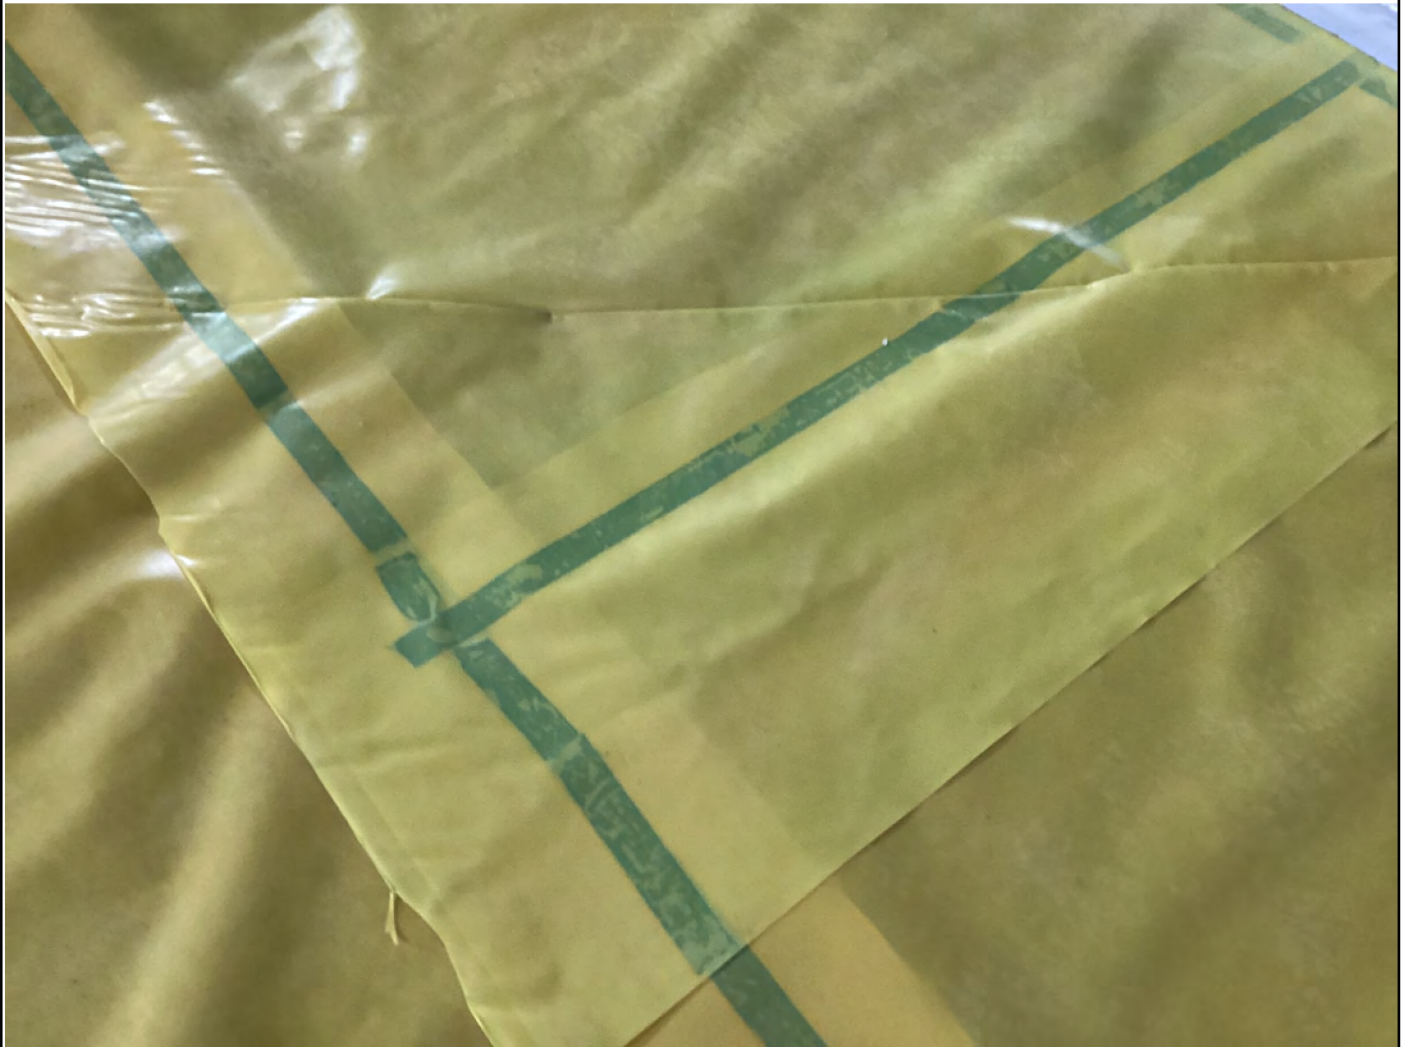
This is an overview image showing typical Visqueen Low Permeability

Membrane lap joints where the Visqueen Double Sided Butyl Tape is visible through

the membrane. In addition, there was also sufficient lap between each sheet of

Visqueen Low Permeability Membrane which was typically more than 150mm.

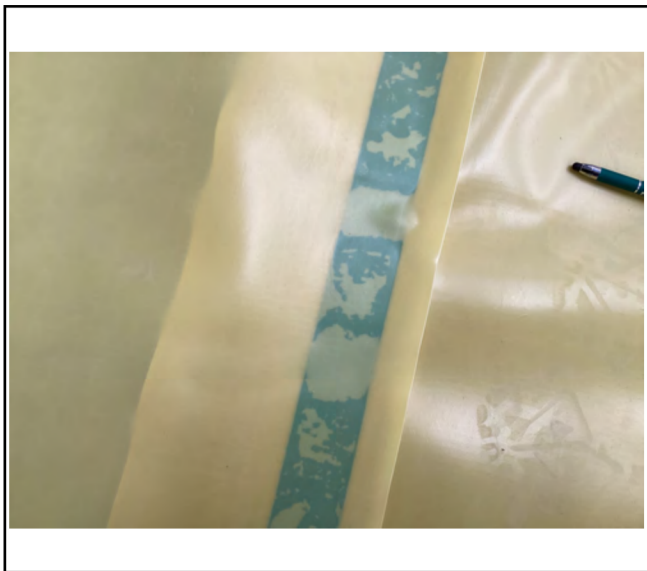
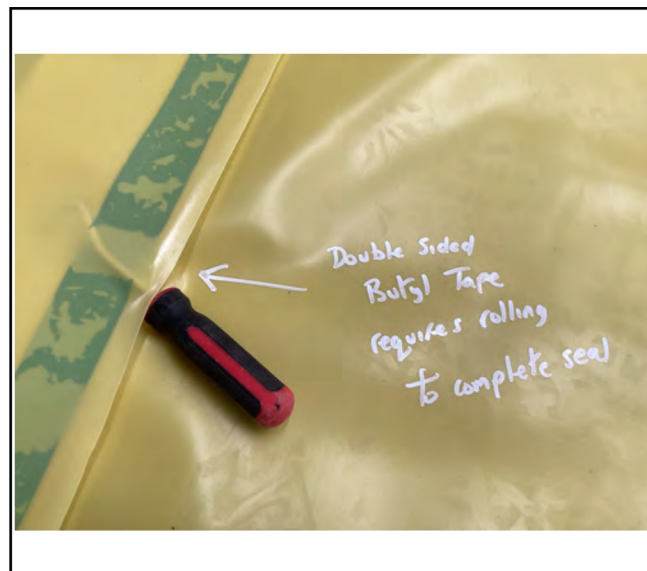
NOTES: Visqueen Low Permeability Membrane - Lap Joints

Further to 'Verification Item Two' the Mechanical Point Stress was continued along the various Visqueen Low Permeability Membrane lap joints. The left image gives an initial view of one of the Visqueen Low Permeability Membrane lap joints where it was

noted that the Visqueen Double Sided Butyl Tape appeared not to have fully

sealed the two sections of the Visqueen Low Permeability Membrane. The

Mechanical Point Stress Test seen being completed in the right image identified a

mis-taped lap joint and therefore a capillary leak risk.

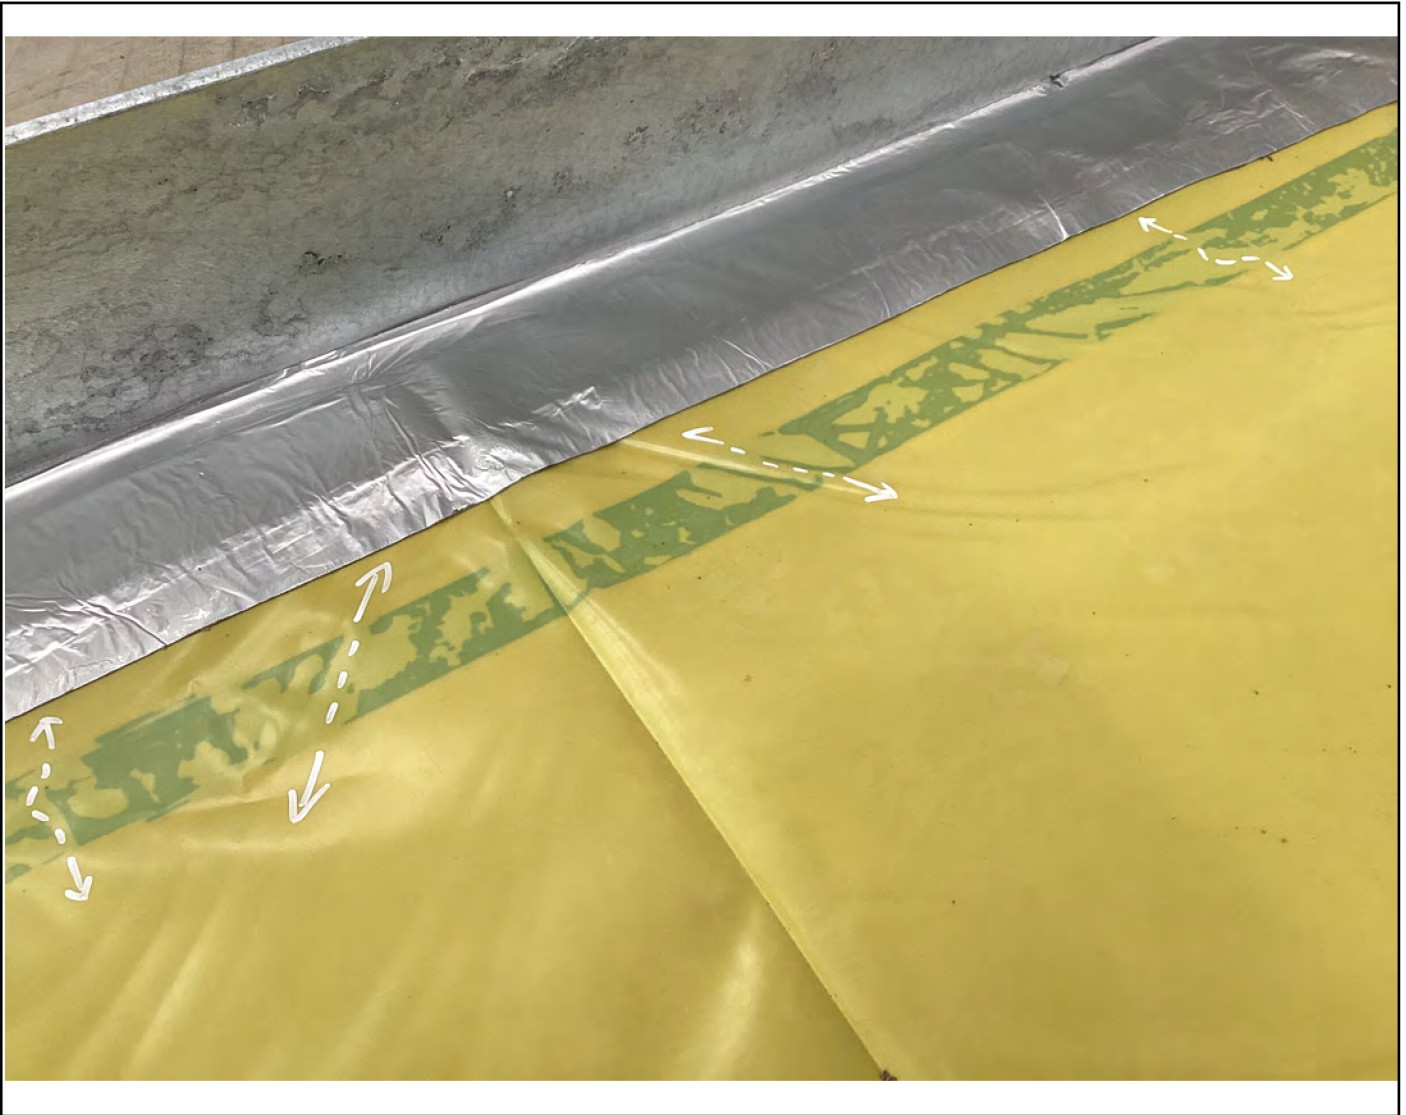
The overview image shows further mis-taped lap joints and are indicated with

with white arrows. These areas required further attention and the installers

proceeded to apply further pressure ensuring the Visqueen Double Sided

Butyl Tape provided a full robust seal as seen in additional photos.

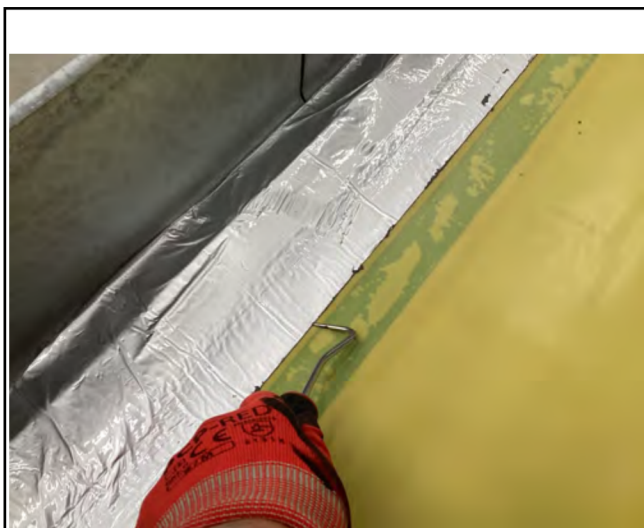
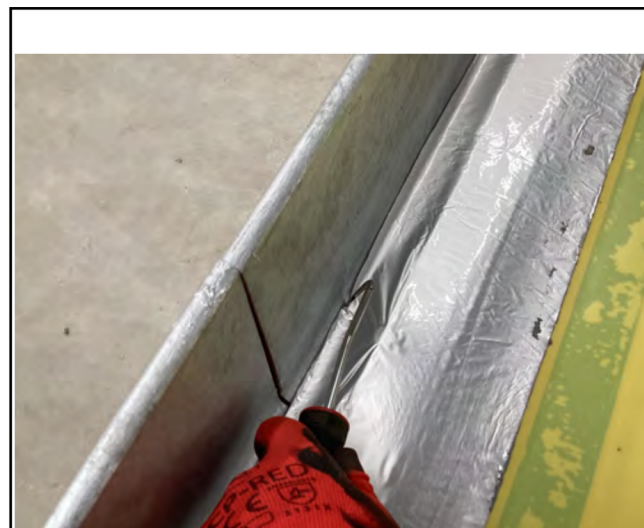
NOTES: Perimeter Retrospective Installation

The two areas of installation were installed within an enclosure where a steel angle had been used to line the perimeter edges. The Visqueen Low Permeability Membrane terminated with the steel angle before a being sealed with a strip of the

Visqueen ProDetailing Tape. The installation was initially checked for any obvious bonding issues where it appeared that there was a sufficient bond and no evidence of any excessive creasing. The images show the Mechanical Point Stress Test being undertaken along the edges which confirmed a robust bond had been completed.

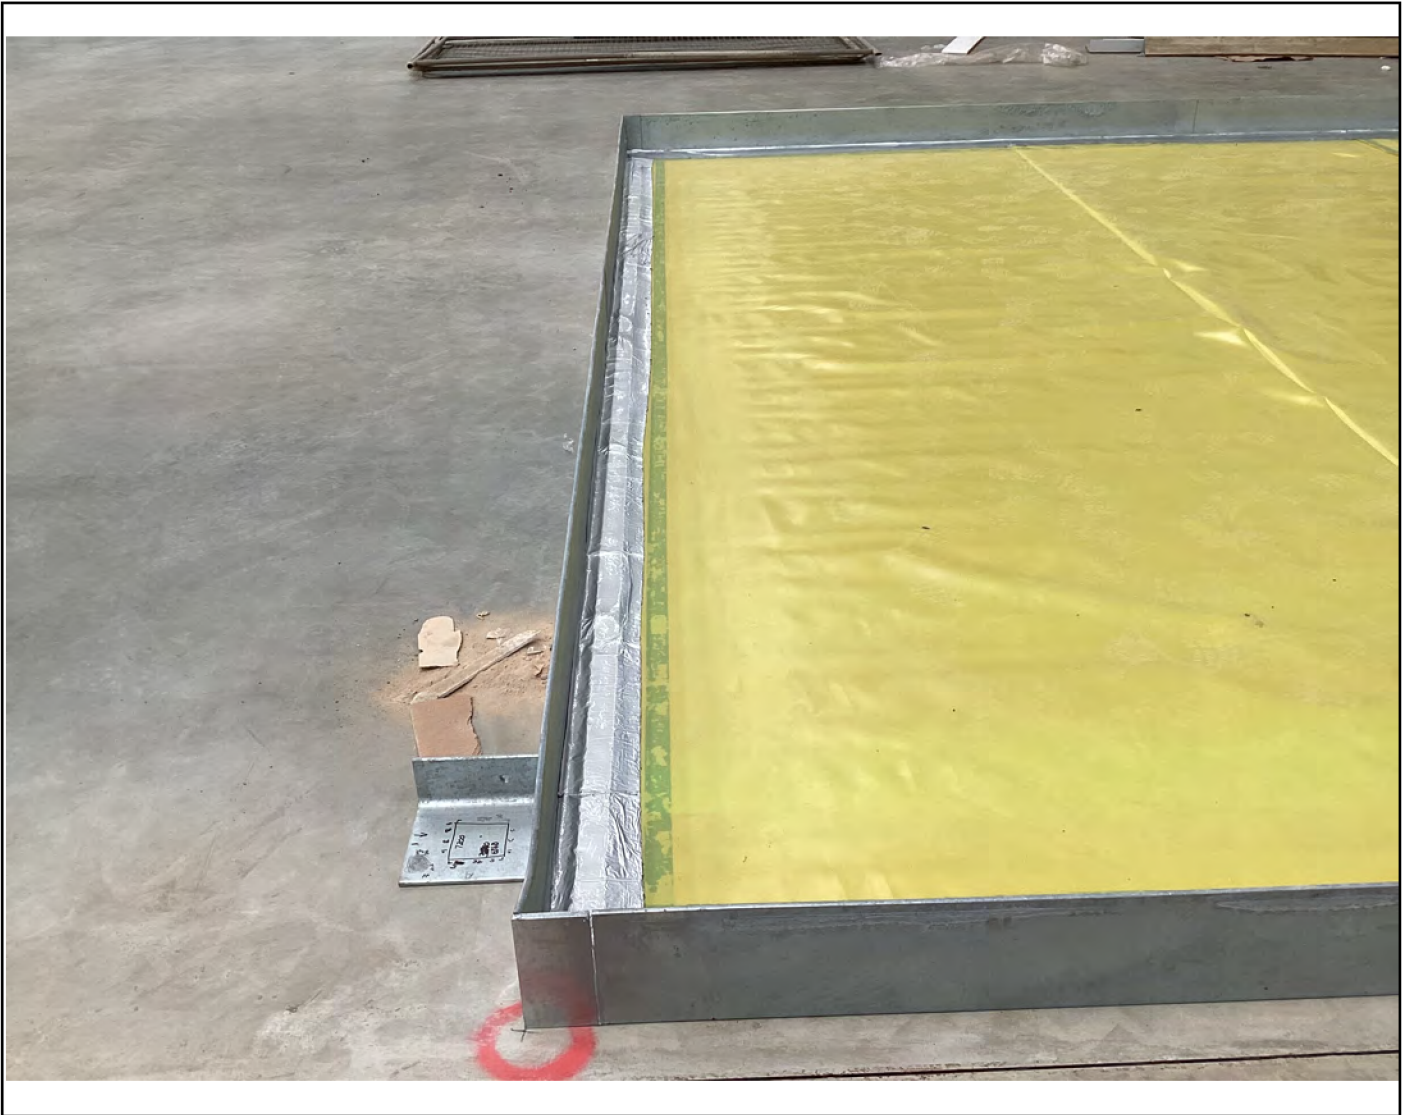
The overview image shows a typical perimeter where the Visqueen ProDetailing Tape had been used to seal the steel angle with the Visqueen Low Permeability Membrane. The verification noted the Visqueen ProDetailing had been lapped and fully bonded and therefore no capillary leak risks identified.

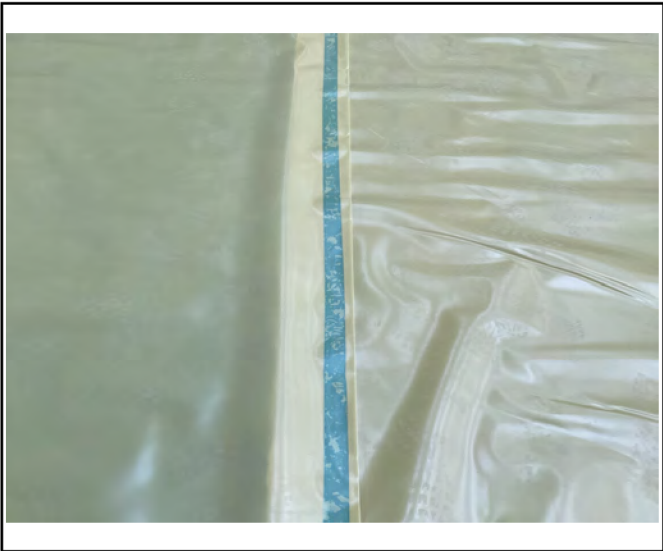
View along a typically sealed Low

Permeability Membrane lap joint

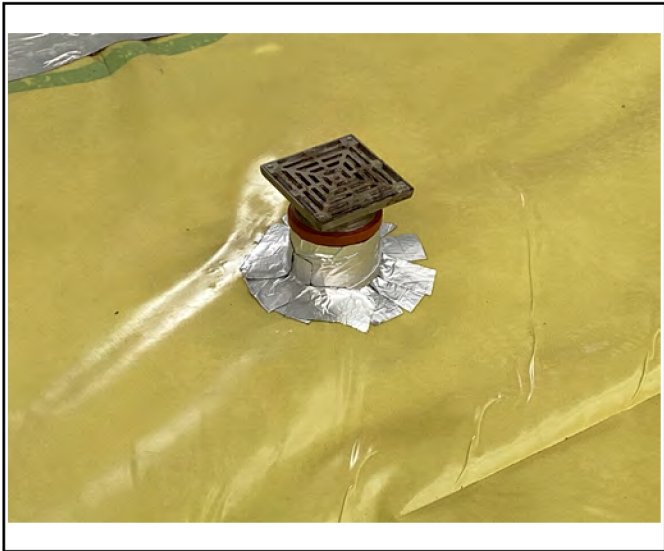
View of a typically sealed pipe

penetration sealed with ProDetailing

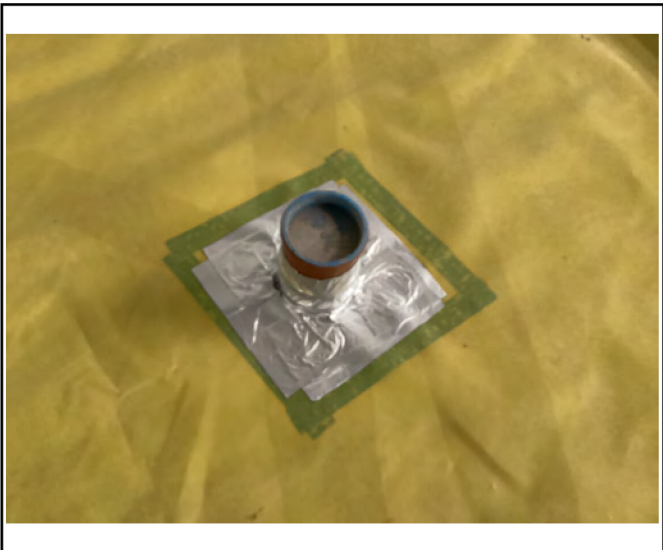
View of a typically sealed pipe

penetration sealed with ProDetailing

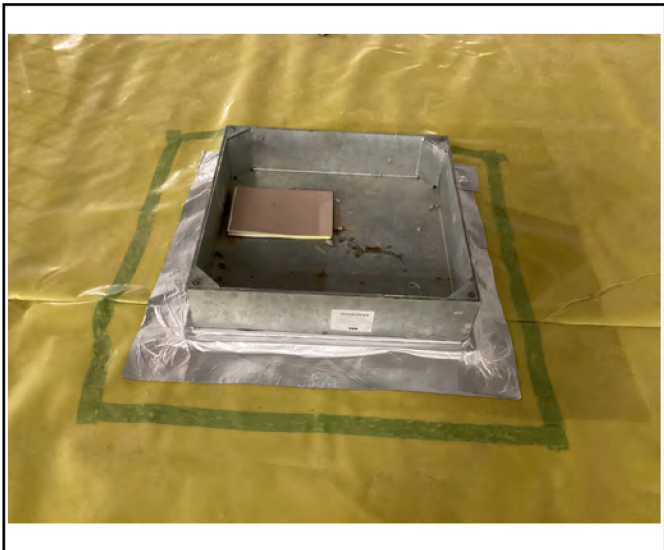
View of an inspection chamber

penetration sealed with ProDetailing

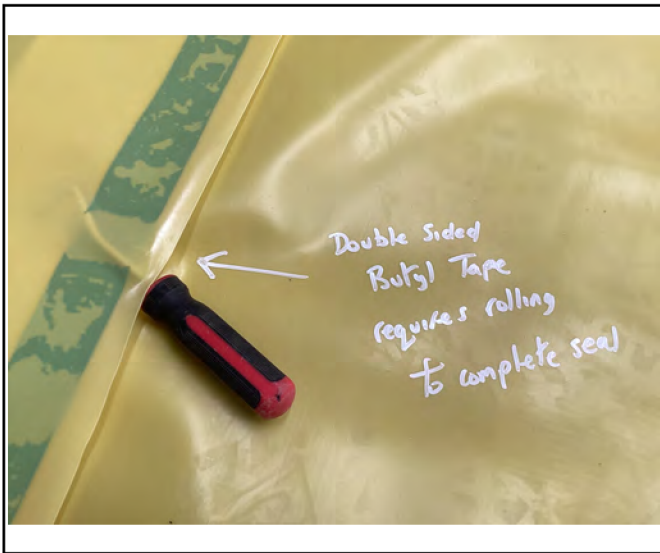
View of un-sealed lap joint requiring  
further pressure to complete seal (1)

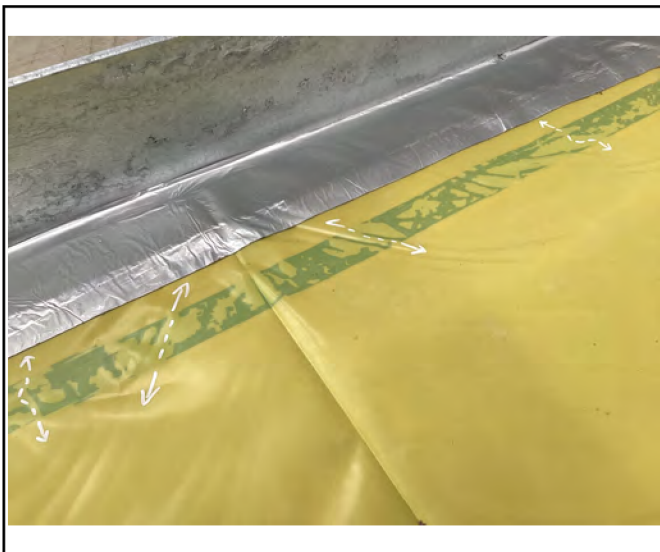
View of un-sealed lap joint requiring  
further pressure to complete seal (2)

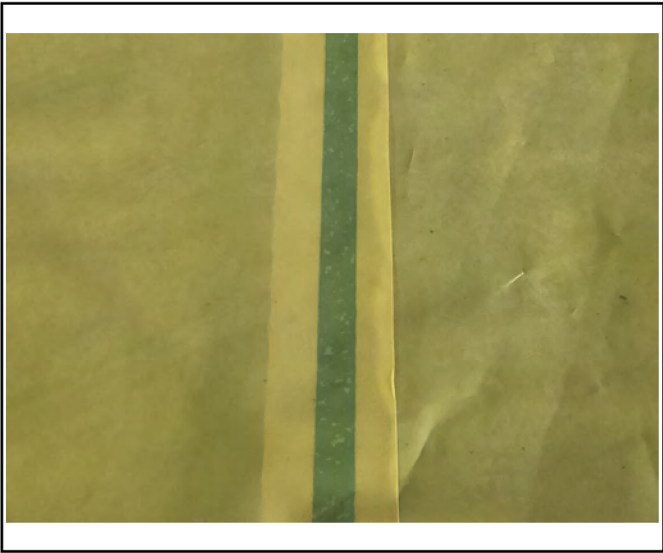
View along a typically sealed Low

Permeability Membrane lap joint

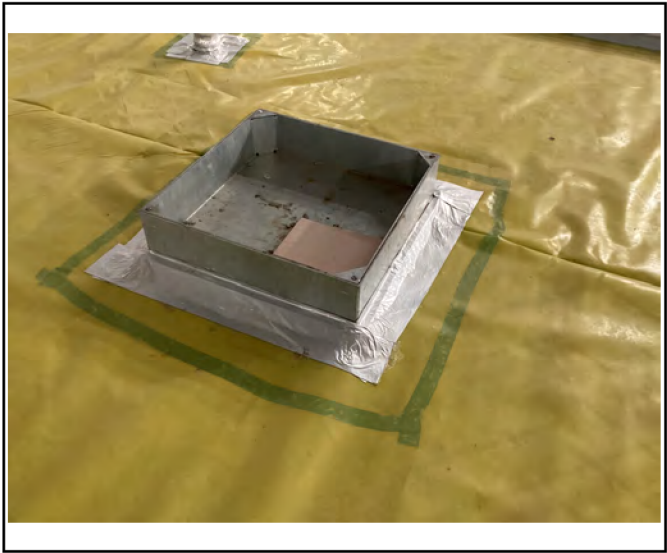
Alternative view View of an inspection

chamber sealed with ProDetailing

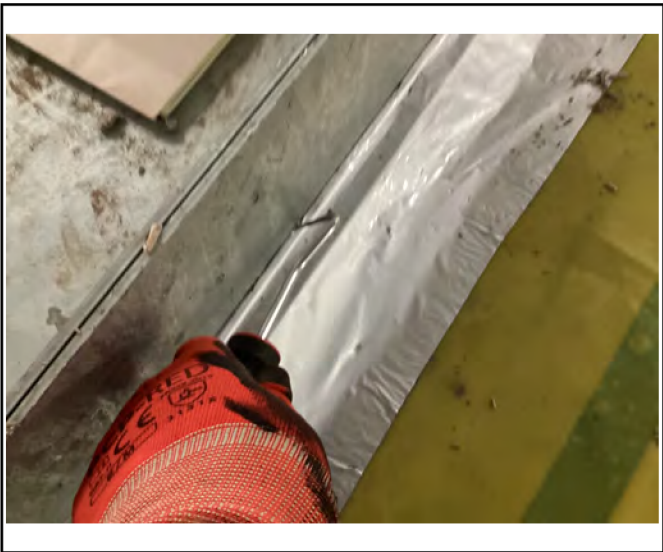
Mechanical Point Stress Test to

retrospective ProDetailing seals

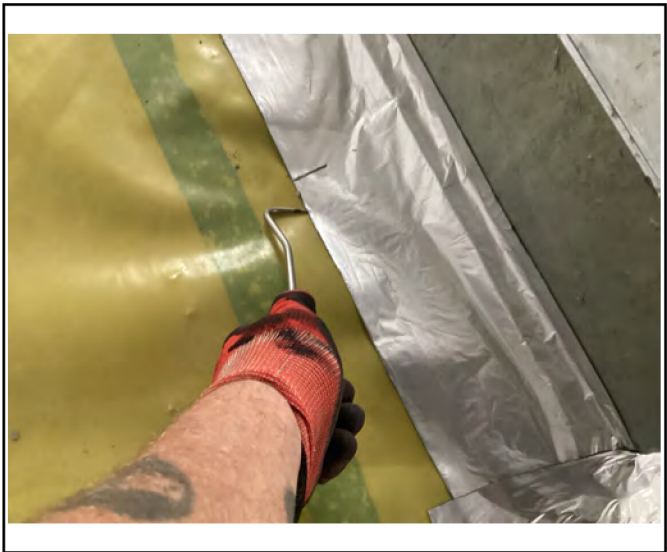
Mechanical Point Stress Test to

retrospective ProDetailing seals

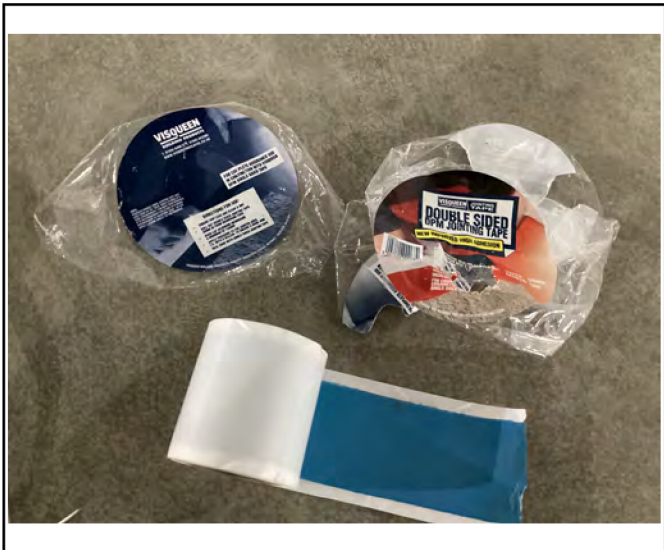
View of a potential lap joint fail

due to creased membrane
