## General Report

### Report of the inspection of the Brick barn at TempleHall Cottages, Bosworth Road, Wellsborough

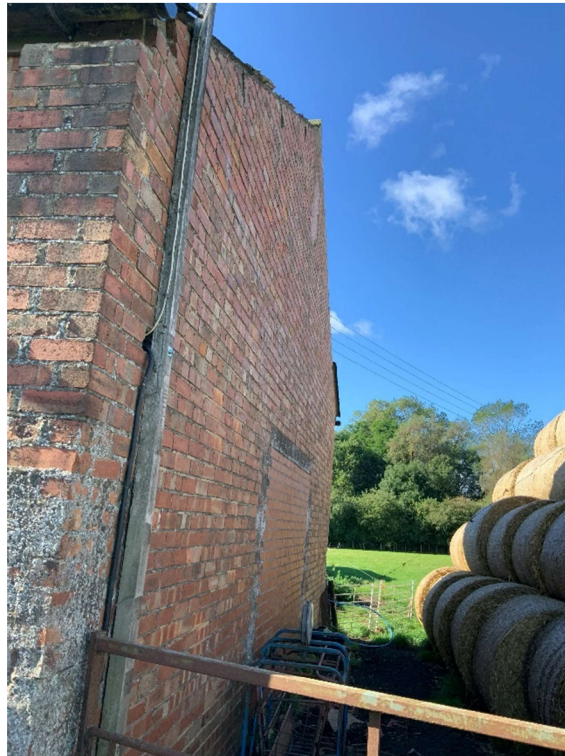
- 3.3. The northern gable wall has racked cracking visible indicative of settlement of the north eastern corner and there is also some similar cracking to the eastern flank wall at the same corner.

Picture 1 – North end gable infilled doorway and exposed verge

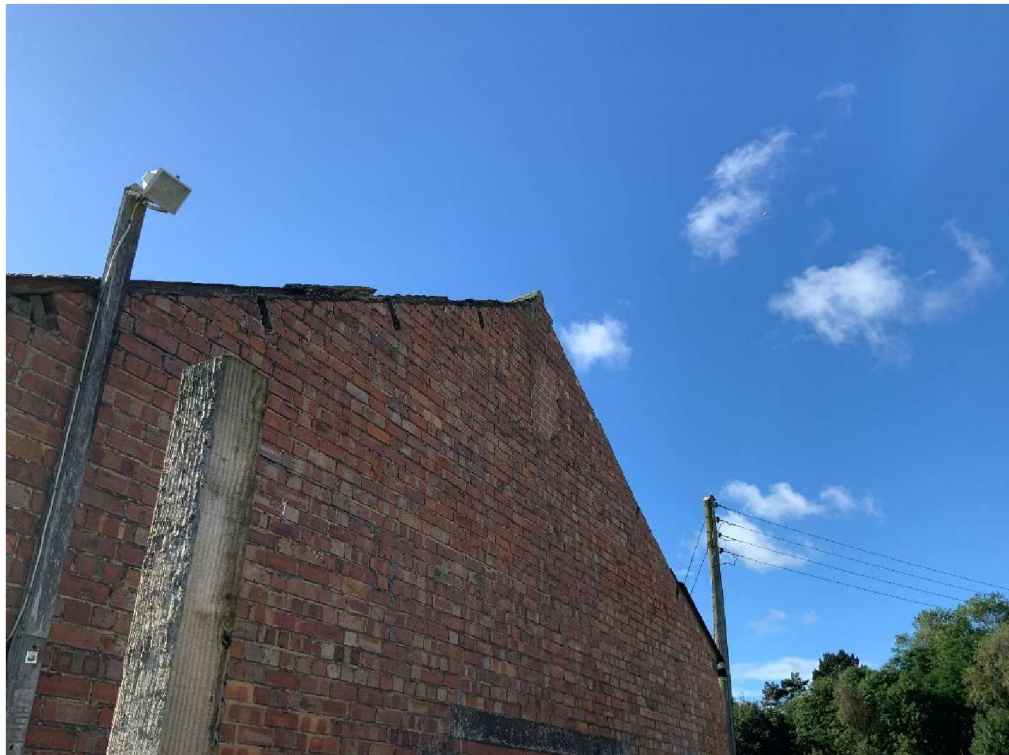
Picture 2 – Exposed verge and purlin protrusion

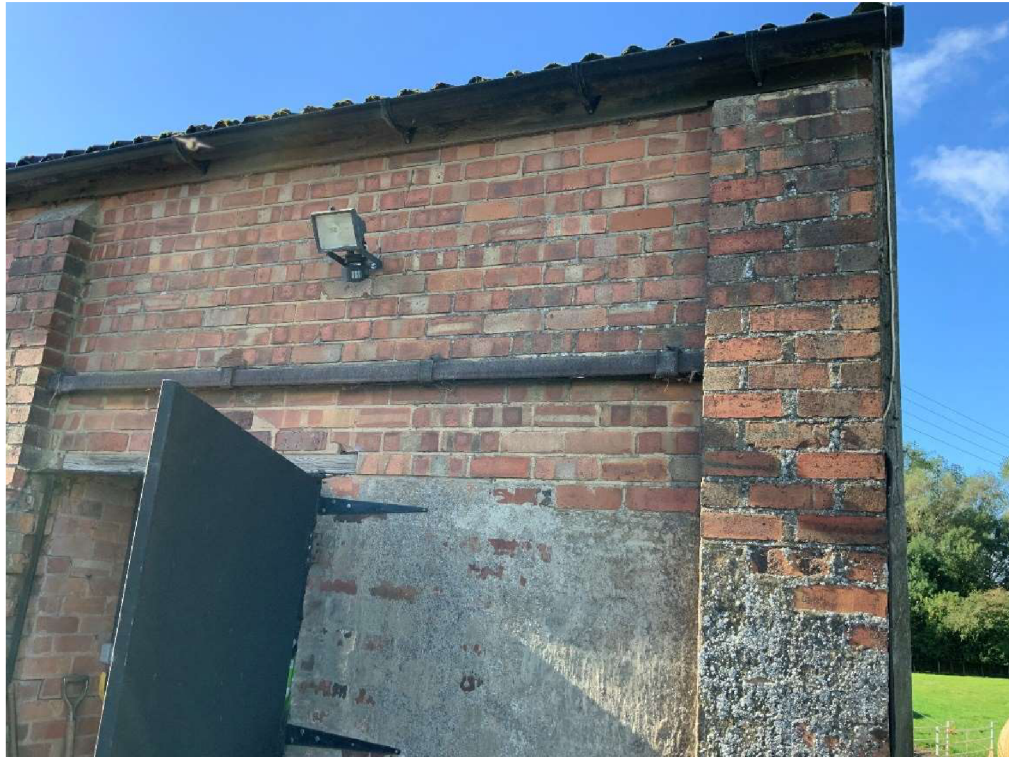
Picture 3 – note lower level thin render and stepped cracking in doorway above shovel handle

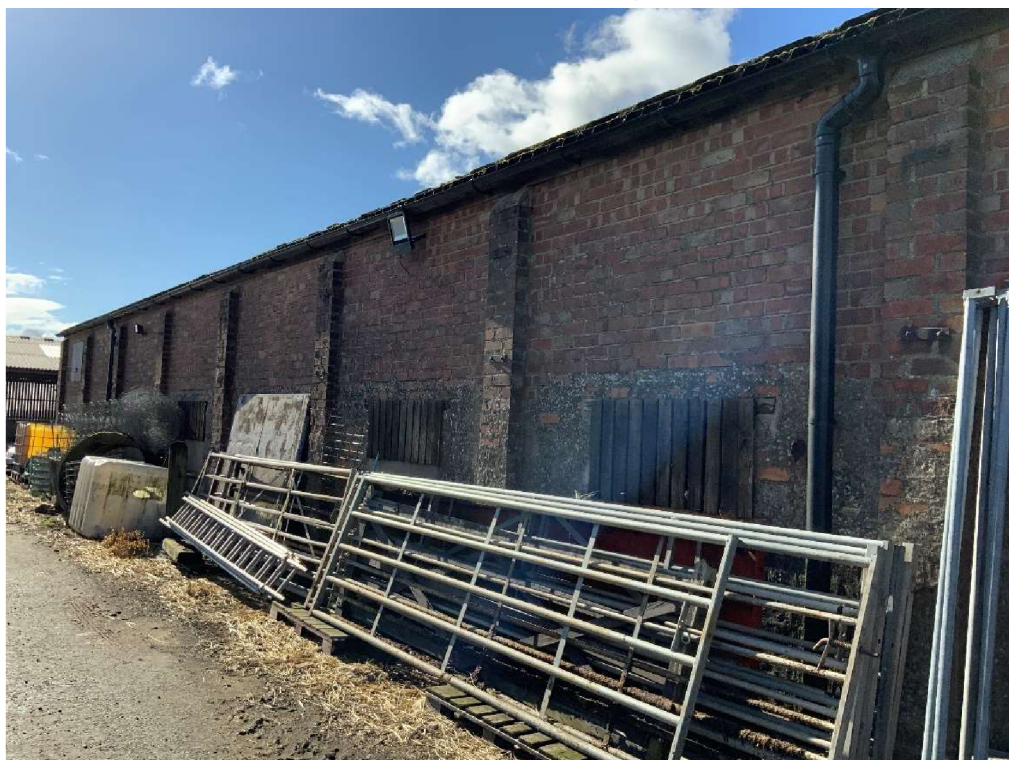
Picture 4 – General eastern elevation showing render line

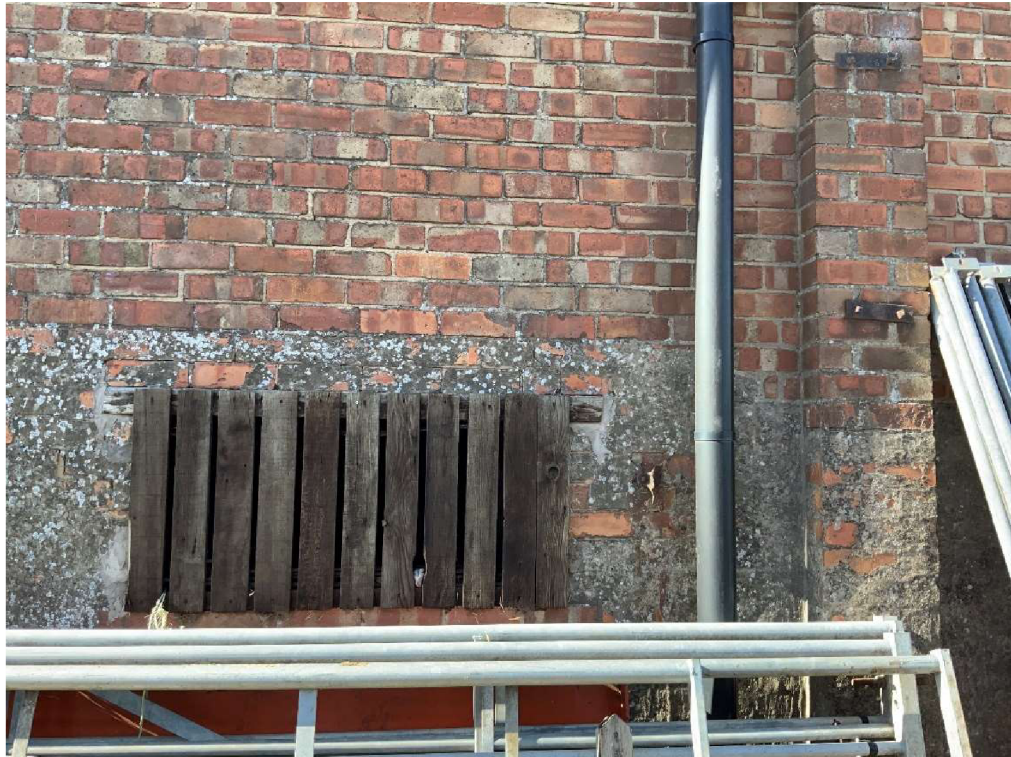
- 3.4. There is also some cracking over windows and doorways to the same elevation considered to be due to the deterioration of the timber lintels.
- 3.5. At the location of the internal steel columns there are external brick piers at approximately 2.9m centres. No expansion or contraction joints were visible in the wall at the recommended maximum brick panel size of 12m length.

- 5.4. Whilst the current mortar joints have opened over these lintels, the cracking has not compromised the stability of the structure.
- 5.5. The Southern elevation has been badly weathered resulting in erosion of the brick faces. If the elevation is to be retained, it is recommended that the wall be re-built with more durable bricks.

Picture 5 – Minor mortar separation above window lintel

- 5.3. The timber lintels are recommended for replacement with either steel or concrete lintel and repointing of the mortar joints over the lintels after installation.

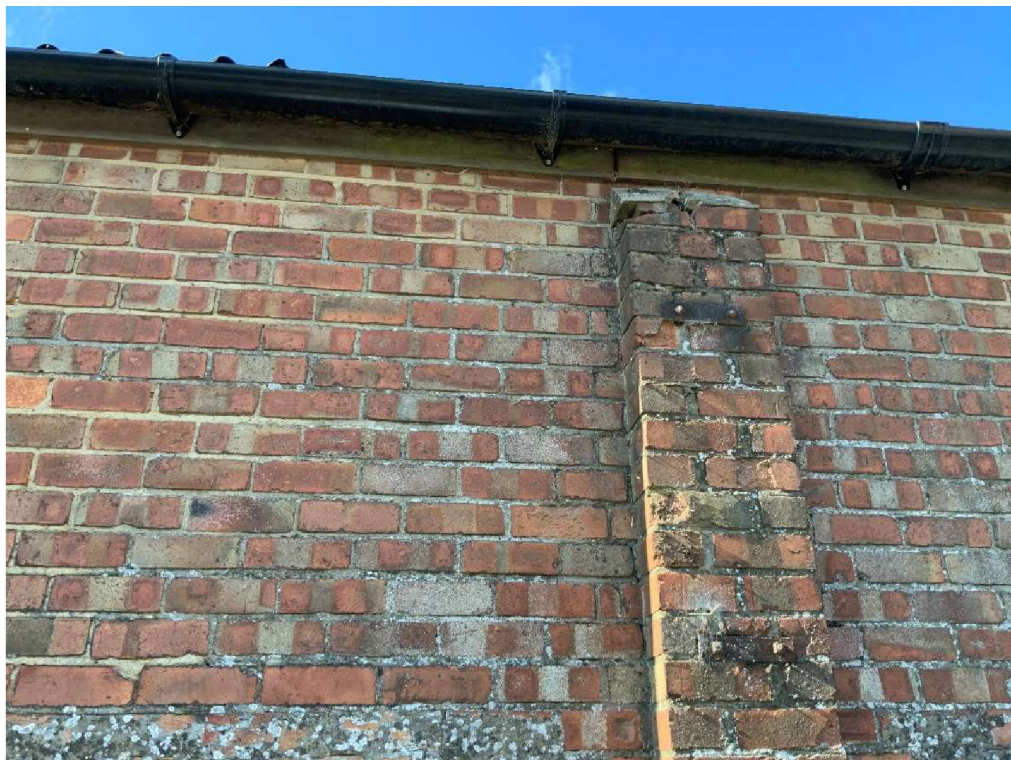
Picture 6 – spalling mortar cap to pier plus light corrosion of strap bolts to internal steel columns

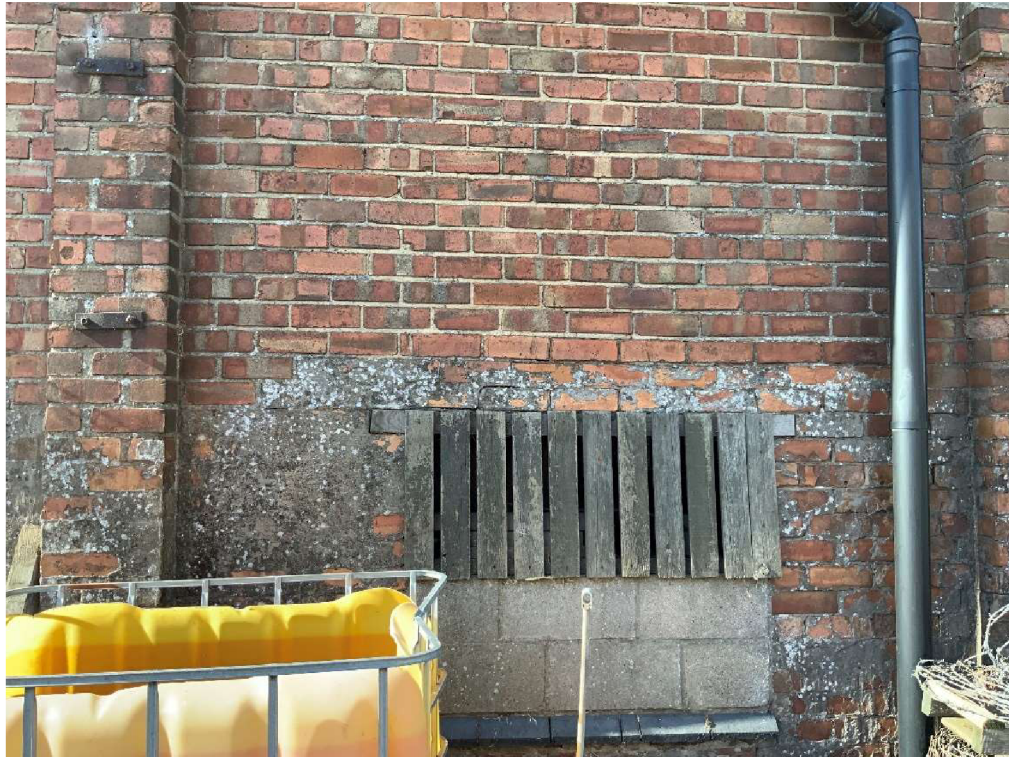
Picture 7 – Minor displacement of brickwork over timber lintel

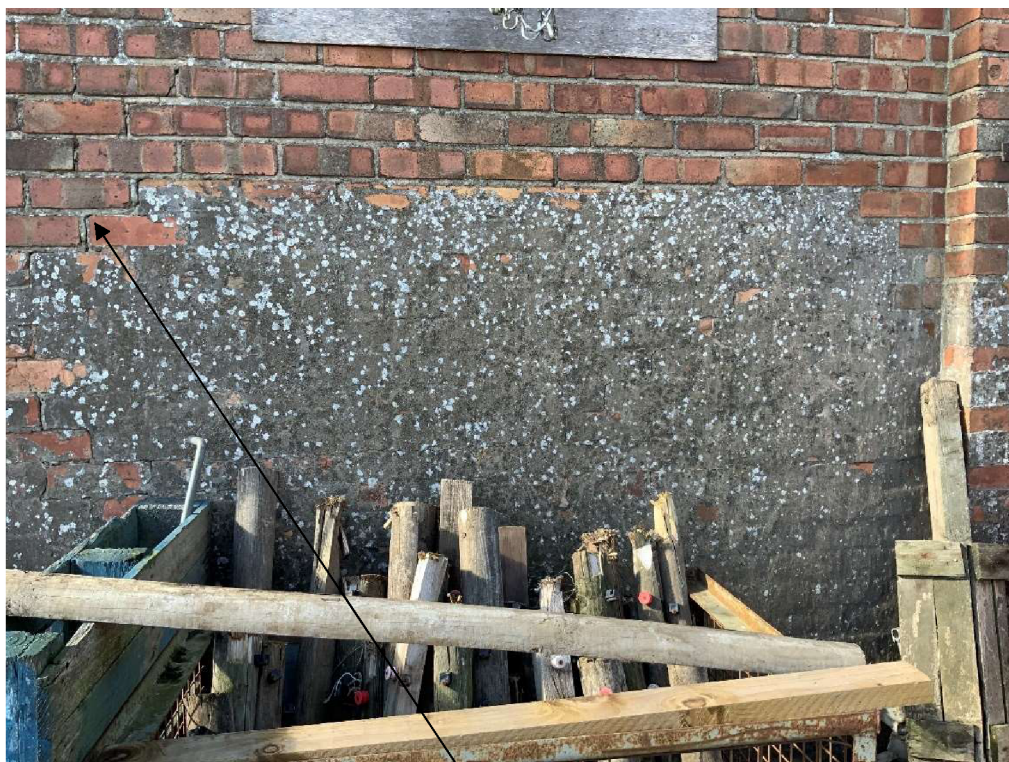
Picture 8 – Slight stepped cracking to left of render line

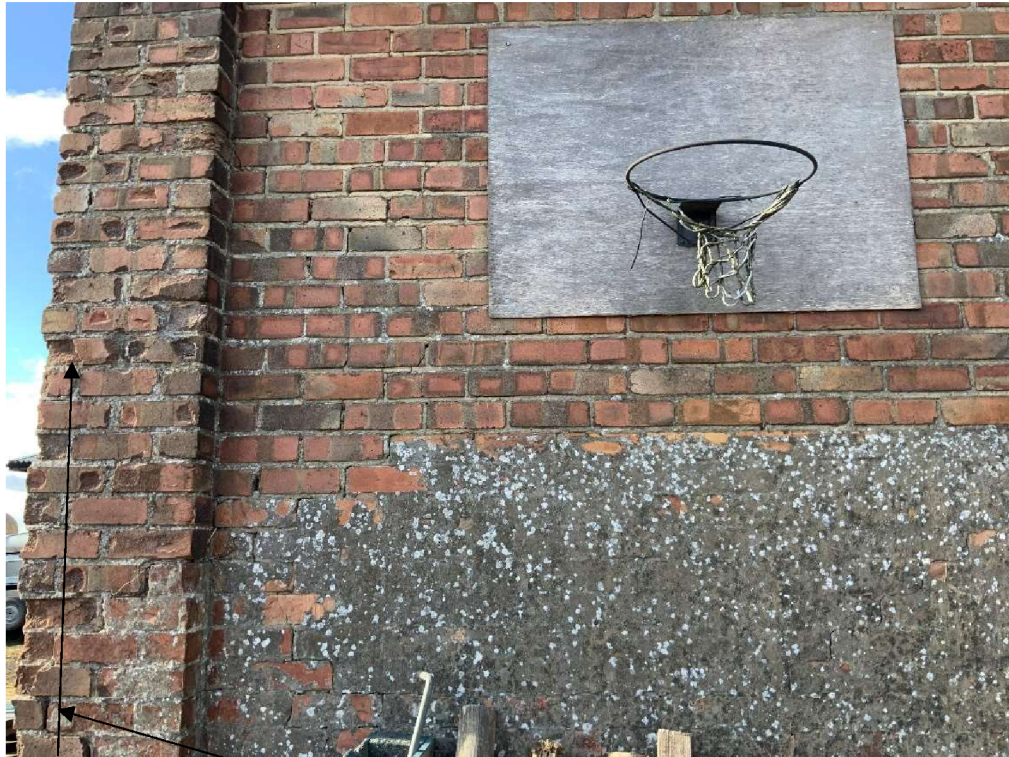
Picture 9 – Brick erosion and impact damage to corner brickwork

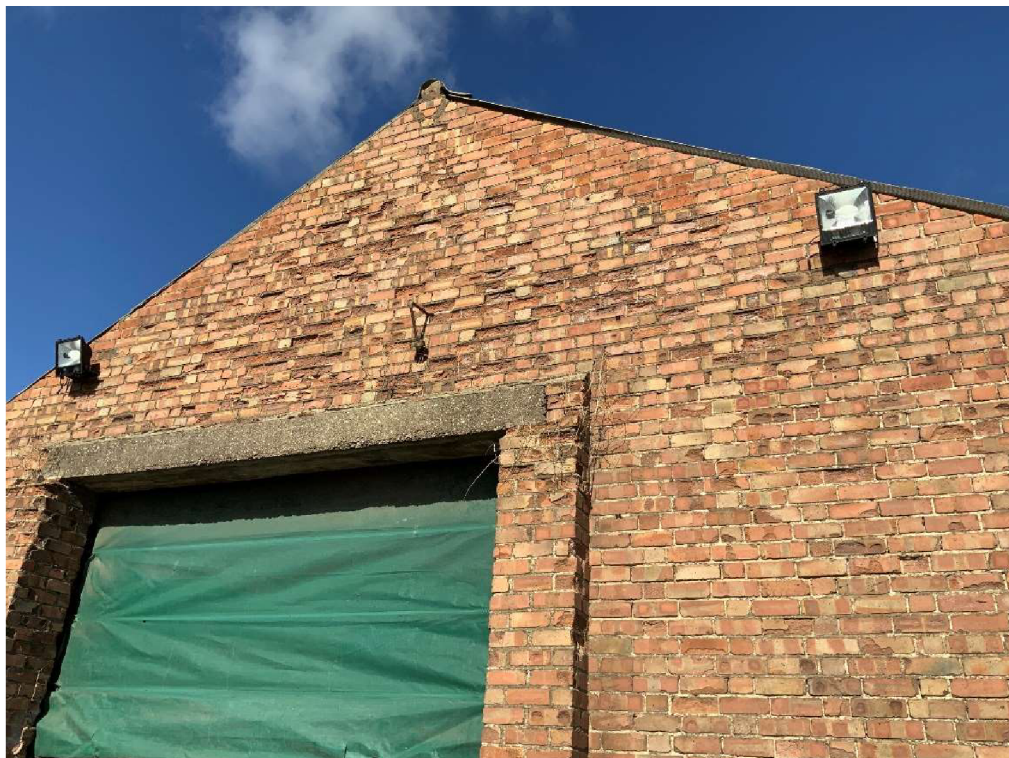
- 3.6. To the south-eastern corner of the elevation, there is some further cracking at mid-height, possibly due to lateral loading locally.
- 3.7. The southern gable is quite badly weathered. There is a central large door opening to this elevation.

Picture 10 – Eroded gable brickwork and exposed verge

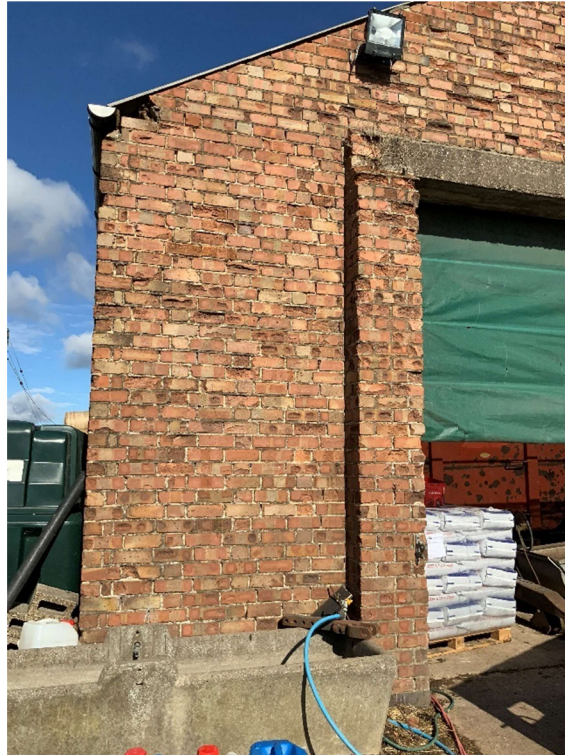
Picture 11 – Missing brickwork at eaves line and eroded brickwork of gable

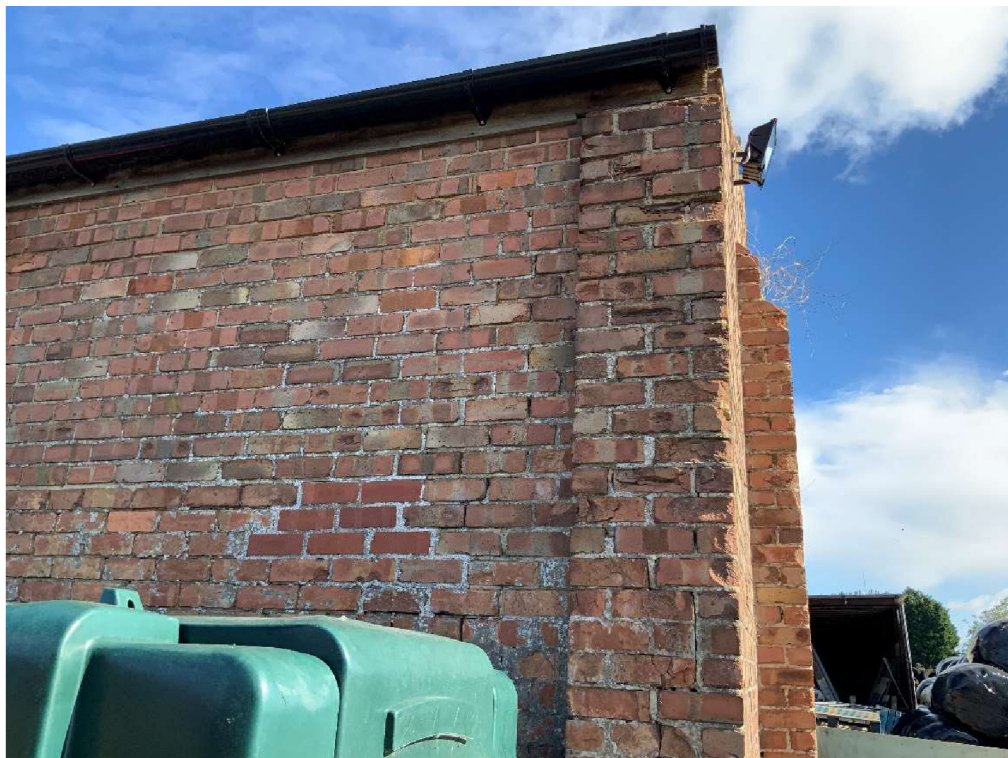
Picture 12 – Cracked and eroded brickwork to corner of barn (south west corner)

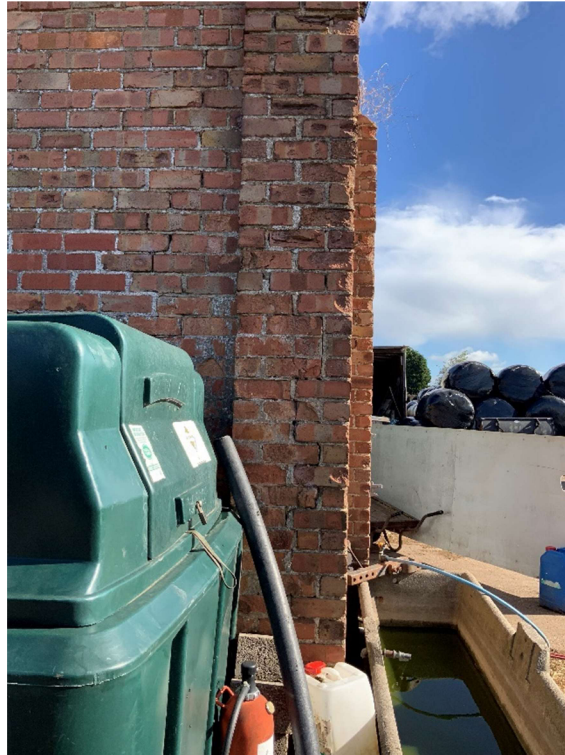
Picture 13 – closer detail of cracked brickwork to corner

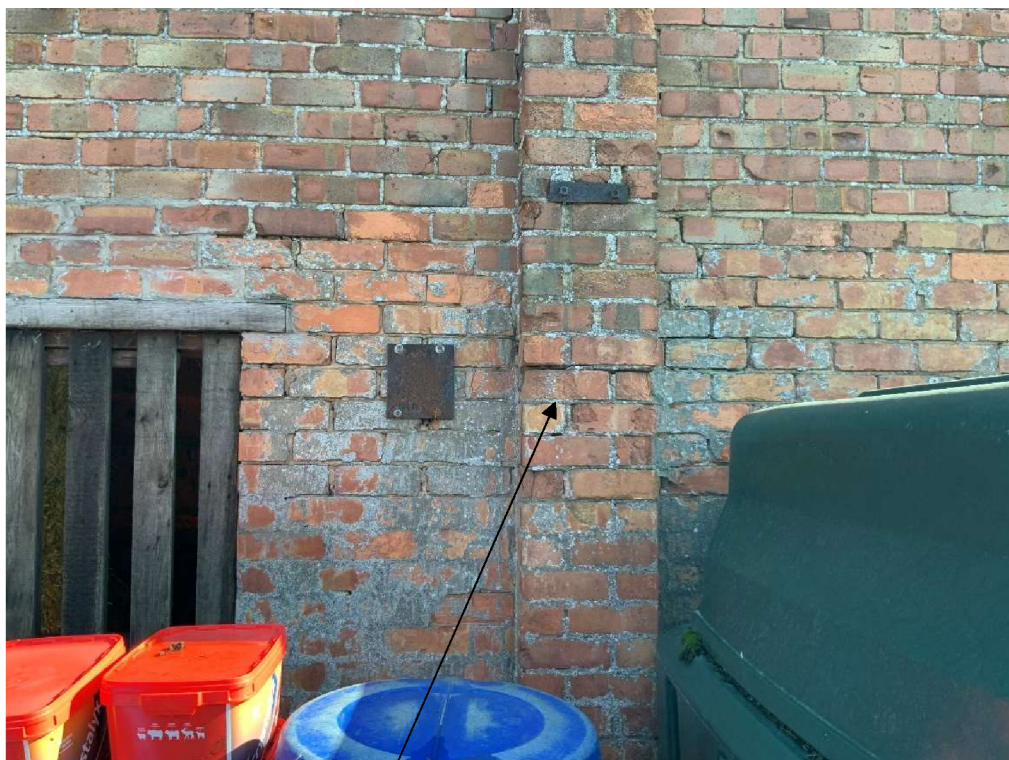
Picture 14 – damaged brickwork to be replaced

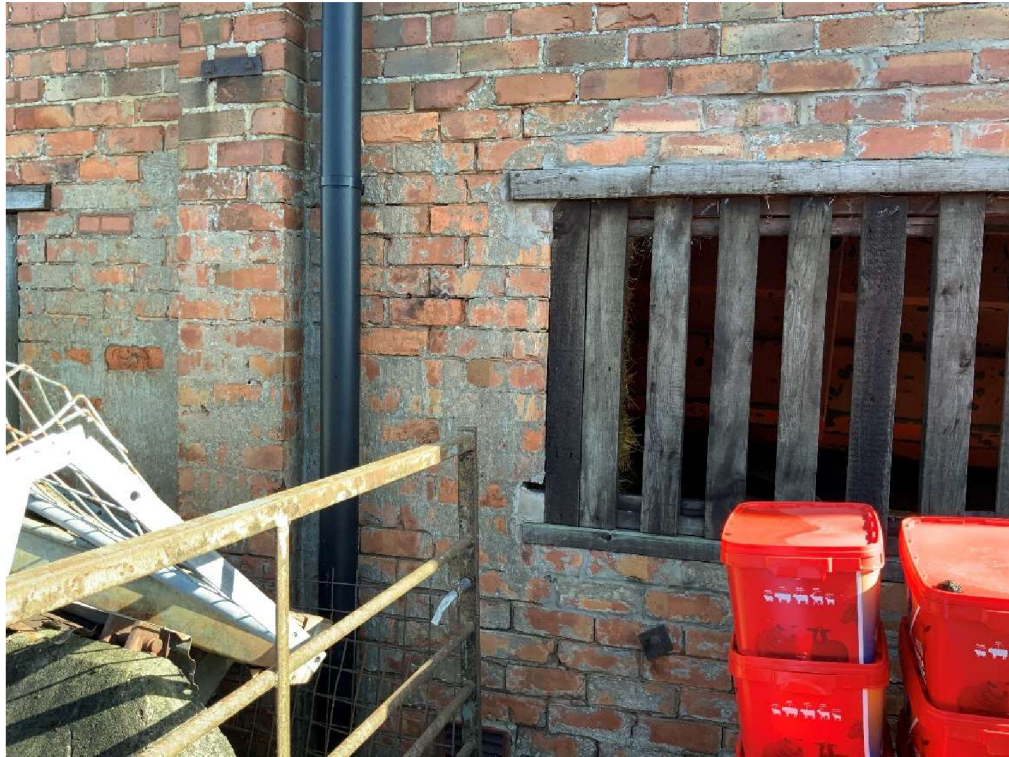
Picture 15 – timber lintels to be replaced as required, minor repointing works

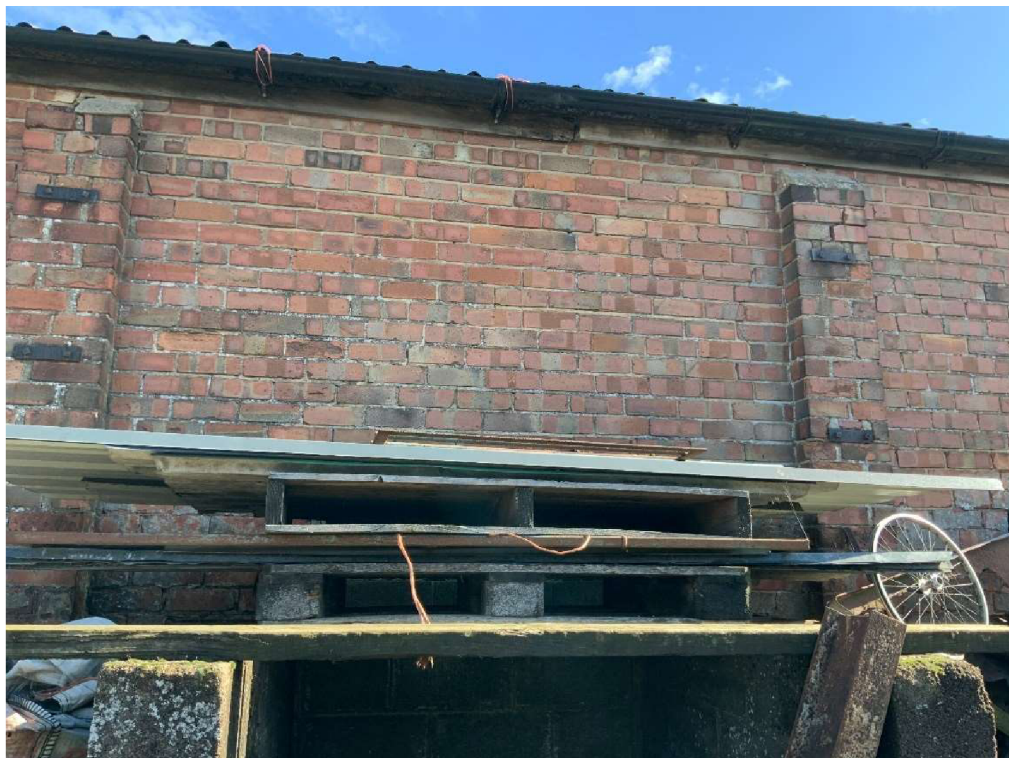
Picture 16 – Mortar coping to pier missing

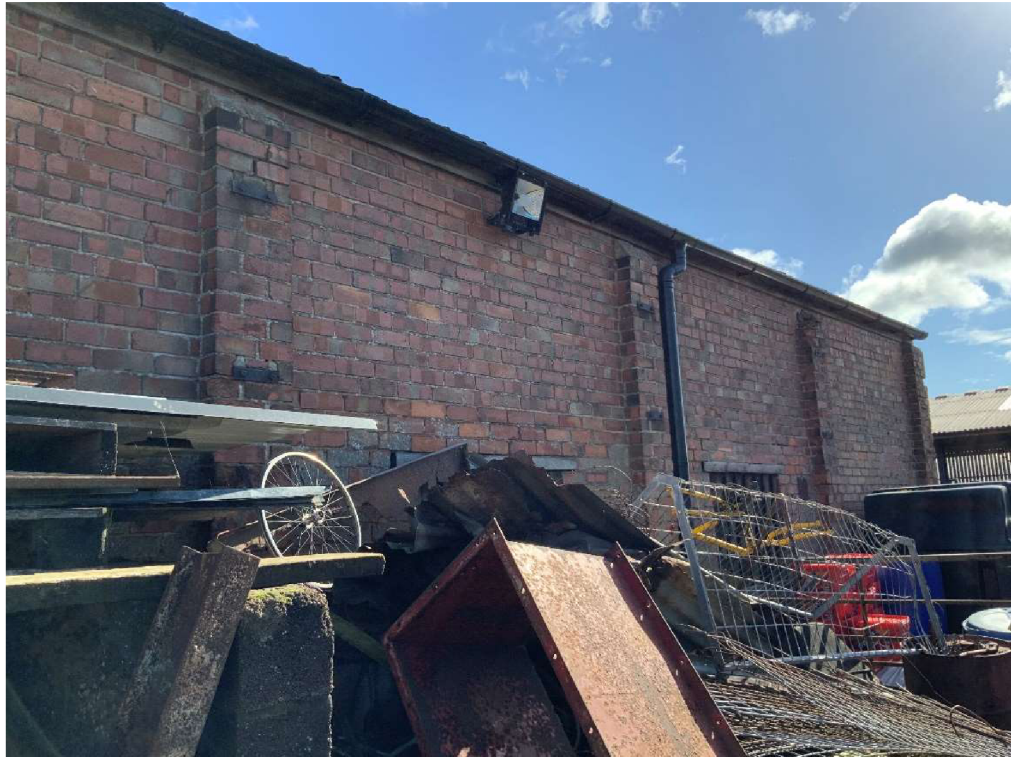
- 3.8. To the western elevation, there was similar cracking in brickwork over timber lintels as noted to the eastern elevation.

Picture 17 – General view towards south-western corner, note cracked brickwork over centre window opening

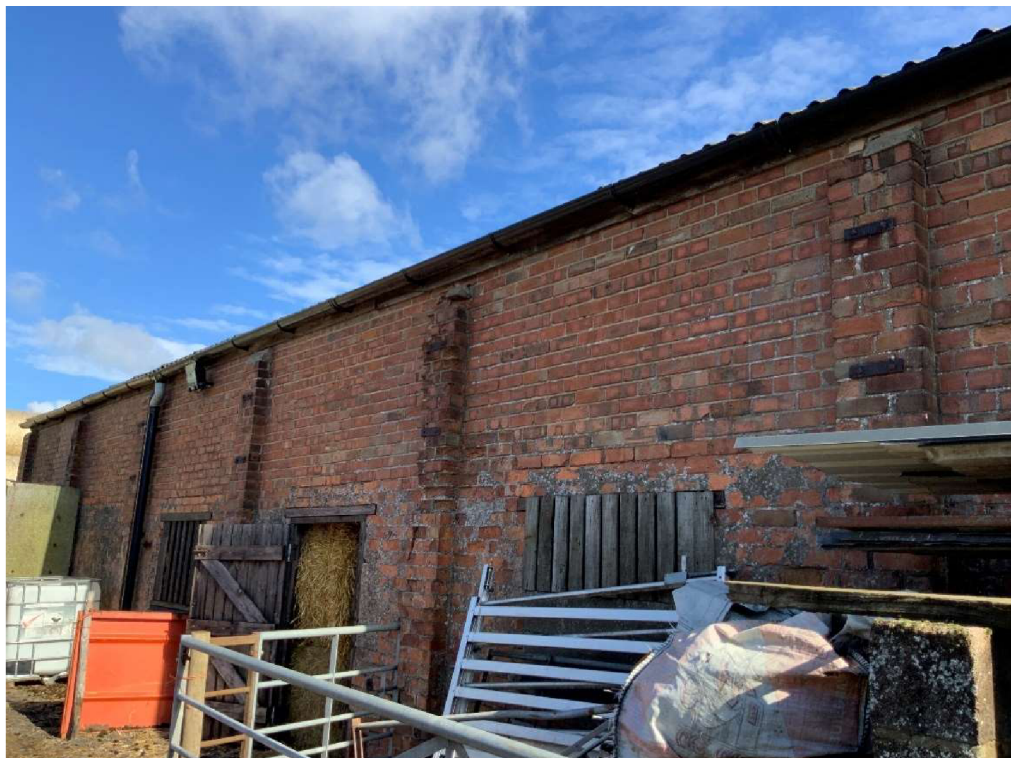
Picture 18 – General view towards north-western corner – note eroded brickwork to central pier to be replaced

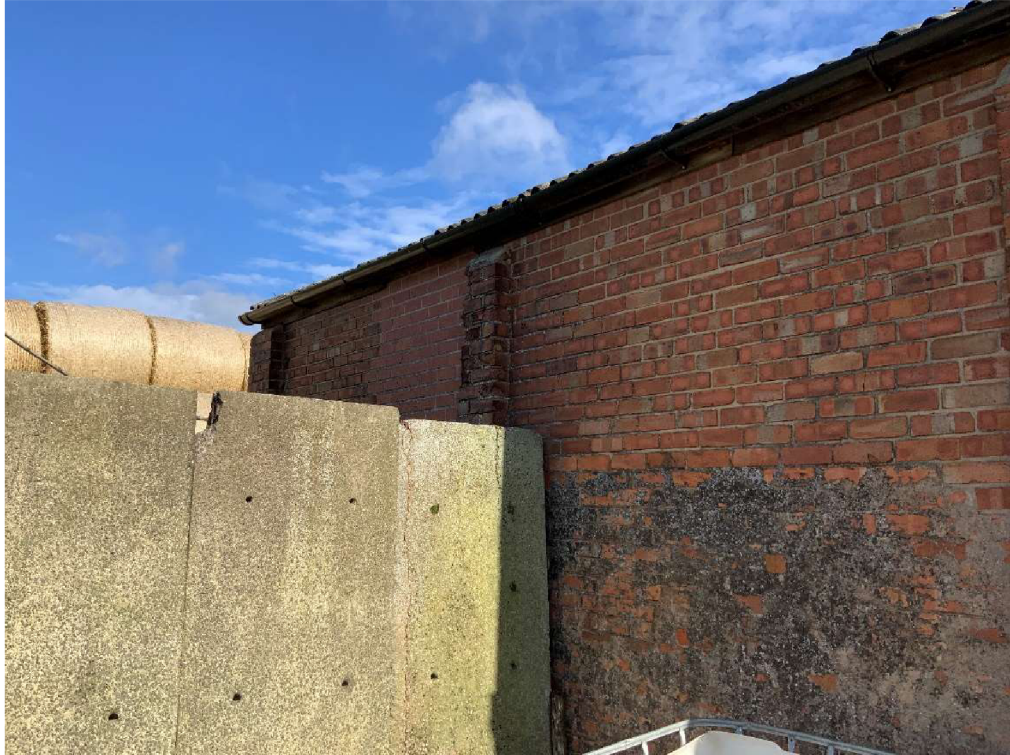
Picture 19 – replaced brick panel behind retaining wall panel

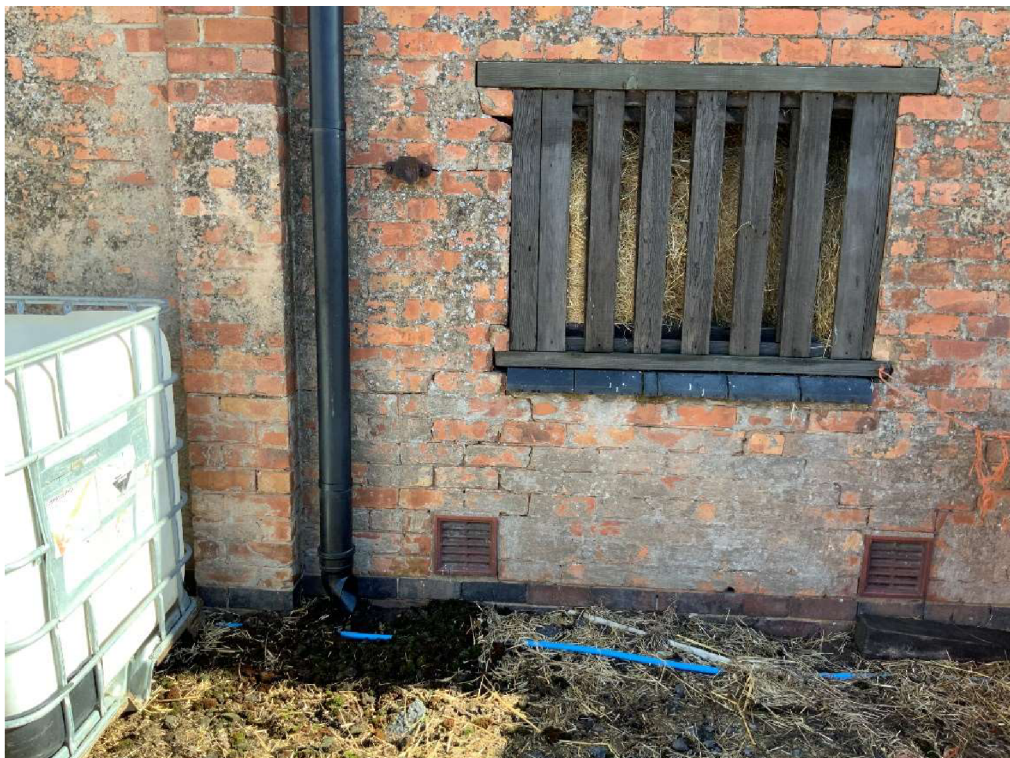
Picture 20 – minor mortar erosion beneath window opening – positive drainage outfall recommended

- 5.2. It is recommended that the below ground drainage in that area be checked and repair made as necessary. This may require the installation of a soak away for the drain which should be constructed at least 6 metres from the building.

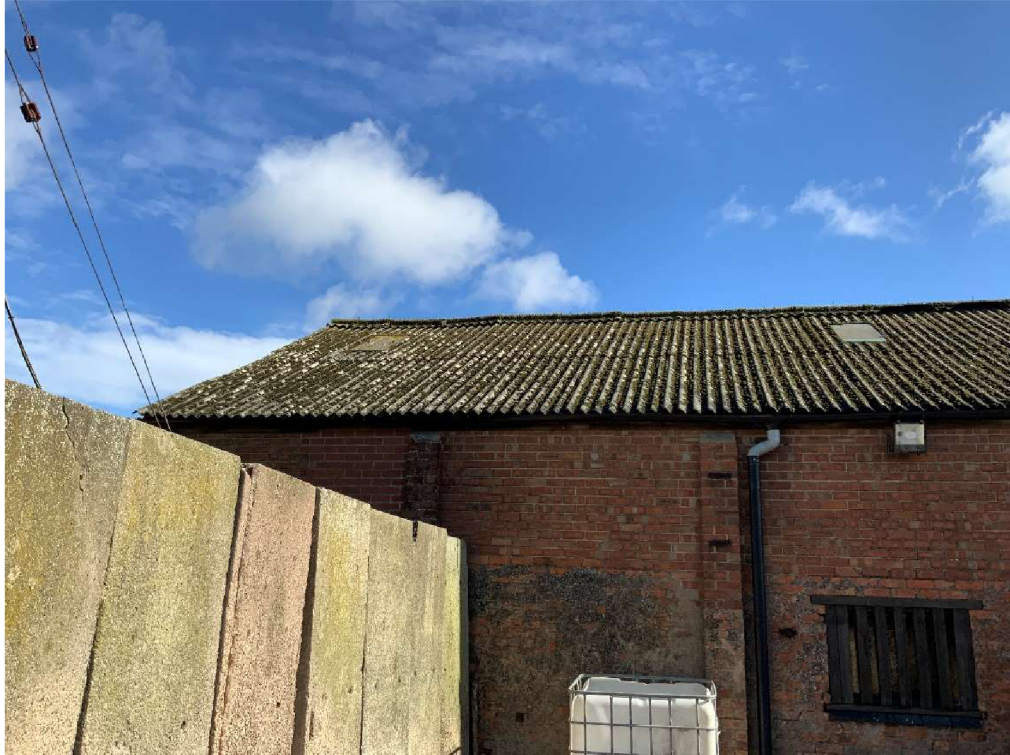
Picture 21 – General roof line good

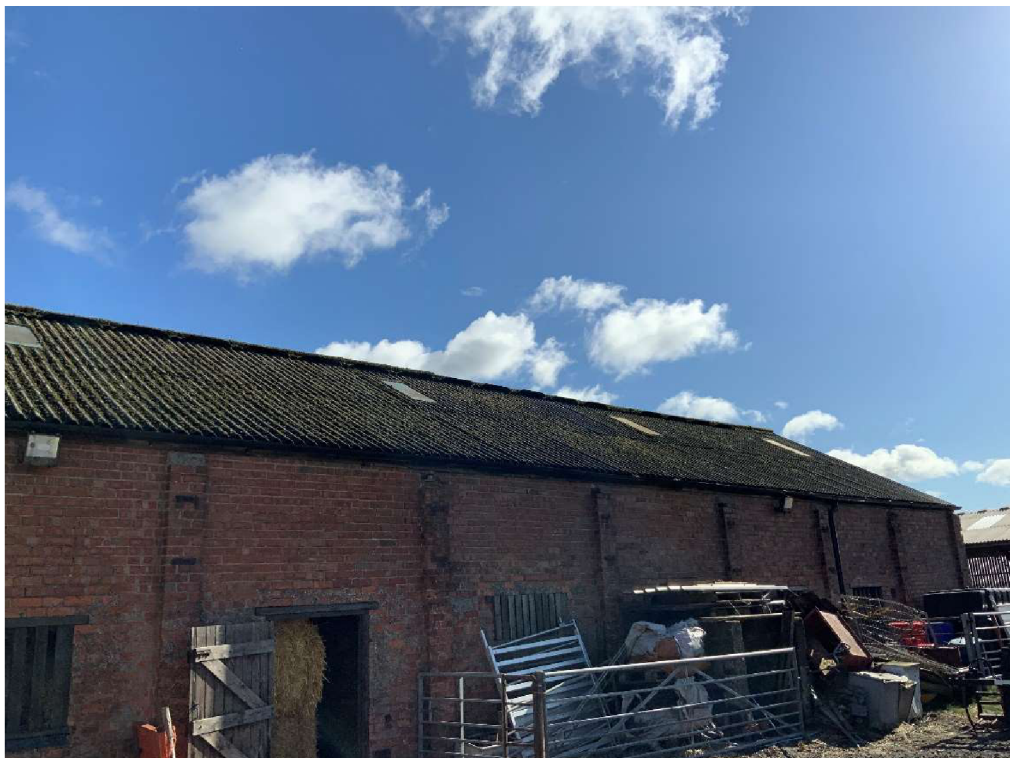
Picture 22 – General roof line good ACM roof panels will need replacement

- 5.7. This suggests that the upper brickwork was constructed at a much later date.
- 5.8. Conversion of the building is considered to be viable, requiring the changing of the roof sheets for insulated sheets. This may require the provision of additional timber purlins or preferably replacement with cold rolled purlins.

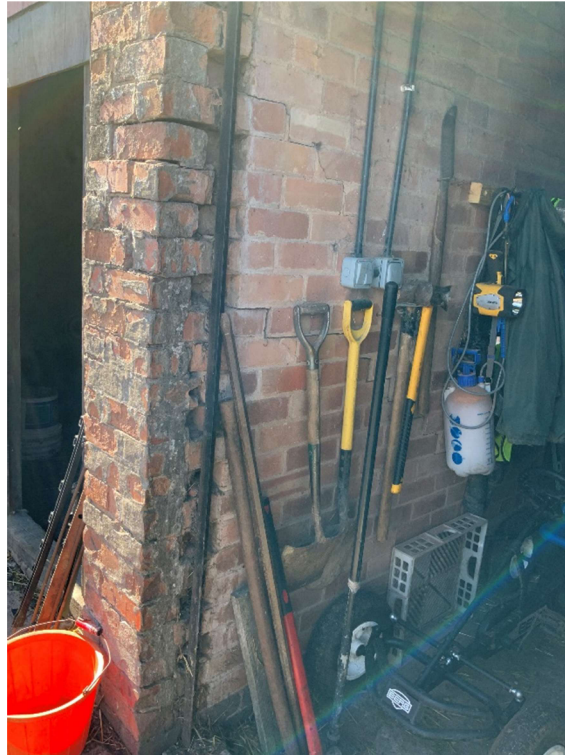
Picture 23 – Closer view of stepped cracking in northern workshop area doorway

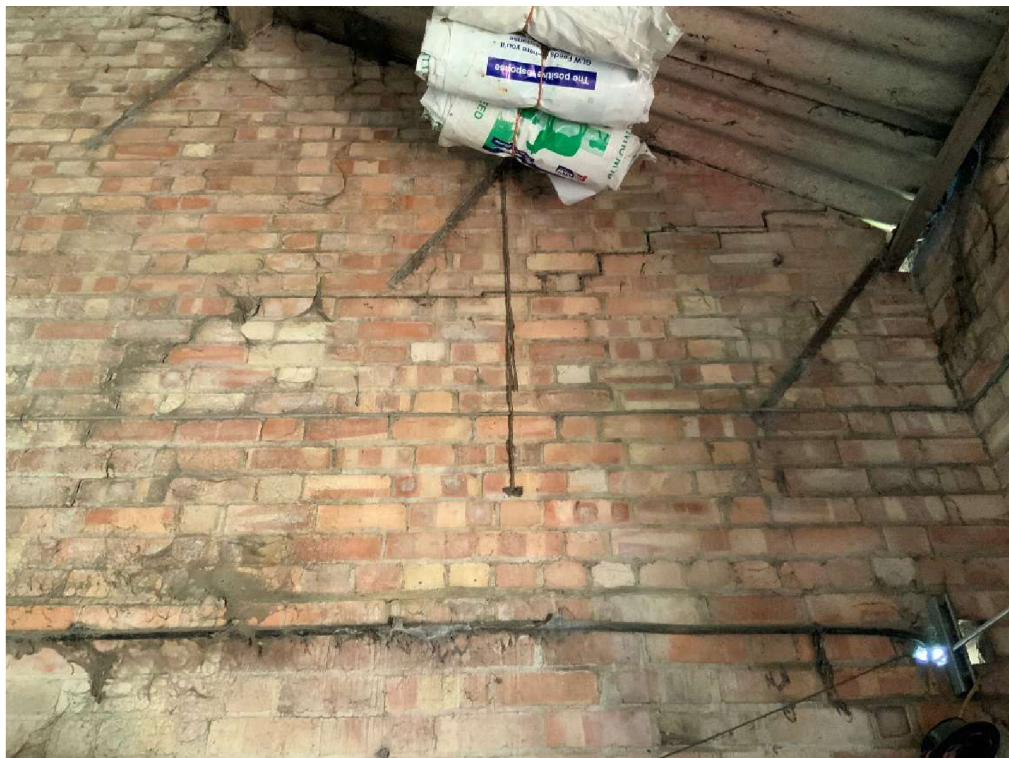
- 5.1. There has been minor settlement of the northern gable which has caused the cracking noted locally. The amount of settlement is around 3-4mm and is not considered to be structurally significant.

Picture 24 – Stepped cracking to north east corner brickwork to be raked out and repointed

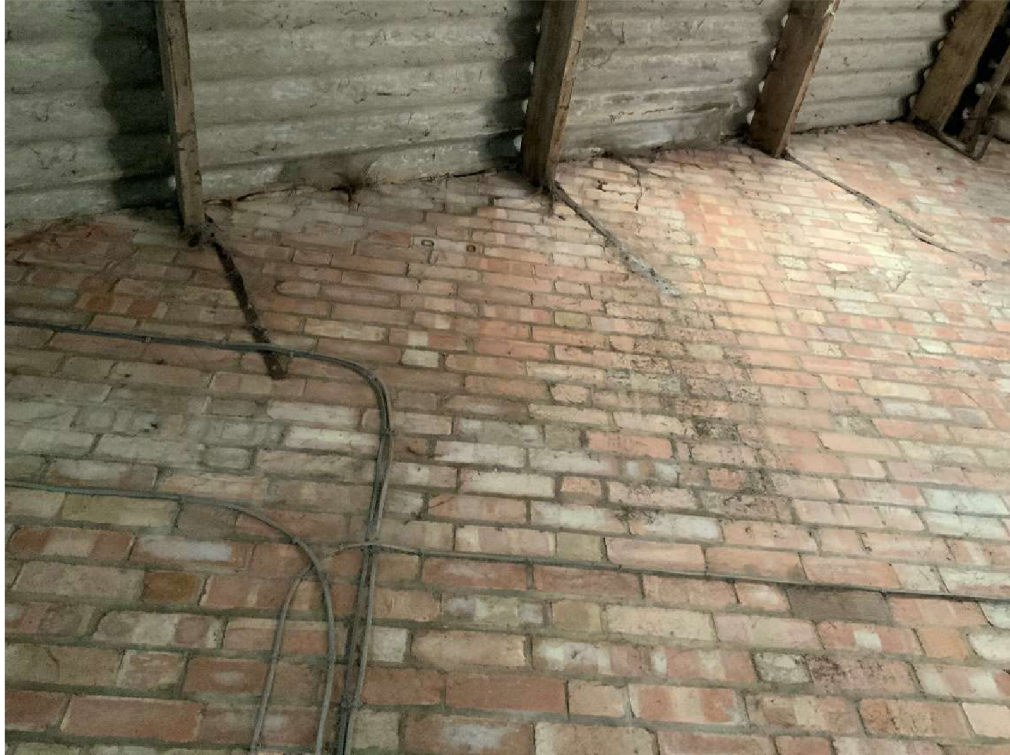
Picture 25 – Purlin holding down straps adequate

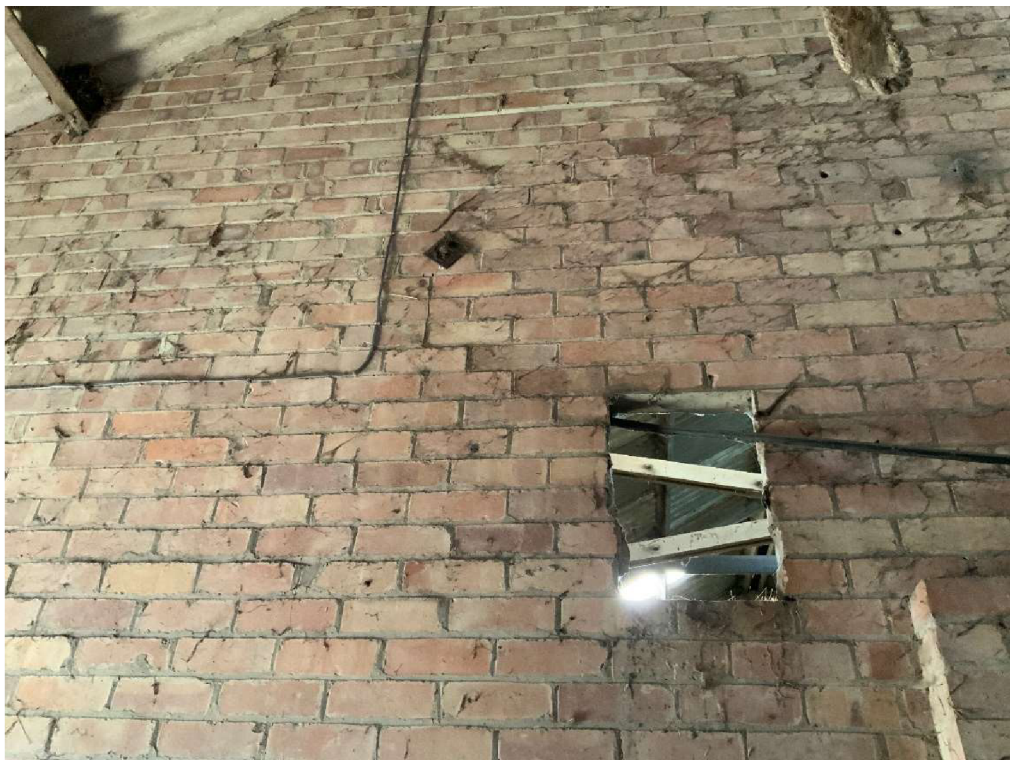
Picture 26 – opening through division wall without lintel over

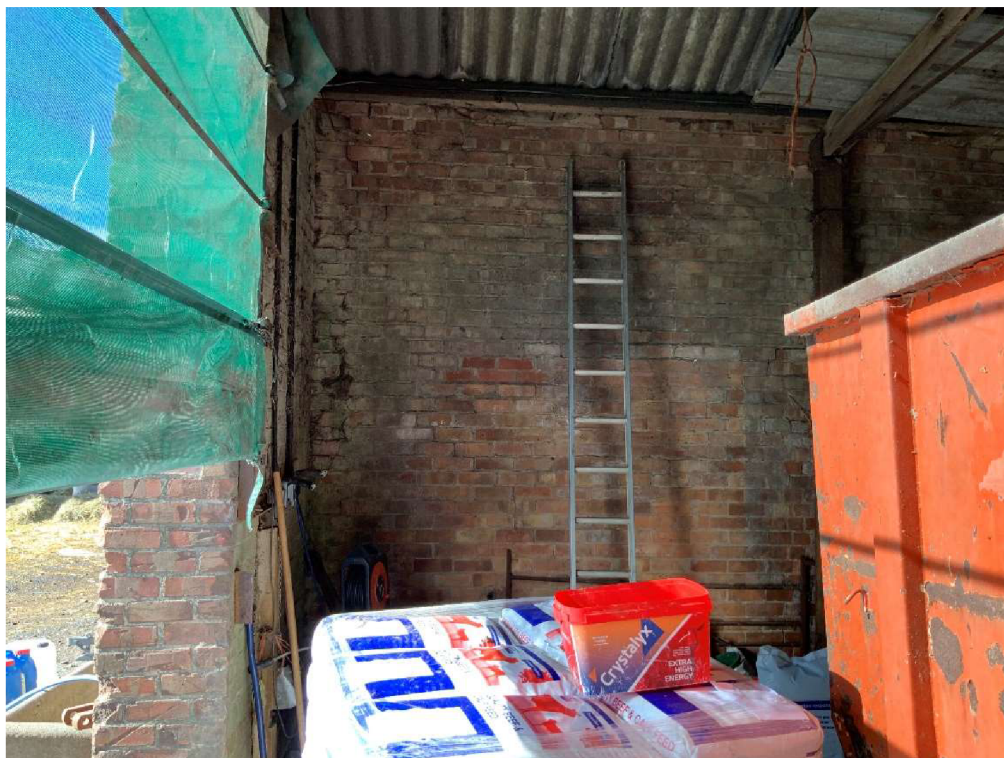
Picture 27 – internal damage to brickwork of south-western corner

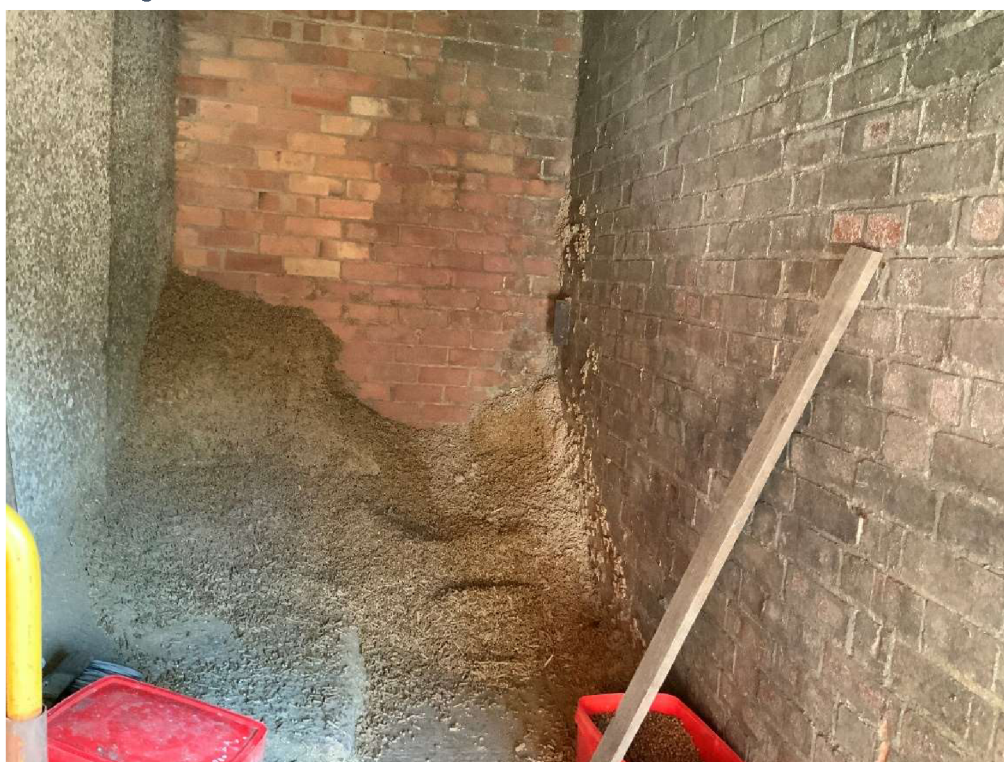
Picture 28 – Stored material in south-eastern corner brickwork which may have caused cracking noted externally

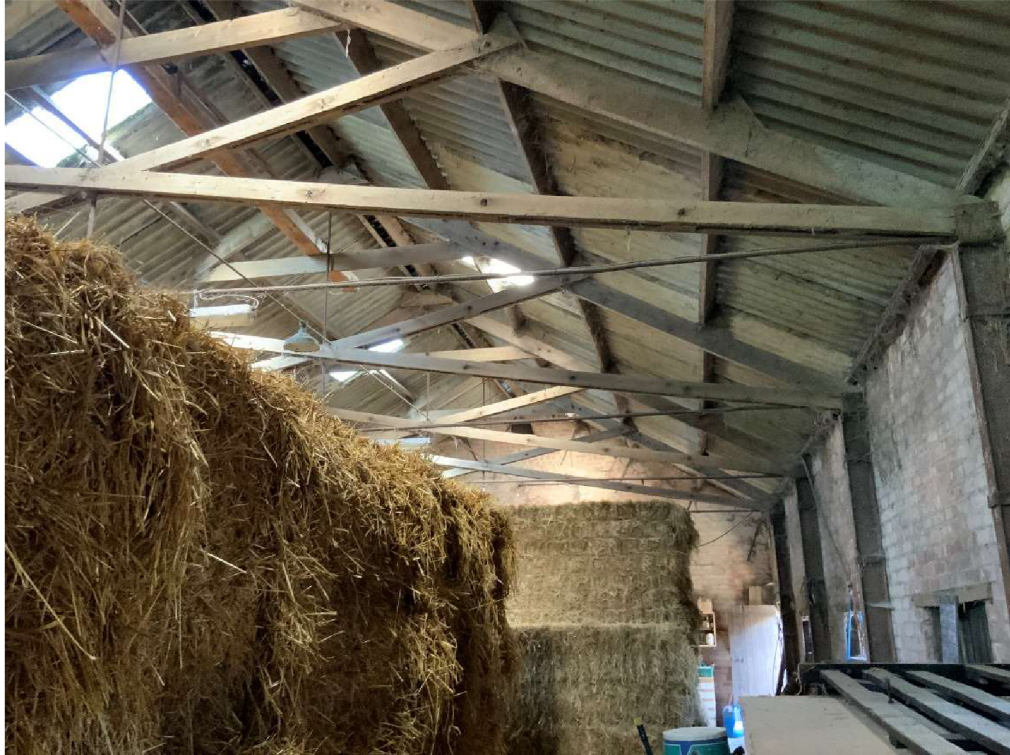
Picture 31 – further view of roof trusses and tie bars of lower member

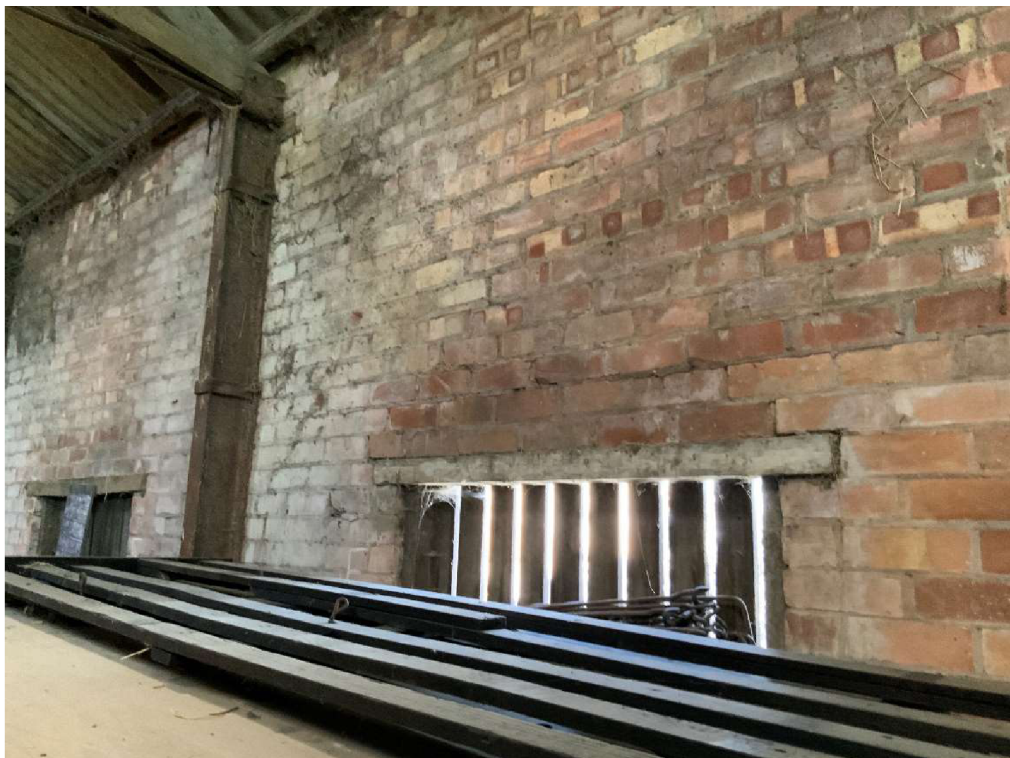
Picture 32 – internal view of cracking over timber lintels
