## General Report

### Report of the inspection of the Brick barn at TempleHall Cottages, Bosworth Road, Wellsborough

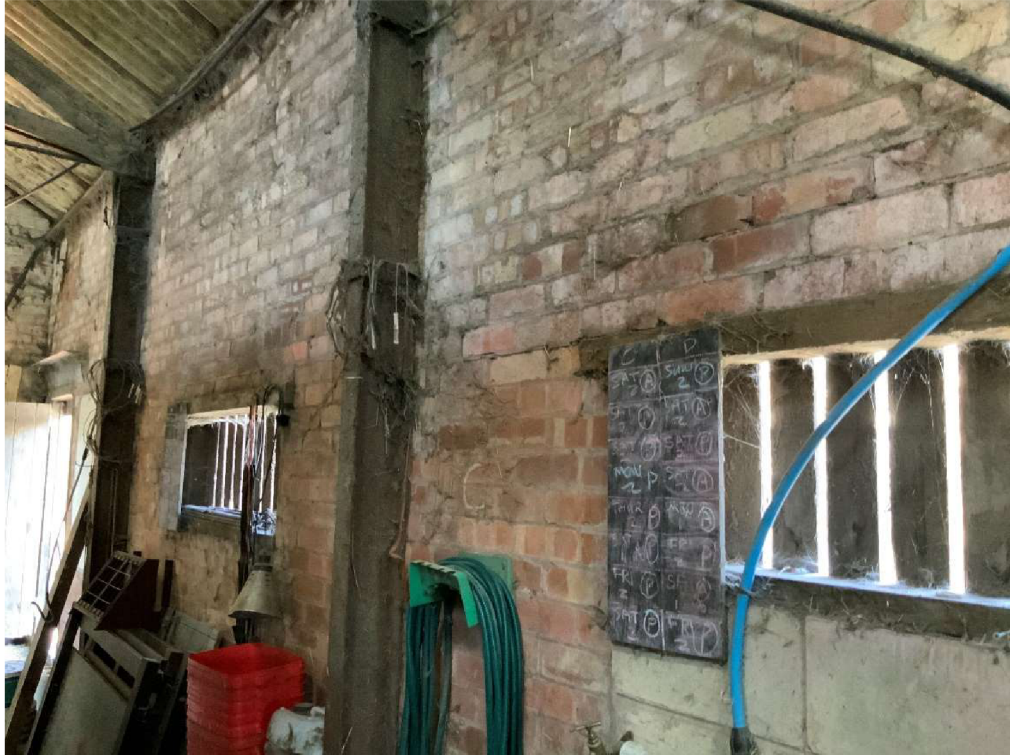
- 5.6. It was noted on the western elevation that there was a difference in the bricks above window lintel level which were smaller and more variegated in colour above lintel level.

- 5.7. This suggests that the upper brickwork was constructed at a much later date.
- 5.8. Conversion of the building is considered to be viable, requiring the changing of the roof sheets for insulated sheets. This may require the provision of additional timber purlins or preferably replacement with cold rolled purlins.

Picture 33 – note change in brickwork approx. 3 courses above window opening

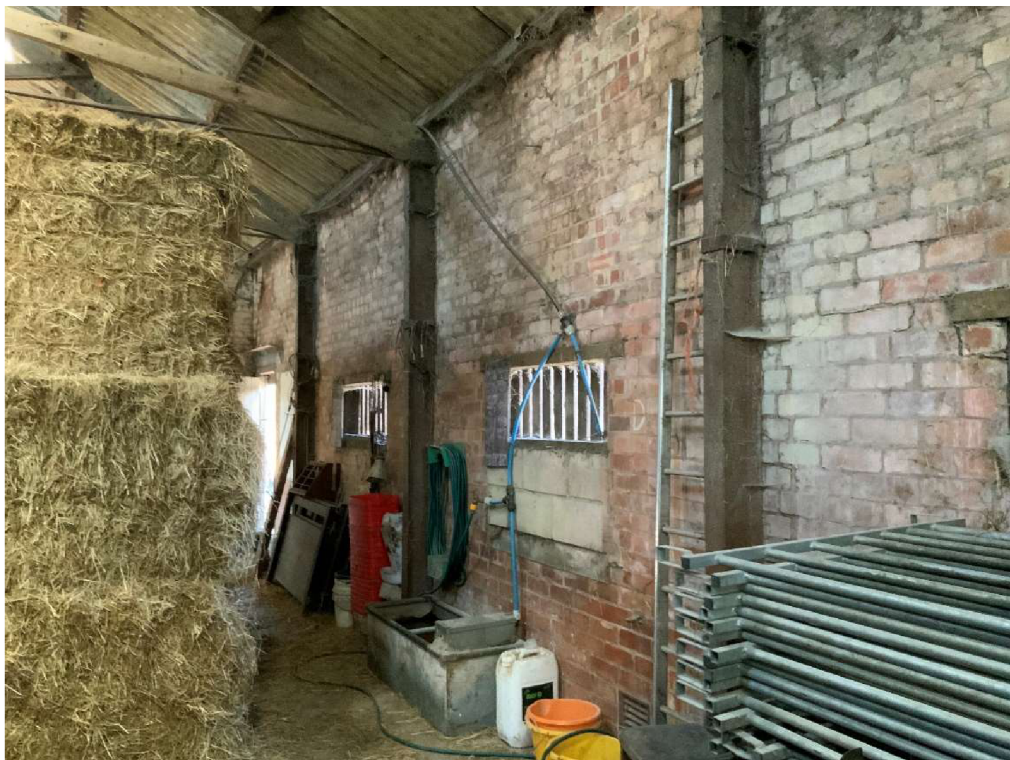
Picture 34 – Note location of strapping bolted through external brick piers at column positions

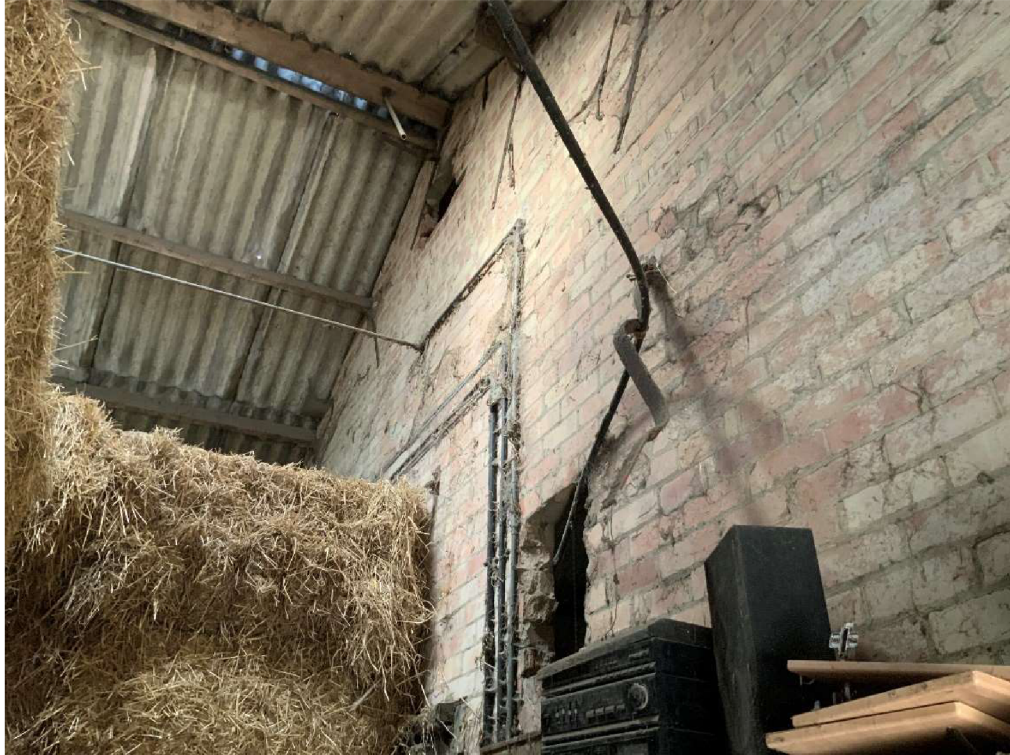
Picture 39 – hole through wall with no lintel – visible daylight at roof vent position (adequate)

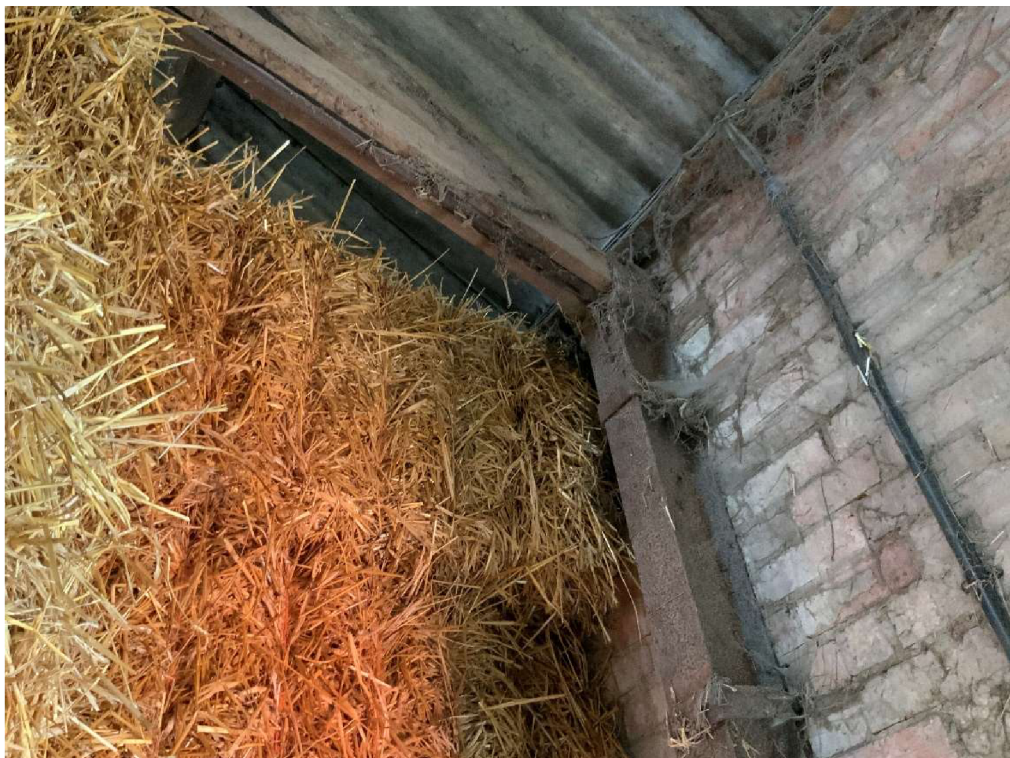
- 3.1. The roof is Big 6 clad and given the age of the building s likely to be asbestos containing material. There are ridge ventilators.
- 3.2. The roof has good line and level, but unsealed at eaves level.

Picture 40 – Open eaves visible as daylight at wall plate

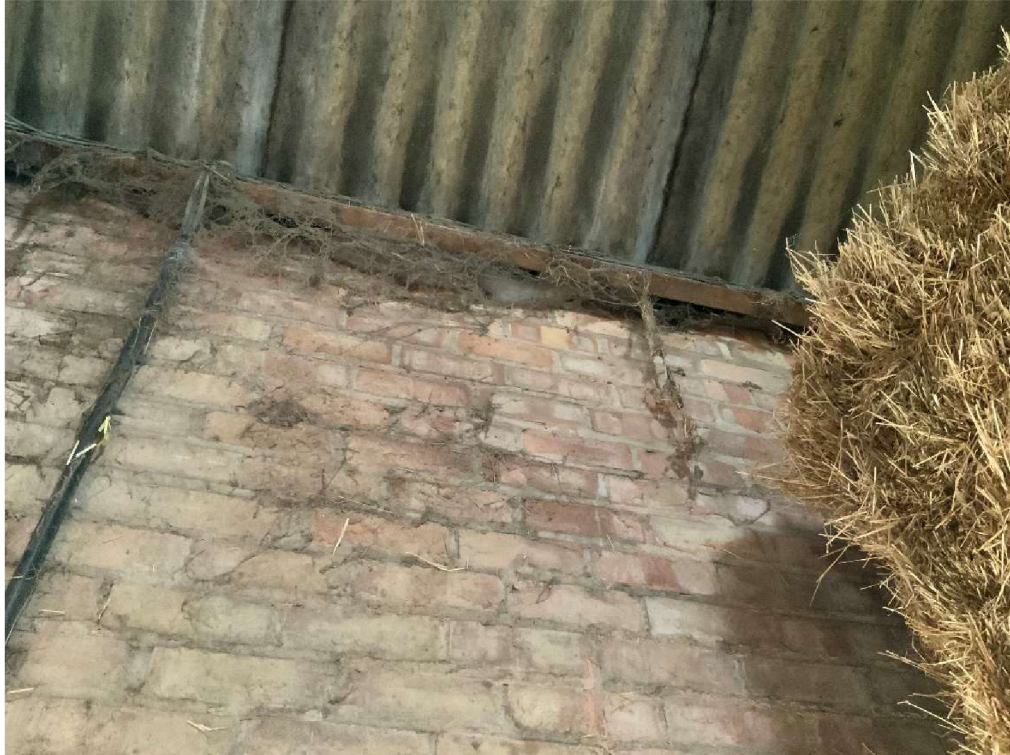
Picture 41 – Purlin adjacent to eaves walls in good condition

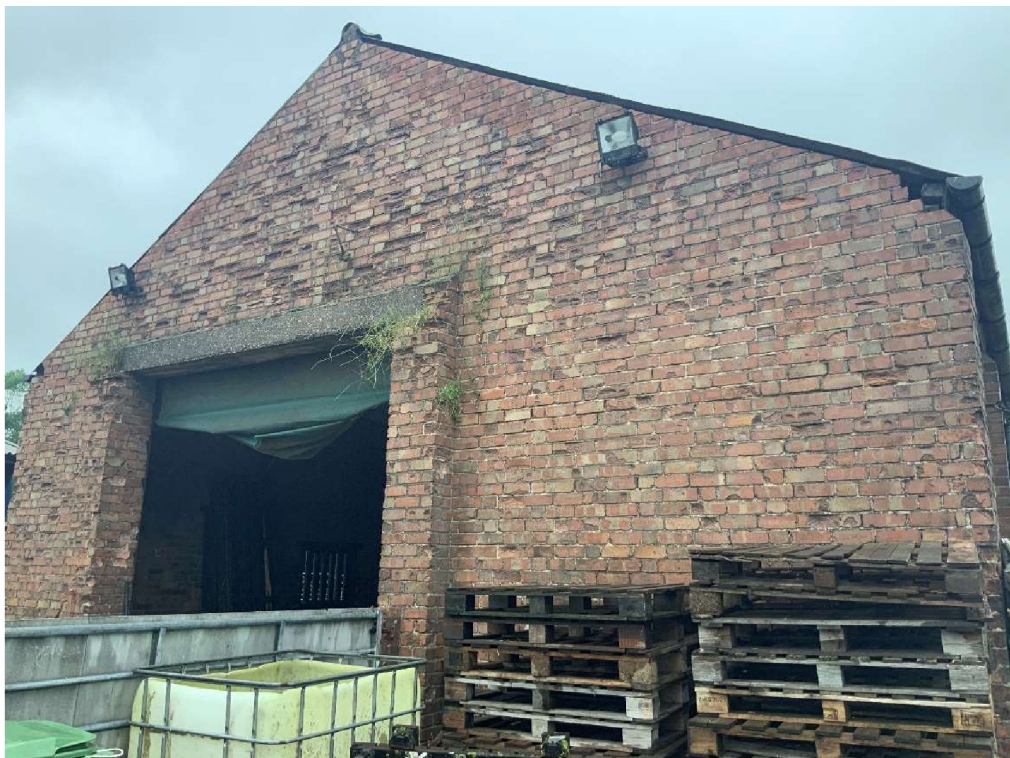
Picture 44 – Southern gable with brick erosion 2023 marginal change and missing eaves bricks

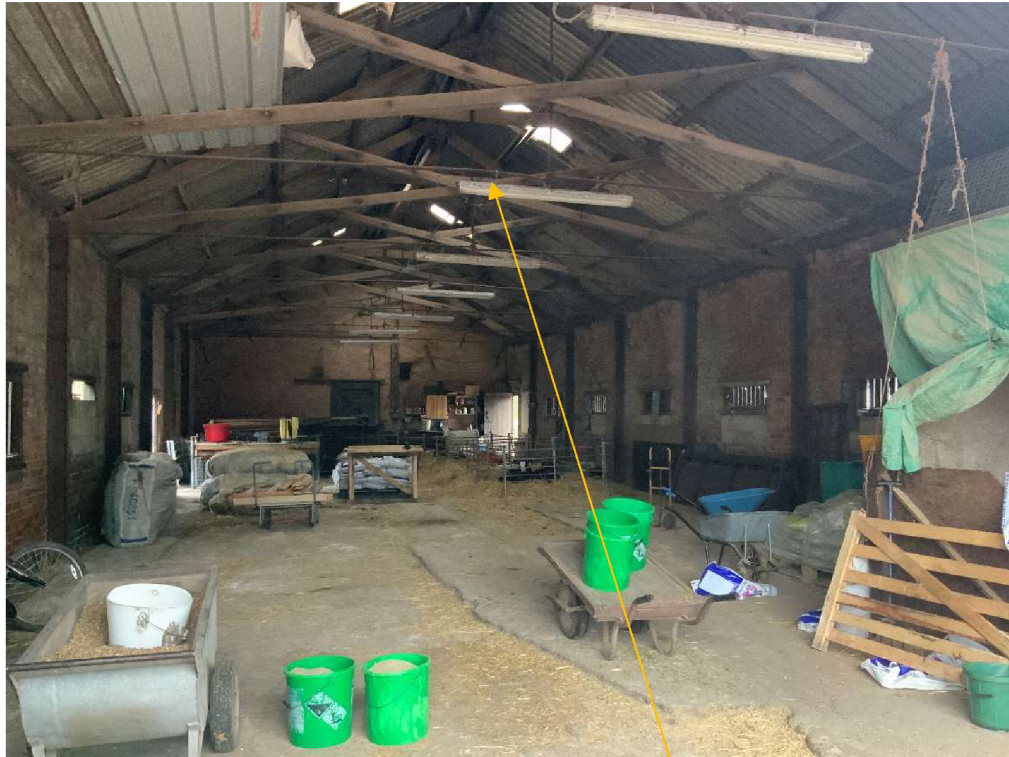
A further visit was carried out on 20 June 2023. The barn had been emptied considerably exposing minor bending to the steel tie bars of the structure which can be heated and straightened if required. Otherwise, the report reinforces the conclusion of clause 5.11  
Photos are appended

Picture 45 – Cleared interior of barn 2023 – note minor bend in tie bar of truss

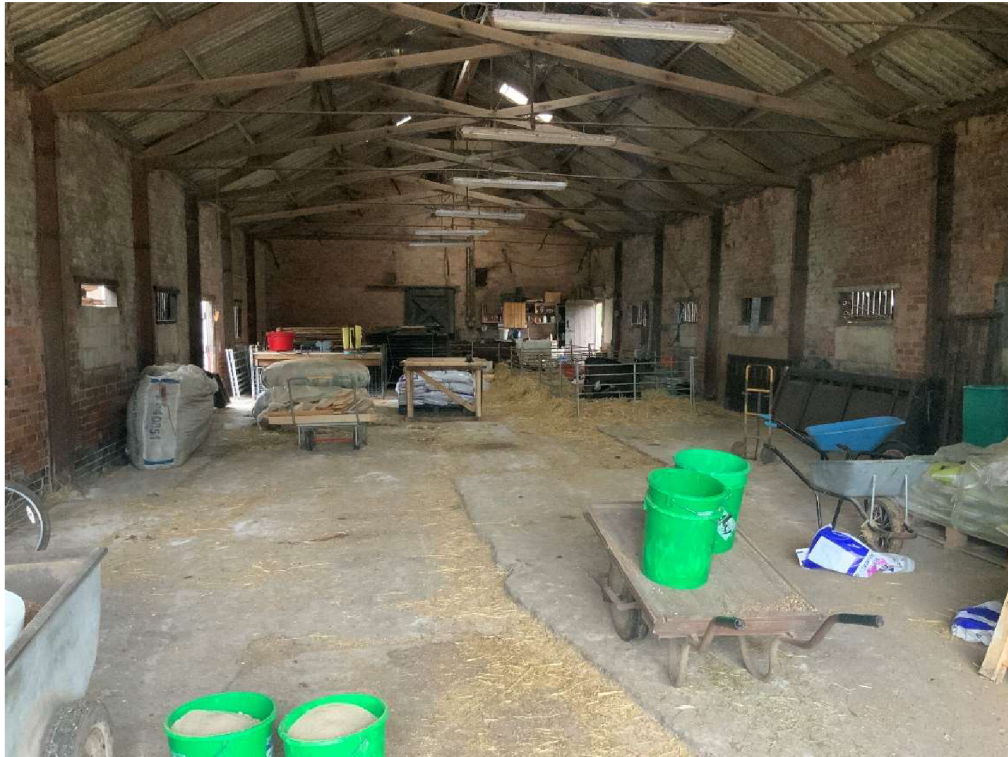
Picture 47 – Interior of cleared barn 2023 - note floor level difference to centre
