**INSURANCE CLAIM**

**CONCERNING SUSPECTED SUBSIDENCE**

**ENGINEERING APPRAISAL REPORT**

35 Manor Street  
HINCKLEY  
Leicestershire  
LE10 0AS

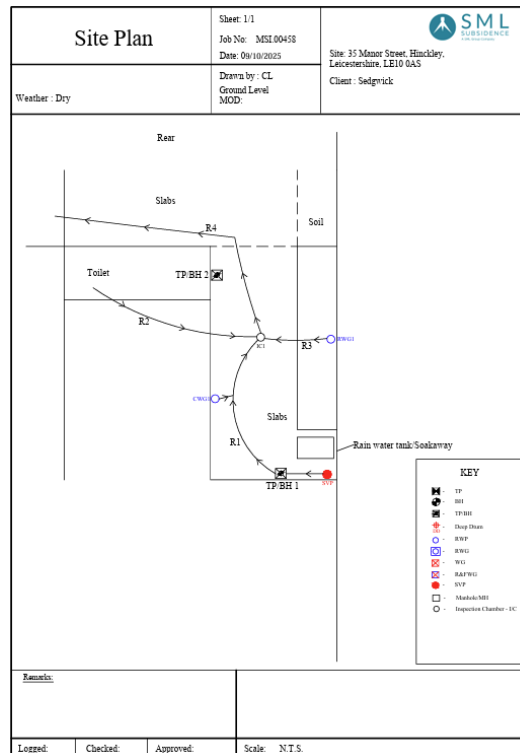
A site investigation was carried out by SML Group on the 9<sup>th</sup> October 2025. The investigation consisted of 2 no trial pit/bore holes and a CCTV survey of the drainage on the localised area.
