# INTERPRETATIVE SITE INVESTIGATION REPORT

35 Manor Street, Hinckley,  
Leicestershire, LE10 0AS

PROJECT REFERENCE: 10806850

OUR REFERENCE: MSI.00458

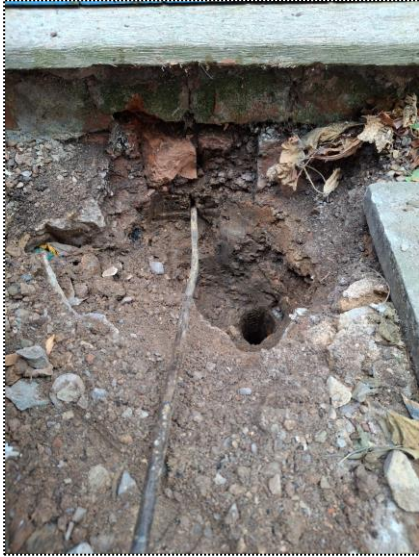
1.

- 1) TP/BH1
- 2) TP/BH2
- 3) Rear of property
- 4) Rear of proeprty

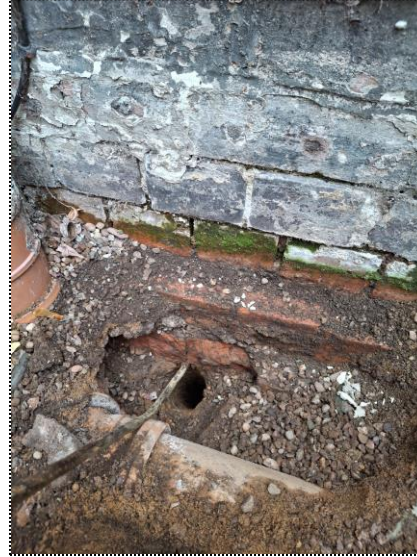
| Remarks<br>1. CAT scanned prior to manual excavation of inspection pit. 2. No groundwater observed. 3. Roots detected at 1.5mbgl. 4. Borehole reached a maximum depth of 4.0mbgl. 5. Terminated due to reaching refusal criteria within very stiff cohesive strata. 6. Backfilled with arisings. | Method, Plant, Stability, Dimensions<br>0.00 - 4.00m WS | Logger<br>CL |

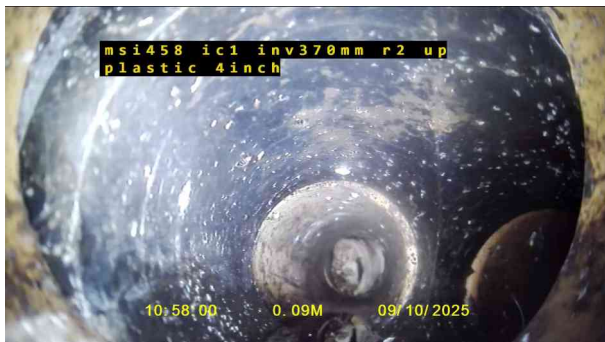
| Scale: 1:50 | Position [m] | Code | Observation | MPEG | Photo | Grade |
|---|---|---|---|---|---|---|
| | 0.09 | JDM | Joint displaced, medium | 00:00:08 | 3 | |

3, 00:00:08, 0.09 m  
Joint displaced, medium

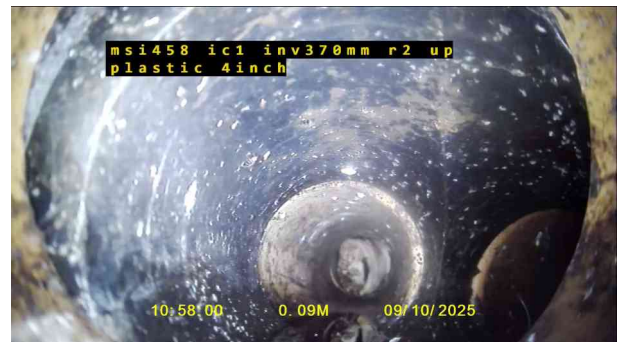
| Scale: 1:50 | Position [m] | Code | Observation | MPEG | Photo | Grade |
|---|---|---|---|---|---|---|
| | 0.09 | JDM | Joint displaced, medium | 00:00:08 | 4 | |

4, 00:00:08, 0.09 m  
Joint displaced, medium

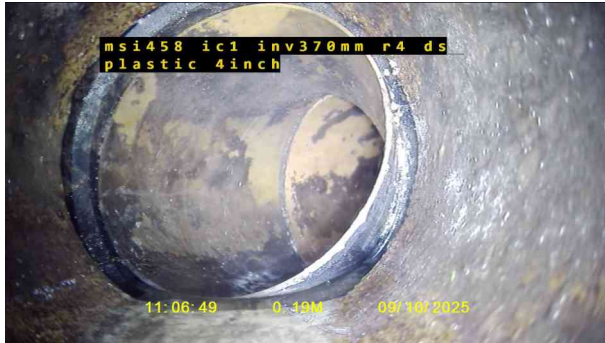
5, 00:00:11, 0.19 m  
Joint displaced, large

| Description | | | | | |
|---|---|---|---|---|---|
| | Excavate and replace junction/bend (100mmØ), Excavation depth 0-1m. | nr | 3 | £83.93 | £251.79 |
| | Excavate trench and replace 100mmØ pipework, Excavation depth 0-1m, First 10m. | nr | 3 | £113.91 | £341.72 |
| | Excavate through and replace concrete paving slabs | m | 3 | £35.97 | £107.91 |

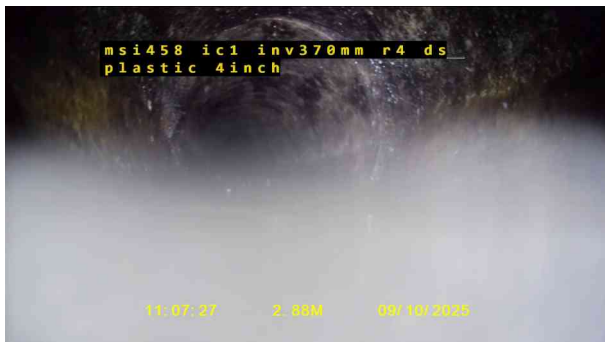
11, 00:00:49, 2.88 m  
Loss of vision, camera under water, start

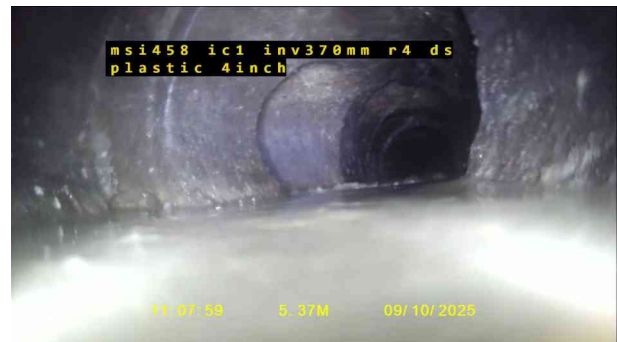
12, 00:01:21, 5.73 m  
Loss of vision, camera under water, finish

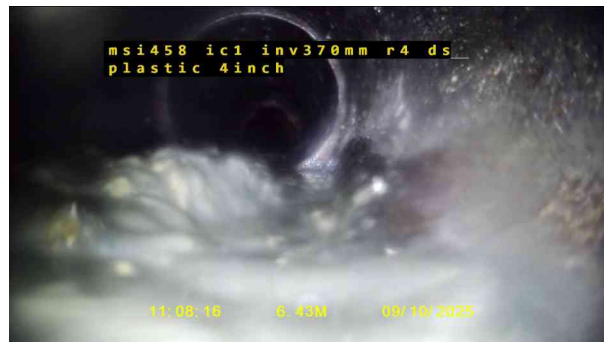
14, 00:01:38, 6.72 m  
Joint displaced, medium
